To: furlongj@telus.net
Subject: cotton slide

Observations in the field

PROJECT: MABEL-COTTONWOOD FSR, TSUIUS CREEK LANDSLIDE DAM OUTBREAK MODELLING FINAL		
TITLE: CHANGES TO THE LOCAL WATERSHED AT KM 33.6 OF THE MABEL-COTTONWOOD FSR FROM 1959-2004		
PROJECT No.: 1114-001	FIG No.: 4-1	REV.:

PROJECT
MABEL-COTTONWOOD FSR, TSUJIS CREEK LANDSLIDE
DAM OUTBREAK, MODELING STUDY

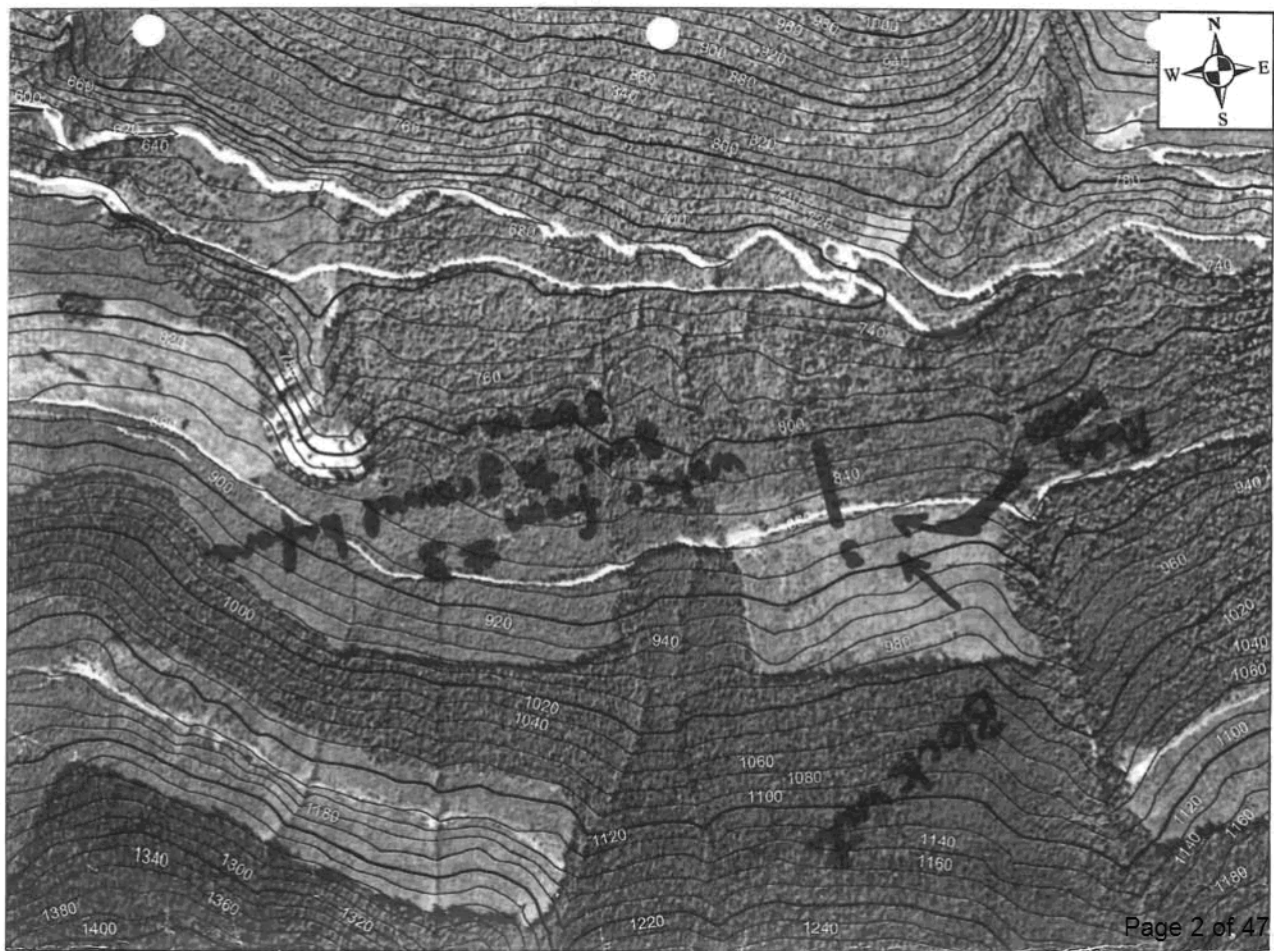
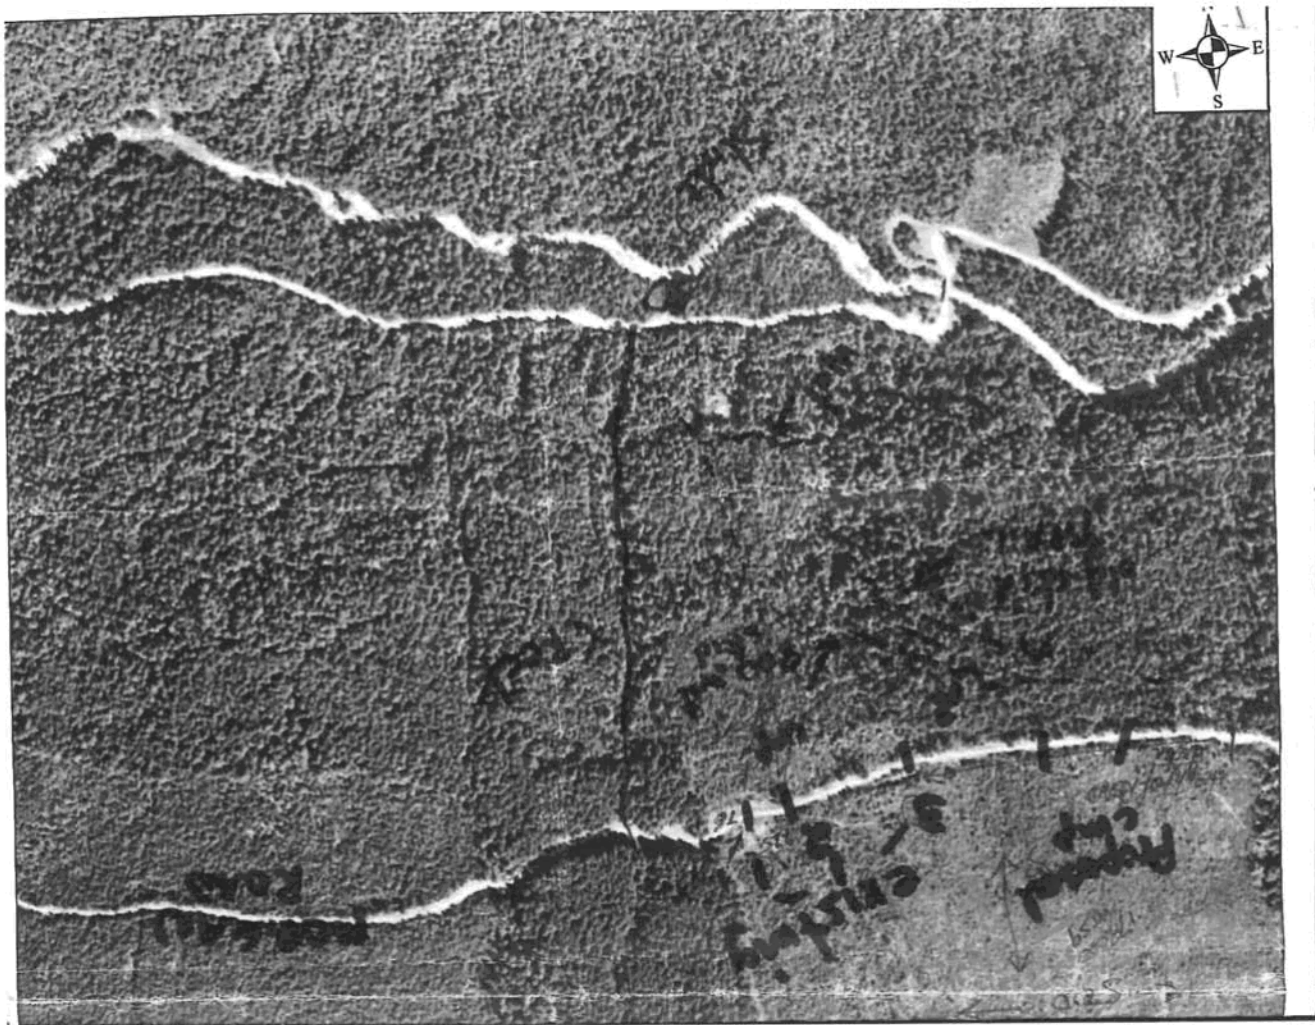
① camp 76 m in from west boundary
 ② camp 125 m " " " existing
 ③ camp 243 m " " " block slope above Rd 40%

Note — after a day & half of hiking — really not a lot to report. water from Morgan Rd + Cutblock are sent thru 3 camps. camp 3 has its water go to ground before the 800 m mark. it seems that #3 water is east of instability — I looked at adding more camps east of #3 — but after hiking down the proposed watercourses — I ran into trail after Trail across the slope — any water directed over would be sent in many directions — this could be done if an excavator went down and cleaned out the gully path.

Below 3rd camp water disappears

GPS 800 water on old trail goes south 30m — over bank.

the trails — the trails are many, and are capable of carrying water during rain events and snow melt. they seem to be stable for the most part and end at major draws

its a large slump.

— solution — water barr Morgan
 to disperse Rono water / culverts #1?
 — squamish culvert at Cotton
 and deal with wet yrs.

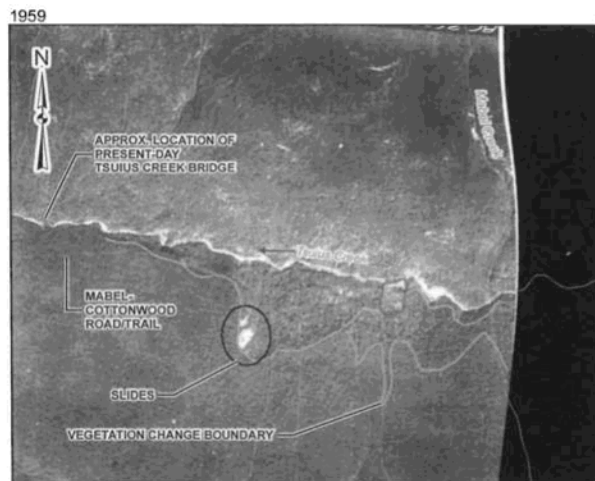
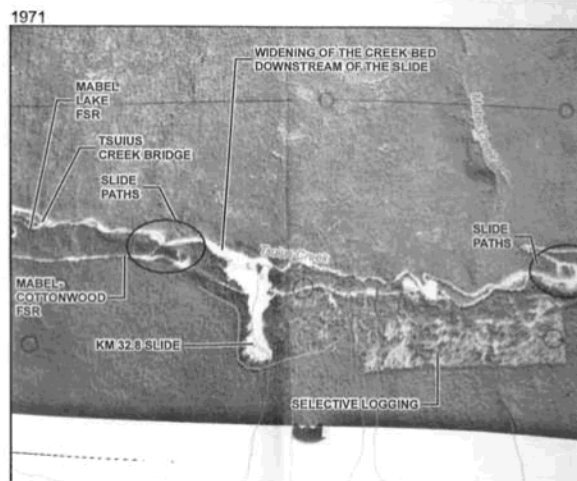
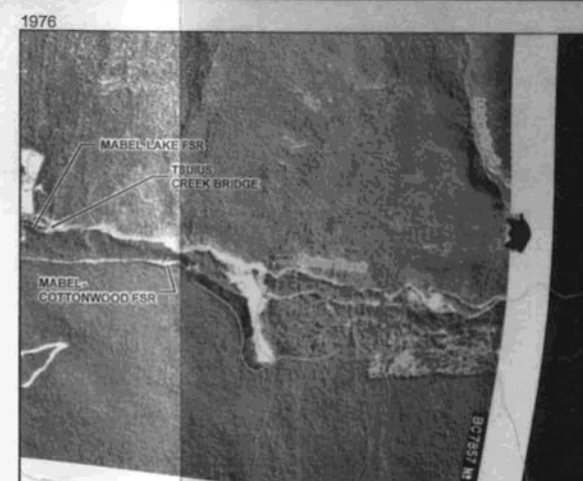
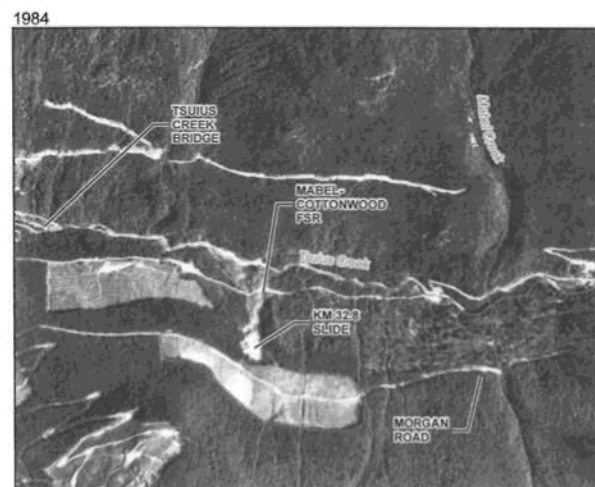
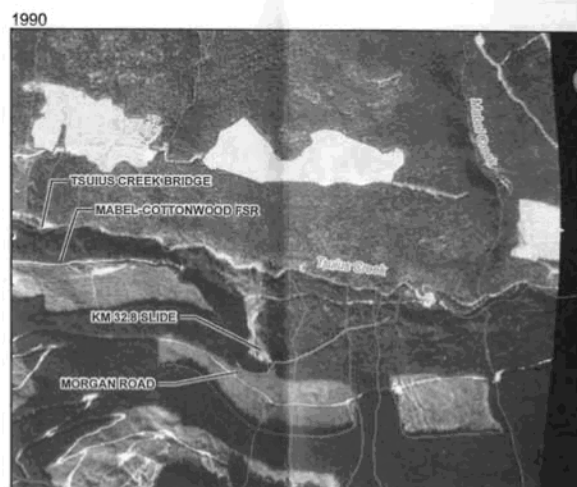
APPROXIMATE LOCATION OF 2011 SLIDE
 — ESCARPMENT
— LOGGING ACTIVITY
← FLOW DIRECTION

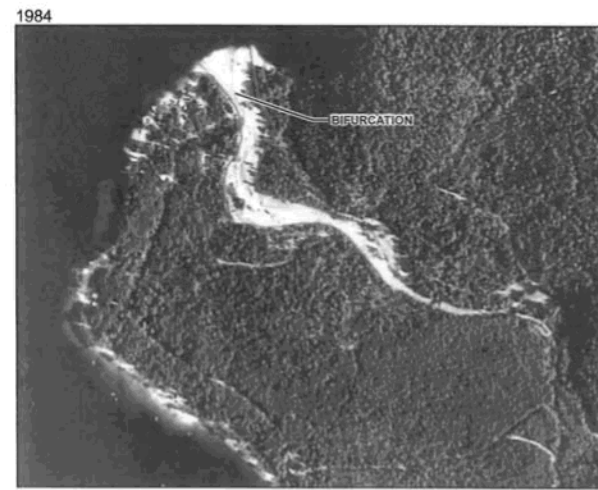
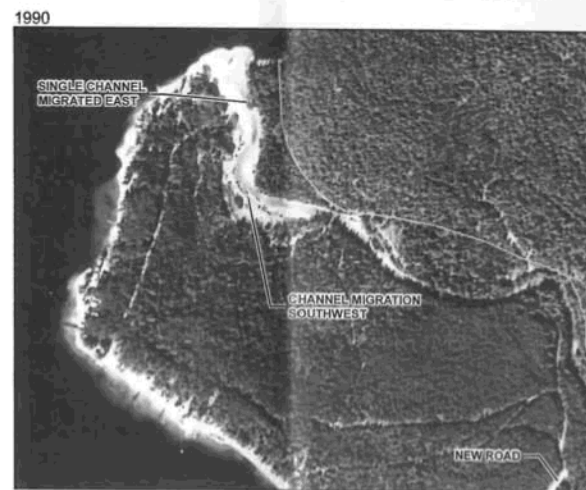
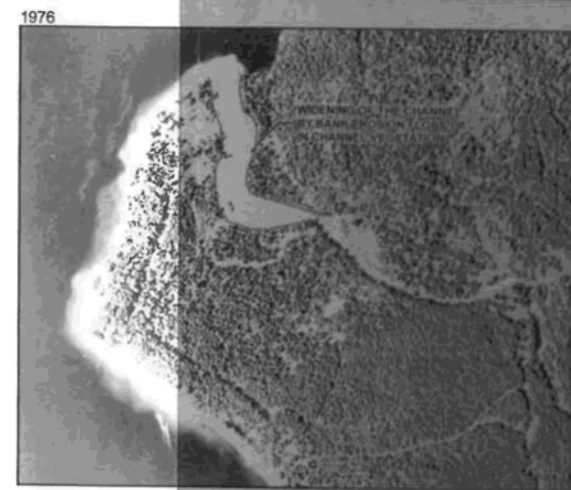
TSURUS CREEK FAN CHANGES FROM 1965-2004

APPROXIMATE
TOP OF BANK

APPROXIMATE
BOTTOM OF BANK

APPROXIMATE EXTENTS OF PROTECTIVE BERM
