Re: Environmental Site Assessment Summary Letter
9857 McKinnon Crescent, Langley, BC & 22346 100 Avenue, Langley, BC

ESA Site Visits – February, May and August 2018

Appendix A – PLG Final ESA Letter (August 23, 2018)

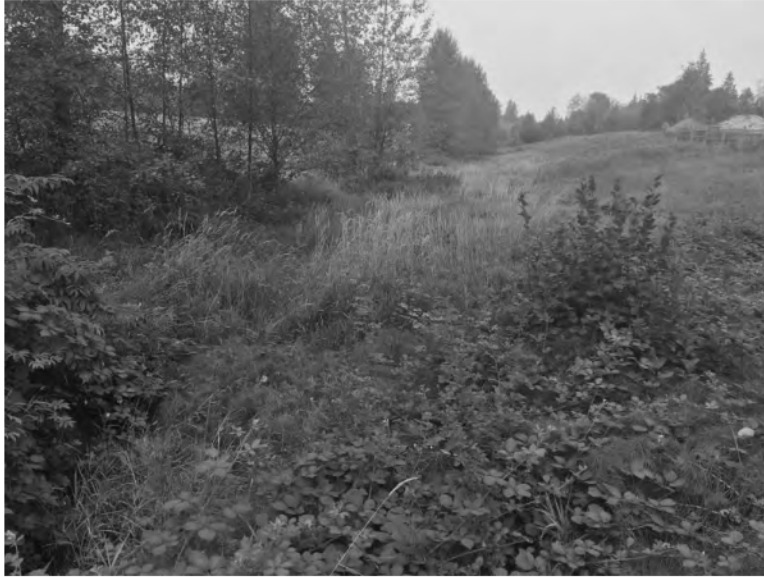
Ditch 1 was observed within a depression along the length of the southern boundary of the Subject Property (Photograph 1). Ditch 1 is confirmed to be a downstream continuation of the off-site watercourse located northwest of the Subject Property. Ditch 1 had a wetted width of approximately 1 m and was moist, with no flow at the time of the site visit. Riparian vegetation adjacent to Ditch 1 included a dominant mixture of Himalayan blackberry (*Rubus discolor*) and common grasses. Several alder trees were also noted along the north side of the ditch.

Photograph 1. View looking west at riparian vegetation of Ditch 1 within the Subject Property.

Based on follow-up ESA results and confirmation during a final field evaluation, Ditch 1 is considered to be a Class B watercourse under the TOL streamside protection bylaw. As a result of placement within the ALR, a setback of 2 m would be appropriate to ensure protection of the watercourse. It is understood that construction will occur away from this ditch and construction will not affect the integrity of this watercourse. No further recommendations are provided.

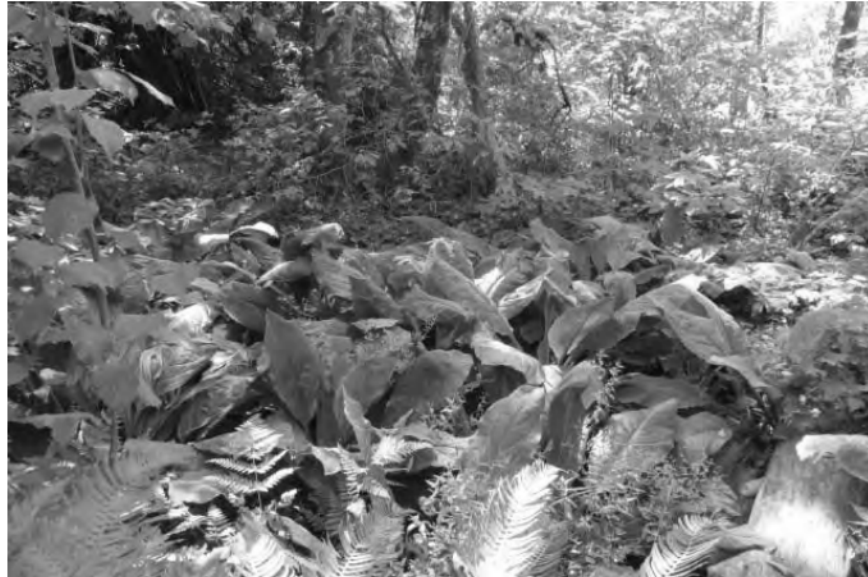
Wetted Pool 1 was observed during the final ESA and was located within the mid-eastern portion of the Subject Property (Figure 3). Wetted Pool 1 is currently not mapped on the TOL's GeoSource mapping and appeared to be a small, topographically and hydrologically isolated wetted area with no evidence of an inflow/outflow source (i.e., no hydrological connection to fish habitat) and no defined edges during the assessment. Although the ground around Wetted Pool 1 was saturated during the assessment, no pooling water was observed (i.e., water present during previous assessments appeared to have drained to ground). Wetted Pool 1 was confirmed to have likely formed as a result of stormwater runoff from the adjacent road (McKinnon Crescent) and overland flow from surrounding higher topography/ground alteration. Vegetation observed within the saturated area of Wetted Pool 1 included mostly Skunk cabbage (*Lysichiton americanus*), with surrounding and overhanging native vegetation consisting of Western red-cedar (*Thuja plicata*), Red alder (*Alnus rubra*), Black cottonwood (*Populus trichocarpa*), Salmonberry (*Rubus spectabilis*), Bracken fern (*Pteridium aquilinum*), Sword fern (*Polystichum munitum*), Horsetail (*Equisetum*) and grasses (*Poaceae*; Photograph 2). Non-native vegetation included Himalayan blackberry (*Rubus armeniacus*), ivy (*Hedera* sp.) and holly (*Ilex* sp.). Non-native Himalayan blackberry made up approximately 10% of the vegetation within and adjacent to Wetted Pool 1. The existence of Skunk cabbage during the assessment was confirmed to be due to the presence of significant canopy cover (i.e., overhanging vegetation) which contributes to a slow the evaporation rate from Wetted Pool 1.

The combination of retained moisture and saturated soils as a result of topography likely explains the presence of Skunk cabbage during the final assessment.

Photograph 2. View looking east at skunk cabbage and native vegetation within and around Wetted Pool 1 within Subject Property.

Based on follow-up ESA results and confirmation during a final field evaluation, Wetted Pool 1 is considered to be a topographically isolated wetted depression with a lack of hydrologic connectivity and no defined aquatic boundary that would indicate a wetland classification. As a result, no classification or streamside setback is applicable.

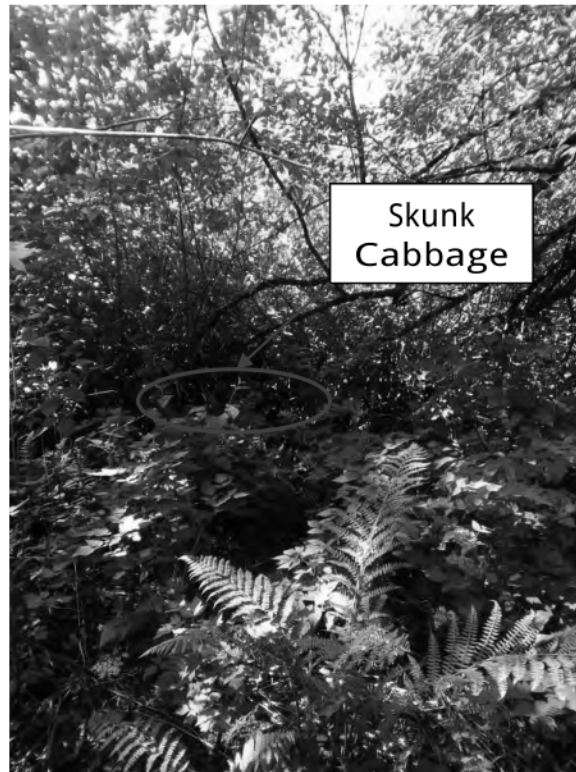
Wetted Pool 3 was observed during the final ESA and was located within the mid-central portion of the Subject Property, between Wetted Pools 1 and 2 (Figure 3). Wetted Pool 3 is currently not mapped on the TOL's GeoSource mapping and appeared to be a small, topographically and hydrologically isolated wetted area with no evidence of an inflow/outflow source (i.e., no hydrological connection to fish habitat) and no defined edges during the assessment. Although the ground around Wetted Pool 3 was saturated during the assessment, no pooling water was observed (i.e., water present during previous assessments appeared to have drained to ground). Wetted Pool 3 was confirmed to have likely formed as a result of stormwater runoff from the adjacent road (McKinnon Crescent) and overland flow from surrounding higher topography/ground alteration. Vegetation observed within the saturated area of Wetted Pool 3 included mostly Skunk cabbage (*Lysichiton americanus*), with surrounding and overhanging native vegetation consisting of Red alder (*Alnus rubra*), Black cottonwood (*Populus trichocarpa*), Salmonberry (*Rubus spectabilis*), Bracken fern (*Pteridium aquilinum*), Sword fern (*Polystichum munitum*), Horsetail (*Equisetum*) and grasses (*Poaceae*; Photograph 3). Non-native vegetation included Himalayan blackberry (*Rubus armeniacus*), ivy (*Hedera* sp.) and holly (*Ilex* sp.). Non-native Himalayan blackberry made up approximately 20% of the vegetation around Wetted Pool 3. The existence of Skunk cabbage during the assessment was confirmed to be due

to the presence of significant canopy cover (i.e., overhanging vegetation) which presumably slowed the evaporation rate from Wetted Pool 3. The combination of retained moisture and saturated soils as a result of topography likely explains the presence of Skunk cabbage during the final assessment.

Photograph 3. View looking south at skunk cabbage (red circle) and native vegetation within and around Wetted Pool 3 within Subject Property.

Based on follow-up ESA results and confirmation during a final field evaluation, Wetted Pool 3 is considered to be a topographically isolated wetted depression with a lack of hydrologic connectivity and no defined aquatic boundary that would indicate a wetland classification. As a result, **no classification or streamside setback is applicable.**

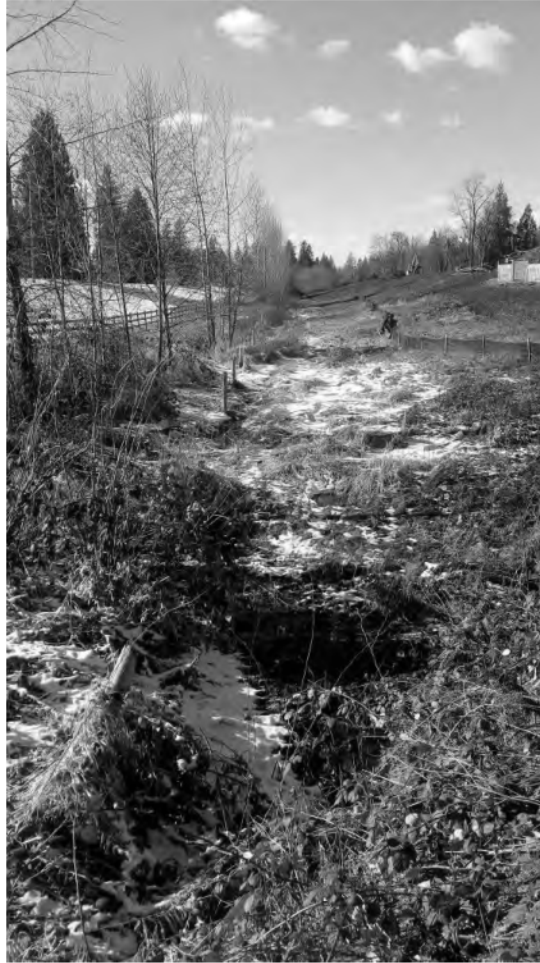
Ditch 1 was observed along the entire southern boundary of the Subject Property (Photograph 1). Ditch 1 is a downstream continuation of the off-site watercourse located northwest of the Subject Property. Ditch 1 had an approximate wetted width of 1 metre, with northwest-southeast flowing water observed at the time of assessment (Photograph 2). Most riparian vegetation adjacent to Ditch 1 was dormant and covered by snow at the time of assessment.

Photograph 1. View looking west at Ditch 1 within the Subject Property.

Under the TOL classification system, Ditch 1 is currently mapped as a Class B ditch. Under the RAR criteria, this watercourse is subject to a **2 m streamside setback**. However, upon completion of a recommended second field assessment, the QEP may consider declassification of the mapped Class B ditch to a Class C ditch. Further evaluation of this watercourse is recommended to confirm classification and setback, if applicable.

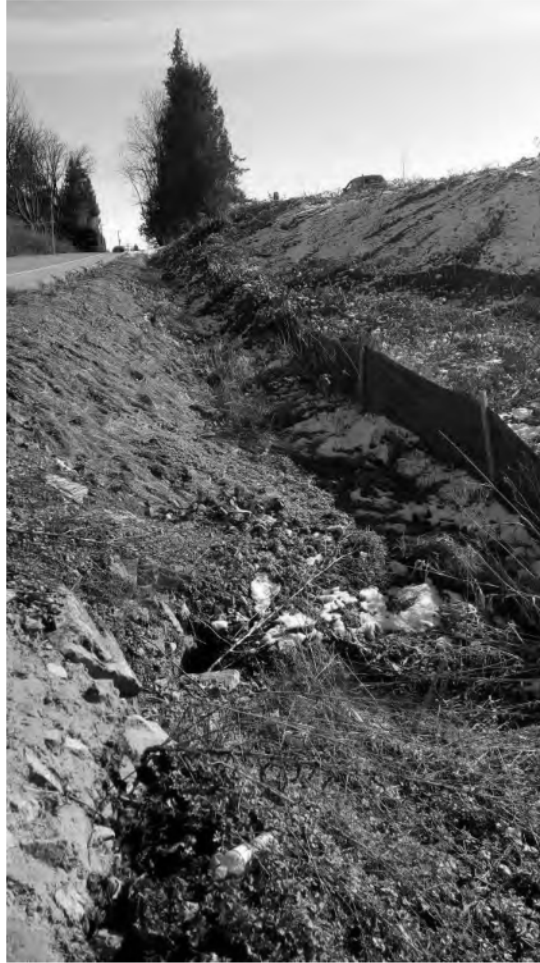
Ditch 2 was an off-site watercourse approximately 85 metres in length along the eastern boundary of the Subject Property. Ditch 2 appeared to be a man-made ditch, likely for roadside drainage purposes and is approximately 0.5 metres wide (Photograph 2). Water present within Ditch 2 at the time of assessment was low and flowed in a south-north direction. No overhanging riparian vegetation was observed and the area was covered in snow during the assessment.

Photograph 2. View looking south at Ditch 2 outside of the Subject Property.

Based on GeoSource mapping and confirmed during a field evaluation, Ditch 2 is considered to be a Class C roadside ditch. As a result, no streamside setback is applicable.

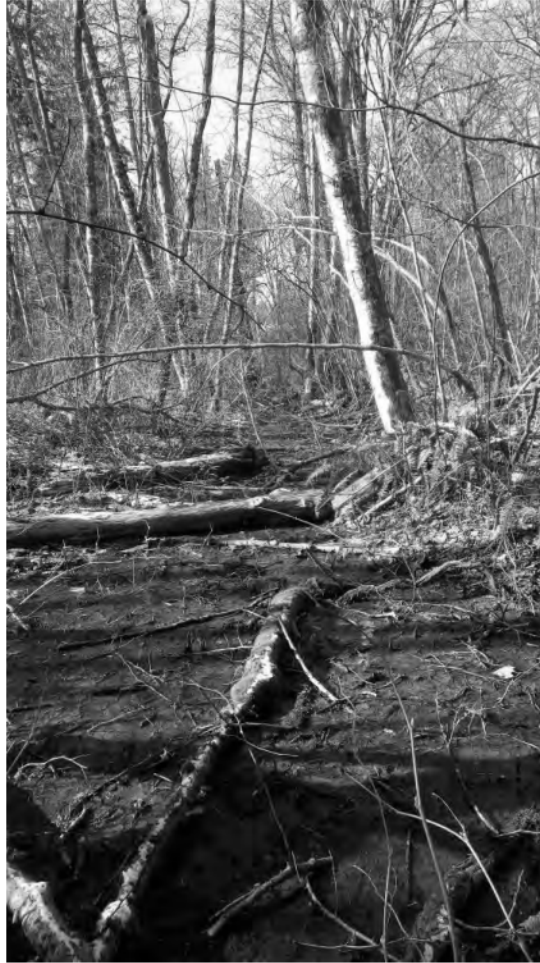
Wetted Pool 1 was identified during the preliminary ESA running northwest-southeast within the northern portion of the Subject Property. Wetted Pool 1 is currently not mapped on GeoSource mapping. Water was present in Wetted Pool 1 with an approximate average wetted width of 2.5 metres at the time of assessment (Photograph 3). Wetted Pool 1 appeared to be a low-lying depression with evidence of shallow scouring in the western portion. A gradual slope to the north showed evidence of overland flow from higher areas. Substrate comprised of mud and leaf litter, consistent with adjacent overhanging riparian vegetation. Native riparian vegetation included Western red-cedar (*Thuja plicata*), Red alder (*Alnus rubra*), Black cottonwood (*Populus trichocarpa*), Salmonberry (*Rubus spectabilis*) and Sword fern (*Polystichum munitum*). Non-native riparian vegetation included Himalayan blackberry (*Rubus armeniacus*) and holly (*Ilex* sp.). Non-native Himalayan blackberry made up approximately 10% of the riparian vegetation along Wetted Pool 1.

Photograph 3. View looking west at Wetted Pool 1 within the Subject Property.

Snow cover and frozen conditions made it difficult to confirm Wetted Pool 1 classification and appropriate setback requirement. A follow-up ESA is recommended to determine if Wetted Pool 1 is hydrologically connected to any watercourses with fish potential/value and confirm if a setback applies. At this time, only preliminary assessment findings are associated with Wetted Pool 1.

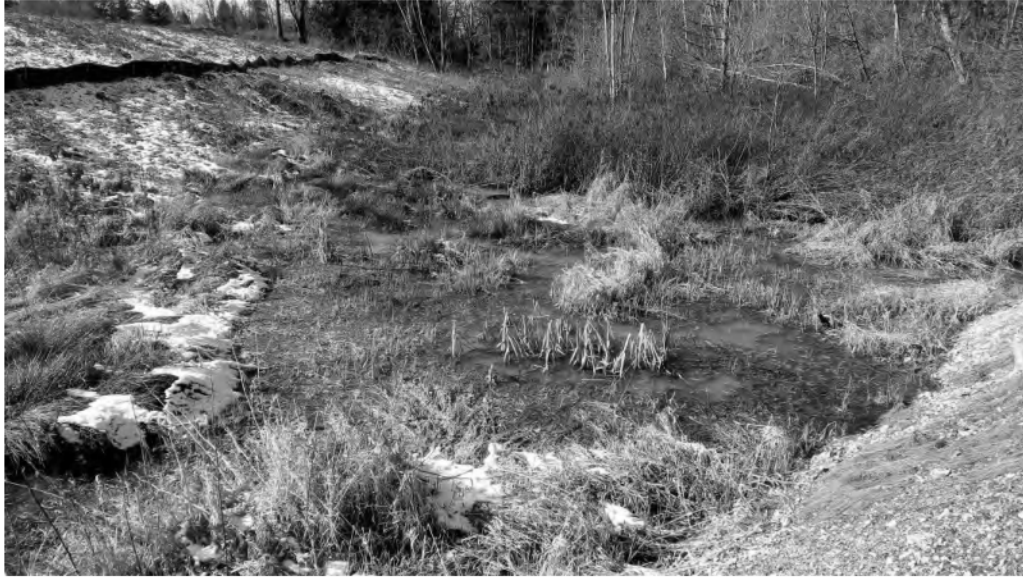
Wetted Pool 2 was identified during the preliminary ESA within the mid-eastern portion of the Subject Property. Wetted Pool 2 is currently not mapped on GeoSource mapping. Frozen water was present in Wetted Pool 2 at the time of assessment (Photograph 4). Wetted Pool 2 appeared to be a large wetted pool area with no evidence of defined edges, except for the delineation from adjacent upward sloping southern and eastern areas. Vegetation observed within and adjacent to Wetted Pool 2 included a mixture of native grasses (*Poaceae*).

Photograph 4. View looking west at Wetted Pool 2 within the Subject Property.

Snow cover and frozen conditions made it difficult to confirm Wetted Pool 2 classification and appropriate setback requirement. A follow-up ESA is required to determine if Wetted Pool 2 is hydrologically connected to any watercourses with fish potential/value and confirm if a setback applies. At this time, only preliminary assessment findings are associated with Wetted Pool 2.

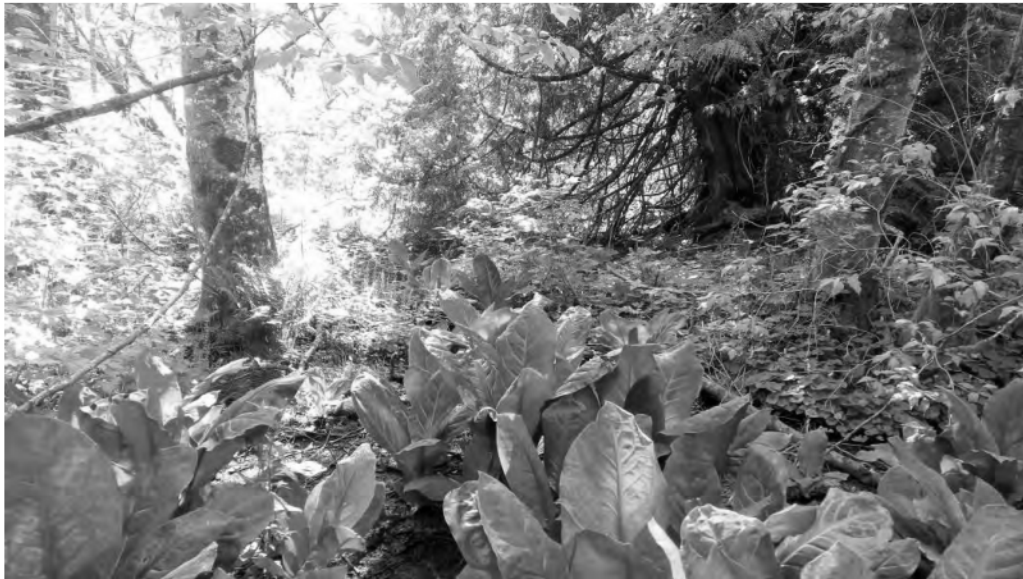
Wetted Pool 1 was observed during the follow-up ESA and was located within the mid-eastern portion of the Subject Property (Figure 2). Wetted Pool 1 appeared to be an independent wetland (i.e., exhibited 'wetland like' features, lacked hydrologic connectivity, unable to provide fish habitat on or off-site) and is currently not mapped on the TOL's GeoSource mapping. Standing water was observed in Wetted Pool 1 at the time of assessment. The ground around Wetted Pool 1 was heavily saturated and water at this location appeared to drain to

ground (i.e., did not appear to travel off-site). Skunk cabbage (*Lysichiton americanus*) and a variety of hydrophytic vegetation were observed within the saturated area (Photograph 1). Substrate comprised of mud and leaf litter, consistent with adjacent overhanging riparian vegetation. Native riparian vegetation included Western red-cedar (*Thuja plicata*), Red alder (*Alnus rubra*), Black cottonwood (*Populus trichocarpa*), Salmonberry (*Rubus spectabilis*), Bracken fern (*Pteridium aquilinum*), Sword fern (*Polystichum munitum*), Horsetail (*Equisetum*) and grasses (*Poaceae*). Non-native riparian vegetation included Himalayan blackberry (*Rubus armeniacus*), ivy (*Hedera* sp.) and holly (*Ilex* sp.). Non-native Himalayan blackberry made up approximately 20% of the riparian vegetation along Wetted Pool 1.

Photograph 1. View looking east at skunk cabbage in Wetted Pool 1 within the Subject Property.

At the time of the assessment, Wetted Pool 1 appeared to lack connectivity and presented like an independent wetland (i.e., not being fed from upstream or downstream watercourses). Due to topographic changes, water collecting in Wetted Pool 1 appeared to be as a result of ground alteration to the north, south and east. Typically, wetlands are subject to a standard 15.0 m setback from high water mark (HWM), as per the DFO Agreement (Appendix B attached); however, due to a lack of connectivity observed during the assessment, construction setbacks may not apply to this particular water feature.

The Provincial *Water Sustainability Act (WSA)* has differing criteria for wetland setbacks and must also be considered prior to assigning a construction setback. A final follow-up ESA is recommended during Summer 2018 (i.e., dry conditions) to further evaluate Wetted Pool 1 and confirm lack of hydrologic connectivity, soil conditions and vegetation present during the driest season. Following the final follow-up ESA, construction setbacks, or lack of, will be confirmed at that time.

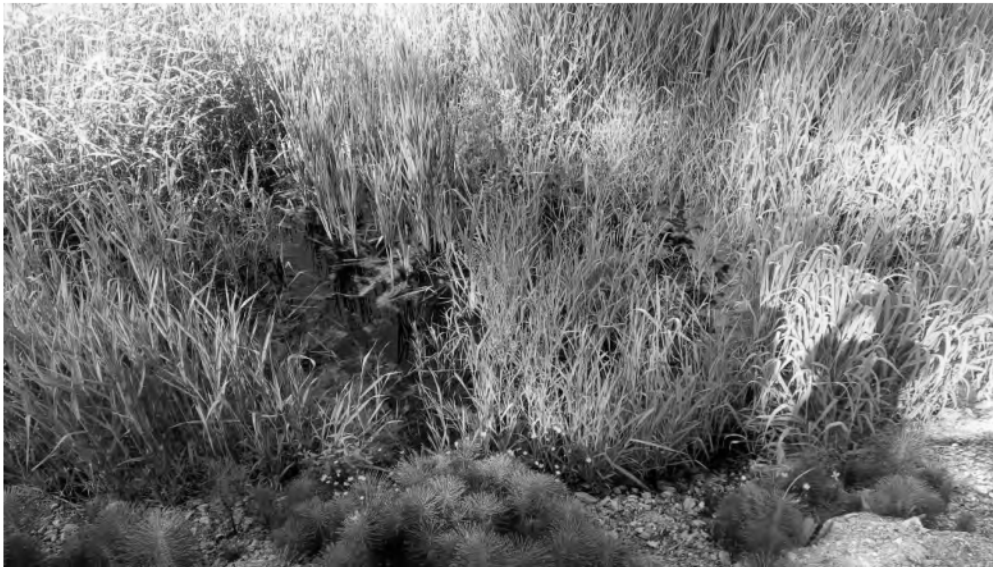
Wetted Pool 2 was identified during the follow-up ESA within the mid-eastern portion of the Subject Property, south of Wetted Pool 1 (Figure 2). Wetted Pool 2 is currently not mapped on the TOL's GeoSource mapping and appeared to be a small, topographically isolated wetted area with no evidence of an inflow/outflow source (i.e., no hydrological connection to fish habitat), no defined edges, and lack of hydrophytic vegetation (Photograph 2). Wetted Pool 2 has likely formed as a result of stormwater runoff from the adjacent road (McKinnon Crescent) and surrounding higher topography/ground alteration (Photograph 3). Vegetation observed within and adjacent to Wetted Pool 2 included a mixture of native grasses (*Poaceae*), Horsetail (*Equisetum* sp.) and buttercup (*Ranunculus* sp.).

Photograph 2. View looking west at Wetted Pool 2 within the Subject Property.

Based on preliminary ESA results and confirmation during a follow-up field evaluation, Wetted Pool 2 is considered to be a topographically isolated wetted depression with a lack of hydrologic connectivity and no defined aquatic boundary or hydrophytic vegetation that would indicate a wetland classification. As a result, no classification or streamside setback is applicable.

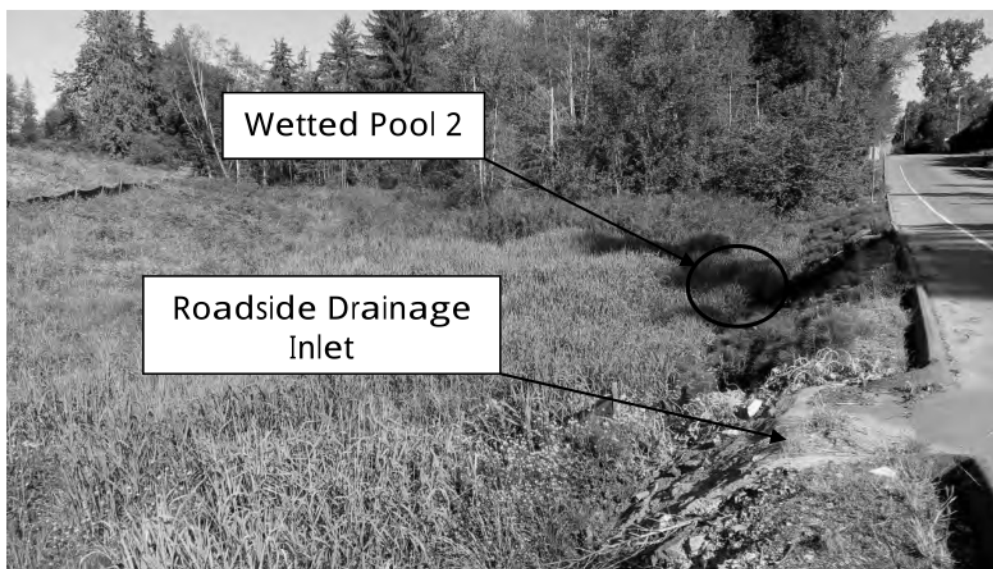
Photograph 3. View looking northwest at roadside drainage inlet and Wetted Pool 2 (black circle) within the Subject Property.

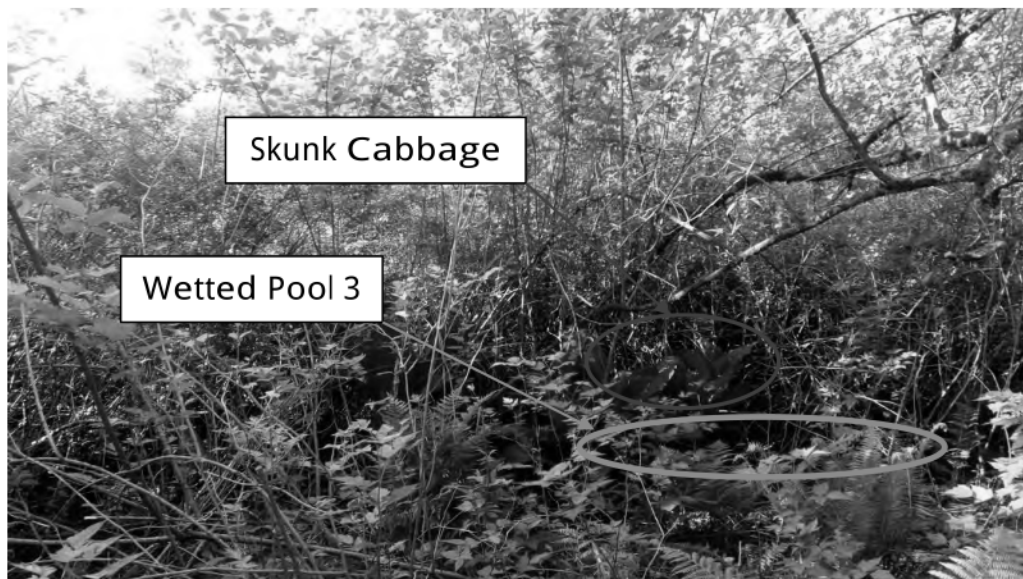
Wetted Pool 3 was observed during the follow-up ESA and was located within the mid-central portion of the Subject Property, between Wetted Pools 1 and 2 (Figure 2). Wetted Pool 3 appeared to be an independent wetland (i.e., exhibited 'wetland like' features, lacked hydrologic connectivity, unable to provide nutrients to fish habitat on or off-site) and is currently not mapped on the TOL's GeoSource mapping. Standing water was observed in Wetted Pool 3 at the time of assessment. The ground around Wetted Pool 3 was heavily saturated and water at this location appeared to drain to ground (i.e., did not appear to travel off-site). Skunk cabbage (*Lysichiton americanus*) and a variety of hydrophytic vegetation were observed within the saturated area (Photograph 4). Wetted Pool 3 exhibited characteristics of a wetland and appeared to be hydrologically separated from upstream and downstream water sources. Substrate comprised of mud and leaf litter, consistent with adjacent overhanging riparian vegetation. Native riparian vegetation included Red alder (*Alnus rubra*), Black cottonwood (*Populus trichocarpa*), Salmonberry (*Rubus spectabilis*), Bracken fern (*Pteridium aquilinum*), Sword fern (*Polystichum munitum*), Horsetail (*Equisetum*) and grasses (*Poaceae*). Non-native riparian vegetation included Himalayan blackberry (*Rubus armeniacus*), ivy (*Hedera* sp.) and holly (*Ilex* sp.). Non-native Himalayan blackberry made up approximately 10% of the riparian vegetation along Wetted Pool 3.

Photograph 4. View looking south at skunk cabbage (red circle) in Wetted Pool 3 (blue circle) within the Subject Property.

At the time of the assessment, Wetted Pool 3 appeared to lack connectivity and presented like an independent wetland (i.e., not being fed from upstream or downstream watercourses). Due

to topographic changes, water collecting in Wetted Pool 3 appeared to be as a result of ground alteration to the north, south and east. Typically, wetlands are subject to a standard 15.0 m setback from HWM, as per the DFO Agreement (Appendix B attached); however, due to a lack of connectivity observed during the assessment, construction setbacks may not apply to this particular water feature.

The Provincial *WSA* has differing criteria for wetland setbacks and must also be considered prior to assigning a construction setback. A final follow-up ESA is recommended during Summer 2018 (i.e., dry conditions) to further evaluate Wetted Pool 3 and confirm lack of hydrologic connectivity, soil conditions and vegetation present during the driest season. Following the final follow-up ESA, construction setbacks, or lack of, will be confirmed at that time.
