From: Ron Storie <rstorie@tnrd.ca>
Sent: April 22, 2020 3:32 PM
To: EMBC CTL PREOC Planning 1 EMBC:EX <preoc3.pln1@gov.bc.ca>
Cc: Bohay, Trevor FLNR:EX <Trevor.Bohay@gov.bc.ca>
Subject: RES 132925-601-040620 cherry creek 5096 Lazy Acres - hydrologist report
Importance: High

Re: Cherry Creek Flood Preparations 2020

Alan Bates, P.Eng.
Water Resources Engineer
Streamworks Consulting Inc.

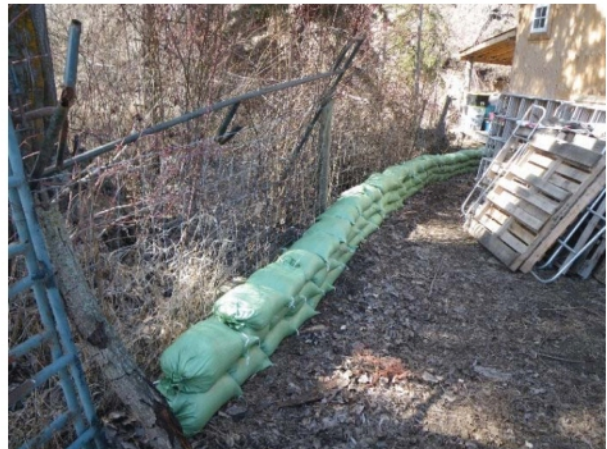
A sandbag wall (three bags high) had been built along the upstream property line and continued down along the creek side of the property. I suggested that the upstream end be tied into higher ground to ensure that any overbank flows occurring on the property upstream would not get in behind the sandbag wall. I also suggested that if flows were sustained against the sandbags during an event, a layer of poly plastic on the outside of the wall would help to reduce seepage. The landowners have been present for previous floods on the creek, so they have a good idea of what to expect.

The currently completed sandbag wall may still be extended further downstream to help protect the residence. Some sand-bagging may also be undertaken downstream to protect two farm buildings close to the creek.

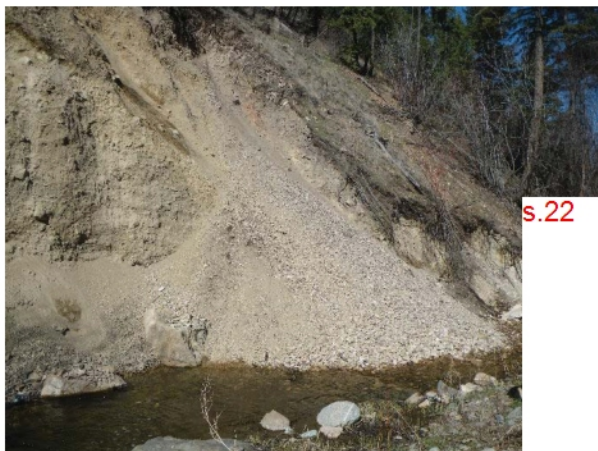
A major concern for the landowners is a dry-raveling slope failure across the creek near the upstream boundary of the property. The failure was activated in 2017/18 by erosion of the toe by creek. The slope has continued to recede since that time, even when dry and not being actively undermined. Gravel materials could be seen falling down the face during the brief time of inspection. Coarse gravel and finer material deposited in the creek by the failure are pushing the creek toward the right bank and the occupied portion of the property. The failure is also contributing bedload to the channel, which may have already caused some aggradation (build-up) downstream in the creek, in turn increasing flood levels.

There is not much that can be done in the short term (i.e. before freshet) to address the slope failure and its potential

impacts. The entire steep valley-wall across the creek from the property has some indication of creep and/or instability. A terrain stability specialist should be consulted on the risk/potential for catastrophic failure and/or possible mitigation options.

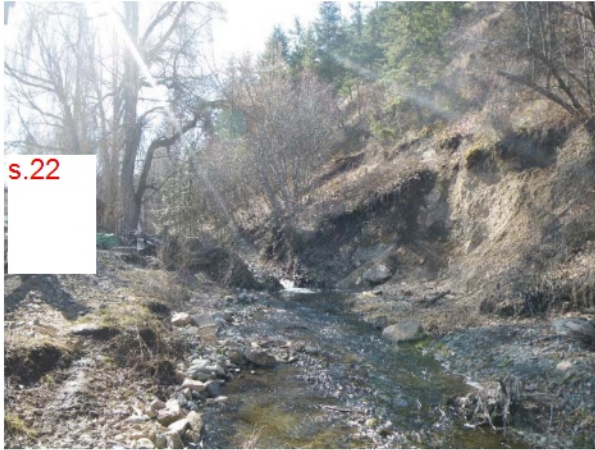
Slightly downstream of the residence, a debris jam in the creek is causing a gradient step and constriction of the channel. The jam has forced flows against the left bank (away from the residence), possibly undermining

the unstable slope (as seen upstream). Encapsulated within the debris forming the jam is a fuel drum, potentially containing deleterious fluids. It is recommended that this jam, including the drum, be removed from the channel. This will help to reduce flood levels through the property by reducing backwater and mobilizing accreted materials in the channel upstream. Removal of the fuel drum should be done carefully to prevent any damage to the integrity of the container resulting to spillage. The landowners were in agreement with the recommendation and with permission, willing to contract a small machine to undertake the channel clearing.

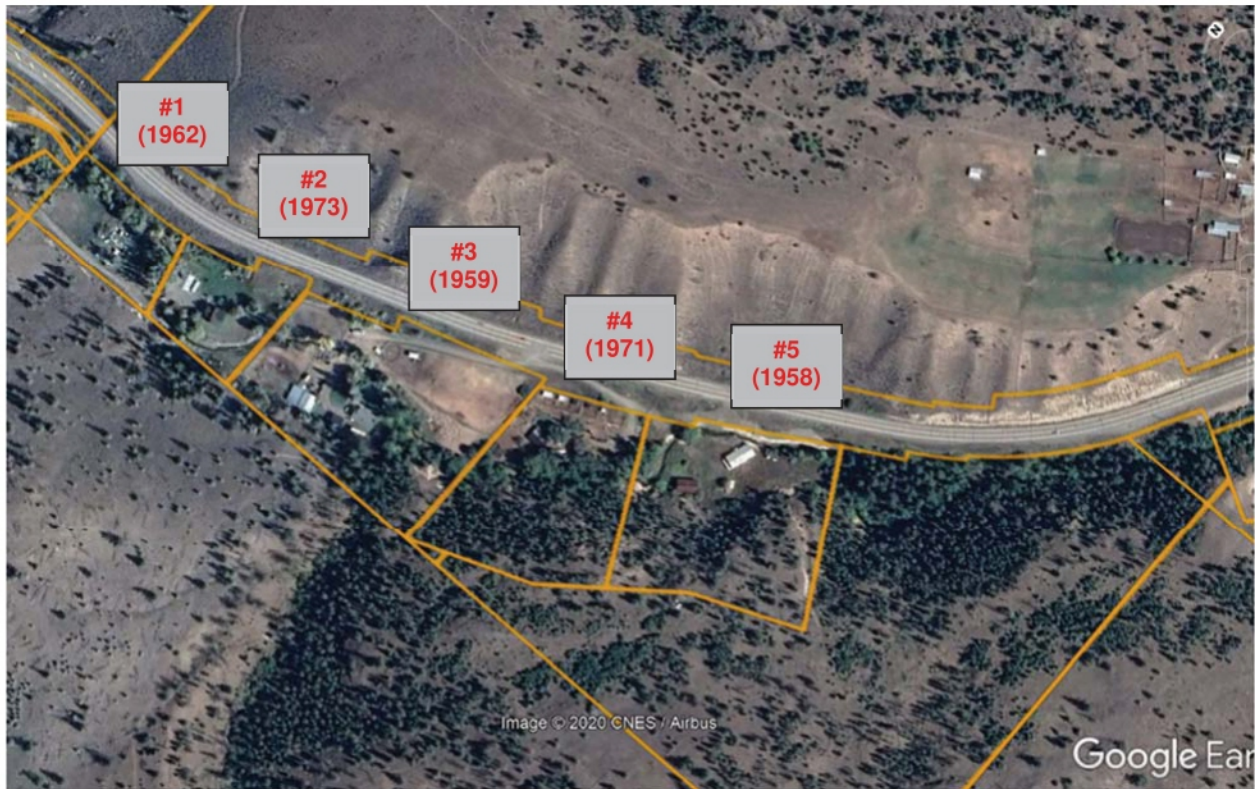
1958 – Property subdivided by KAP9050. Five properties south of Beaton Road were subdivided from the parent parcel over the period of 1958 to 1973. The following drawing indicates the subdivision date and the information that follows includes ownership details.

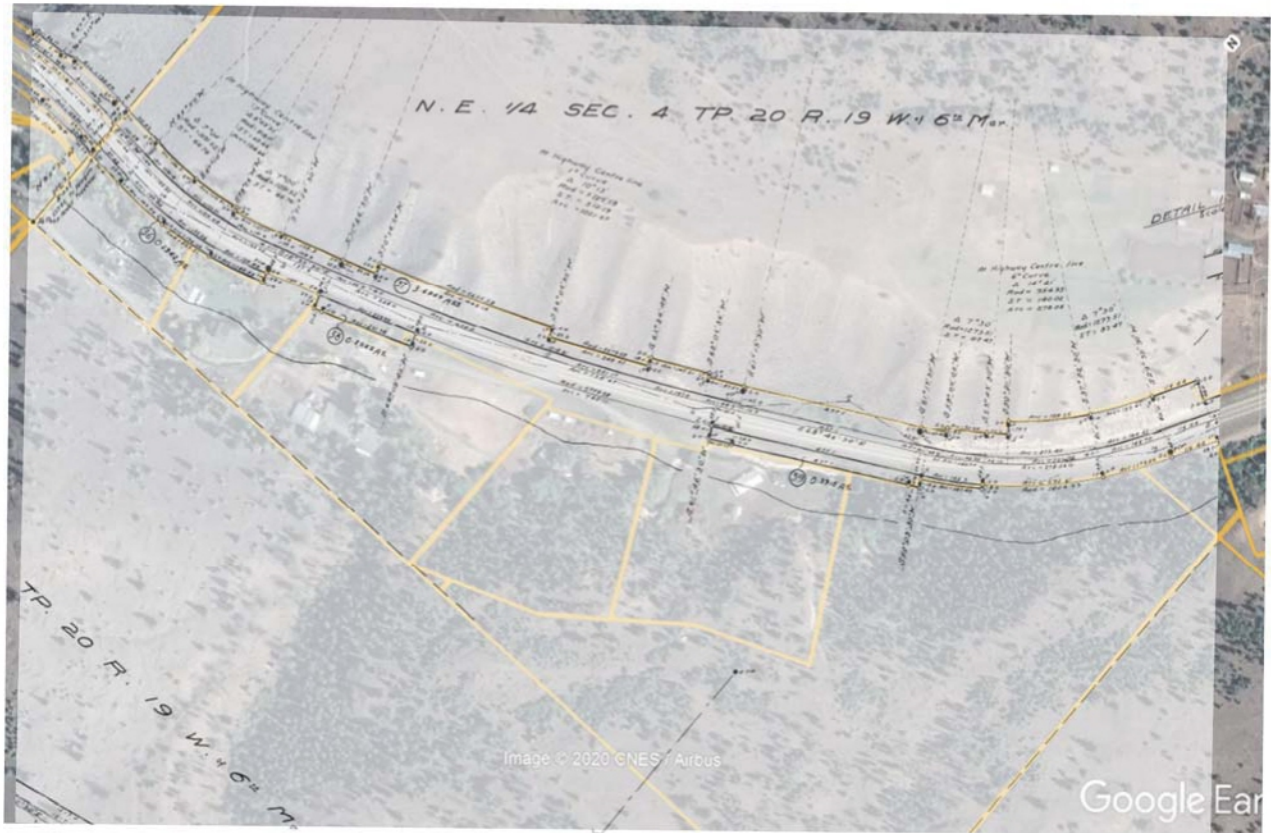
1951 – Ministry of Transportation Highway survey for the proposed Trans-Canada Highway and associated Right of Way. At the time of the highway survey, it is important to note that the surrounding property was crown land which was not granted until 1958 (with the subsequent creation of KAP9050 and Property #5 being first subdivided). The underlain imagery with the 2019 airphoto indicates present day property lines. This 1951 document shows the approximate depiction of Cherry Creek flowing in a linear direction from south to north parallel to the highway

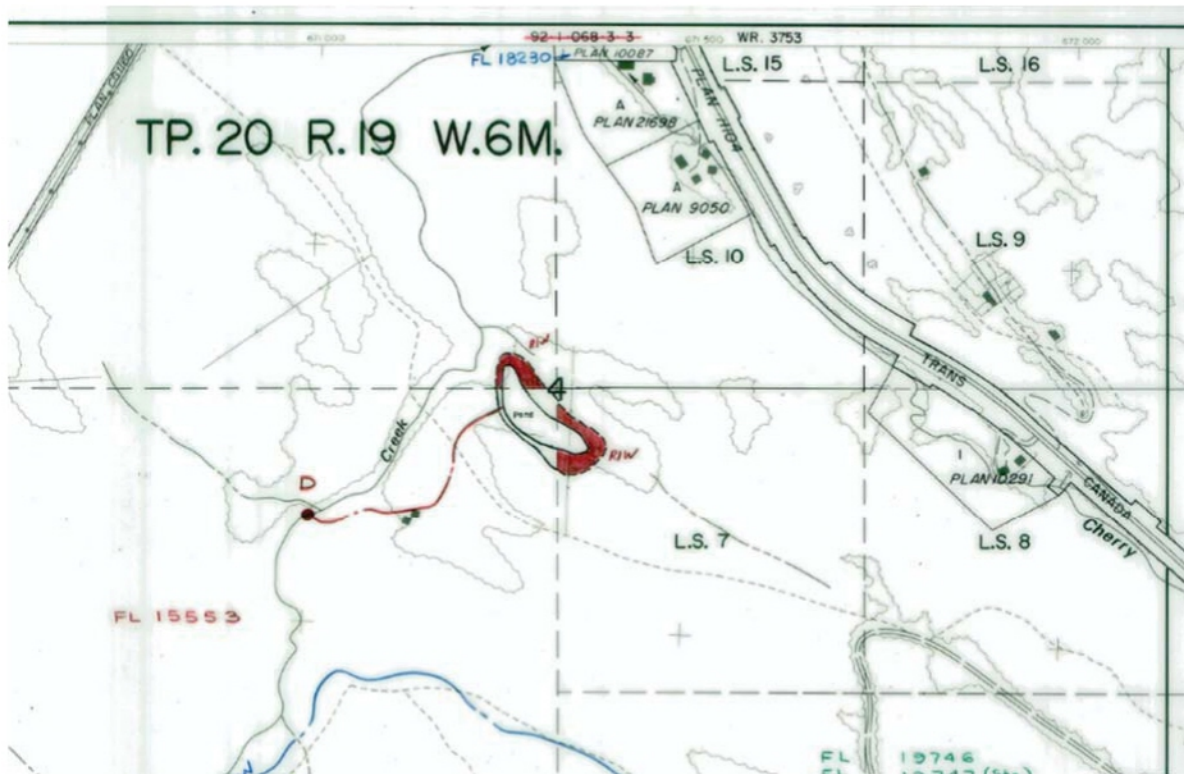
1989 – Water Rights maps show the location with both the current day subject properties developed. The TRIM base map is dated as 1983 with shaded areas representing structures. The water rights information is superimposed on this base map. Creek appears to be more or less in its present-day location with the general location being the east valley wall of Property #5 and crossing westward to flow along the west valley wall of Property #4.

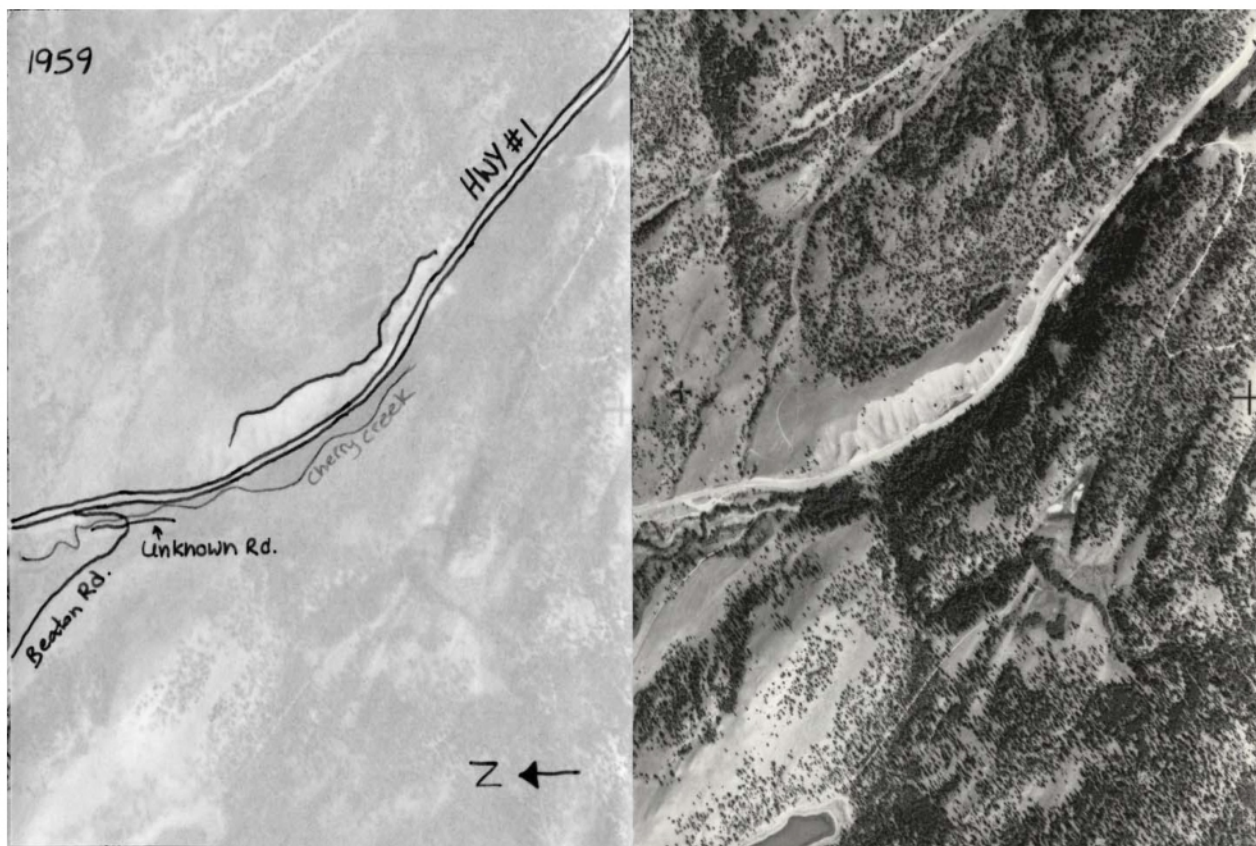
Figure 1. 1959 Air Photo Composition. The image on the left shows an overlay with road and creek interpretation, the image on the right shows the original imagery.

The air photo imagery from 1959 (Figure 1) shows that no development of, or along Lazy Acres Road. To the north, Beaton Road is constructed which crosses Cherry Creek along with an unnamed road branching off to the north and south near where Beaton Road meets with Highway #1.

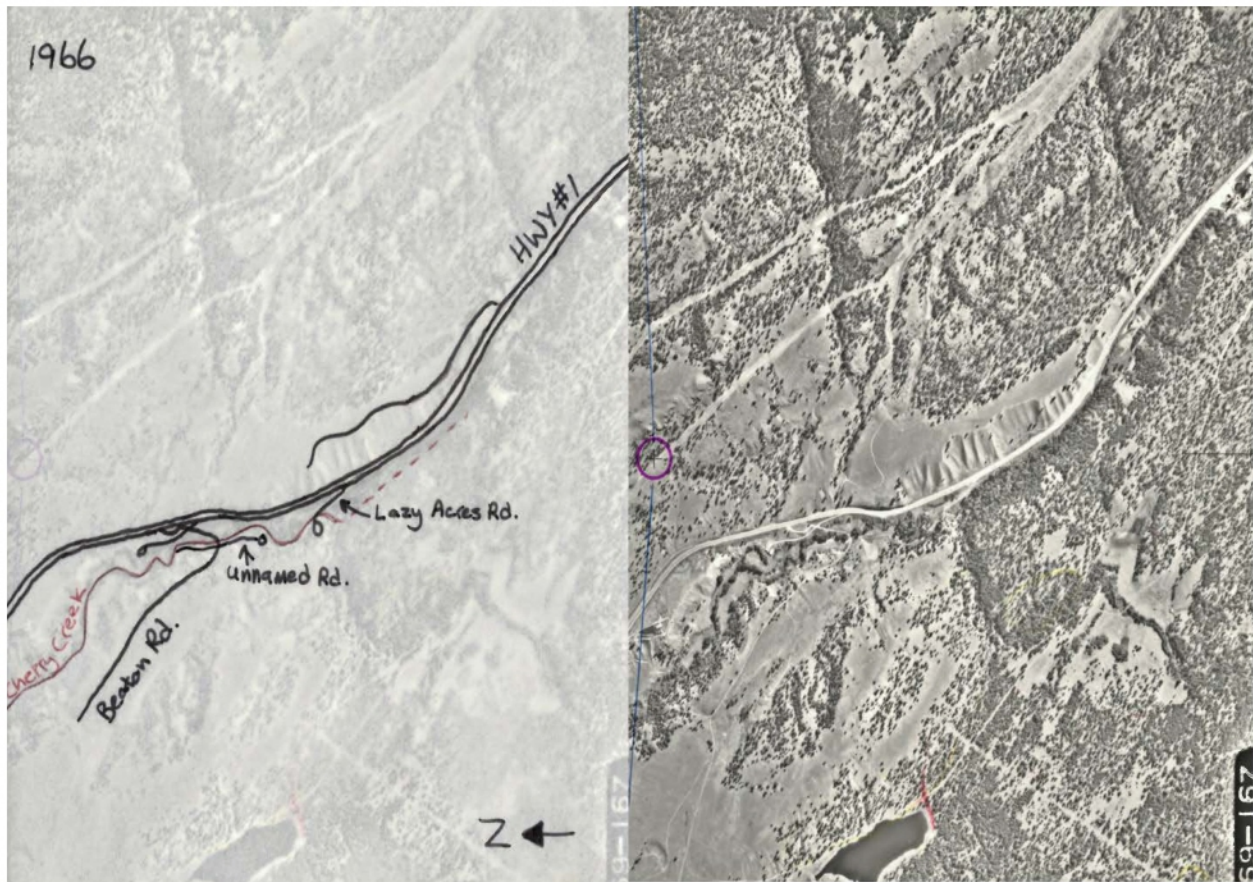
Figure 2. 1966 Air Photo Composition. The image on the left shows an overlay with road and creek interpretation, the image on the right shows the original imagery.

The air photo imagery from 1966 (Figure 2) shows land development (indicated by signs of land disturbance) with a structure on Lazy Acres Road that crosses Cherry Creek. The unnamed road off of Beaton Road to the south shows a small structure at the end where it meets but does not cross Cherry Creek. Due to vegetation cover it is not possible to determine the course along the upstream portion of Cherry Creek.

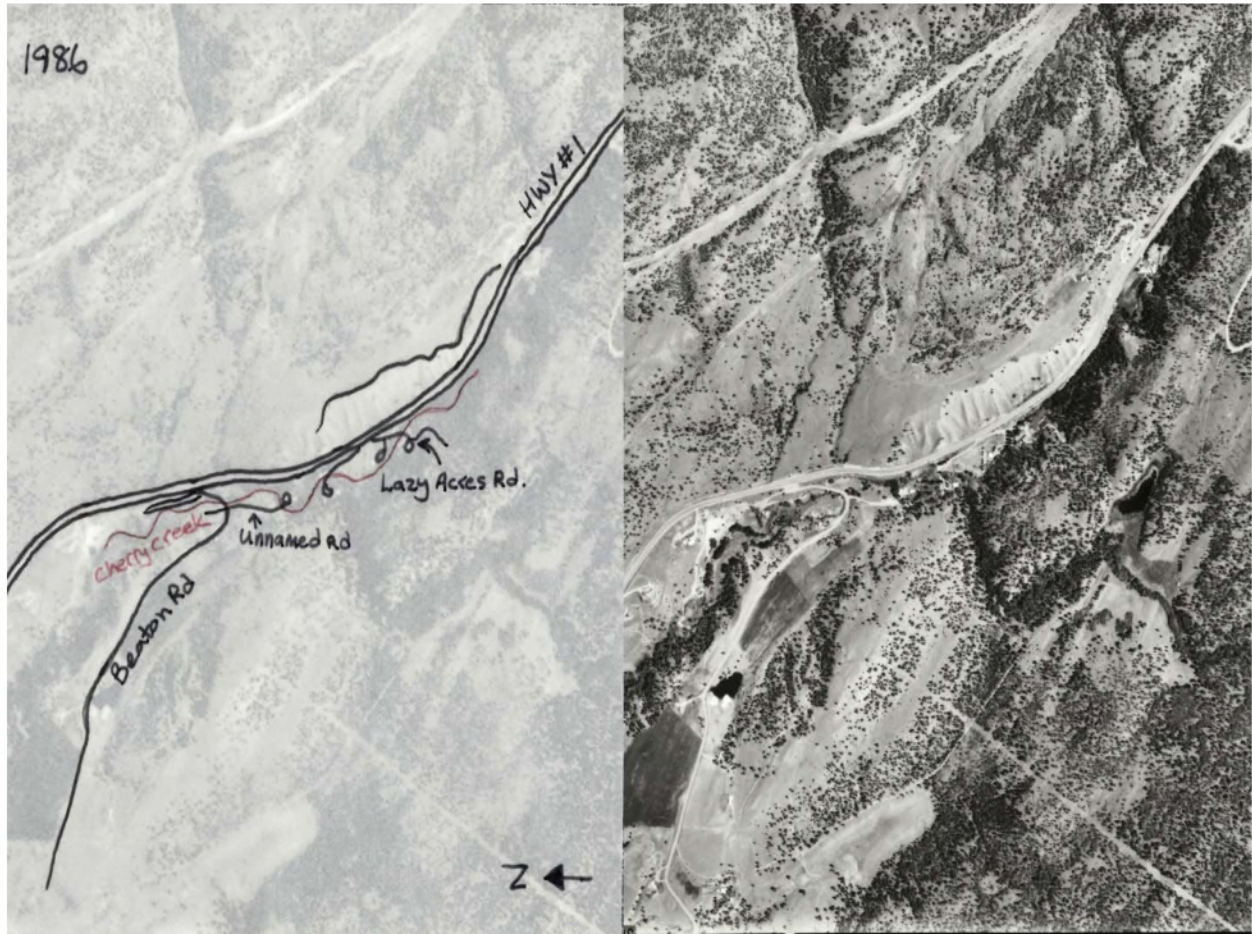
Figure 3. 1986 Air Photo Composition. The image on the left shows an overlay with road and creek interpretation, the image on the right shows the original imagery.

The air photo imagery from 1986 (Figure 3) shows significant land development along Lazy Acres Road, as well as on the south end of the unnamed road off of Beaton Road. Unfortunately, due to the twenty-year gap in air photo imagery, it is not possible to determine when the development first occurred. Lazy Acres Road shows three possible properties with structures, two of which cross Cherry Creek. The unnamed road has been extended to cross Cherry Creek and has structures at the end.

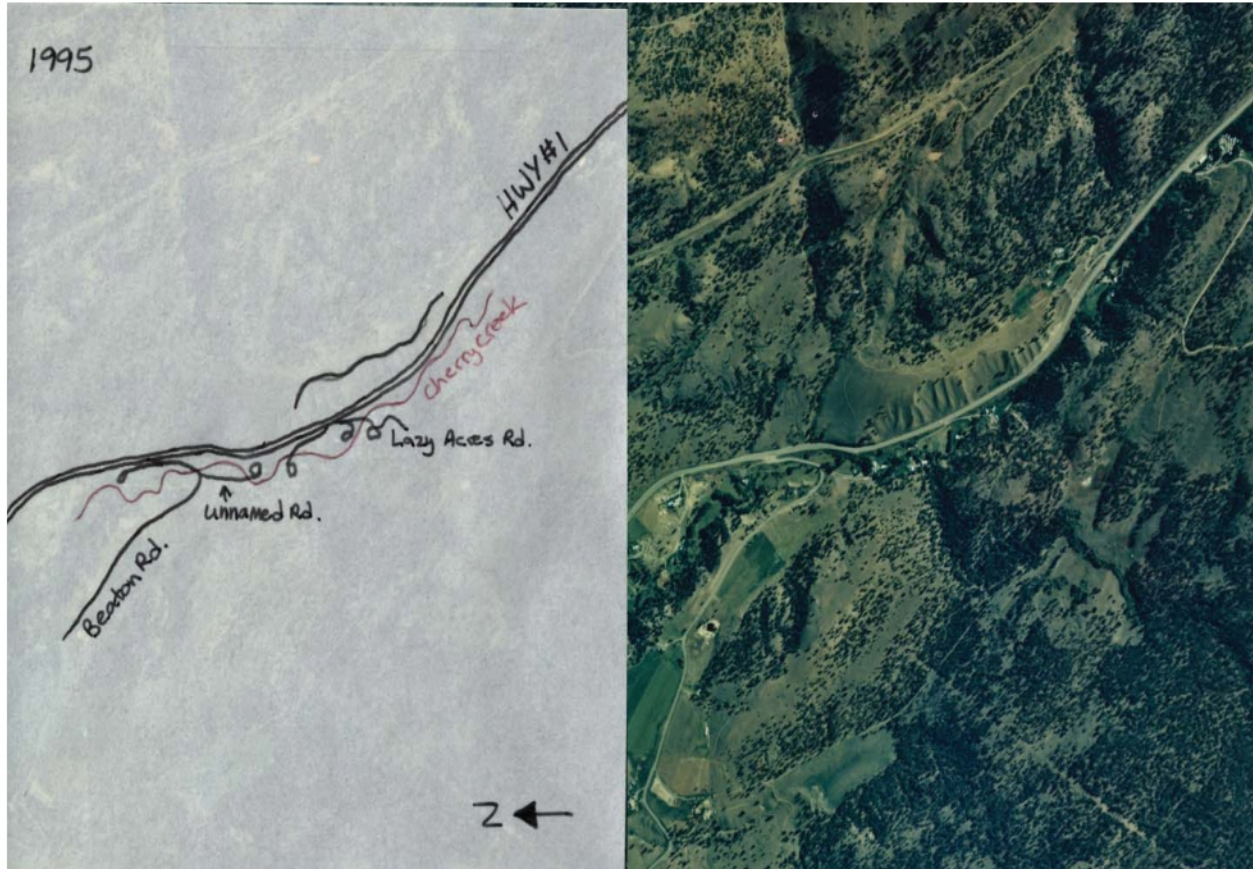
Figure 4. 1995 Air Photo Composition. The image on the left shows an overlay with road and creek interpretation, the image on the right shows the original imagery.

The air photo imagery from 1995 (Figure 4) shows no significant changes from the previous air photo taken in 1986. A reduction in vegetation surrounding the property at the south end of Lazy Acres Road is visible.

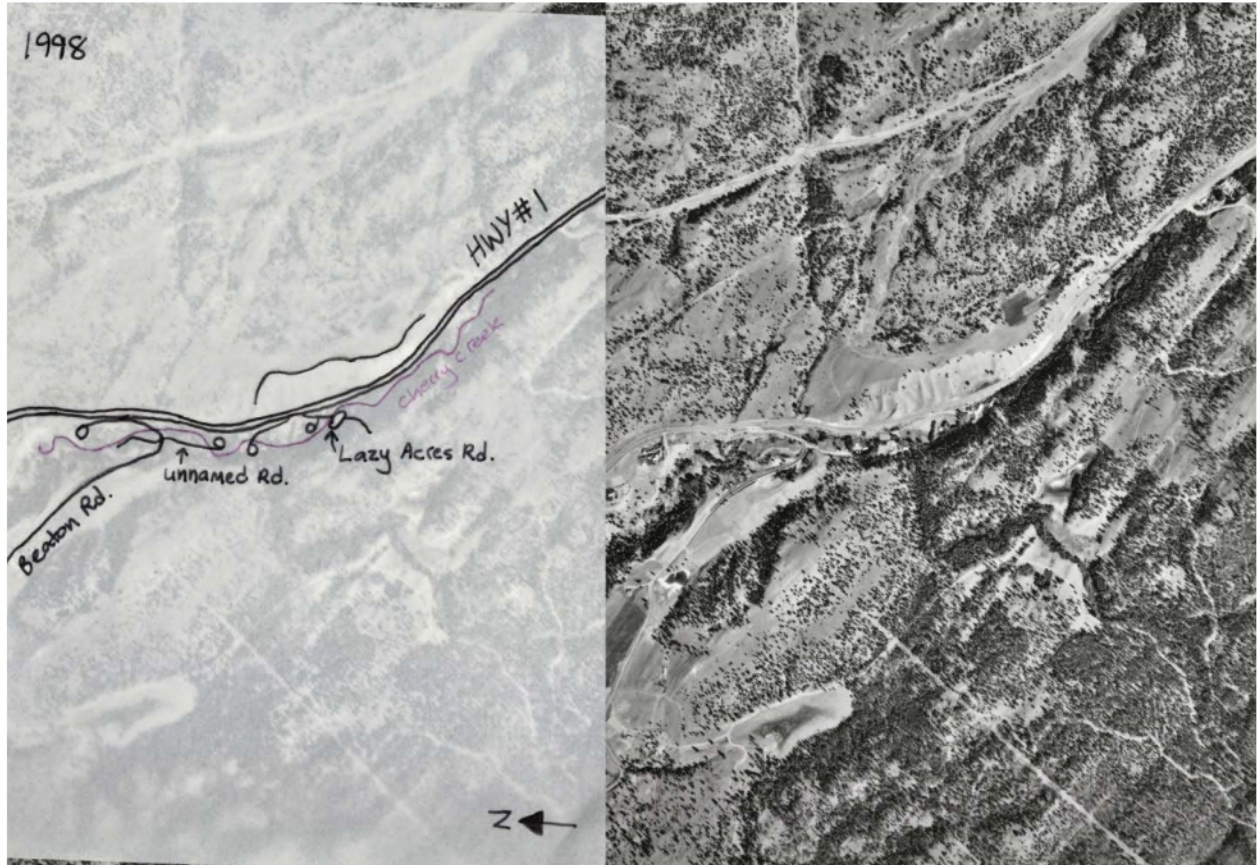
Figure 5. 1998 Air Photo Composition. The image on the left shows an overlay with road and creek interpretation, the image on the right shows the original imagery.

The air photo imagery from 1998 (Figure 5) shows minimal change from the air photo from 1995. A slight increase to removed vegetation is visible and a large structure at the south end of Lazy Acres Road is visible.

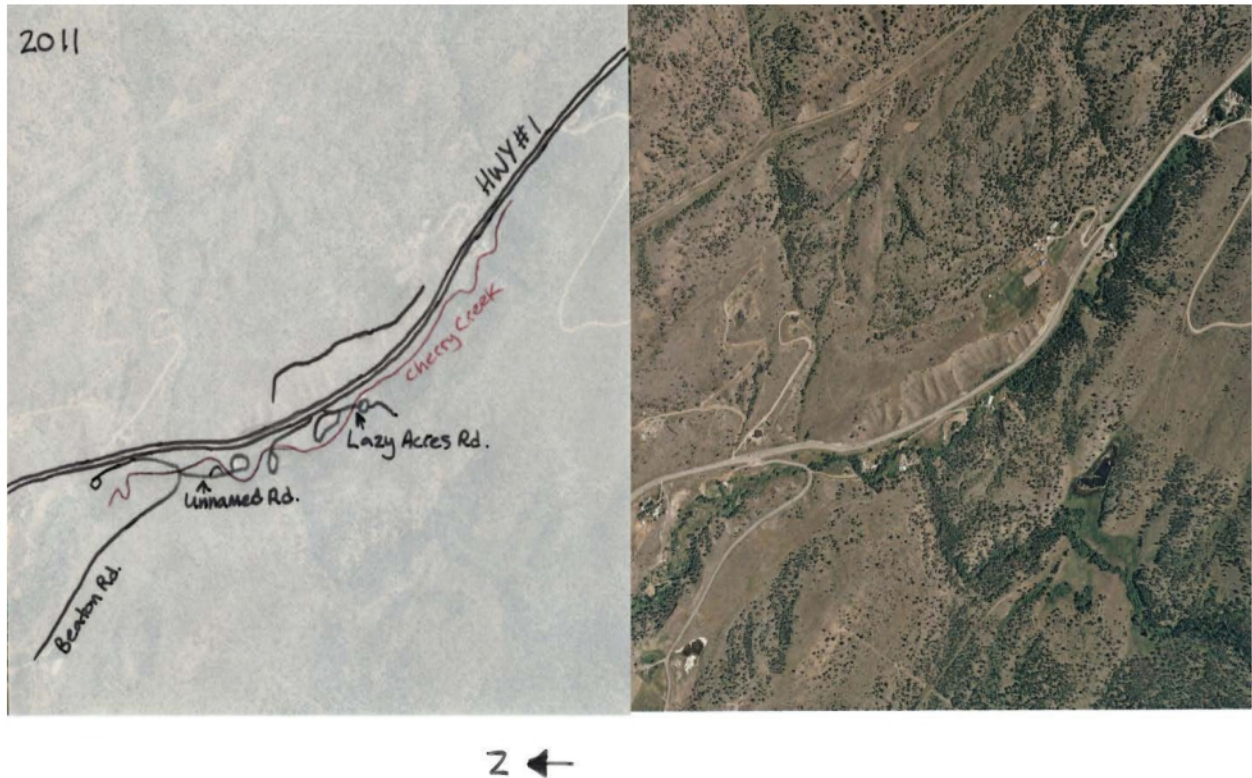
Figure 6. 2011 Air Photo Composition. The image on the left shows an overlay with road and creek interpretation, the image on the right shows the original imagery.

The air photo imagery from 2011 (Figure 6) shows increased areas of cleared vegetation around the properties along Lazy Acres Road. As well, along the unnamed road off of Beaton Road structures are visible in a small cleared area before and after the road crosses Cherry Creek.

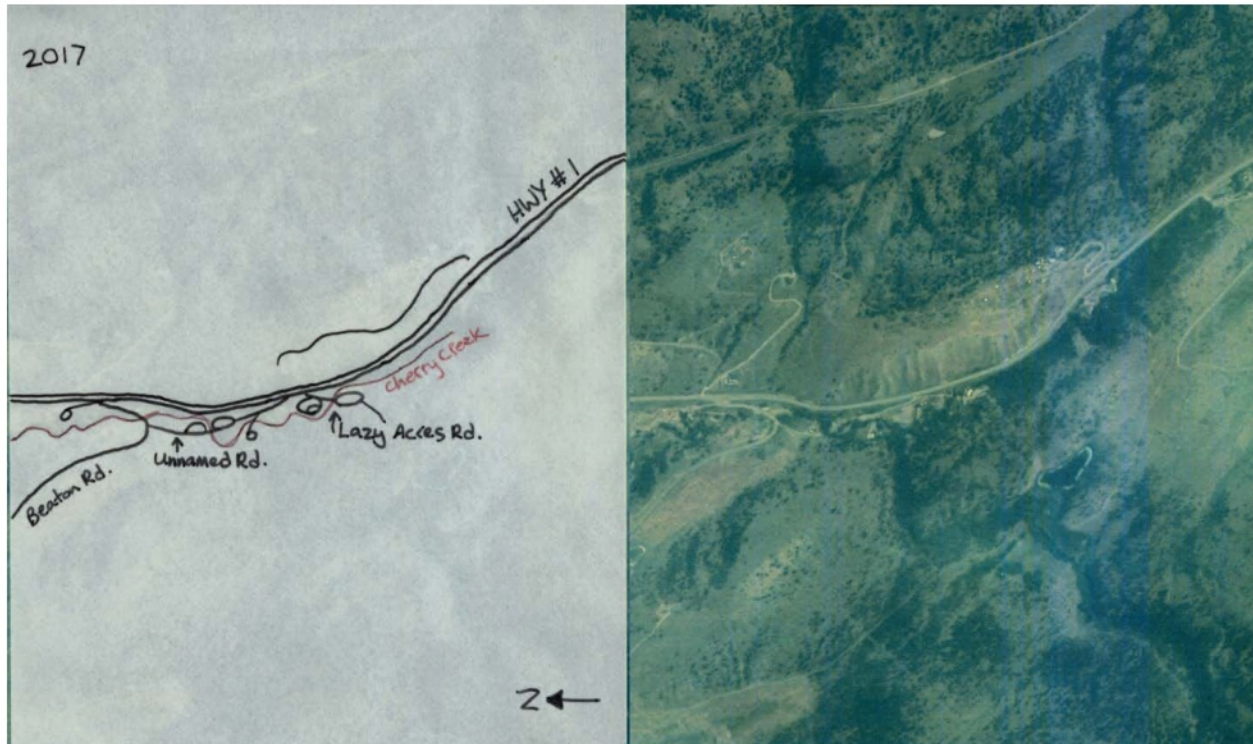
Figure 7. 2017 Air Photo Composition. The image on the left shows an overlay with road and creek interpretation, the image on the right shows the original imagery.

The Google Earth imagery from 2017 (Figure 7) shows a general expansion of properties along Lazy Acres Road with a possible minor increase in cleared vegetation. The unnamed road off of Beaton Road now connects to Lazy Acres Road but does not show an increase in developed area.
