Vaseux Lake - West Reconnaissance-level Assessment

*Environmental Feasibility Study
Kettle Valley Railway, South Spur Trail*

Vaseux Lake West, Reconnaissance-Level Assessment
Environmental Feasibility Study
Kettle Valley Railway, South Spur Trail

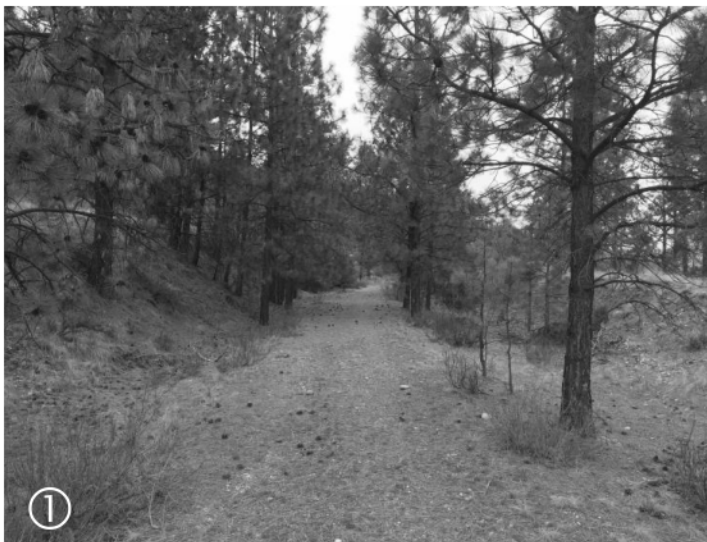
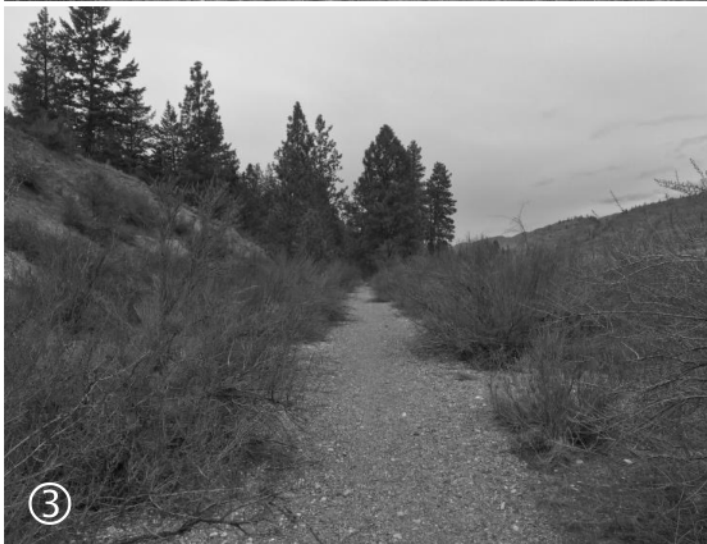
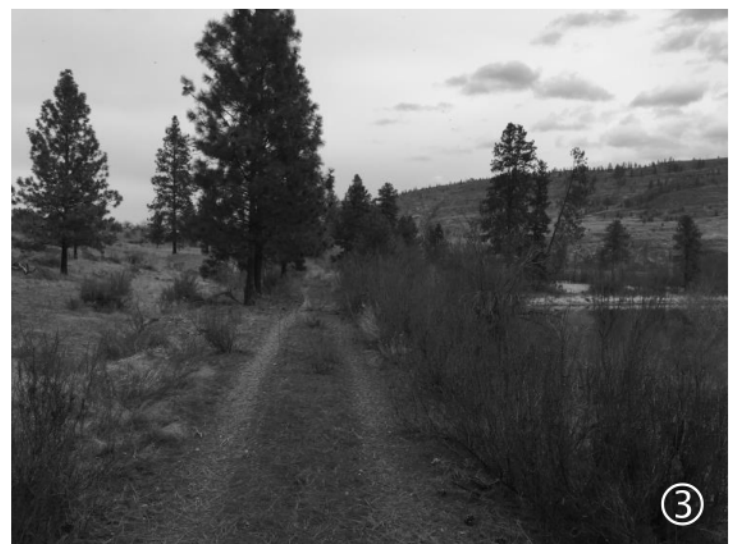
Observations of the former KVR right-of-way indicates that the railbed has retained many qualities of a disturbed site, with little to no re-establishment of vegetation on the former railbed. Some ground cover has started to establish; however, the route remains predominately exposed gravels. Encroachment of the shoulders of the former railbed was noted, with instances of antelope-brush, rabbit-brush and big sagebrush occurring throughout the observed area. Ponderosa pine was also observed re-establishing along the shoulders of the former railbed (Figure 1). Slight to moderate existing use of the trail was observed, both by hiking and horseback riding. Given the pre-existing level of disturbance, habitat loss qualifiers for critical habitat, sensitive ecosystem and ecosystems at risk are likely to be less affected by the re-activation of the trail corridor. Similarly, changes to habitat as a result of trail use will likely be suppressed given the presence of residual effects from the historical railway and its operations.

Figure 1. Representative photos of the existing trail conditions; (1) trail surface with minimal groundcover establishment and ponderosa pine; (2) exposed trail surface with evidence of trail use and density of antelope-brush along the shoulders; (3) exposed railbed and (4) trail condition near the north end of Vaseux Lake.

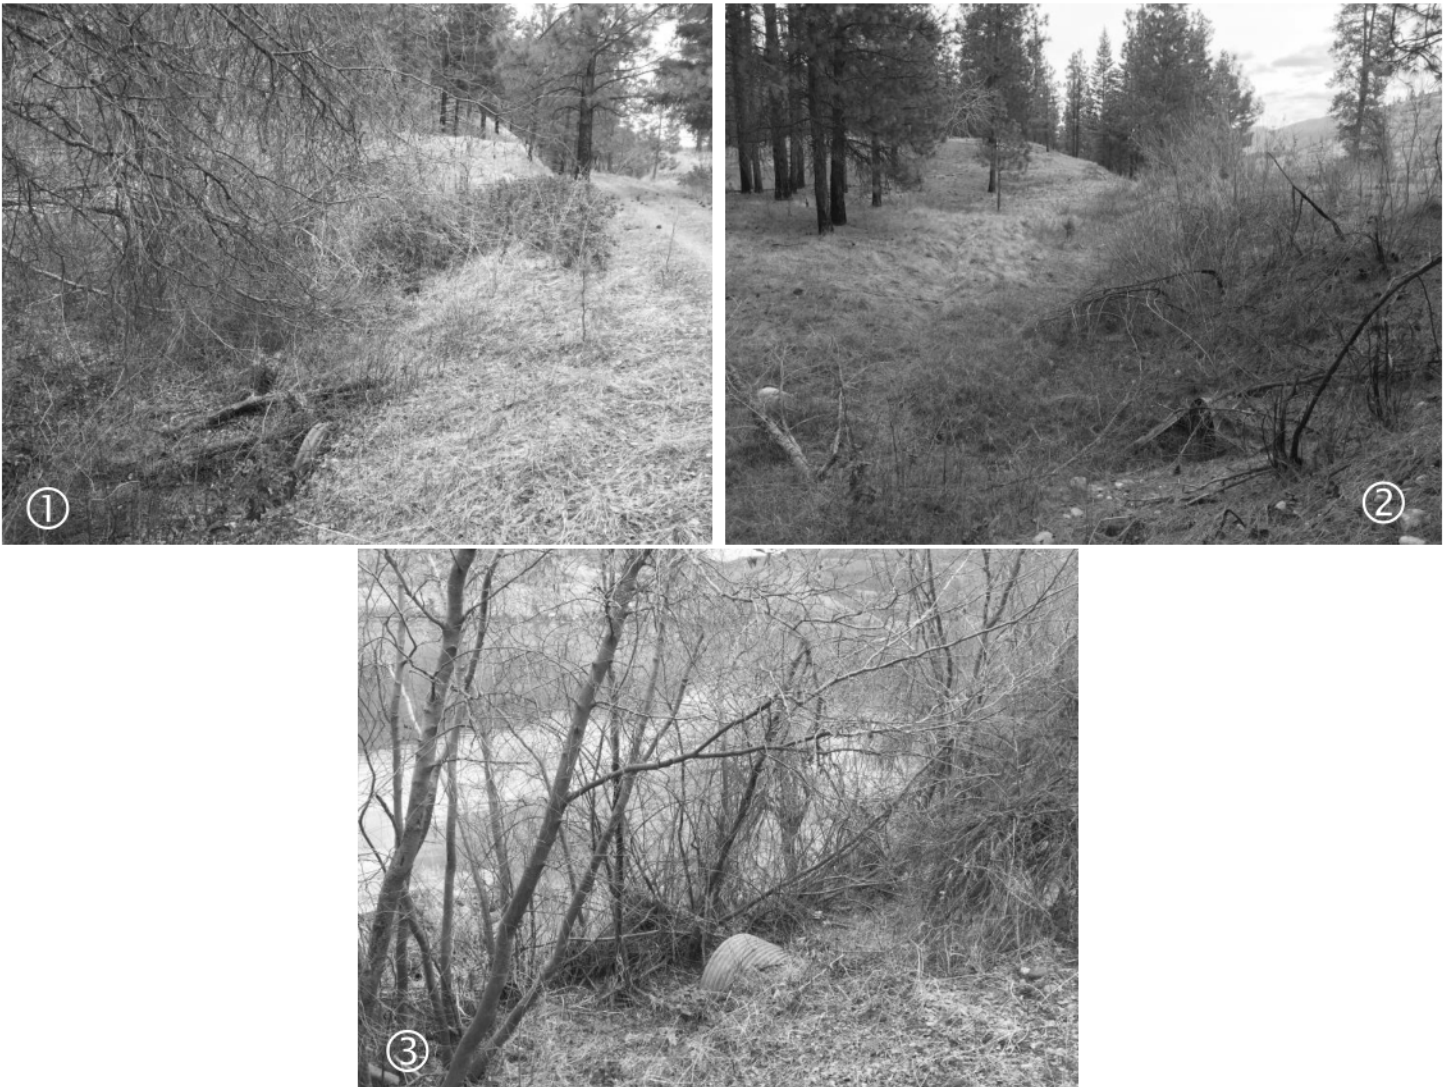
Three existing culverted crossings were observed crossing the exiting railbed (Figure 2). While no active flows were observed at the time, these are presumed to convey snowmelt and stormwater flows and represent one type of sensitive habitat along the route.

Figure 2. Representative photos of the observed culverted crossings trail conditions, (1) inflow of culvert 1; (2) inflow of culvert 2, and (3) outflow of culvert 3.

- Maintain the surfaced area of the trail to no more than 2.0 m.
- Elevated boardwalks are recommended to maintain connectivity and wildlife migration from the upland habitat to larger tracts of habitat along the western shore of Vaseux Lake.
- Elevated boardwalks should be constructed over any permanently or seasonally wetted areas and watercourses occurring along the trail alignment.
