Re: Non-compliance Warning Letter

Ministry of Environment
Inspection Record

UA27607	Canoe Forest Products Limited
April 8, 2016	Canoe

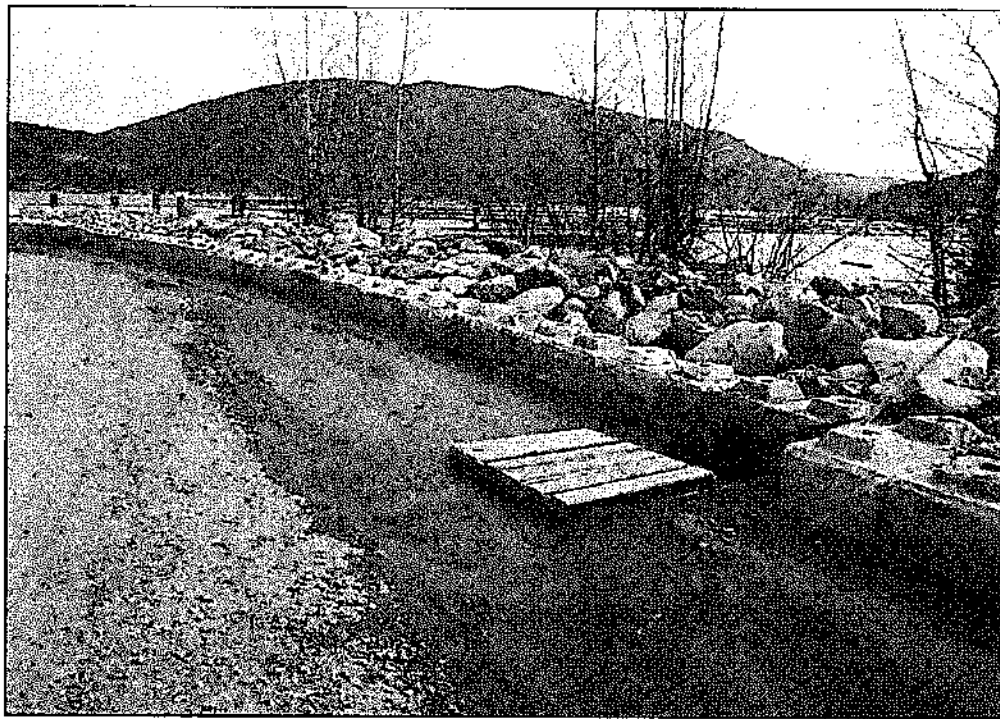
The unauthorized discharge of 7 March 2016, travelled across the yard and escaped to the lake at the top left of this picture. A sump pump was subsequently installed in the sump by the pallet. The berm (rip-rap barrier) was constructed following the incident in an attempt to better contain future spills in this area.

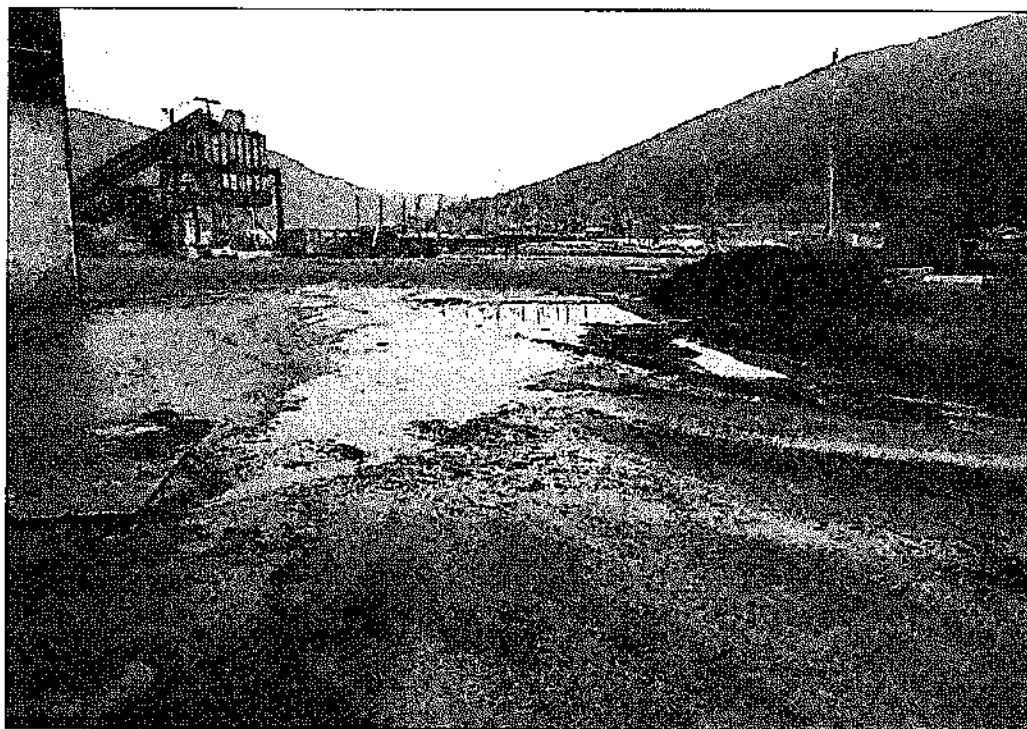
During the on site inspection on 8 April 2016, residual oil was observed in the area of the yard where the release occurred. Also observed was a berm along the border where the discharge escaped off site, which was constructed since the unauthorized discharge. CFPL's current effluent permit, PE-1356, does not authorize this discharge.

The effluent travelled across the yard, collecting residual oil material lying on the floor of the yard. These contaminants were evident in the sample results collected from the lake shore, after the discharge had occurred.

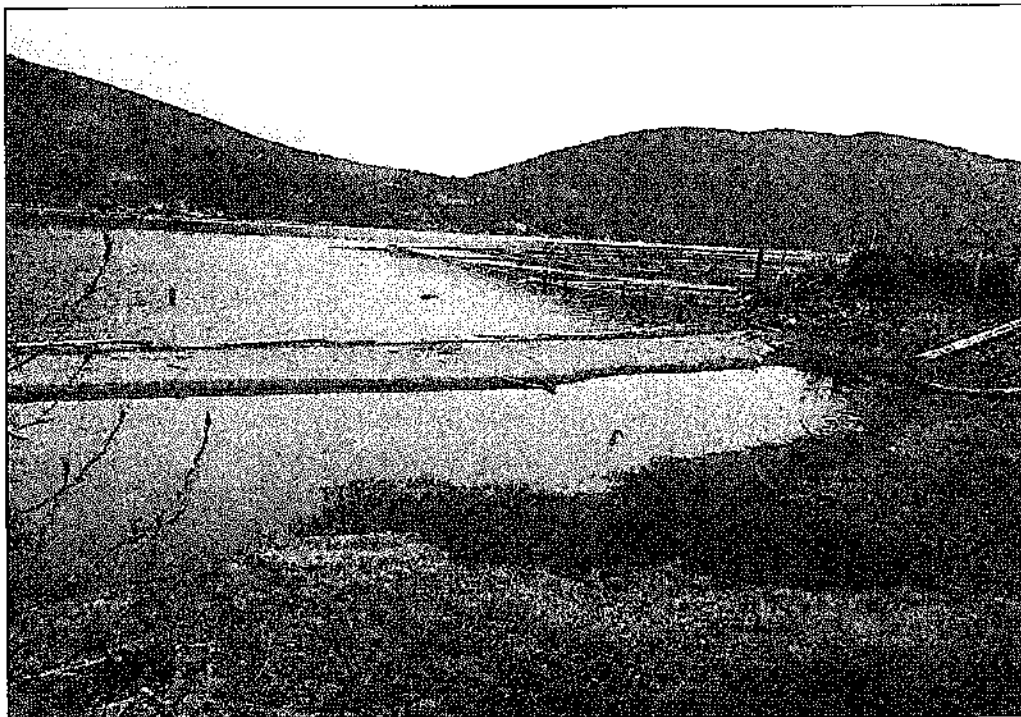
The unauthorized discharge that occurred on 29 March 2016 escaped down the bank to the right of the picture into the lagoon area separated from the lake by the sandy berm. This is where tankers attempted to retrieve the effluent from. No samples were collected following this discharge.

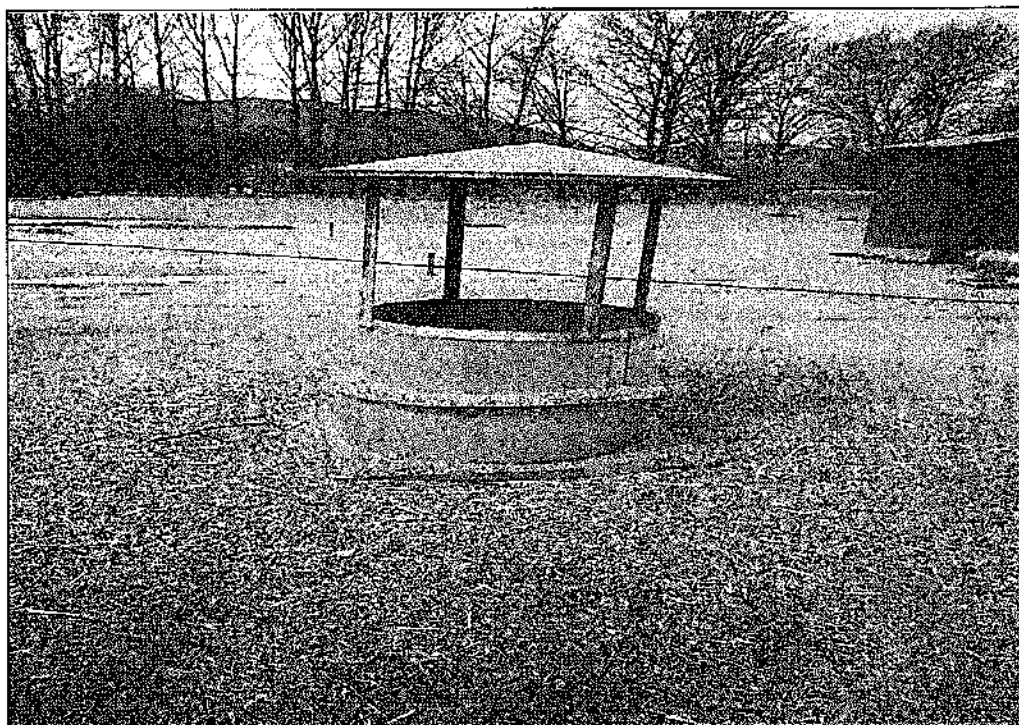
Unauthorized discharge from the vacuum fan over the Lay-up Line. Wood debris had accumulated on the roof around the stack and particulate matter was observed leaving the stack during the inspection.

However, during the planned on site inspection on 8 April 2016, an unauthorized discharge was observed from the vacuum fan over the Lay-up Line was identified. Particulate matter was observed discharging from a stack and there was significant wood debris accumulation in the immediate vicinity (see picture). CFPL's current air permit, PA-2573, does not authorize this discharge.

Discharge point from vacuum fan over the Lay-up Line. This point of discharge is unauthorized. Particulate matter was observed leaving the stack and wood debris had accumulated in the immediate area.

ACTIONS REQUIRED BY REGULATED PARTY: You are requested to submit an application to amend air permit PA-2573 in order to request that the discharge from the vacuum fan over the Lay-up Line be authorized as a discharge point.	
ADDITIONAL COMMENTS: Please ensure all spills to the environment are reported in accordance with the Spill Reporting Regulation.

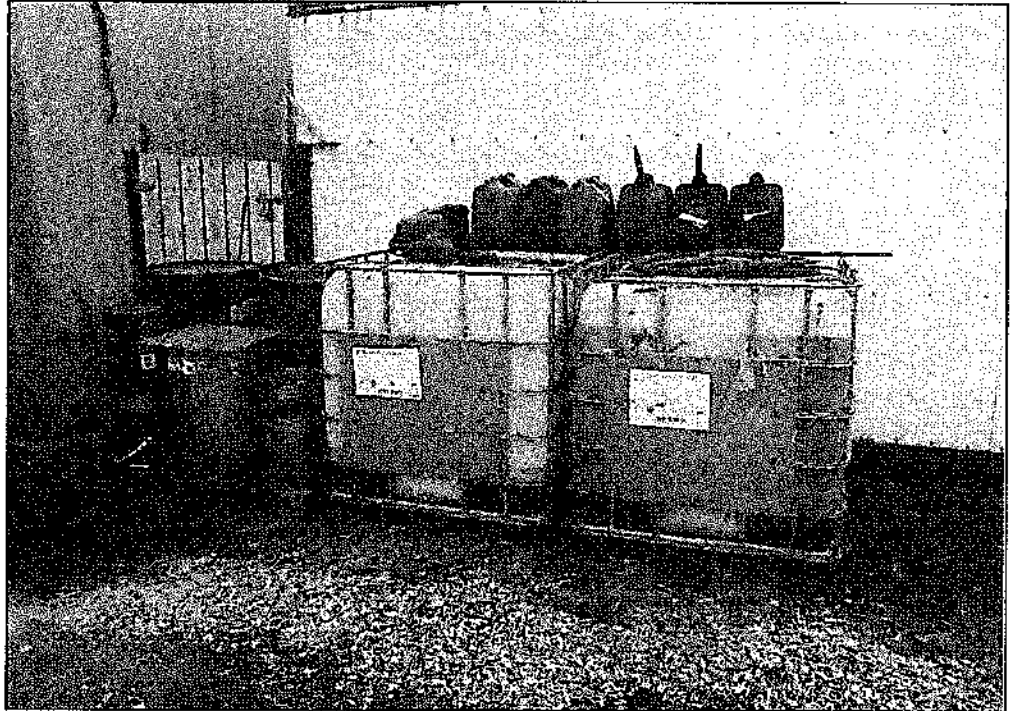
Details/Findings: Hazardous waste, including waste oil and oily water was observed stored in open containers, and not closed as required by section 50(3)(a) (See Figures 1 and 4). In addition to the open storage containers observed, there was also waste oil staining on the unmade ground surrounding the areas of hazardous waste storage, evidencing previous leaks or spills. The waste oil was observed to be stored in containers in a manner which have caused it to leak, and may cause it to leak in the future, and thus out of compliance with section 50(3)(b) (See Figure 1). Many containers of hazardous waste were not clearly labelled with the information required by section 50(3)(c) (See Figure 1).
Compliance: <u>Out</u>
Requirement Type: <u>Operations</u>
Requirement Description: 50. STORAGE AND TRANSPORTATION

Waste oil and oily water was observed stored in an open bucket-like container, and not under cover. The container was filled to the brim, likely as a result of precipitation. Any further precipitation would likely result in the escape or leak of the oil. There was also waste oil staining on the unmade ground surrounding the areas of hazardous waste storage, evidencing previous leaks or escapes of oil into the environment (Figures 1 and 4).

Figure 1. Hazardous waste storage area (Site 1). Containers stored on unmade ground with no secondary storage. Note oil staining on ground from historical spills. Several open oil containers were stored on top of the totes. None of the containers were labelled.

<p>ACTIONS REQUIRED BY REGULATED PARTY:</p> <p>All hazardous waste must be stored in such a manner as to prevent discharge to the environment.</p>

CFPL have informed the Ministry that CTQ Consultants had recently been on site looking to address the storage conditions of hazardous waste. CFPL should consider secondary containment for the hazardous waste storage area as a best practice.

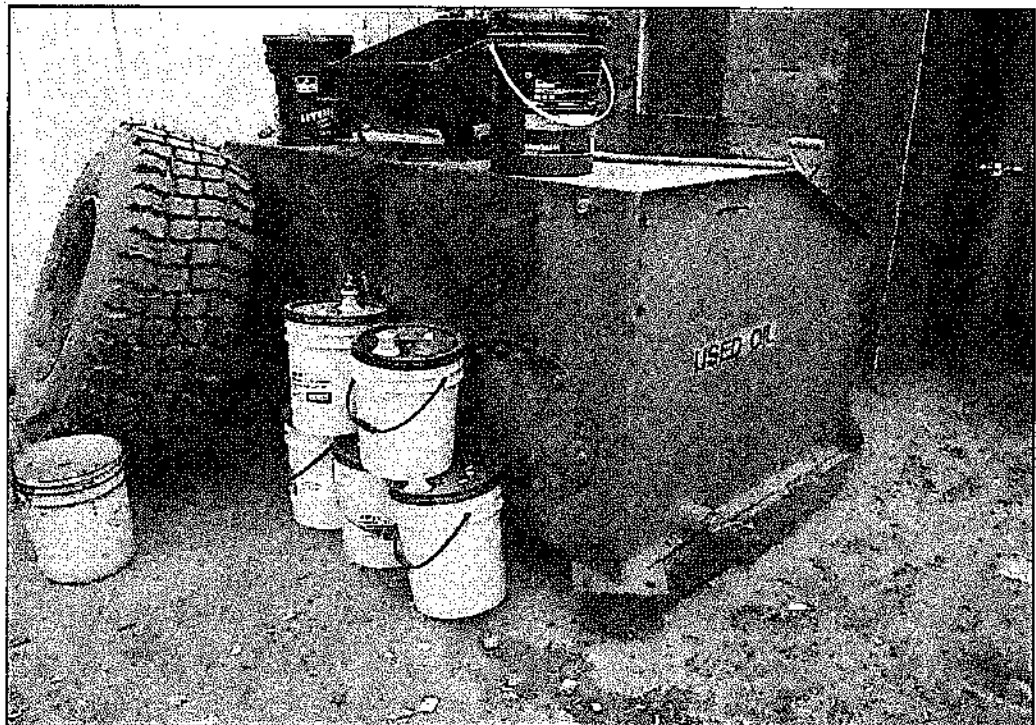
Figure 2. Used oil storage at Site 2, by maintenance shop. Tank is single skinned with no secondary containment. Note the valve/tap at the bottom. This should be contained in case of leakage.

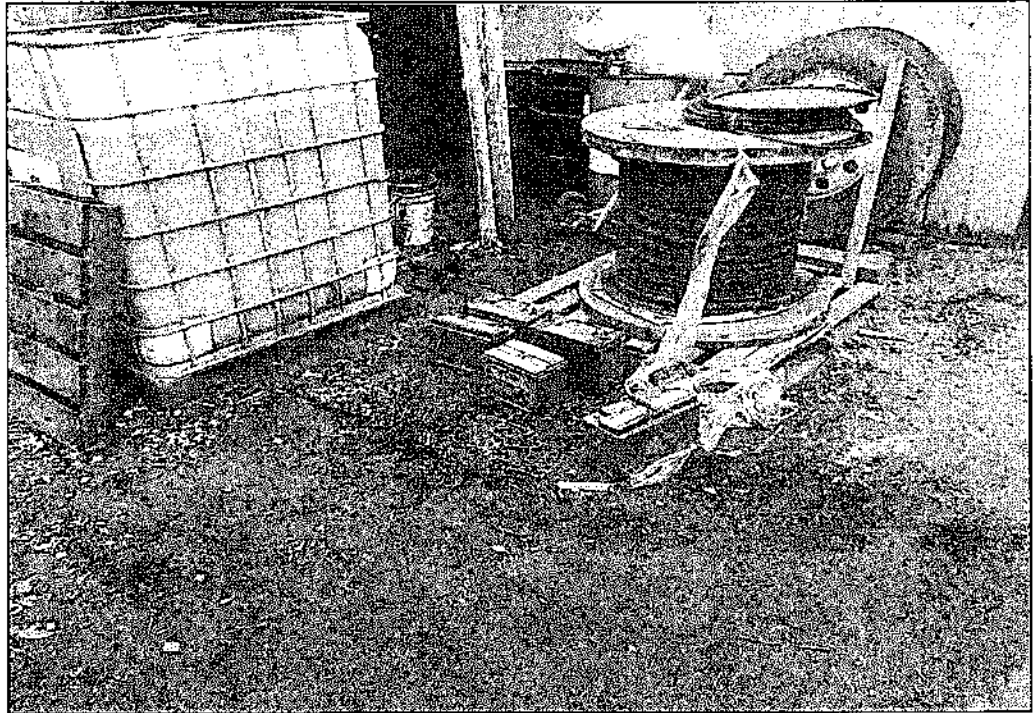
Waste batteries were observed to be stored on unmade ground and not in a container, or under cover (See Figure 3).

Figure 3. Waste batteries stored without cover or containment.

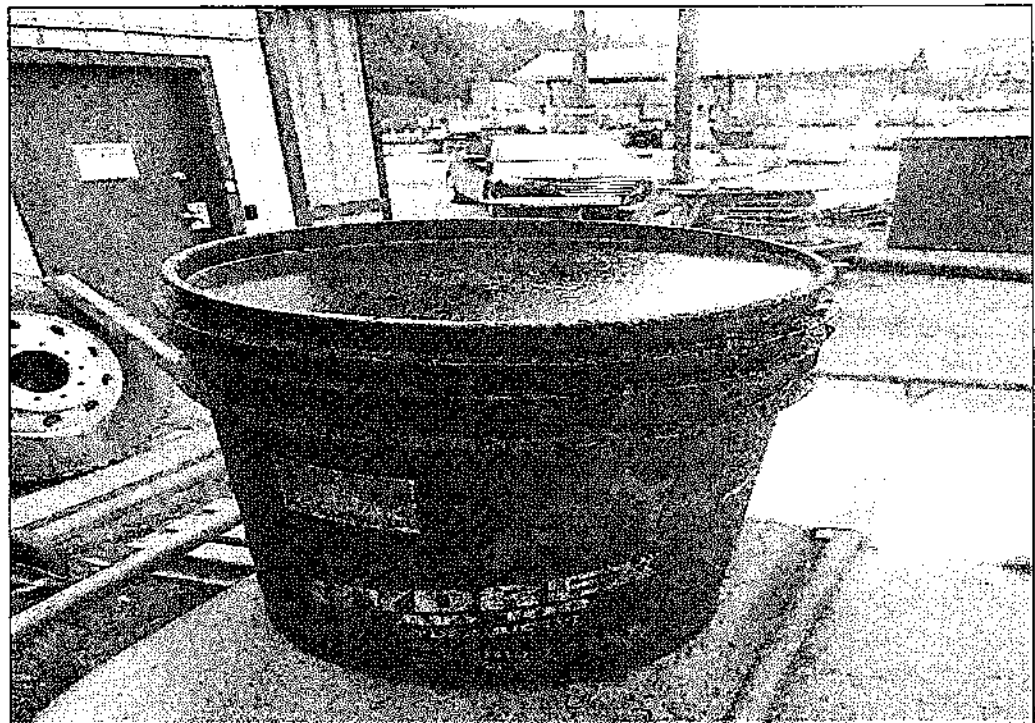
Waste batteries stored on unmade ground without cover or containment. Oil/water stored in uncovered bucket like container, not under cover. Vessel was filled to the brim, likely as a result of precipitation. Further precipitation would result in spillage. This hazardous waste storage area had no secondary containment.

Figure 4. Open container of oily water stored on top of the tote of antifreeze. The container was full, likely the result of precipitation. Any further influence from precipitation would result in spillage. There was no secondary containment in this area.

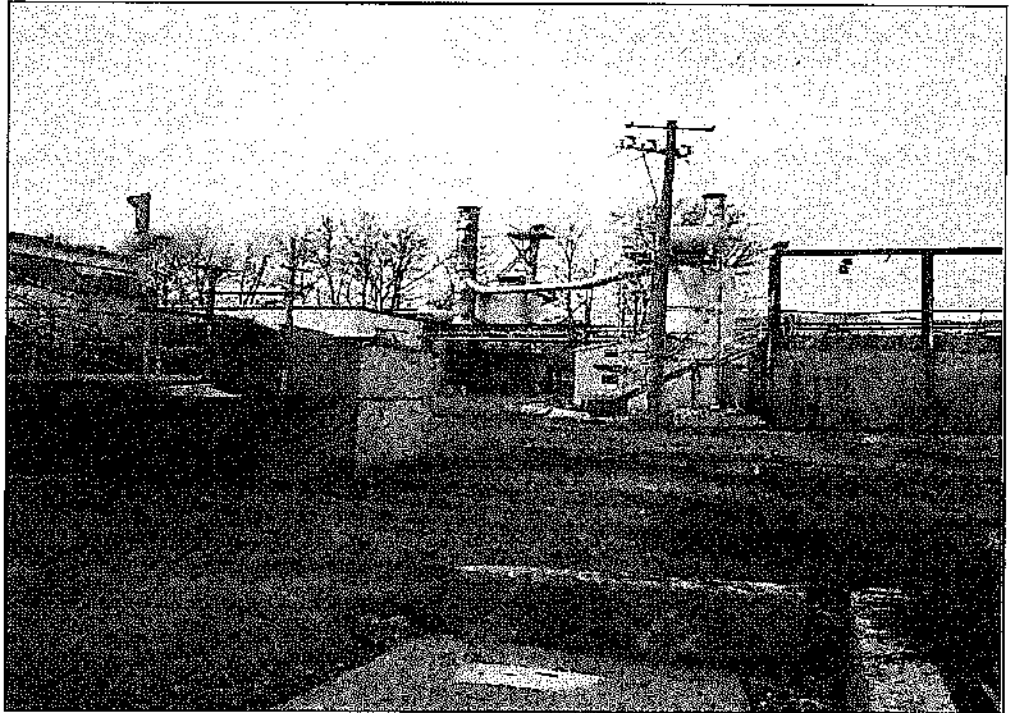
In the centre of the picture is the Electrified Filter Bed (EFB) stack. This is currently unauthorized. The stack to the right is the Natural Gas Fired Veneer Dryer - New (section 1.4). This discharge has been diverted to the EFB, the stack is now just for emergency bypass events.

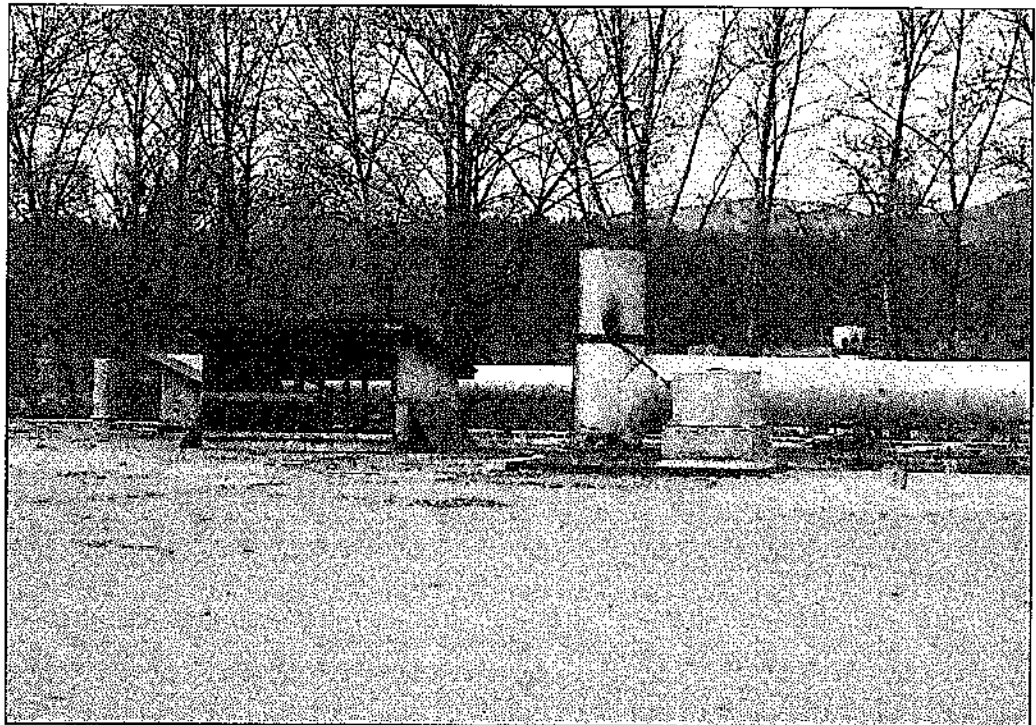
Stacks in the foreground and in the background to the right are from the Natural Gas Fired Veneer Dryer - Old (section 1.3). These discharges have been diverted to the EFB. These stacks are now used for emergency bypass events.
