Stage 1 Preliminary Site Investigation

4295 Robertson Road, Glenora, BC

Project #128-001-02
March 16, 2018

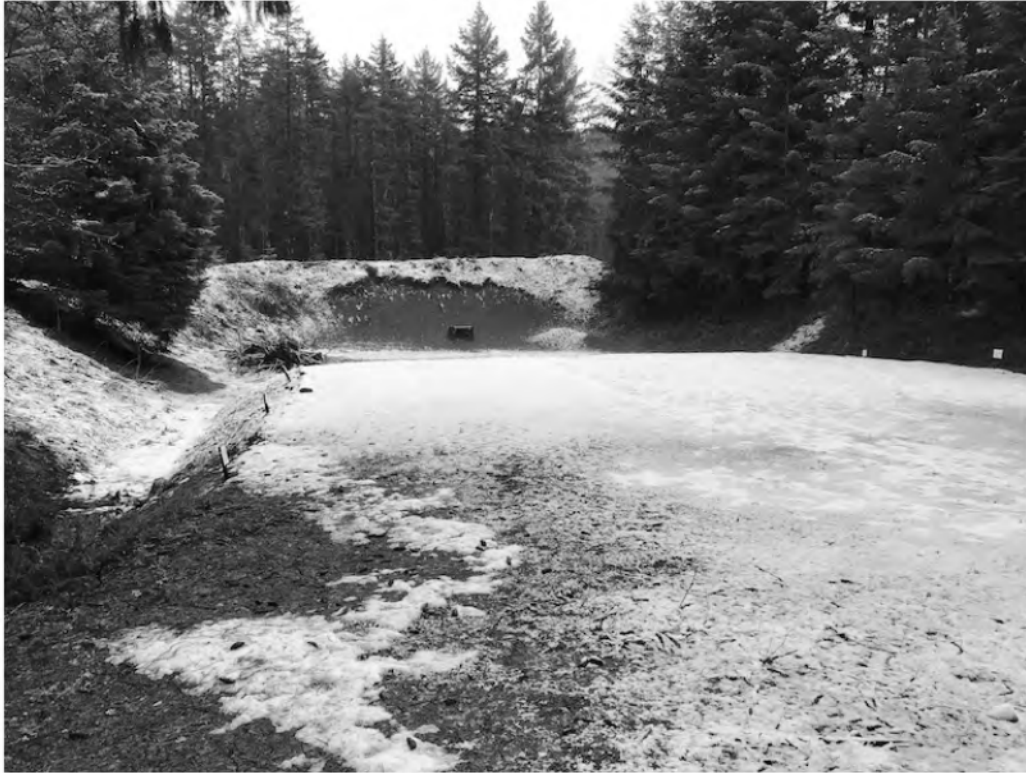
Photo 1 – Outdoor 50-yard target range.

- Evidence of spent lead bullets, unjacketed and copper jacketed, lead slugs, and bullet fragments of various calibres were observed amongst the soils at each of the three outdoor gun range target berms.

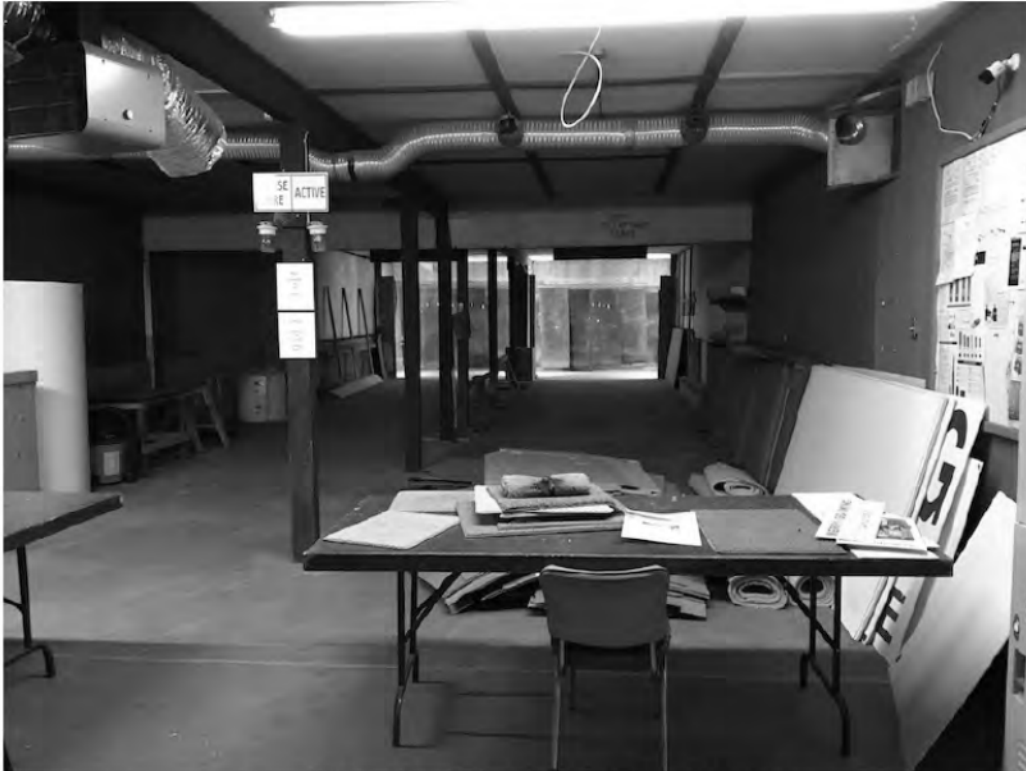
Photo 3 – Indoor 20-yard target range.

- The buildings are heated electrically. A wood stove was also present within the Founders Hall.
- The northern wall behind the target area within 20-yard range building is comprised of a bullet trap. The bullet trap is comprised of thick rubber mat draping, behind which are downward angled ½" steel plates, backfilled with sand. The bullet trap captures or contains bullets to within the building.

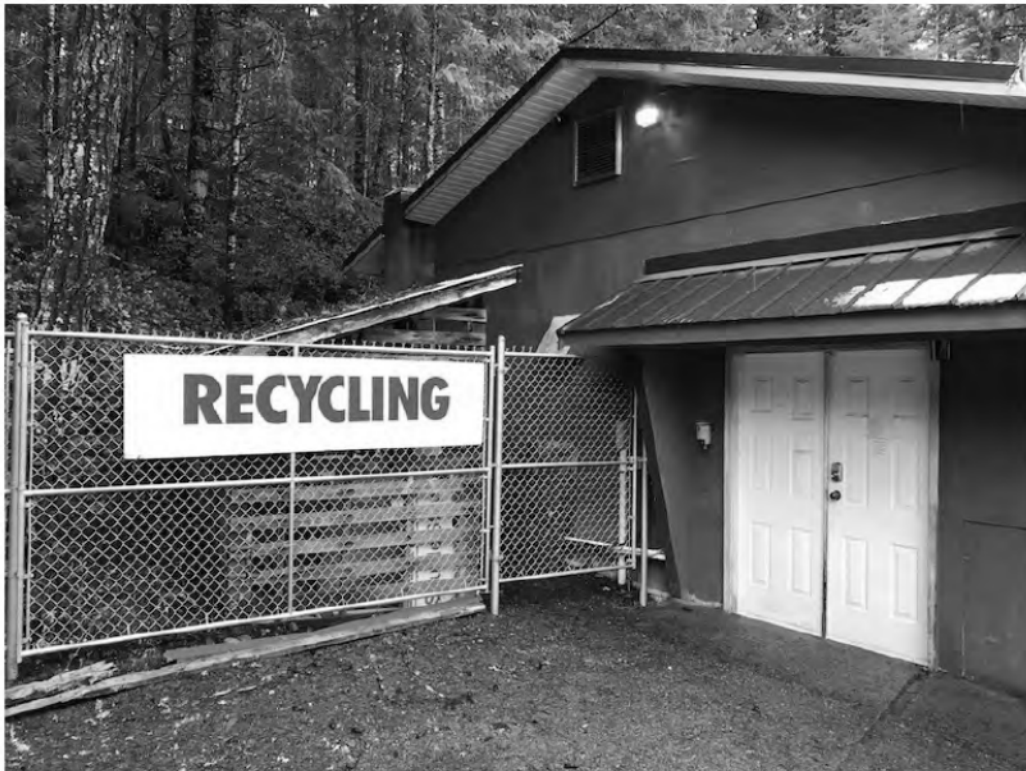
Photo 4 – South side of 20-yard target range building.

The preliminary soil sampling identified contamination adjacent to the 20-yard indoor target range. The analytical result identified lead and zinc at concentrations above CSR standards applicable at this location. The source was believed to originate from the ventilation exhausting air from within the indoor range building. The indoor 20-yard target range ventilation exhaust is considered the likely source of soil contamination at this location. However, given the anticipated low mass of aerial deposition, this source is considered to have a low potential to cause groundwater contamination.

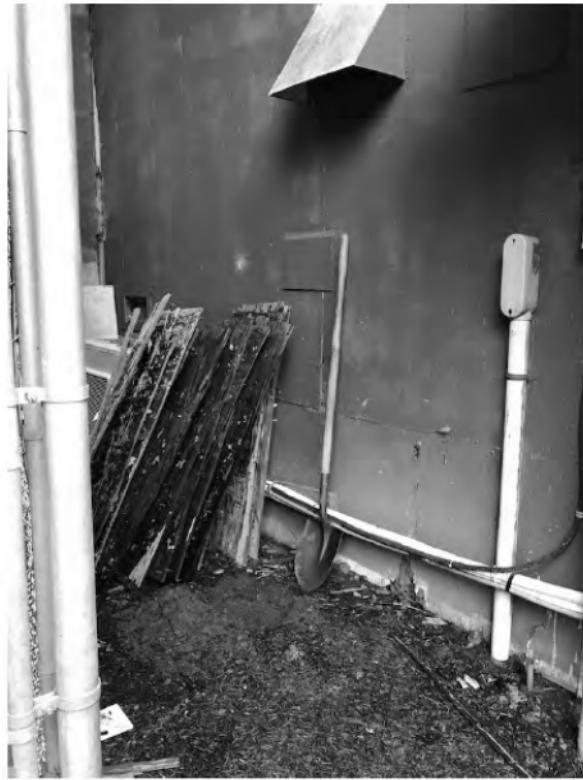
Photo 5 – Vent outside of 20-yard indoor range.

The indoor 20-yard target range is designed to contain bullets fired inside the building; however, a certain amount of lead associated with the building's ventilation system appears to have been transported outside the building and impacted surficial soils to the south of the building (Trillium, 2018). However, given the anticipated low mass of metals via aerial deposition, this source is considered to have a low potential to cause groundwater contamination.

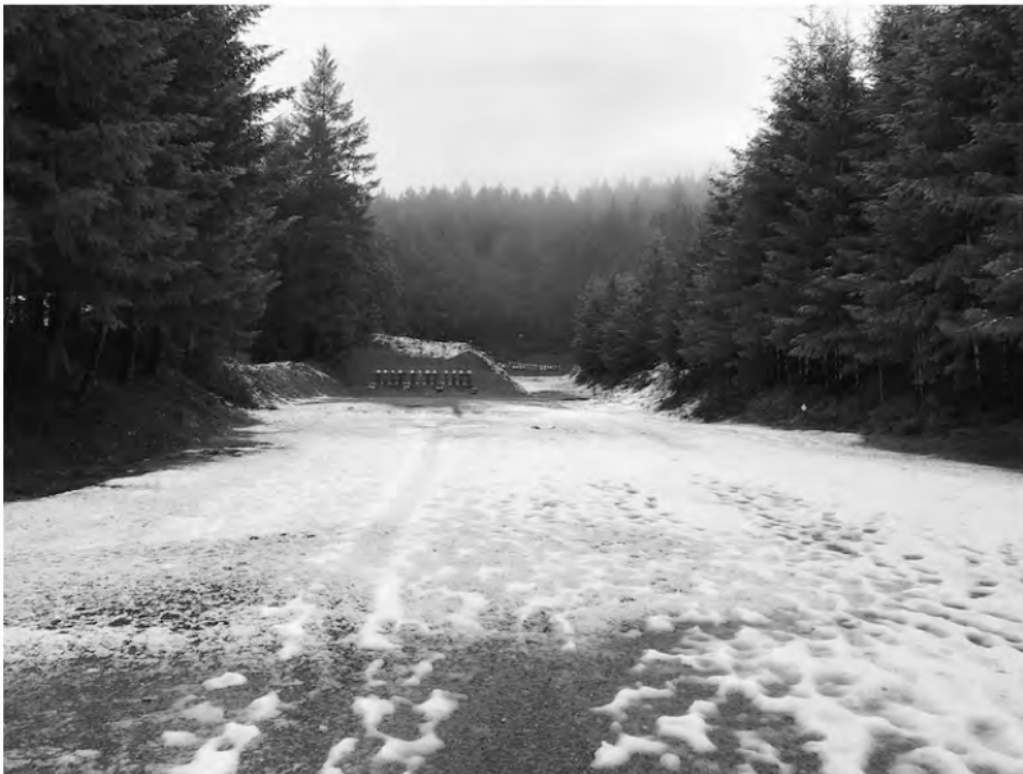
Photo 6 – 100-yard (near left) and 200-yard (distant right) range target areas.

Soil analysis results from the preliminary sampling program confirmed the presence of three metal COCs in the target area backstop soils of AEC 3: antimony, copper, and lead. The soil analysis results of the PSI 2 borehole sampling showed that these metals were not found at concentrations above CSR standards at depth. PAHs were also identified as PCOCs due to the presence of clay pigeon fragments and have yet to be investigated in soil. The lateral extent of shallow soil contamination would be required in advance of preparing a remediation plan.

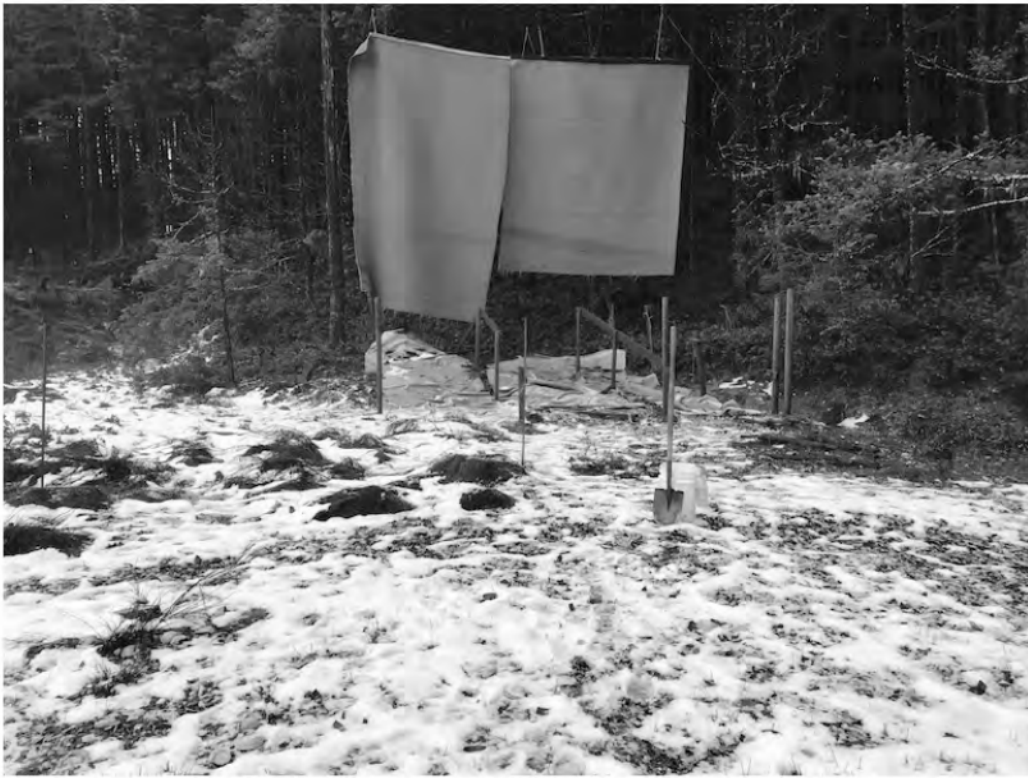
Photo 9 – Trap range target area with backstop tarps.

- A soil berm was not present in the designated target area at the trap range; rather, a large black rubberized tarp was observed to be hoisted by two trees in the target area. A similar tarp was placed under the backstop tarp to capture gun shot. Spent gunshot and clay target

fragments were observed through all the outdoor ranges, but predominantly in the target area of the trap range. The side-berm of the 200-yard outdoor range is adjacent to the north side of the trap range, which approaches the trap range target area at its eastern limit. Spent gunshot was observed amongst the soil of this berm, and was observed beyond this berm as far away as 20-25m north and 50m east of the 200-yard range target area.

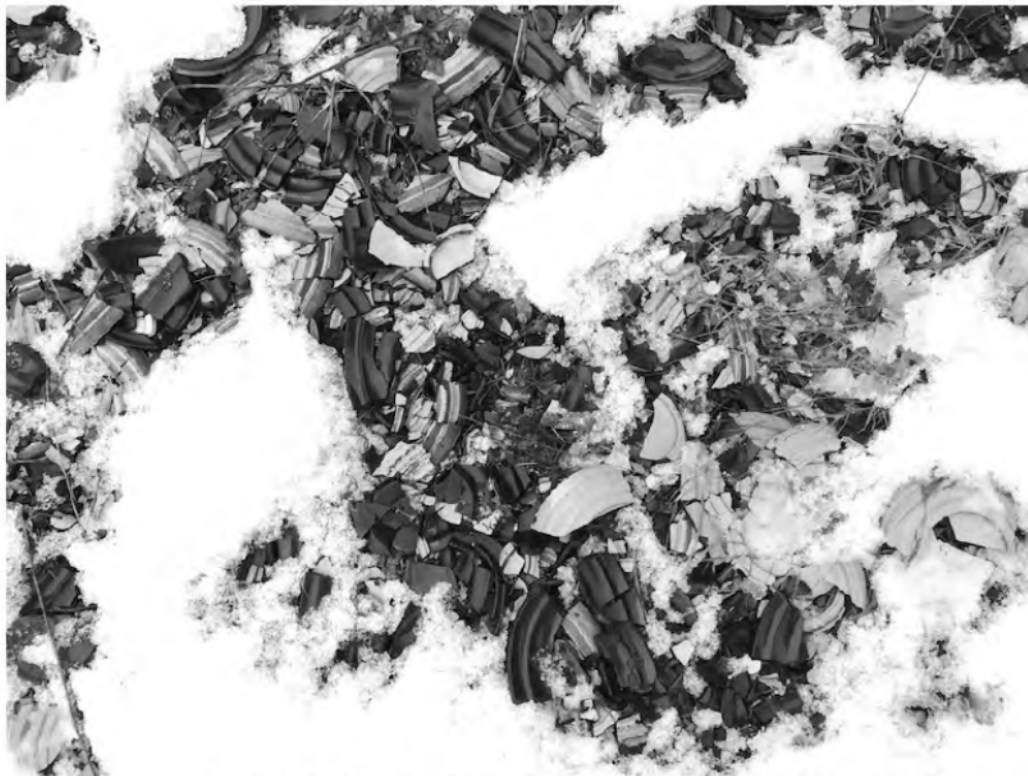
Photo 10 – Clay pigeon fragments in trap range target area.

During the site reconnaissance and preliminary soil sampling conducted by Trillium, spent gunshot was observed across a relatively wide area including the trap range target area and an overspray area to the north and east of the target area. Fragments of spent clay pigeons were observed most densely in the trap range target area, and to lesser amounts in the remaining outdoor gun range target areas. Results of the preliminary soil sampling did not reveal soil metals contamination based on one sample taken from the soil berm adjoining the trap range target area. However, the overall area influenced by spent gunshot, including overspray, is large and requires additional soil characterization. The trap range and overspray areas are considered potential sources of soil and groundwater metals contamination at the Site. Pitch from clay pigeon fragments can contain polycyclic aromatic hydrocarbons (PAHs) with potential to impact soils; however, if present, the PAHs are tightly bound to a limestone-pitch matrix and are considered unlikely to leach and impact groundwater.

The trap range area has been used since at least the 1990s for clay pigeon shooting with shotguns. During the site reconnaissance and preliminary soil sampling conducted by Trillium, spent gunshot was observed across a relatively wide area including the trap range target area and an overspray area to the north and east of the target area. Fragments of spent clay pigeons were observed most densely in the trap range target area, and to lesser amounts in the remaining outdoor gun range target areas. Results of the preliminary soil sampling did not reveal soil metals contamination at a single sample taken from the soil berm adjoining the trap range target area. However, the overall area influenced by spent gunshot, including overspray, is large and requires additional soil characterization. The trap range and overspray areas are considered potential sources of soil and groundwater contamination at the Site.

It is recommended that further investigations be conducted to complete the investigation of PAHs at AEC 2 and 3, and metals and PAHs at APEC 4. Detailed investigation is recommended to delineate shallow soil metals contamination found at AECs 1, 2, and 3. Determination and delineation of all COCs at the Site is a prerequisite for the development of a remedial action plan for the Site. A summary of remaining APECs/AECs and PCOCs/COCs for the Site is provided in Table 7-1 below.
