Report Date:October 10, 2018 File:107664

Report Number:099541

Re: Non-compliance Advisory Letter, Permit 107664, 1810 Verling Ave, Saanichton BC V8M 1X6, Air

NRIS Photo Record	Page <b>1</b> of <b>4</b>
Authorization: 107664	Client Name: CIF Composites Inc.
NRIS IR#: 99541	(Date) Site Inspection Photos: 2018-09-05

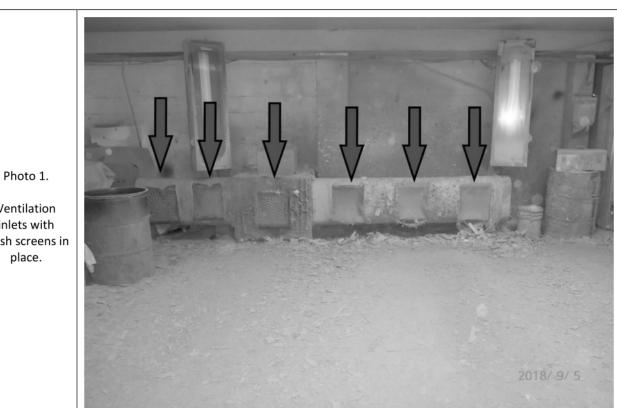
Ventilation inlets with mesh screens in

Compliance:	In
Requirement Description:	2.1 Authorized Works
	2.1.1: The Permittee must ensure that inlet mesh screens are in place during operations, where required in Section 1.
Details/Findings:	During the inspection, Officer Wheating observed that some of the ventilation system inlets did not have mesh screens in place (Photos 1 to 4).
Compliance:	Out
Actions to be taken:	Ensure that all ventilation systems inlets have mesh screens in place during operation.
Requirement Description:	2.1 Authorized Works

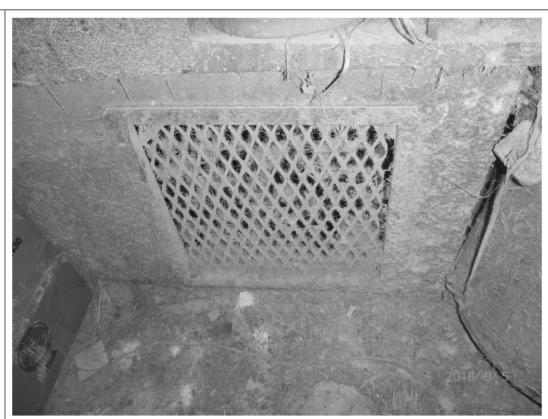
Photo 3.

Ventilation inlet without mesh screen in place.

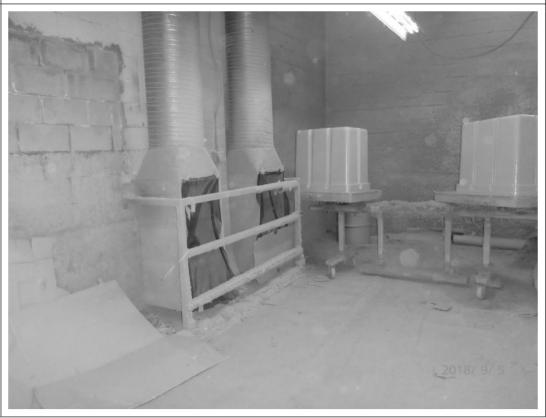
Photo 4.

Ventilation inlet with mesh screens in place.

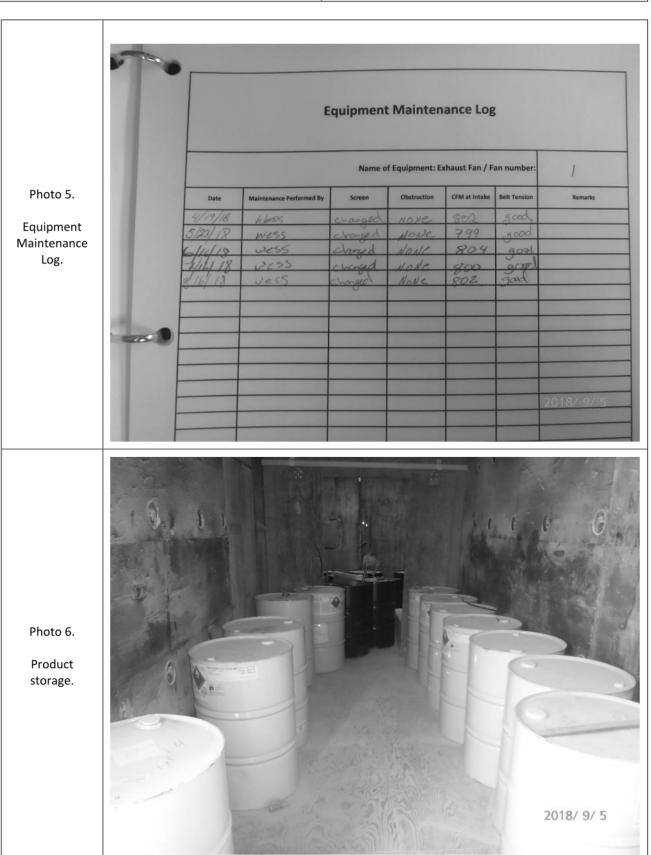
Compliance:	Not Determined	
Requirement Description:	2.1 Authorized Works	
	2.1: The authorized works for the discharges in Section 1 must be complete and in operation while discharging.	
	The Permittee must inspect the authorized works and maintain them in good working order.	
Details/Findings:	During the inspection, Mr. Peters informed Officer Wheating that the facilities current ventilation fans are used when equipment they ventilate is in operation.	
	During the inspection, Mr. Peters produced an equipment maintenance log document for each of the facilities current ventilation fans (Photo 5).
