File: UA79205

Report Number: 134683

Re: Warning Letter, Unauthorized Discharge, 17256 8th Avenue Surrey B.C.

Authorization: UA79205	Baird Cattle Company Ltd.
NRIS IR #: 134683	(May 16, 2019) Site Inspection Photos

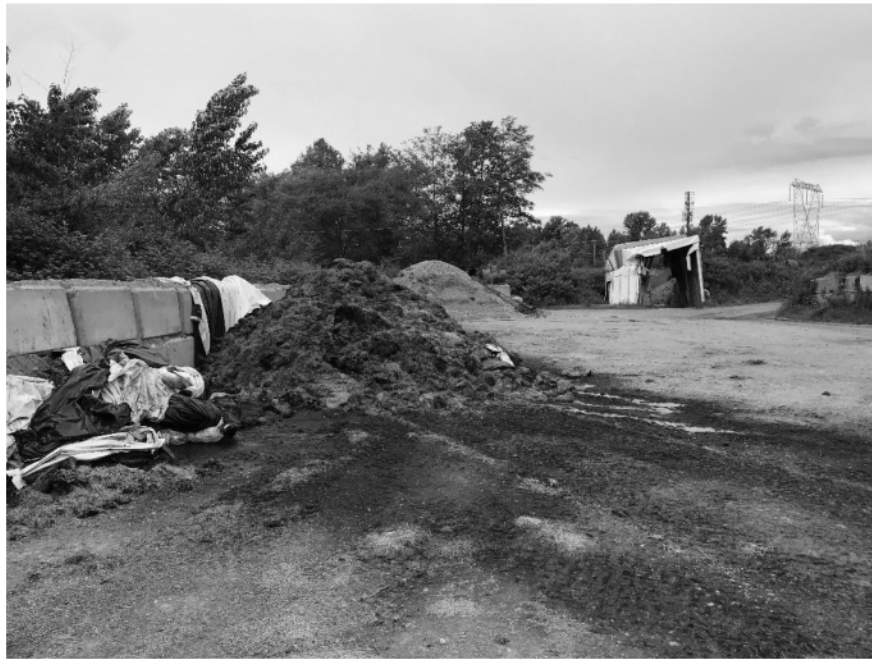
Photo 1

Agricultural by-products stored neither in a permeant storage structure or as temporary field storage.

Photo taken west of the lagoon east of the tributary, facing north.

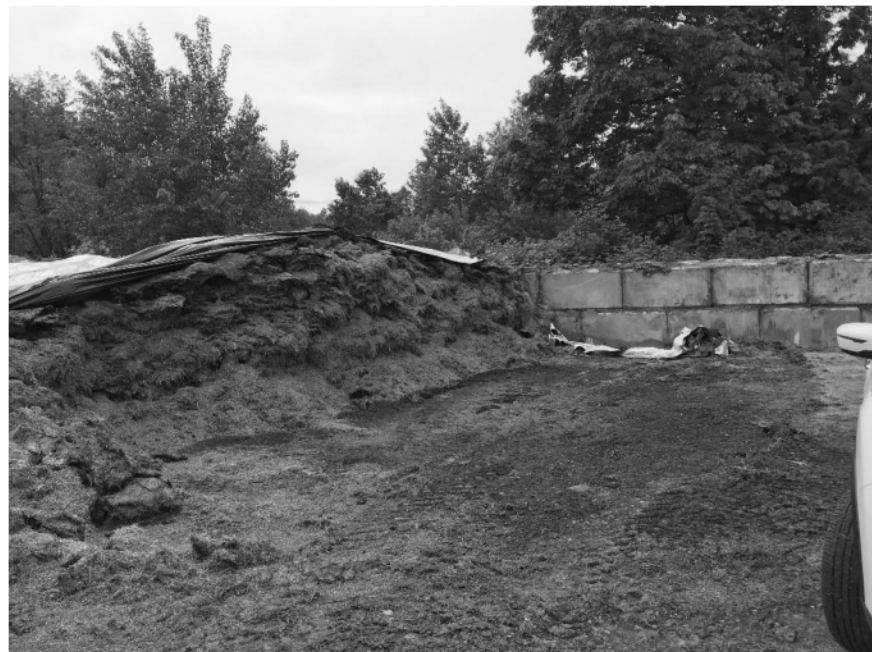
Photo 2

Agricultural by-products stored neither in a permeant storage structure or as temporary field storage.

West of the lagoon, east of the tributary. Photo facing south-west.

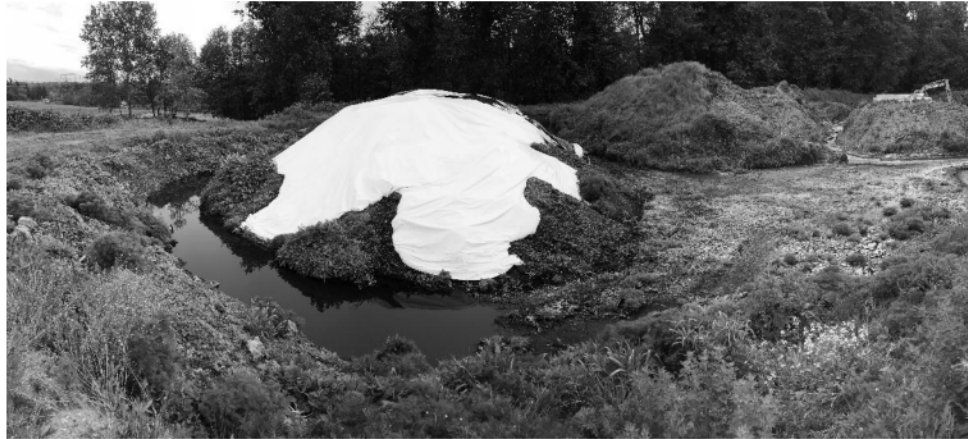
Photo 3

Requirement Description:	Environmental Management Act, Code of Practice for Agricultural Environmental Management (EMA) 32 (c): A person may store and use solid agricultural by-products, or carry out an agricultural composting process, only as follows: (c) solid agricultural by-products may be stored only in a permanent storage structure or as temporary field storage
Details/Findings:	<p>Solid agricultural by-products were observed by Ministry staff during the inspection stored neither within permanent storage structure or stored as temporary field storage.</p> <p>Two manure piles were observed stored to the east of the lagoon partially covered and contained to the east with a lock block wall (Photos 1 & 2).</p> <p>Three large piles were observed stored south of the lagoon (Photos 3 & 4) as previously documented in IR-79205 from February 2018. The three large piles of agricultural by-product were surrounded by contaminated runoff which was being pumped into the lagoon (Photos 3, 4 & 5).</p>

Three agricultural by-product piles stored neither in a permeant storage structure or as temporary field storage.

Photo taken standing on the south berm of the lagoon, facing south.

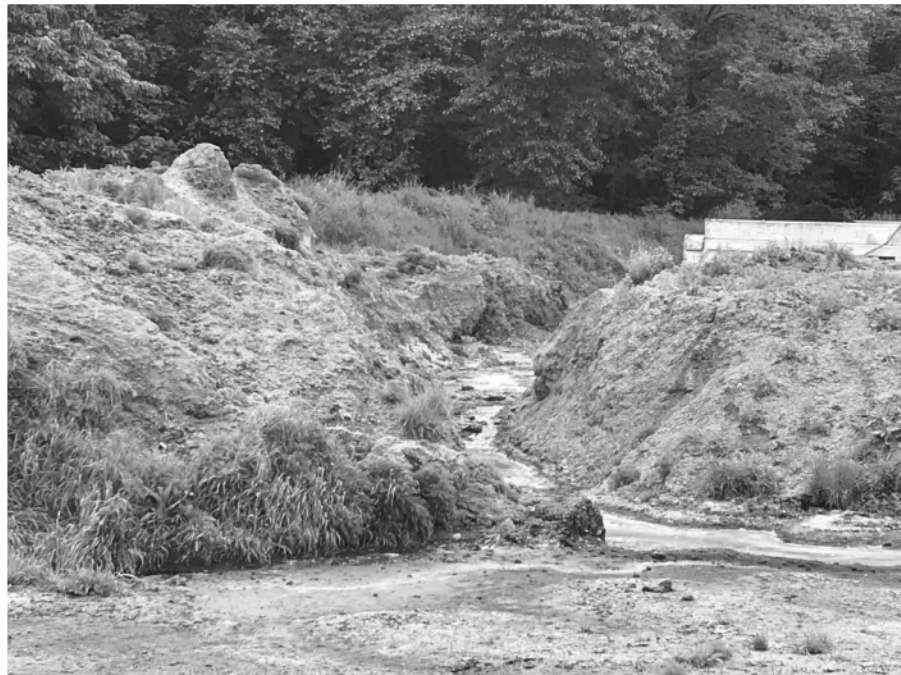
Photo 4

Contaminated runoff at the base of the agricultural by-product piles located south of the lagoon.

Photo taken standing on the south berm of the lagoon, facing south.

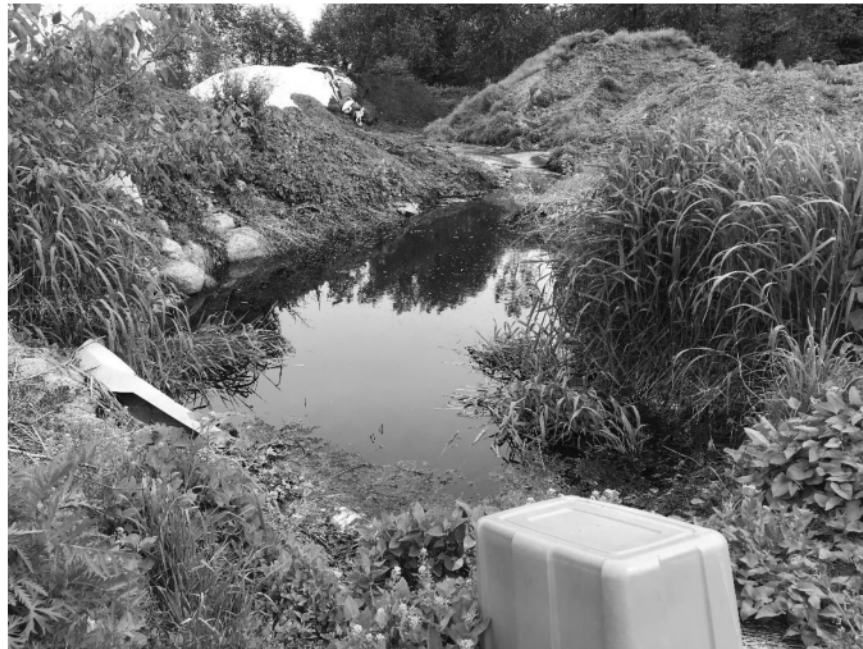
Photo 5

Contaminated runoff ponding south of the lagoon. A pump is setup to transfer the effluent into the lagoon.

Photo taken standing south-west of the lagoon, facing south-east.

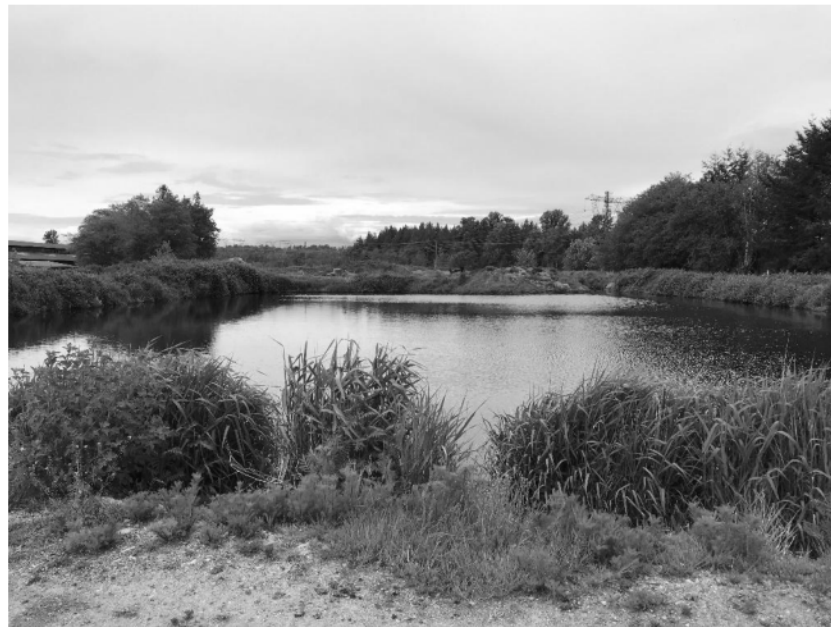
Photo 6

Lagoon at Baird Cattle.

Photo taken standing on the south berm of the lagoon, facing north.

Compliance:	Out
Actions to be taken:	Retain the services of a qualified professional to assess the lagoon.

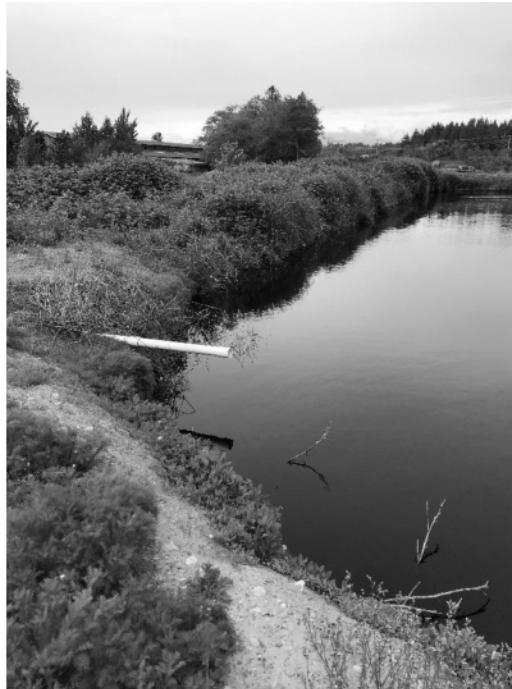
Photo 7

PVC pipes which transfer contaminated runoff from the agricultural operation into the south-west corner of the lagoon.

Photo taken standing on the south berm of the lagoon, facing north-west.

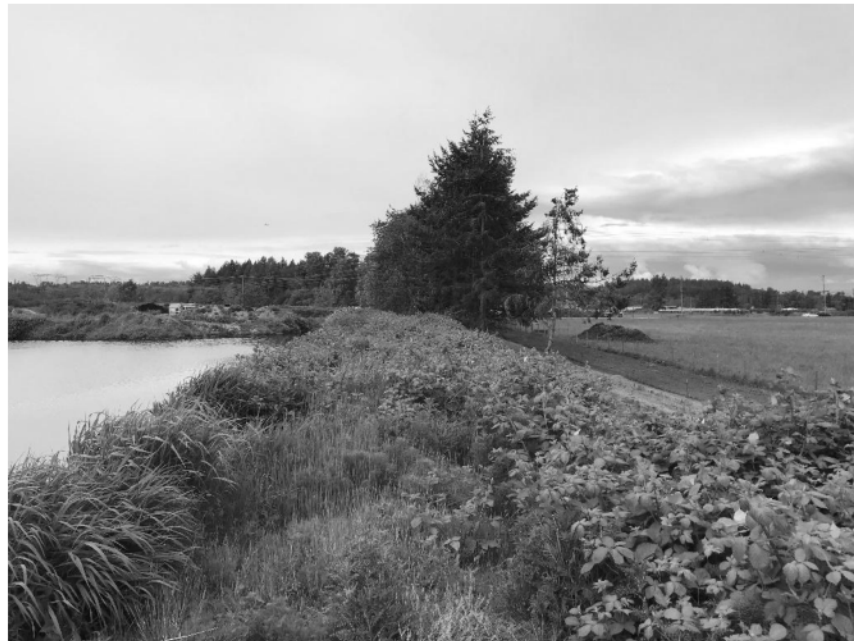
Photo 8

Eastern berm of the lagoon/
Eastern property boundary.

Photo taken standing on the south-east corner of the lagoon berm, facing north.

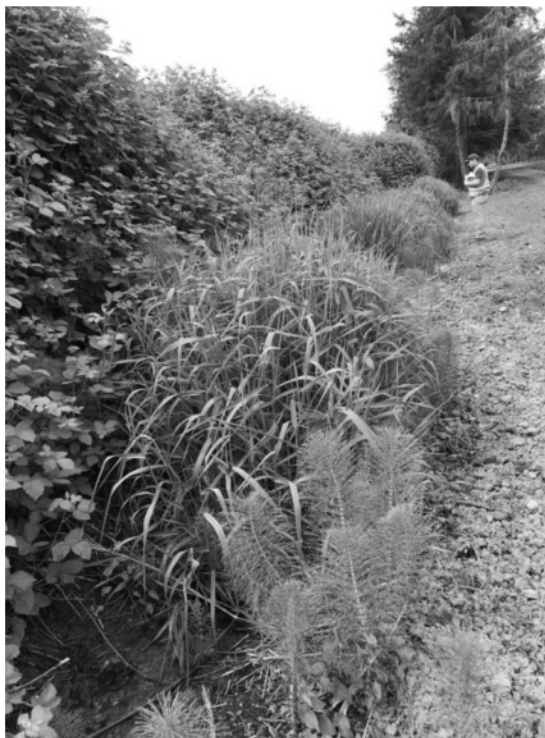
Photo 9

Eastern edge of lagoon berm along the east property boundary.

A ditch runs north to south and feeds a tributary that flows into Little Campbell River to the immediate south of the property.

Photo facing north.

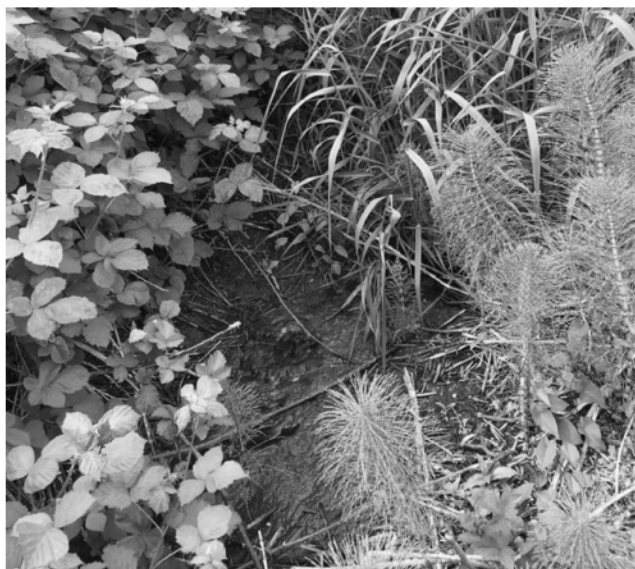
Photo 10

Black effluent in the ditch at the base of the lagoon berm along the east property boundary.

Photo taken standing on the property to the east of Baird Cattle Co.

Compliance:	Out
Actions to be taken:	1) Implement the necessary changes or modifications immediately to address this situation and to bring it into compliance. 2) Notify this office by email or letter within 30 days of this letter, advising what corrective measures have been taken, and what else is being done, to bring this authorization into compliance.
Requirement Description:	Environmental Management Act, Code of Practice for Agricultural Environmental Management (EMA) 2 (2)(a): This code applies to an agricultural operation described in subsection (3) that is carried out in British Columbia (a) on (i) an agricultural land base that is owned, rented or leased, and managed, by the person who carries out the agricultural operation, and (ii) land that is not zoned for residential purposes, and
Details/Findings:	Baird Cattle owns and operates an agricultural operation (cattle feedlot) on the agricultural land base on land that is not zoned for residential purposes.
