Office of the Fire Commissioner
Fire investigation Report

Incident No. NWI202210100301
PFR No.

Location: 4912 Athalmer Road, Invermere BC

Property Use: Restaurant, under construction

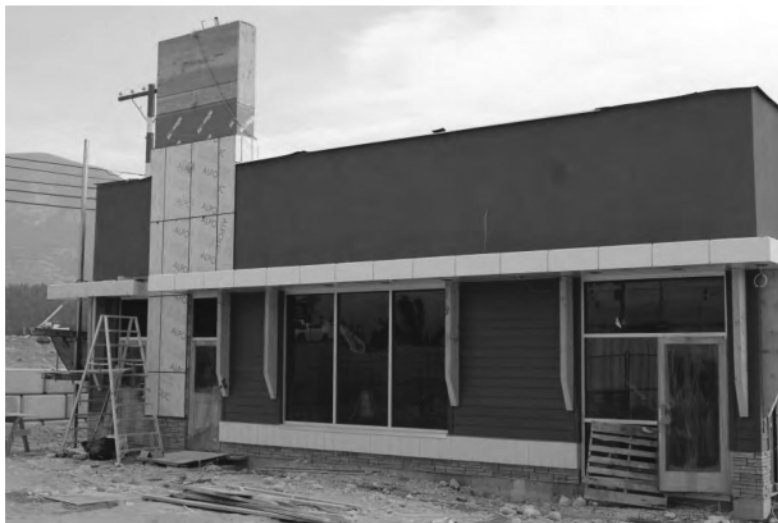
Figure 1 - Exterior Alpha Side

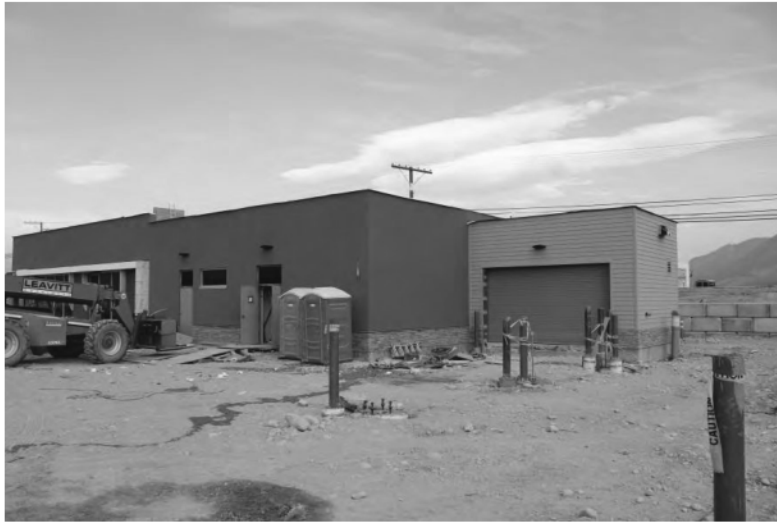
- The man door on the Alpha side was propped open with a pallet. This was confirmed by AFC Advocaat to have been done by the suppression crews.
- The man door on the Delta side was open. This was confirmed by AFC Advocaat to be the position the door was in on arrival of the fire crews.

Figure 2 - Exterior Delta Side showing open man door

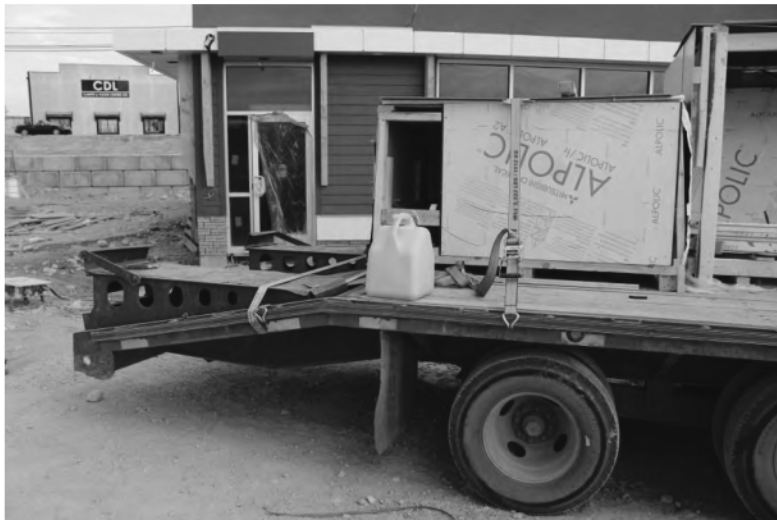
- Delta side of the building had large amounts of cardboard and other construction debris. A flat deck trailer was also situated on the Delta side. There was a 20-litre fuel container containing diesel fuel on the trailer deck.

Figure 3- 20 litre Diesel located on Delta side

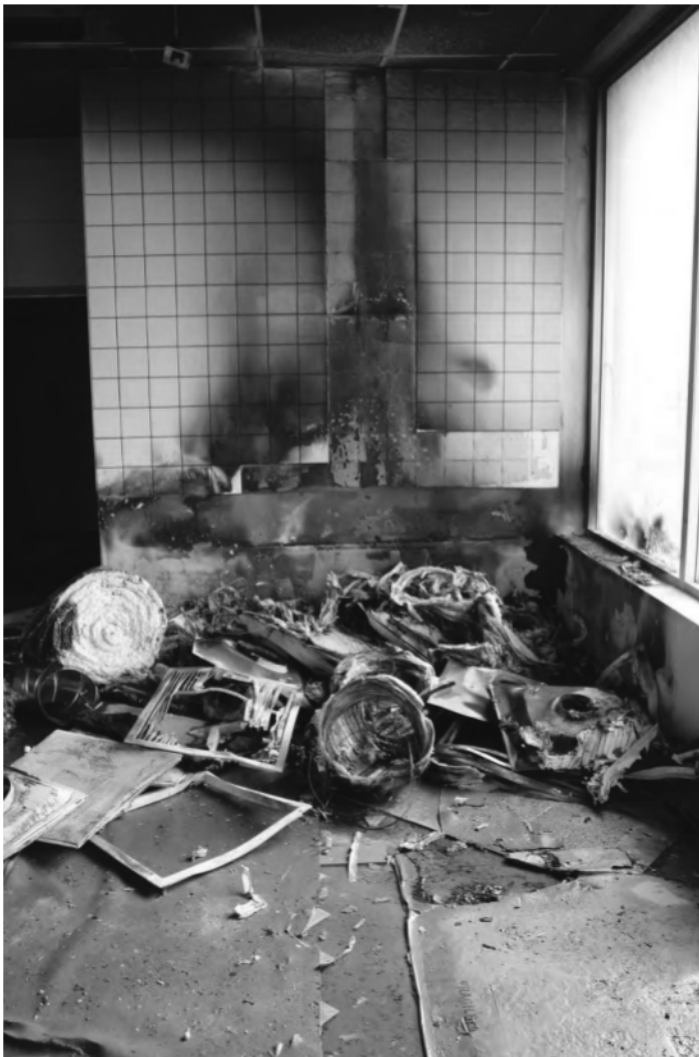
- Multiple areas of origin, all areas appeared to be focused on readily available combustible materials within the building
- All the fire damage appeared to be building content fires only and did not involve building structural components.
- Area of most fire damage was in the seating area of the restaurant. This was likely to be caused by a large fuel load of construction materials located at that location.

Figure 4 – Area of most fire damage

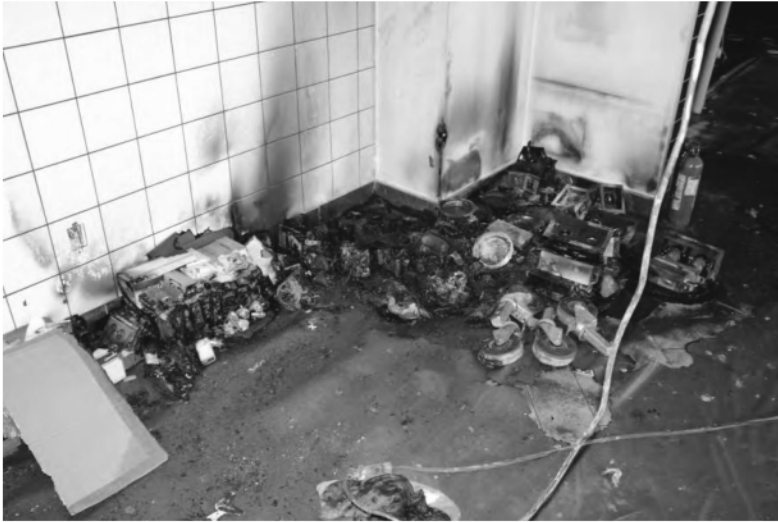
Figure 5 – Electrical building materials in seating area

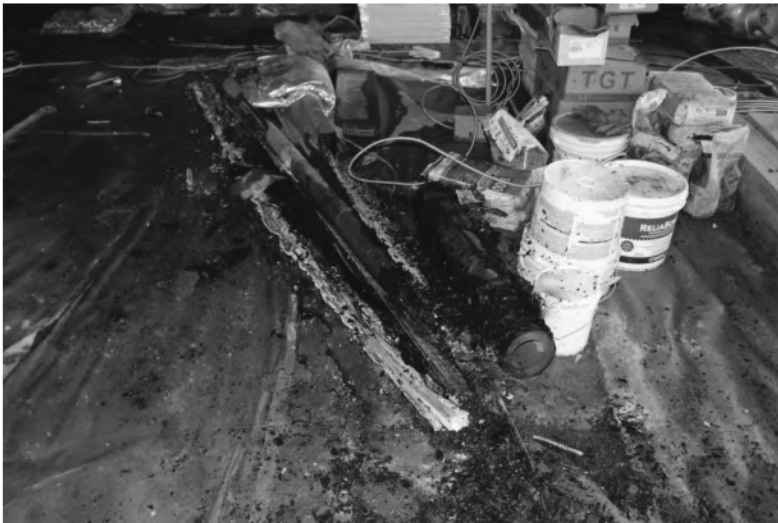
Figure 6 – Building materials in seating area

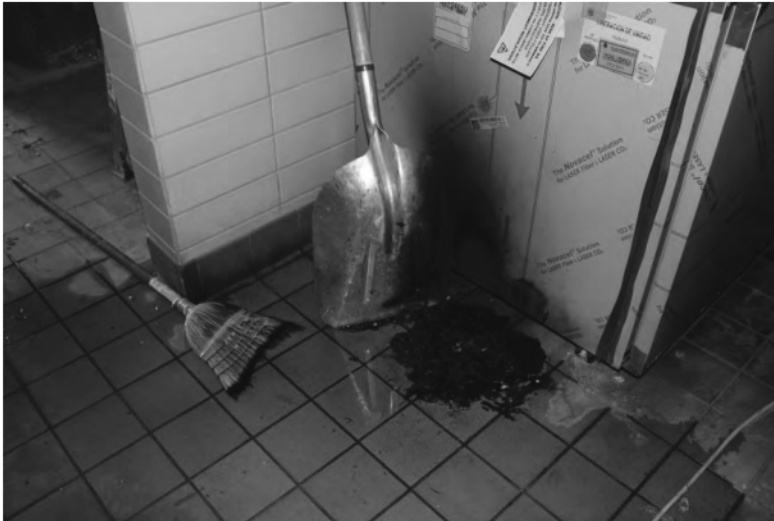
Figure 7 – Broom found in kitchen area

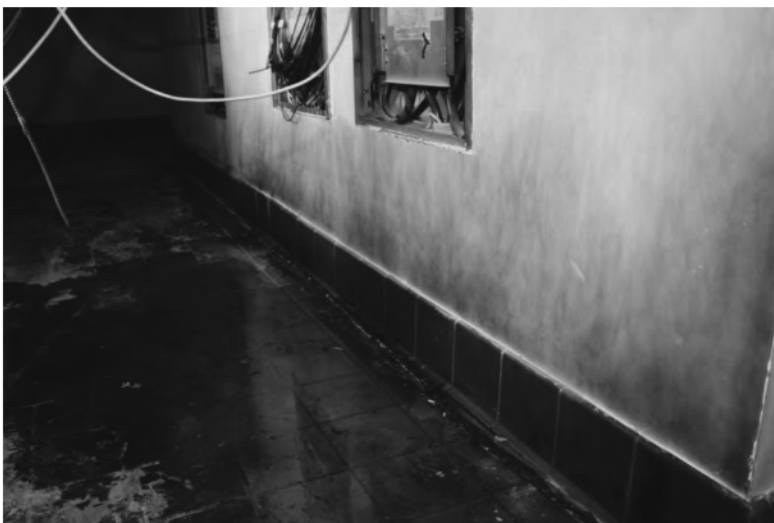
Figure 8 – Floor area burns, like other floor area burns throughout the building

- After a complete walkthrough and examination of the burns throughout the building I decided to test for accelerants using my assigned Grace Industries 950-ASH Accelerant and Hydrocarbon detector.
 - I performed the unit calibration as per the manufacturer's instructions.
 - I tested locations as per the manufacturer's instructions.
- I tested at all the identified burn locations and at no time did the device indicate the presence of accelerant or hydrocarbons.
