From: Molony, Anne TRAN:EX
Sent: Wednesday, May 7, 2014 2:58 PM
To: 'Bill Wheeldon'
Subject: RE: 432 Powerhouse Road - RAR Assessment Draft/for your info

Subject: 432 Powerhouse Road - RAR Assessment Draft

Riparian Areas Regulation: Assessment Report

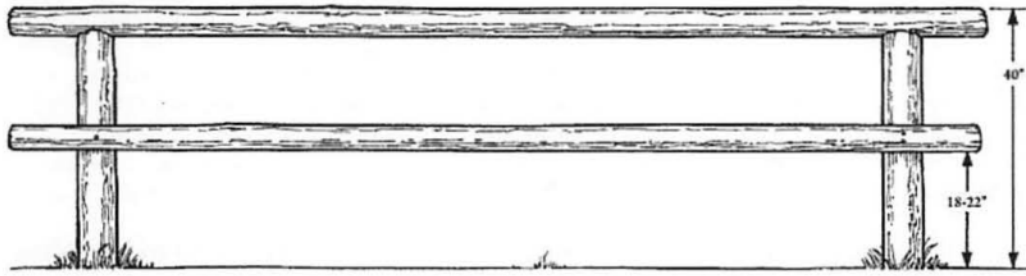
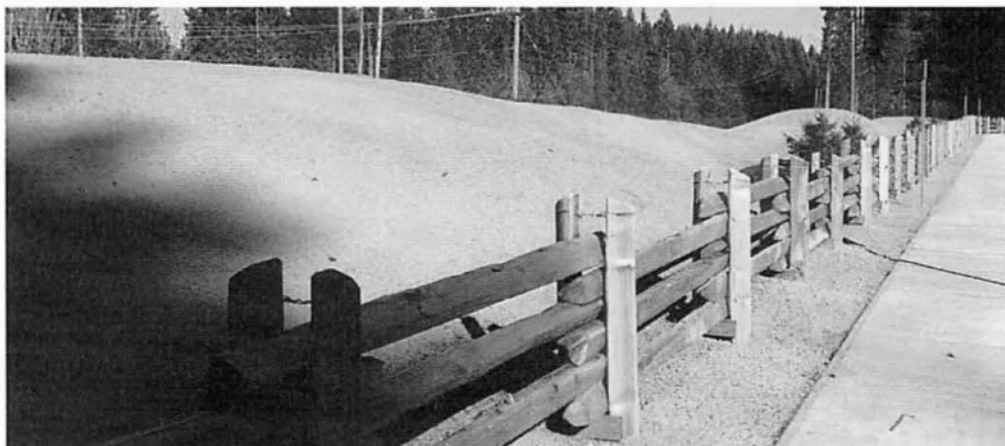
Figure 1. The above fence examples meet criteria for supporting ungulate and bird passage including high-visibility, low height, and under passage. Gaps in fence panels are also recommended where animals are likely to migrate.

Examples of wildlife passage friendly fences are provided below. The ideal fence is very visible and allows wild animals to easily jump over or pass under. It is recommended that a short (maximum 1 m) split rail cedar fence be considered or if wire fencing must be used that it have a 0.6 m gap under it and include open sections where wildlife trails exist and be at least 6 m from hwm of the creek. Increased visibility using a toprail or smooth, coloured poly-wire can help ungulates and birds avoid or navigate fences.

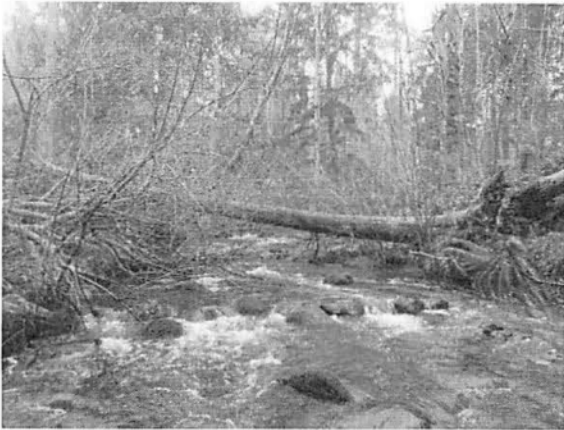
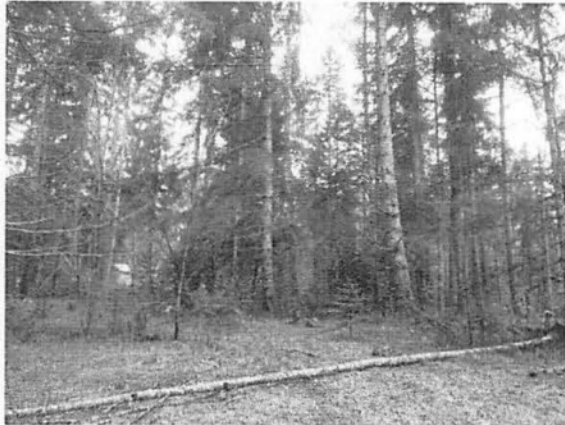
Photo 1 & 2. Morrison Crk. riparian areas showing general vegetation composition including upstream view (above left) taken from the northwest portion of the property and a terrestrial portion of the riparian area (above right). Photo 1 shows one possible location for proposed bridge construction. Bankfull width at this location is approx. 6.6 m.

The stand structure of the existing riparian vegetation is characterized by a mixed young forest, which provides 70-90% canopy closure over the stream (Photos 1-2). Occasional mature trees occur in the riparian zone dominated by Douglas fir (*Pseudotsuga menziesii*), and grand fir (*Abies grandis*), with subdominant red cedar (*Thuja plicata*), hemlock (*Tsuga heterophylla*), red alder (*Alnus rubra*), and maple (*Acer macrophyllum*). While there is active self thinning of the young forest stand, recruitment of functional LWD to the Morrison Creek mainstem is limited. Other criteria for riparian condition that are functioning favorably include stream shading, and bank/channel stability provided by rooted vegetation. Shrub and herb species include salal (*Gaultheria shallon*), dull Oregon grape (*Mahonia nervosa*), swordfern (*Polystichum munitum*), salmonberry (*Rubus spectabilis*), nine bark (*Physocarpus capitatus*), and skunk cabbage (*Lysichiton americanus*).

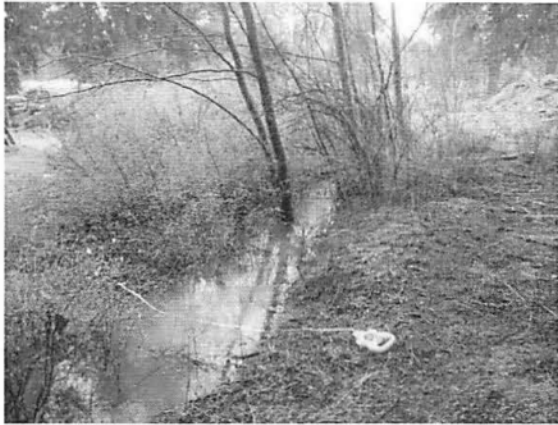
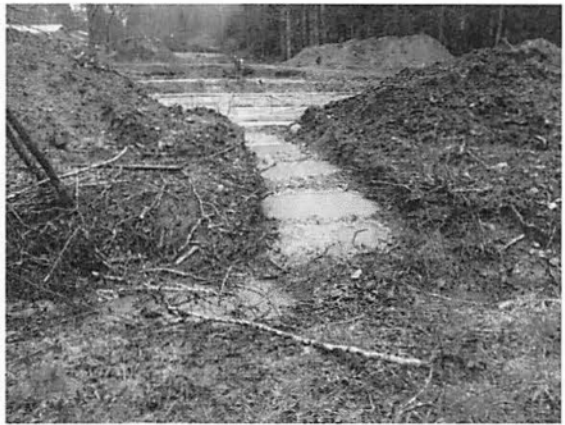
Photo 3-4. View upstream (south) of the roadside ditch along Timberlane Road (above left). Note turbid water in ditch resulting from runoff through active construction site on Lot A (above right). Recommendations for check dam install to mitigate sediment laden water leaving the site have been made and are expected to be installed in the near future.

At the time of assessment (April 3 2014) construction on Lot A (in the Comox Valley Regional District) had progressed to pouring a foundation for a residential dwelling (Photo 4), and framing of a carriage house. This report was not solicited in response to the above works and is limited to the proposed installation of a fence with hand dug cast-in-place concrete post anchors. The alignment of the fence will be parallel to the future driveway off of Timberlane Road and may in part delineate a portion of the 22.3 m SPEA (Figure 2). During the site visit it was observed that sediment laden water was flowing from the construction footprint into the Timberlane Road ditch and from there in to Morrison Creek (Photo 3-4).

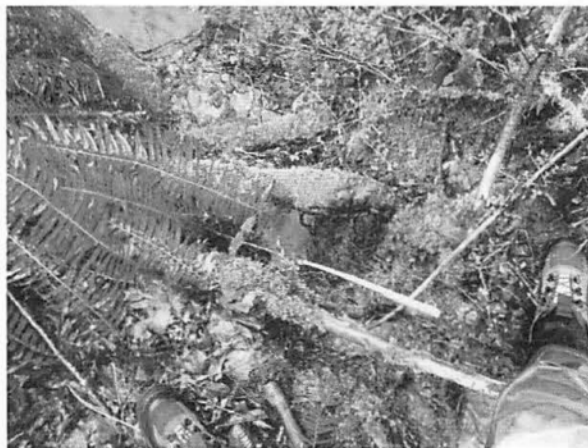
Photo 5. View of 1 m drop in ditch at confluence with Morrison Creek acting as an obstruction to fish passage. Note: yellow meter stick in centre of image showing depth of drop.

A prescribed SPEA width of 2.0 m was calculated for the riparian assessment areas of Segment #3 (Ditch) based on the calculated zones of sensitivity (ZOS) for the various features, functions and conditions (FFC) as presented in Table 3-7 of the RAR Assessment Methods. Segment #3 is a constructed Ditch with no headwaters, and no fish access based on the presence of a 1 m vertical drop at the confluence with Morrison Creek.

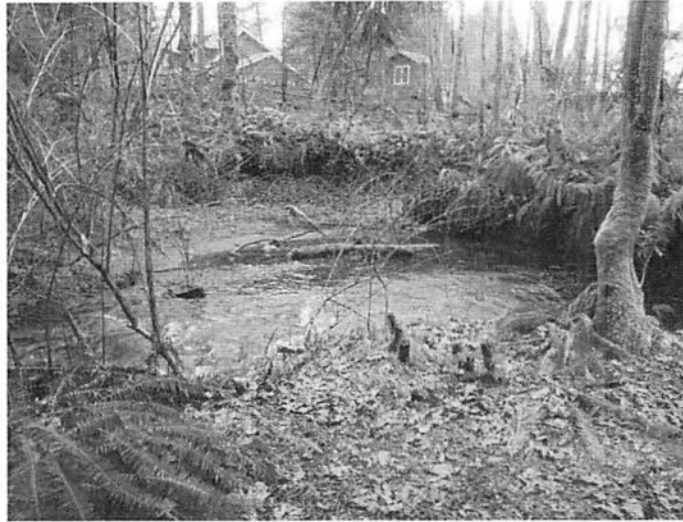
Photo 6. View to the north taken from near the northwest corner of the property showing a location on the left bank where active erosion (right of image) and sediment accumulation (left of image) are taking place.

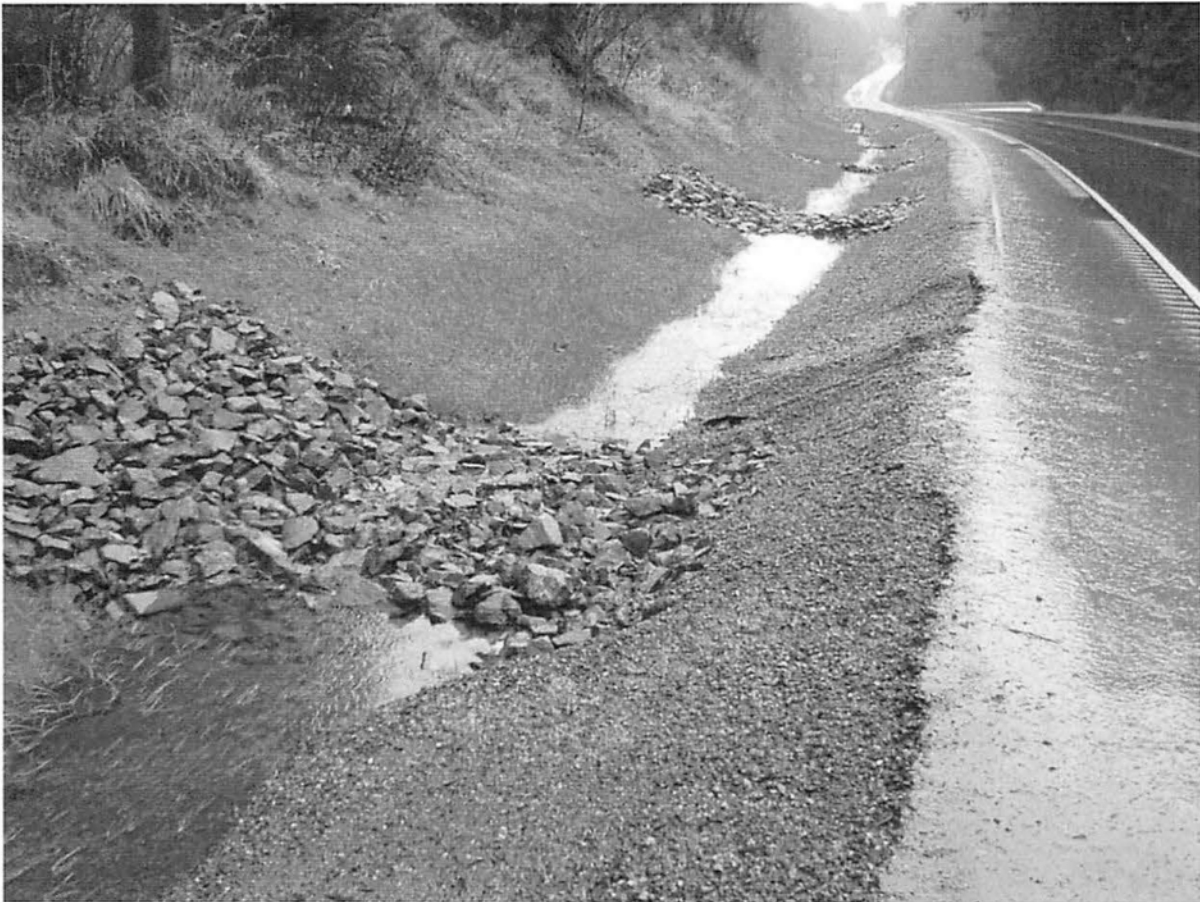
Photo 1. View downstream of appropriate rock check dams used to filter sediment and reduce flow velocities.

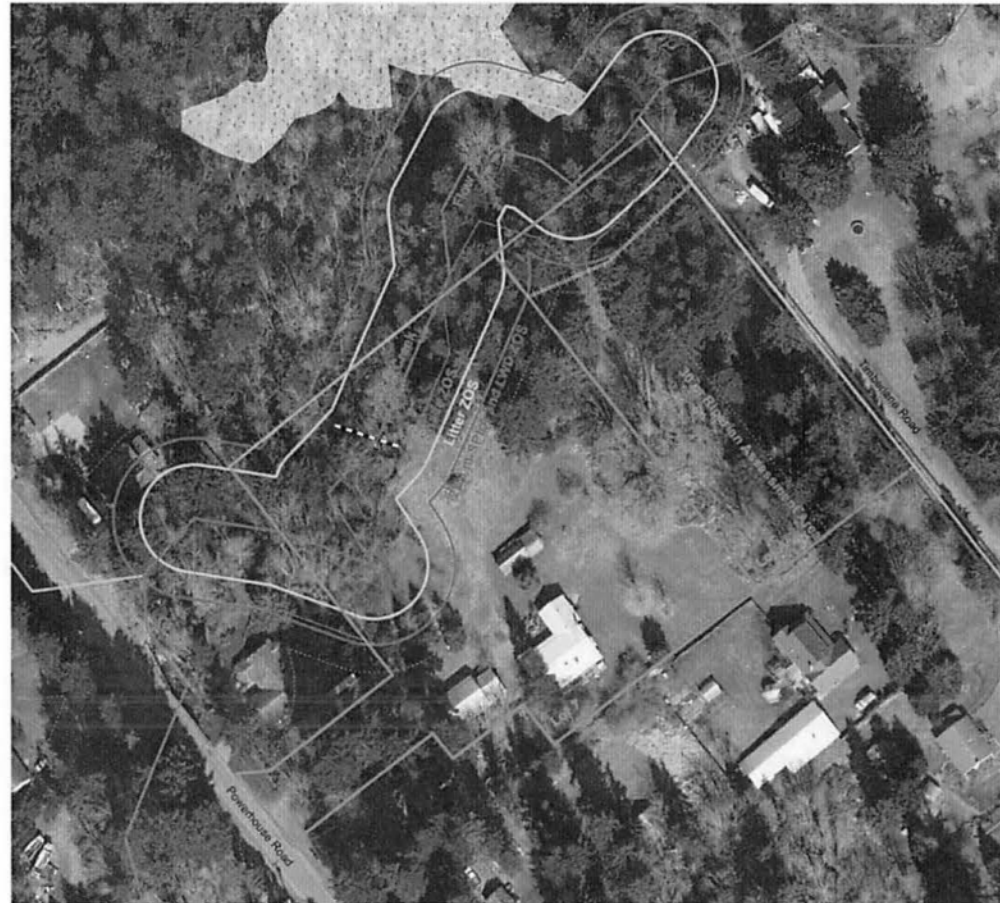
Figure 1. Site plan of subject property from Riparian Areas Regulation assessment showing calculated SPEA setbacks for Morrison Creek (red line) and the ditch along Timberlane Road (Purple line).
