Compliance Certificate

Report on CMVSS Compliance:

MetroTrans Bus (Unit #806)

Document No: 2009IVT034R1

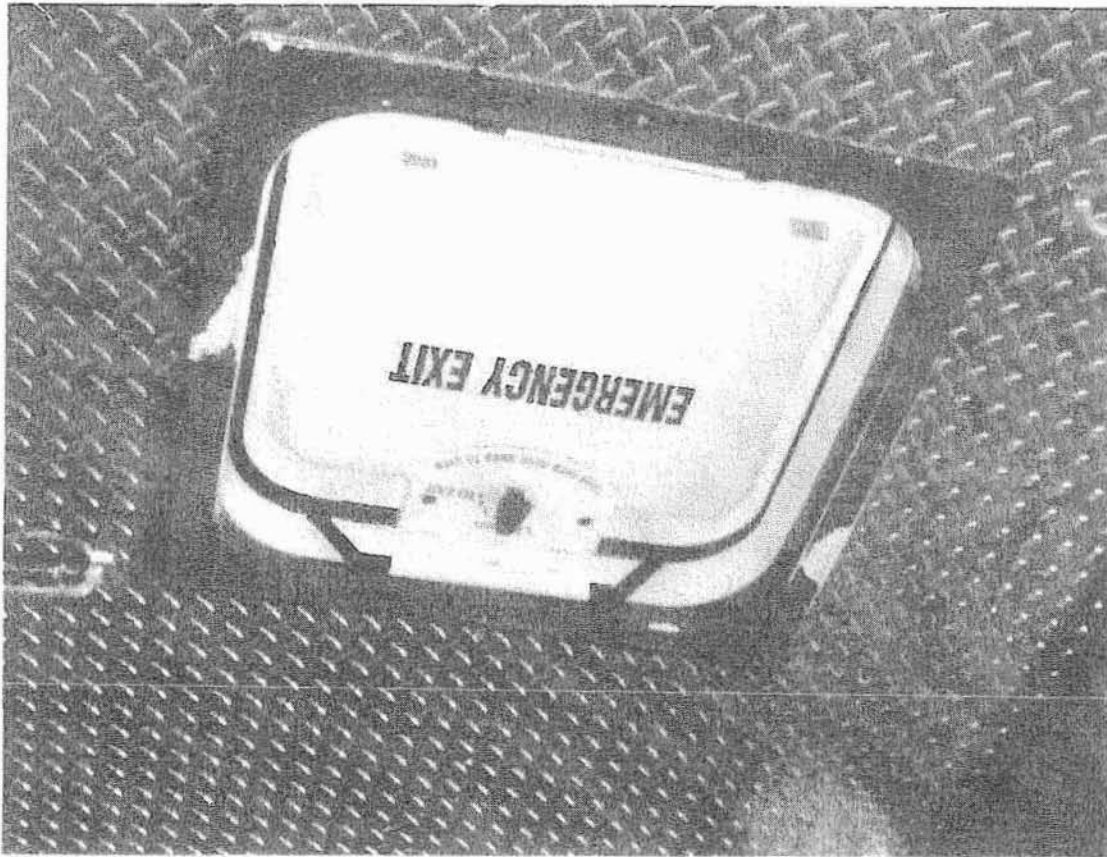
Figure 7 Roof emergency exit

The roof emergency exit is depicted in Figure 7, below.
