B.C. Ministry of Transportation and Infrastructure

Cosen's Bay Road - Environmental Impact Assessment

July 2014

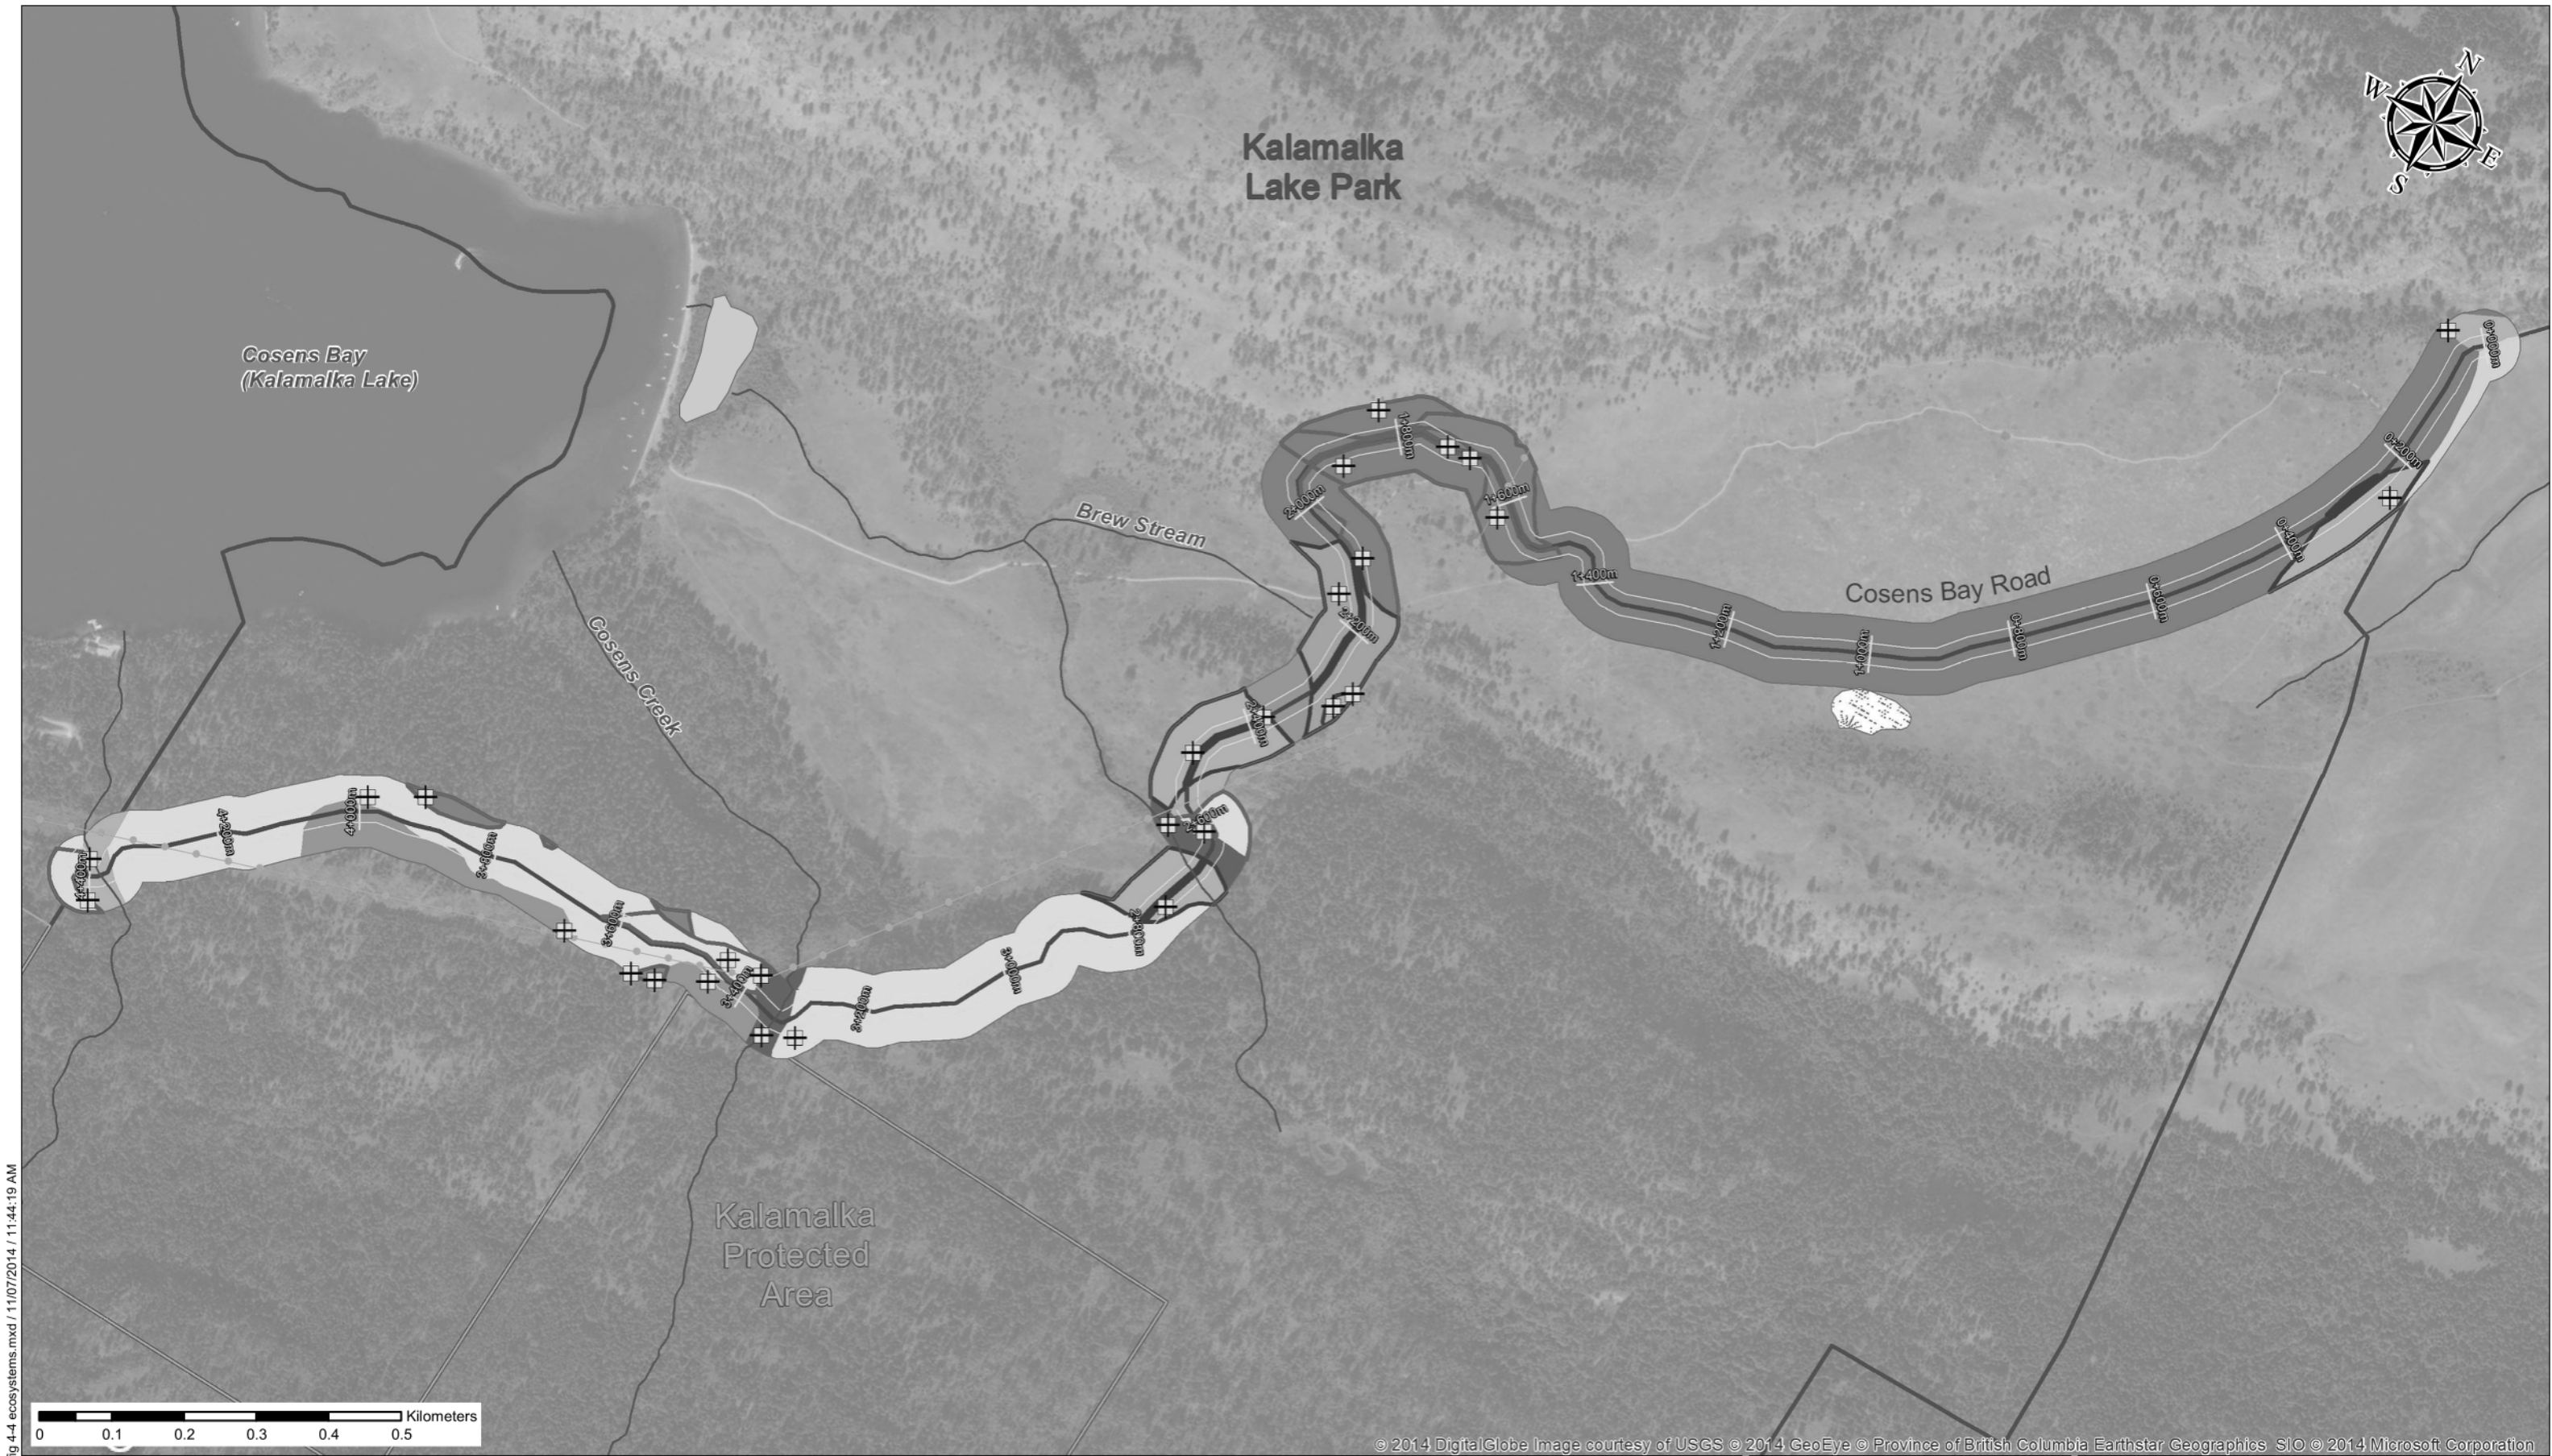
fig 4-4 ecosystems.mxd / 11/07/2014 / 11:44:19 AM

Based on the field assessment and SEI data (Iverson and Uunila 2008), five primary ecosystem units were identified in the Project Area. Figure 4-4 shows the ecological communities identified within the Project Area, and the location of each survey plot within each of the five primary units. Within the five units, 10 sensitive ecological communities (Table 4-2) and two non-sensitive units (Table 4-3) were identified.

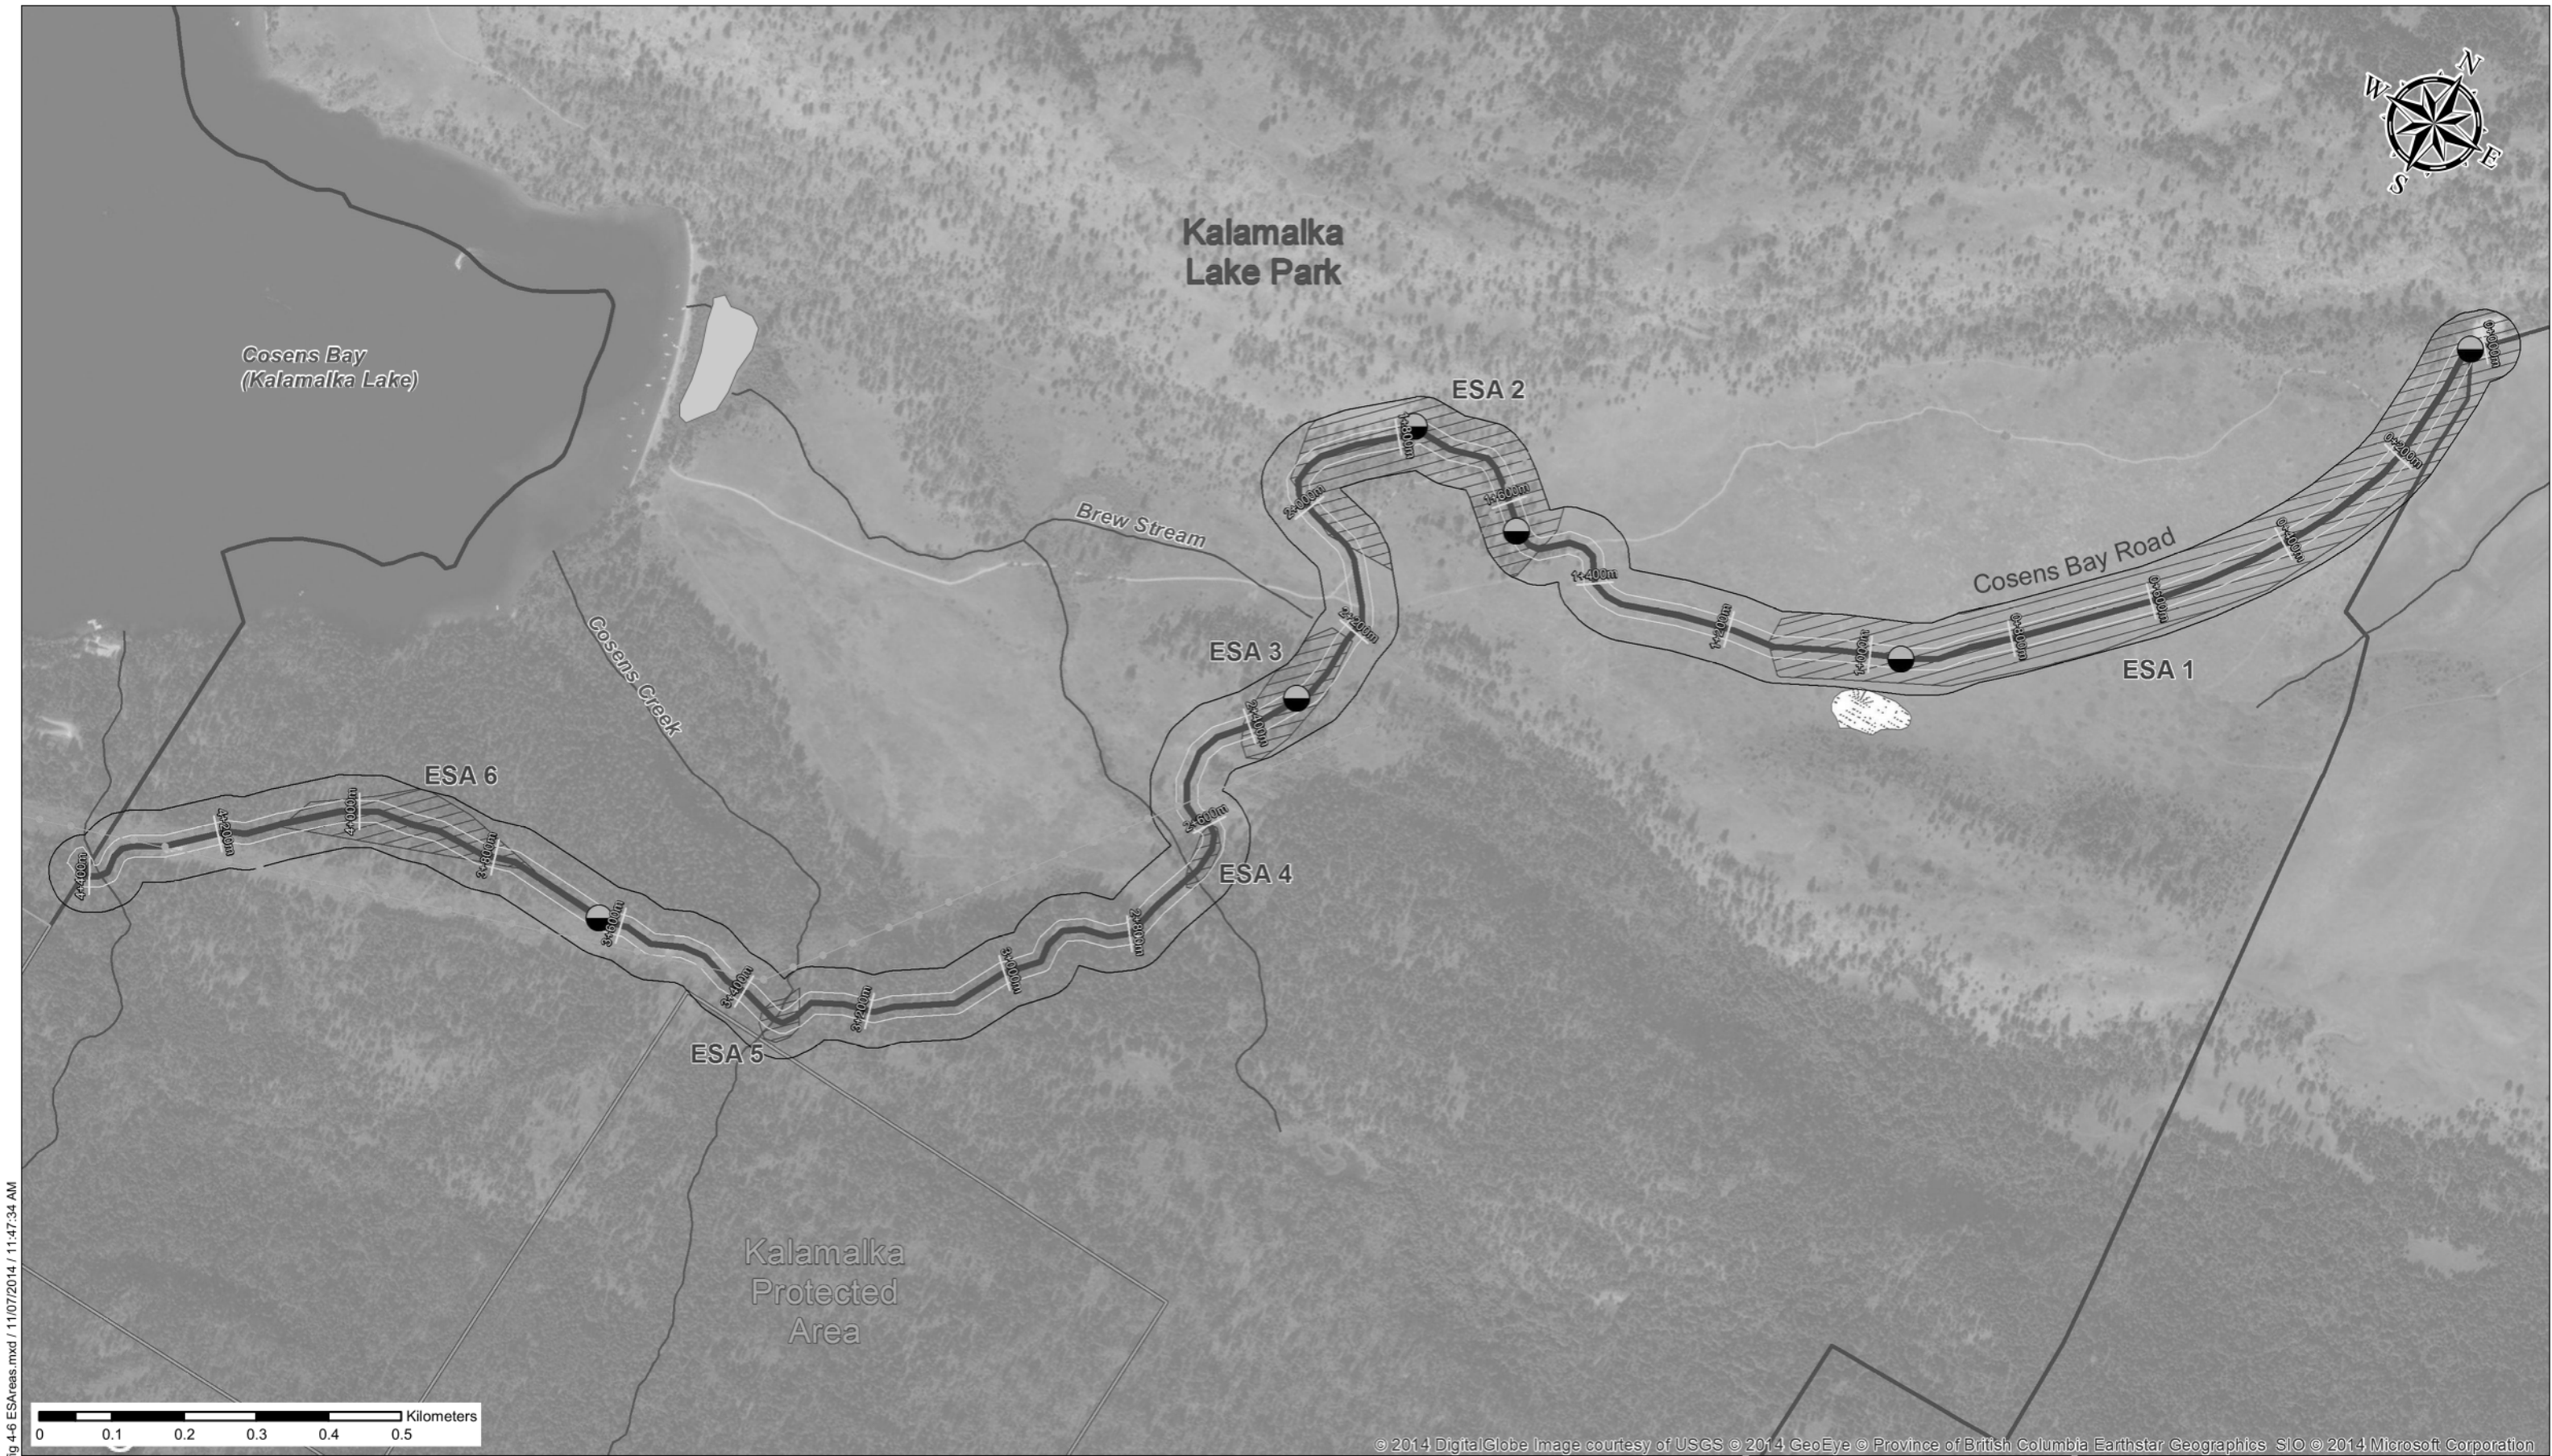
fig 4-6 ESAreas.mxd / 11/07/2014 / 11:47:34 AM

This ESA (11 ha, Figure 4-6, Photographs 2-4, Appendix A) begins at the entrance gate (0+0 m) to the park and ends approximately around 1+150 m, and has been identified for the protection of snakes and snake habitat, as well as grassland ecosystems. The rocky outcrop immediately north of the road provides excellent denning, basking, foraging and refugia for rattlesnakes and gopher snakes. The large boulder immediately west of the entrance gate (north of the road) provides suitable refugia for snakes as they emerge from dens. Foliage around the parking lot at the gate is dense and provides suitable foraging and refugia for snakes. The entire area around the entrance gate and parking lot is considered a migratory route for snakes as they travel to and from denning sites.

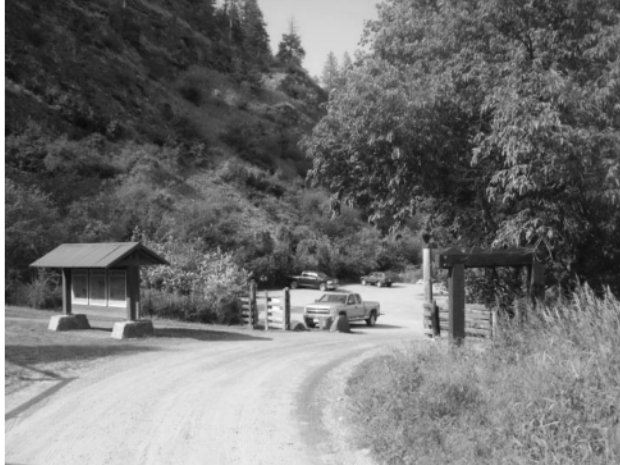
Photograph 1:
Start of Project Area, car park and
gate entrance to KLPP.

There is a large rock outcrop at the entrance to the Park north of the road, and a second outcrop and talus slope along the sharp bend in the centre of the road, also north of the road (Photographs 1 and 7, Appendix A). Rock outcrops and talus are some of the defining features of the Park and provide habitat for unique species, such as the Red-listed flat-topped broomrape (*Orobanche corymbosa*), and for other wildlife species, such as snakes. Other plant species adapted to the harsh conditions of rocky substrates include mock-orange (*Philadelphus lewisii*), oceanspray (*Holodiscus discolor*), fern-leaved desert-parsley (*Lomatium dissectum*), Oregon woodsia (*Woodsia oregana*) and round-leaved alumroot (*Heuchera cylindrica*). These areas are often surrounded by saskatoon, chokecherry, and snowberry, all of which provide cover, foraging opportunities and resting habitat for a variety of species.

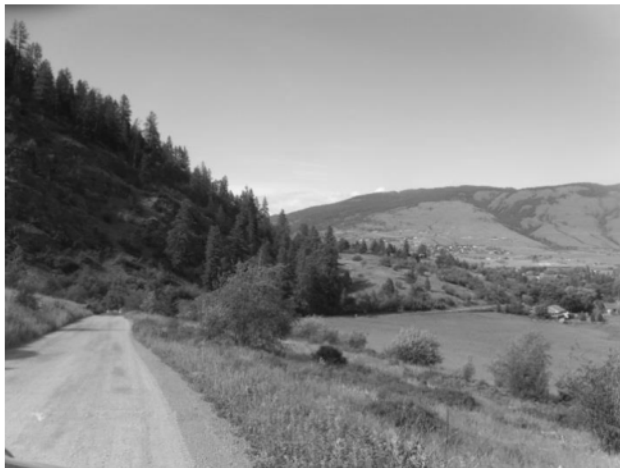
Photograph 2: Looking north
towards gate entrance in ESA 1.
Note rocky outcrop to left and
natural grassland to right.

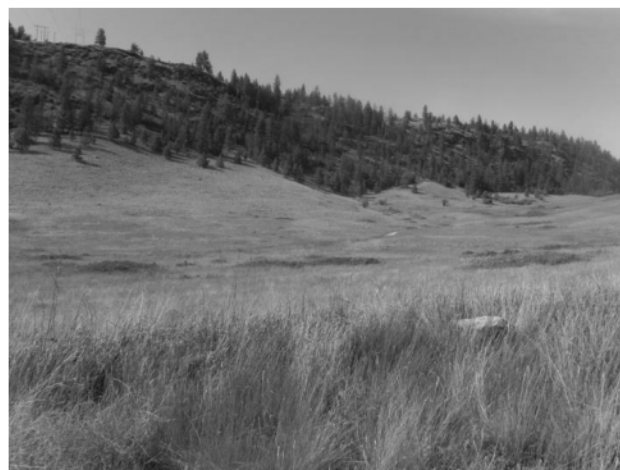
Photograph 3: Grassland habitat
borders the first third of Cosens
Bay Road, ESA 1.

The Park is considered to be the best representation of North Okanagan grassland in the region (Tedesco 2006). Grasslands dominate the northern half of Cosens Bay Road, running from the Park entrance to Brew Stream (Photographs 3 and 4, Appendix A). Most of the grasslands have patchy sections of noxious weeds; however, the first kilometre of the road from the north entrance is particularly weed infested, with weeds seeming to radiate outwards from the road. Noxious weeds include diffuse knapweed (*Centaurea diffusa*), Russian knapweed (*Acroptilon repens*), sulphur cinquefoil (*Potentilla recta*), Dalmatian toad flax (*Linaria dalmanica*), and mullein (*Verbascum thapsus*). Typical native grassland species such as desert-parsley (*Lomatium* spp.), yellow bell (*Fritillaria pudica*), large-flowered tritelia (*Brodiaea douglasii*), yarrow (*Achillea millefolium*), silky lupine, june grass, Baltic rush meadow (*Juncus balticus*), arrowleaf balsamroot, and Idaho fescue are also present.

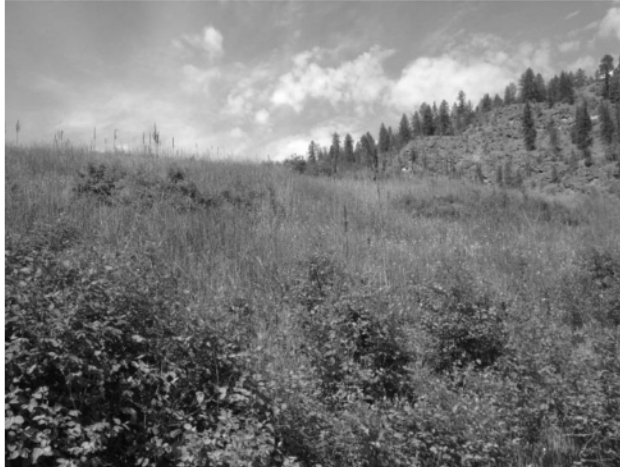
The grassland section included in ESA 1 is an area of heavy weed infestation, in particular those areas closest to the road. The grassland ecosystems of the Park constitute one of the areas of greatest concern noted in the 2006 State of the Park Analysis (Tedesco 2006). Increased access to the Park could facilitate further encroachment of weeds. The future protection and remediation of these grasslands should be a priority for Park officials and users.

Photograph 4:
Weed encroachment in grassland
habitat, ESA 1.

1. Prepare a Construction Environmental Management Plan prior to any works commencing.
2. Prepare a Weed Management Plan in advance of works to control the spread of weeds to grassland habitats. This should include a detailed weed maintenance plan for ESA 1 post-construction that is aimed at eradicating most weeds from this area of the Park. A recommended reference for developing this plan is Best Management Practices for Recreational Activities on Grasslands in the Thompson and Okanagan Basins (MWLAP 2004c).

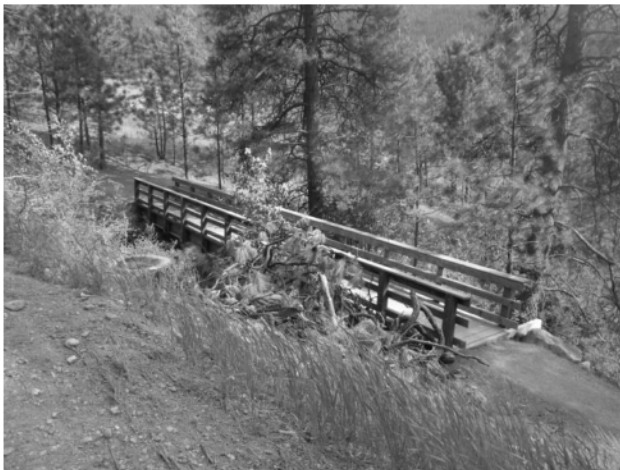
Photograph 5:
Pedestrian bridge along a
recreation path.

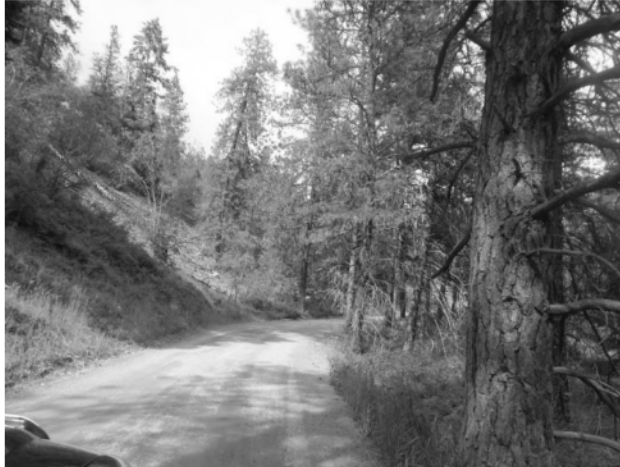
Photograph 7:
Looking northeast towards talus
slope in ESA 2.

- Retain habitat that provides shelter for reptiles, such as talus, rock outcrops with fissures, and coarse woody debris.
- Avoid construction around rock outcrops in the winter to reduce disturbance to reptile dens.

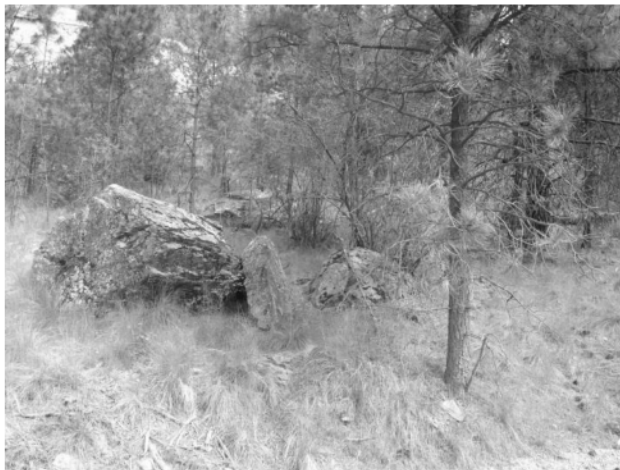
Photograph 8:
Boulders in ESA 2, suitable snake
habitat.

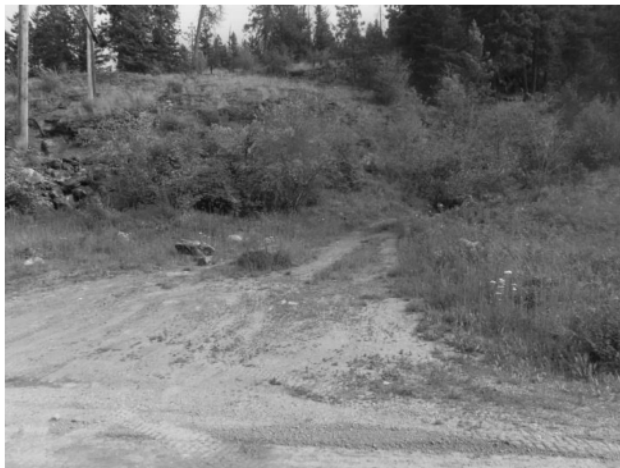
Photograph 9: Unauthorized pullout
areas at trail heads.

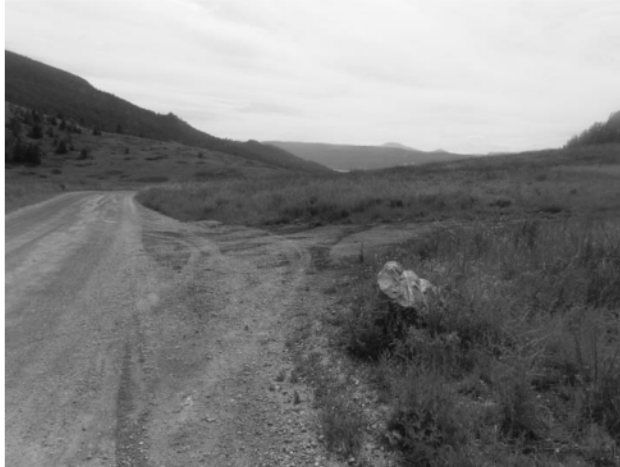
Photograph 10:
Pullouts and weeds encroaching on
grassland habitat.

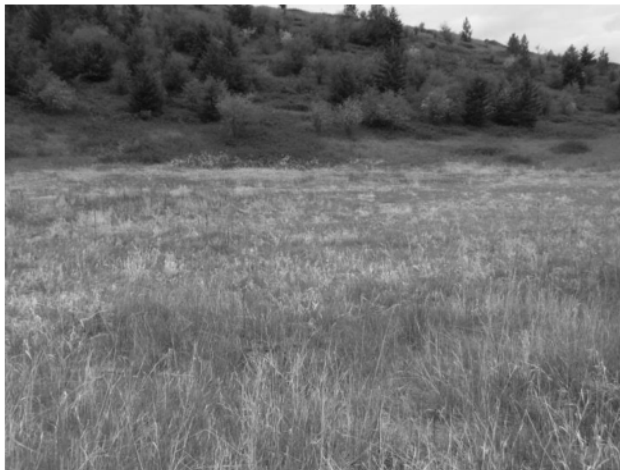
During the field assessment, the area identified previously as a wetland was dry but low lying (Photograph 10, Appendix A). This wetland is most likely ephemeral in nature, providing seasonal habitat to a variety of amphibians, small mammals, birds, and invertebrates. There is some encroachment of weeds, such as mullein, burdock (*Arctium* sp.), and diffuse knapweed, and this reduces the habitat value to some degree. This ephemeral wetland is located 50 m from the road (i.e. outside the Project Area). Several dry gullies were also noted along the forested section to the south. A small dry culvert was noted crossing under near where the road leaves the Park. Little evidence of wetland habitat was noted.

Photograph 11: Looking southeast
towards SEI wetland area. No
water present.

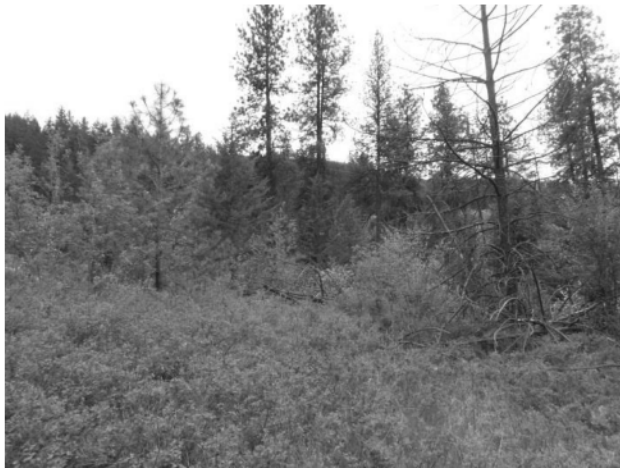
This ESA is just over 1 ha in size (2+200 m to approximately 2+425 m) and encompasses the northern fork of Brew Stream, which is dry and well vegetated (Photograph 12, Appendix A). This depression likely acts as a natural migratory corridor, providing suitable cover for large and small mammals. White-tailed deer (*Odocoileus virginianus*) were observed in this area during one of the field visits. This densely shrub-covered dry gully that borders open grasslands may also provide suitable habitat for the blue-listed western harvest mouse. Nearby are rocky outcrops and mature Douglas -fir and ponderosa pines on both sides of the road. These provide high-value habitat for small mammals and birds, and, therefore, forage and hunting habitat for reptiles and raptors. The large trees provide roosting, perching and nesting habitat for raptors such as Swainson's hawk. Large over-mature trees also provide suitable forage and roosting habitat for insectivorous birds seeking larvae and insects in bark.

Photograph 12: Shrubs and snags
at ESA 3.

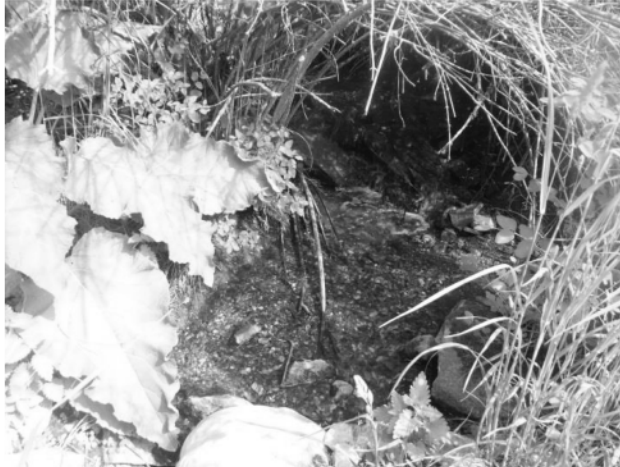
Photograph 13: Outflow at Brew Stream

- Undertake culvert replacement in line with Standards and Best Practices for In-stream Works (MOE 2004), and conduct work in the dry.
- Limit removal of riparian vegetation.

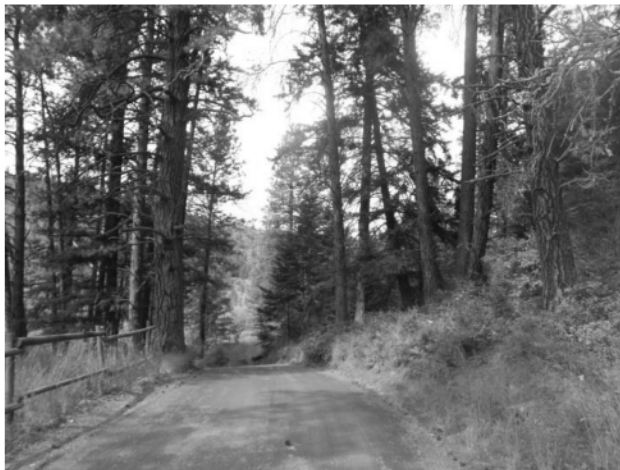
This ESA (0.2 ha) encompasses the southern fork of Brew Stream (2+600 m to 2+750 m; Photograph 14, Appendix A). Here, the stream was flowing at the time of the field assessment and the habitat had higher moisture than the surrounding Park. The existing culvert at the outflow location of this stream is a perched outfall and should be replaced during future road upgrade works.

Photograph 14: ESA 4 at Brew Stream crossing

- Undertake culvert replacement in line with Standards and Best Practices for In-stream Works (MOE 2004), and conduct work in the dry.
- Limit removal of riparian vegetation and mature Douglas-fir.
- If possible, widen on the downslope side of the road.

6. Replace or extend existing culverts at stream crossings. Carry out an assessment to properly size culverts replace or modify them accordingly.

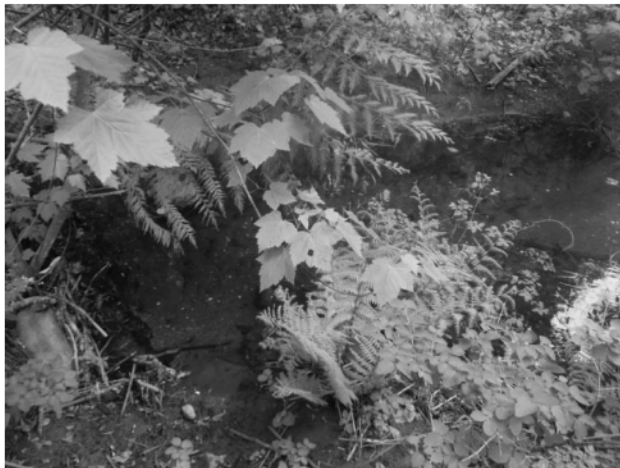
The Project Area includes riparian habitat at Cosens Creek (photograph 15, Appendix A) and Brew Stream, and in some low-lying areas where moisture collects. The mature trees in these areas consist mainly of Douglas-fir and ponderosa pine, and there are some paper birch (*Betula papyrifera*). The understory is comprised of willow, Saskatoon, Douglas maple, and snowberry. These areas are much wetter than the surrounding habitat, and they create a diverse landscape, habitat variability, and a larger percentage cover of moss than elsewhere in the Project Area. The vegetation detected during the field assessment was inconsistent with the SEI ecological community classification, as hybrid white spruce (*Picea engelmannii* x *glauca*) was not observed. However, our assessment was based on a small percentage of the entire SEI study area, and this species may be present outside the Project Area.

Photograph 15: Inflow at Cosens Creek. Note woody debris blocking culvert entrance.

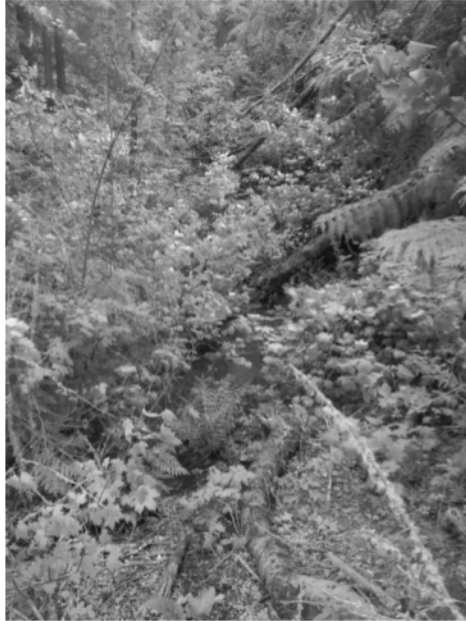
This area (0.3 ha) is located at the crossing point of Cosens Creek (3+250 m to 3+350 m) to a fast-flowing creek in an incised channel. The surrounding vegetation also represents a higher-moisture habitat than surrounding areas (Photograph 16, Appendix A). The crossing is upstream of Cosens Creek waterfall, which is a natural barrier to fish due to its high gradient. Two 500 mm culverts are located at the outflow point as a result of the steeply sloped stream channel. Culvert inflow was partially blocked by woody debris, backwatering, and siltation, which indicates that the size of the culvert may need to be increased. A number of high-value Douglas-fir trees in the area provide nesting and roosting habitat for raptors. Large shrubs along the drainage channel are likely to support small passerines, such as yellow-breasted chat (*Icteria virens*).

Photograph 16: Riparian habitat
around Cosens Creek – ESA 5.

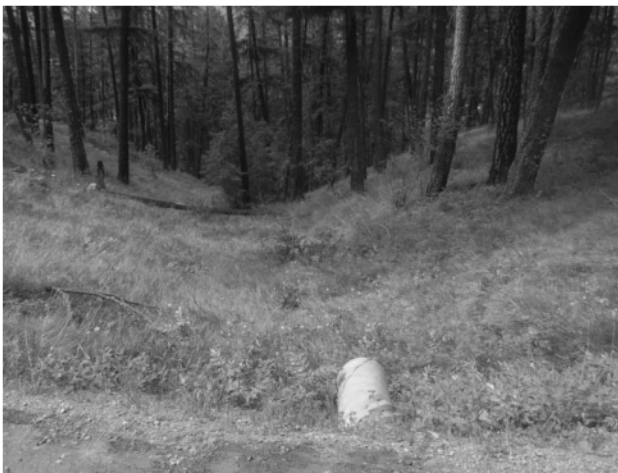
Photograph 17: Drainage culvert in
ESA 6, potential wildlife underpass.

- Limit removal of mature trees and snags, particularly on the downslope side of the road.
- If mature trees adjacent to the road or trails are deemed a safety hazard, top the trees at 5 m to create wildlife snags rather than removing the trees.
- Replace removed trees at a ratio of two trees to every one removed. Newly planted trees should be inspected over 2 years and any that die during this period should be replaced.
- If possible, widen the upslope side of the road where the trees are younger.
- Install a wildlife underpass at the location shown in Figure 4-7. Ensure that natural substrates are placed along the bottom of the underpass.

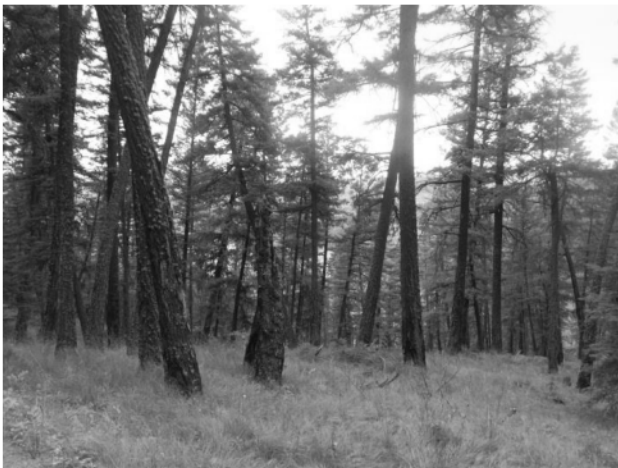
Photograph 18: Mature coniferous
forest of ESA 6.

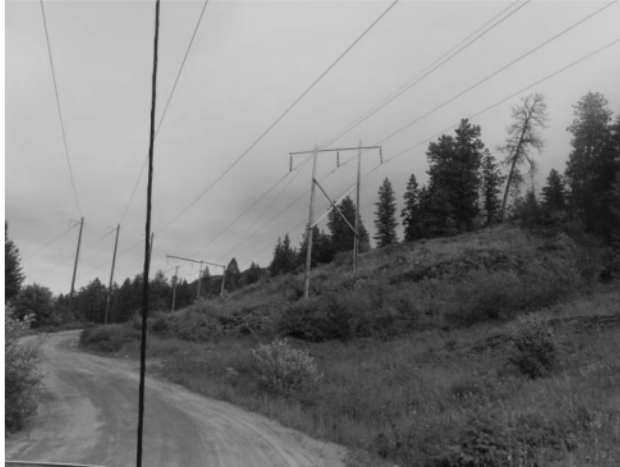
Photograph 19: Previously disturbed ground under power lines, suitable for pull out areas.
