Ministry of Transportation  
and Infrastructure  
**Commercial Vehicle  
Inspection Report**

## **Low Speed Turning Performance Analysis:**

### **Peterbilt 320 Refuse Truck**

**Document No: 2015RWB017R1**

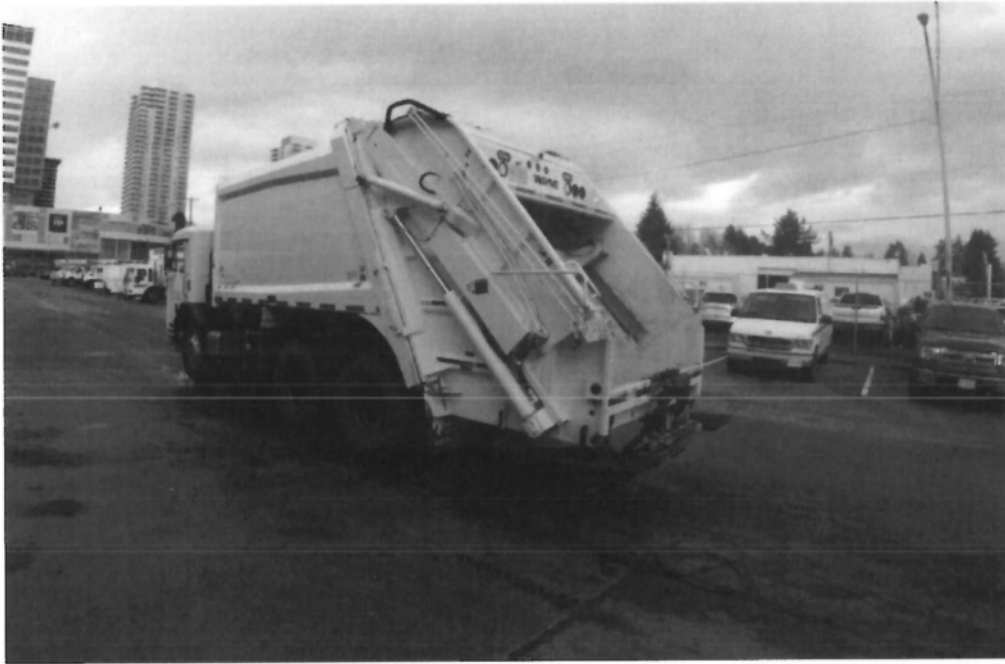
**Figure 1 Test 1 - reverse and brake**

Truck starts in stationary position and backs up at 20 to 25 km/h and then applies brakes (Figure 1). Observers noted the level of wheel lift.

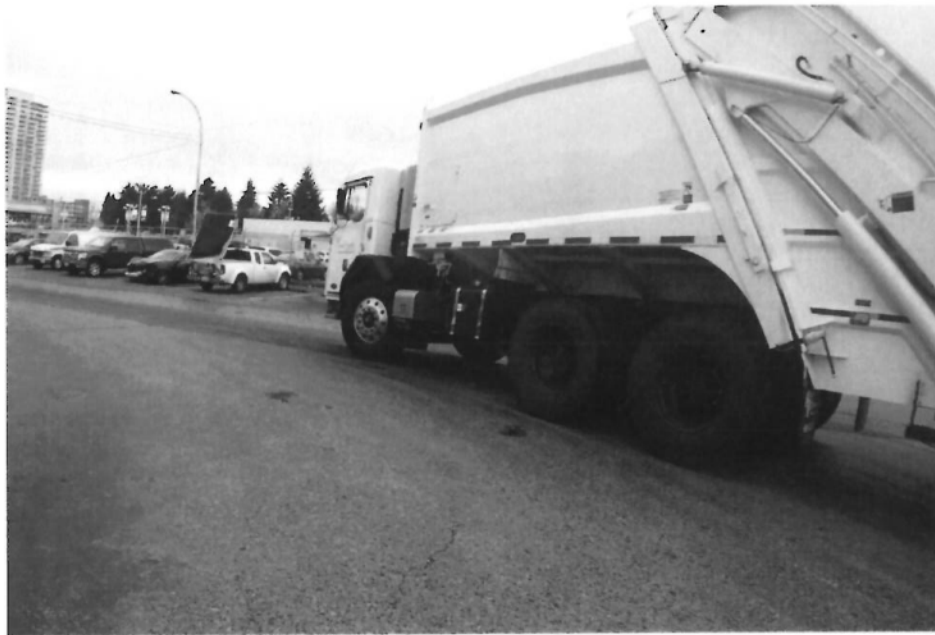
**Figure 2. Test 2 - 90 degree turn level ground**

Truck starts in stationary position and makes left turn for 90 degree corner (estimated radius 12 m to outside steer tire) at 15 to 20 km/h (Figure 2). The curve had reverse super elevation (outside lean). Observers noted the trucks ability to make corner successfully.

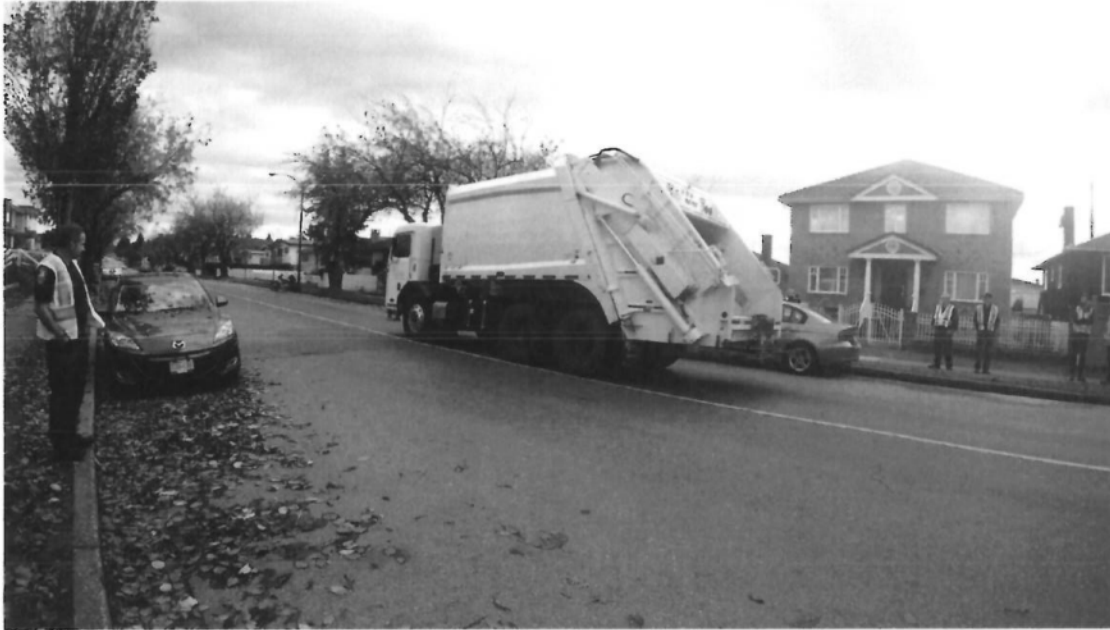
**Figure 3. Test 3 – Bump test 30-50 km/h**

Truck drives forward over bump in road at speeds ranging between 30 to 50 km/h (Figure 3). Observers noted the trucks steering axle wheel lift and its ability to dampen the axle motion and pitching following the input.

The steering axle load of 6250 kg is very close to the maximum legal allowance for the tires (315/80R22.5) when loaded with a full load and equipped with a counterweight;; extra care was taken during loading not to exceed the maximum combined steering tire allowance of 6350 kg. This could be an issue in practice so the counterweight load may need to be reduced. The steering axle load as a proportion of drive group was 38.6%, well above the recommended level prescribed in the engineering analysis (33%). Overall the truck performed very well in this condition, with good steering performance under all conditions. See Table 1 for summary of test observations. Axle lift was only noted in Test #1, where the truck was reversed at high speed and brakes applied with estimated decelerations of 0.5 g. This is not a normal safe manoeuvre and little if any wheel-lift occurred under lower speed decelerations. A reduction in steering axle load occurred during the higher speed bump

test on the road (Test#3), with no wheel lift observed. The induced pitching was minimal and was quickly dampened.

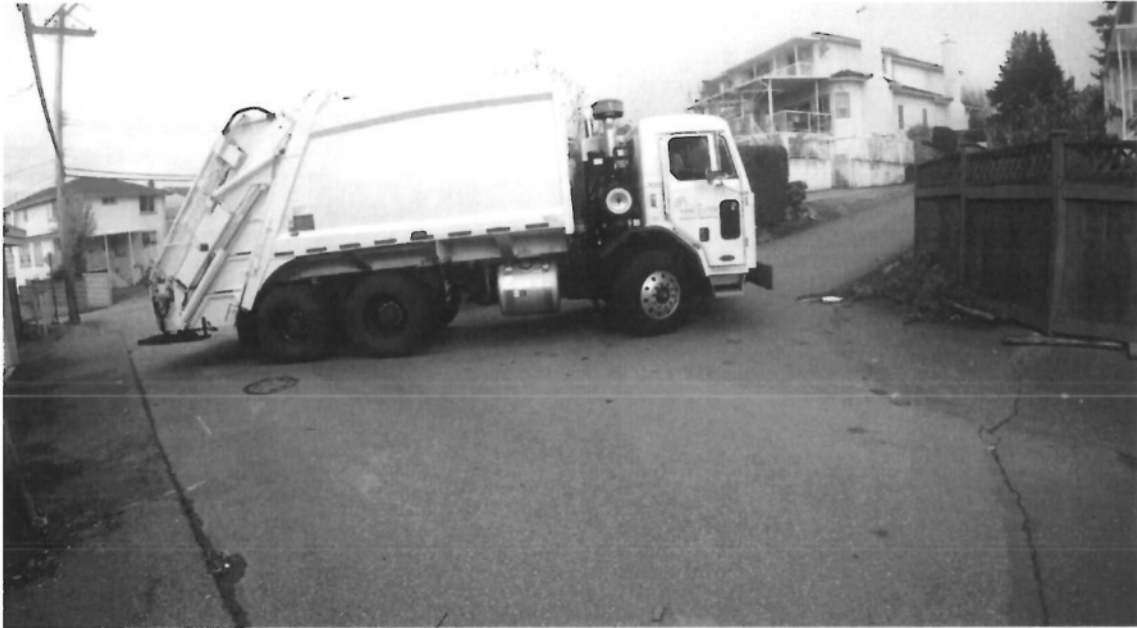
**Figure 4. test 4a – 90 degree turn climbing incline**

Truck starts in stationary position and makes left turn for 90 degree corner (estimated radius 11 m to outside steer tire) at 5 to 10 km/h on incline (estimated grade 5%) (Figure 4). Observers noted the trucks ability to make corner successfully.

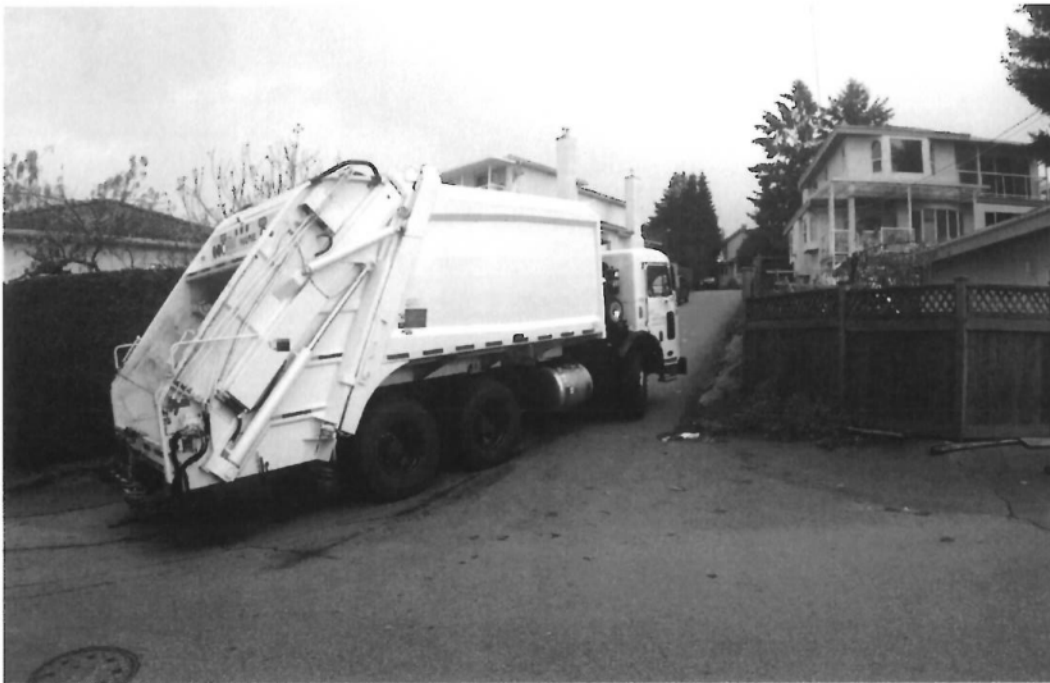
**Figure 5. Test 4b – 90 degrees reversing down incline**

Truck starts in stationary position and reverses through same incline 90 degrees turn as for Test 4a at 5 to 10 km/h (Figure 5). Observers noted the trucks ability to make corner successfully.

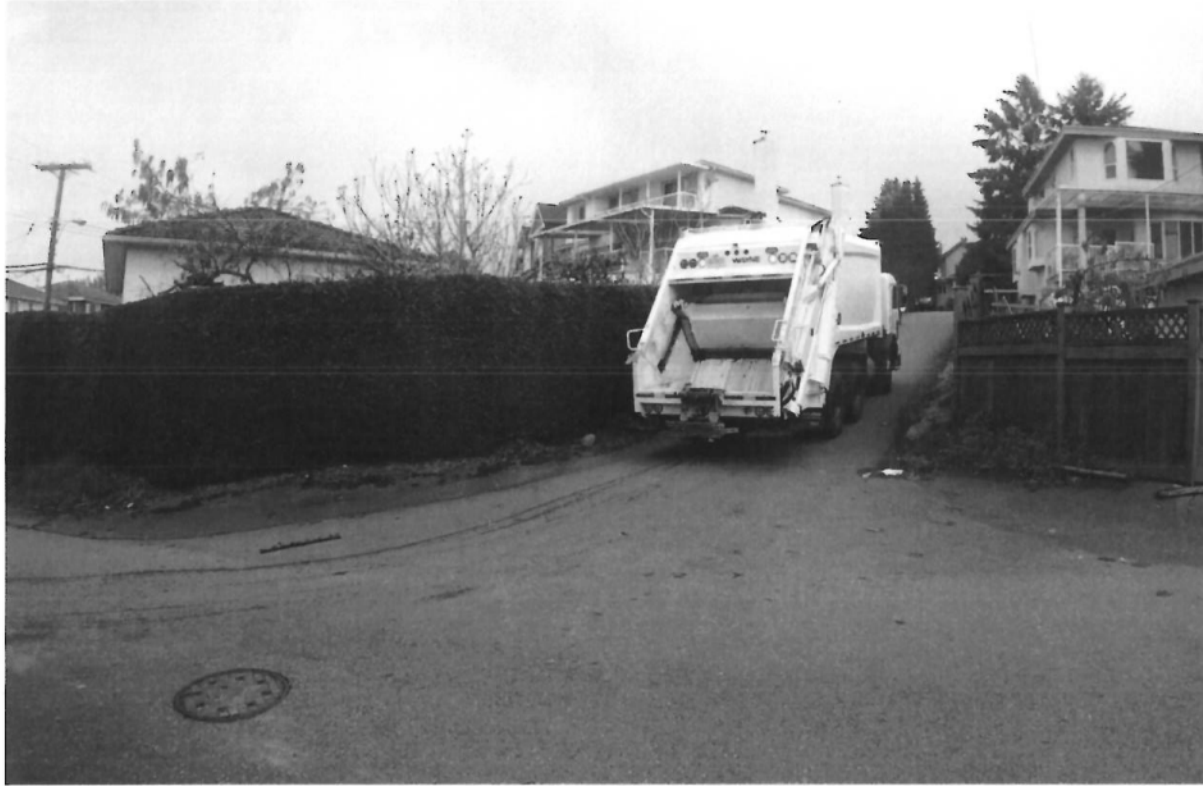
**Figure 6. Test 4c – Reverse down incline and brake**

Truck starts in stationary position and reverses at 5 to 10 km/h down incline and applies brakes (Figure 6). Observers noted the level of wheel lift.

The only potential issue noted during the testing was the increased level of wheel lift observed backing down an incline with a partial load. However this is not a safety concern as the wheel lift only occurs when applying brakes while reversing and is only momentary and quickly stabilizes. This relatively minor issue could either be addressed through modified operating practices and training to minimize its occurrence (e.g. braking procedures, moving ejector plate remotely from cab to transfer weight). It is the author's opinion that the level of wheel lift or bounce is similar to existing trucks and can be safely mitigated through modified operating practices. Another option would be to ensure an appropriate counterweight (300 kg) is installed on the front bumper.

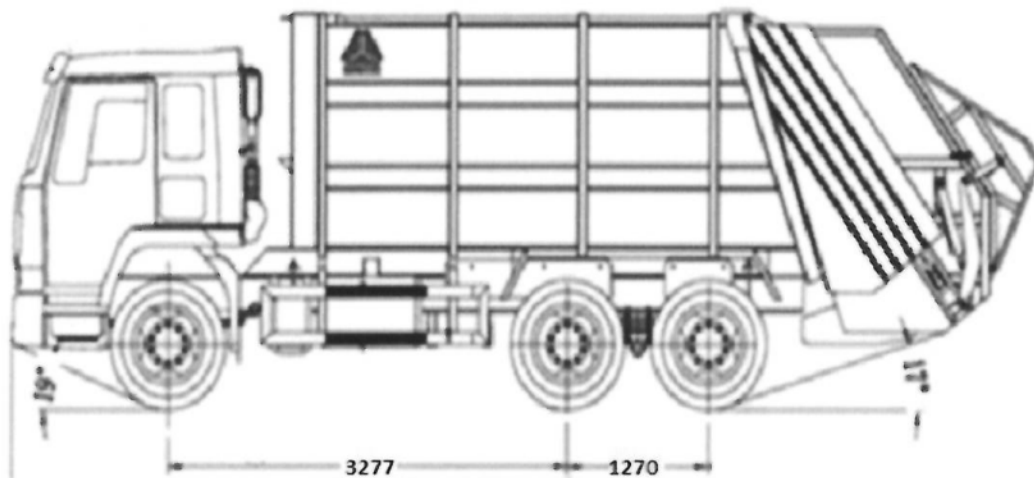
**Table 1:** Examined axle group loads for a similar 3-axle Truck

Full combination weight distribution on each axle group (Kg)				
Data Source	Steering Axle	Second Axle	Third Axle	Total Weight
Vehicle Data (Loaded) UOIT	7,324	8,013	8,013	23,350

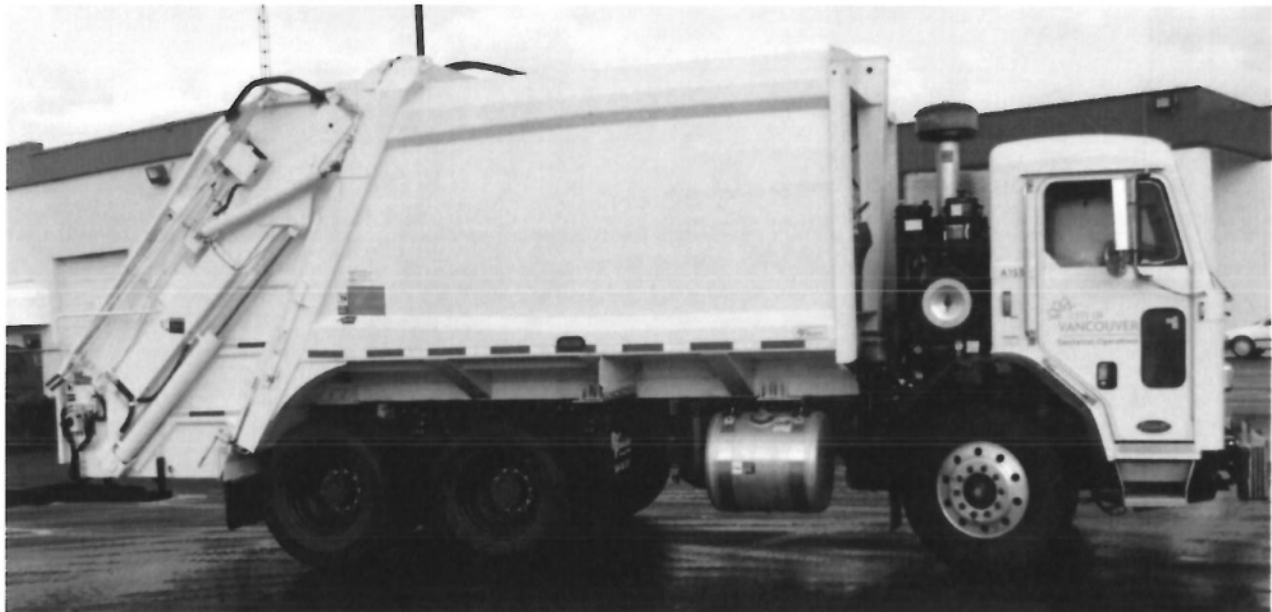
**Figure 1. Modified Wayne Engineering Refuse Truck Design**

- Modified<sup>2</sup> design used in low friction tests (A1531) (Figure 1)
- Existing refuse trucks currently used by City of Vancouver (Sterling Condor)(Figure 2)

<sup>2</sup> Note Fort Fabrication modified the original design based on the City of Vancouver input- this included lengthening the wheelbase, lightening the tailgate, moving the body forward, and removing previously installed counterweights on the bumper.

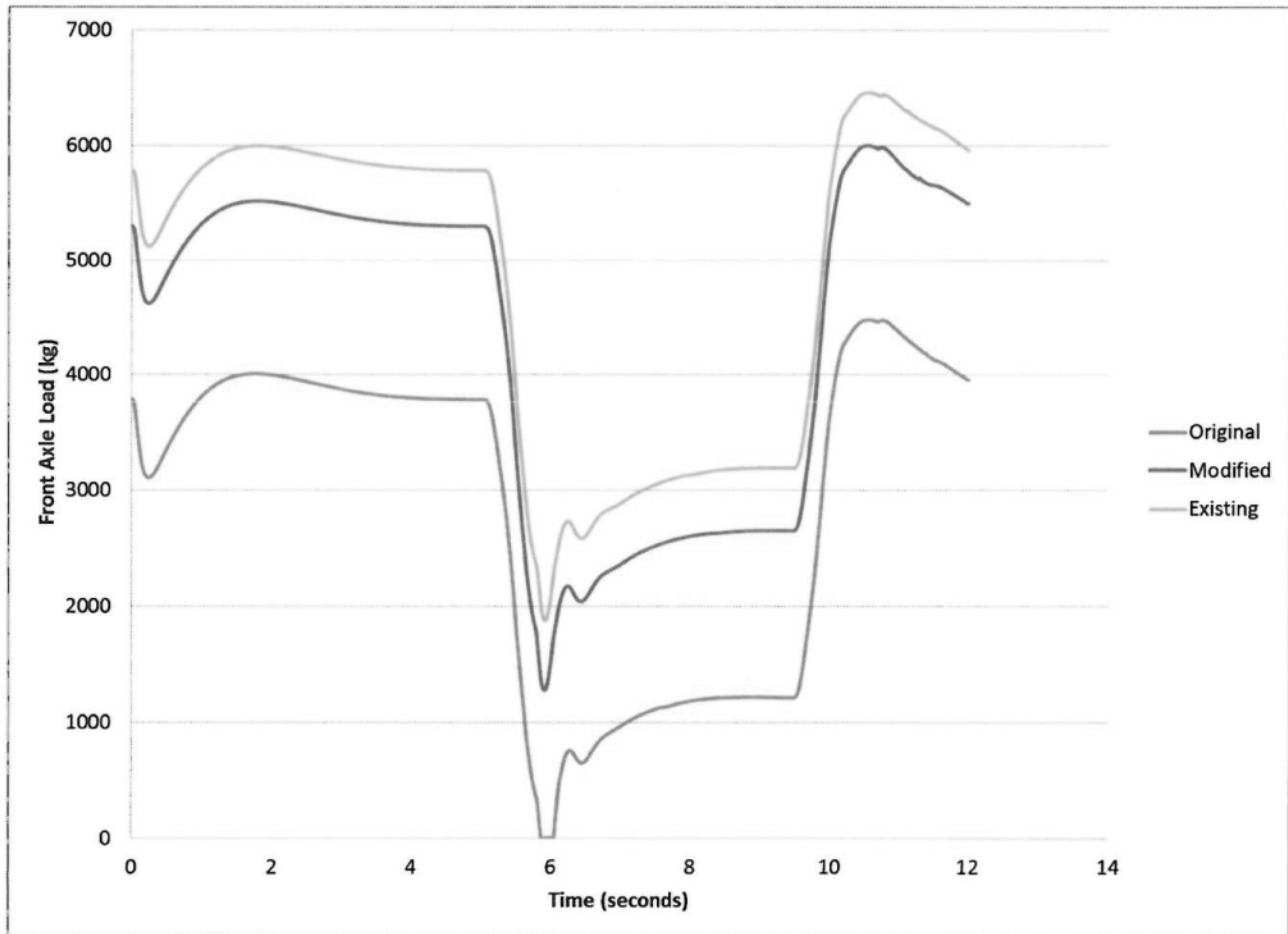
**Figure 3. Comparison of steering axle load shift for the three refuse trucks**

Supplementary simulations conducted of the three trucks show that front wheel lift would occur for the original Wayne Engineering design at 0.25 g acceleration when loaded to its worst case loading (Figure 3). This is a fairly extreme acceleration for a truck, but a similar effect could be achieved braking in the reverse direction on a slope at a relatively low deceleration. It is interesting to note that while the modified and existing trucks did not achieve front axle lift-off, the reduction in load was similar to the original truck design. These simulations demonstrate the importance of maintaining a relatively high steering axle weight so that front wheel lift-off will not occur dynamically.
