NON-CONFORMANCE REPORT

Ministry of
Transportation
and Infrastructure

Service Area: SA13 - Okanagan-Shuswap

Name of Contractor: **AIM Roads**

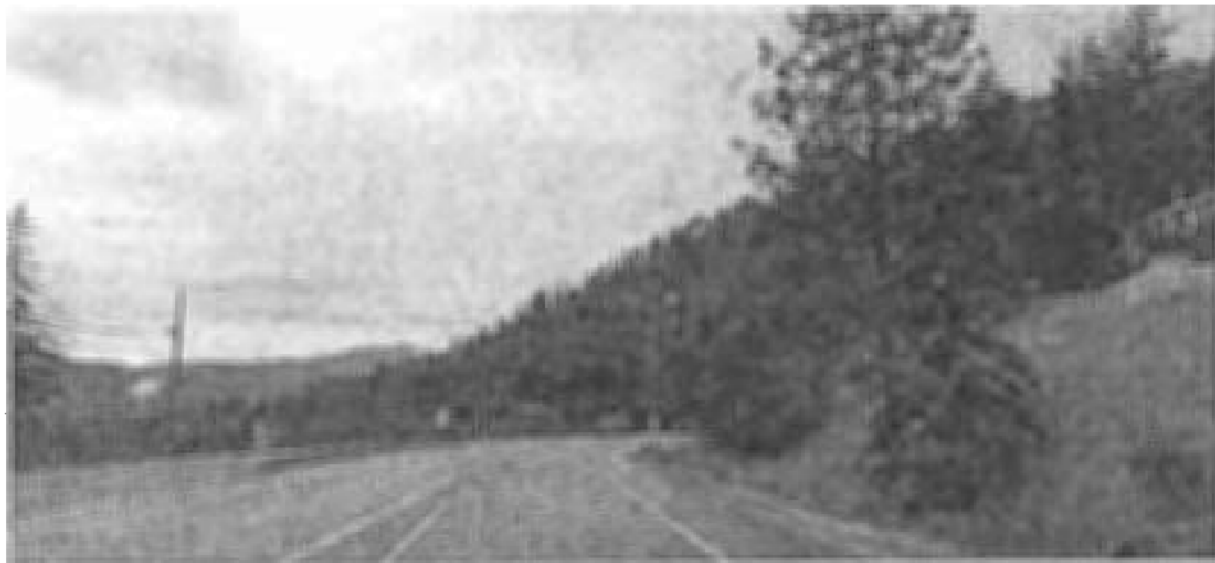
Pavement markings have been obscured for far more than 7 days coming just West of Lumby due to Accumulations on Hwy 6 in the Armstrong Foreman area. The contractor is also found to be non-conforming under PM1.07.2-1c) . Under 1.07.4a) the coordination of surface sweeping was not done with the pavement marking contractor, and some sections were not properly painted as a result. One section is depicted below.

Hwy 6 Lumby West- pavement marking obscured and not coordinated with pavement marking contractor

The root-cause resulting in the non-conformances with the contractual requirements listed above (Section 3) are due to a failure of following and executing AIM internal processes outlined in the Quality Maintenance Manual (QMS) and unpredicted increased frequency of road maintenance due to extreme weather events. These include but are not limited to a lack of communication and guidance from the AIM internal mechanical division, an absence of document referral for steps in completing duties, a lack of training within all departments of AIM standard operating procedures, specifically routine maintenance services and delay in executing the proposed spring road maintenance services plan. The regional area has also undergone extreme weather condition with above average water volumes resulting in increased accumulation of sediment and runoff drainage holes, scuppers, and barrier openings. The extreme rainfall has also contributed in delayed sweeping efforts due to unable to sweep in high water volume road conditions. This has resulted in a frequency demand for sweeping and cleaning that was not included or predicted in the spring road maintenance services plan. The frequency of demand for sweeping and cleaning has resulted unpredicted in increased personnel and rescheduling of priority work which has contributed in the non-conformances listed above (Section 3). AIM will continue to coordinate and communicate with the contractor to ensure all line painting requirements are met within the specifications.

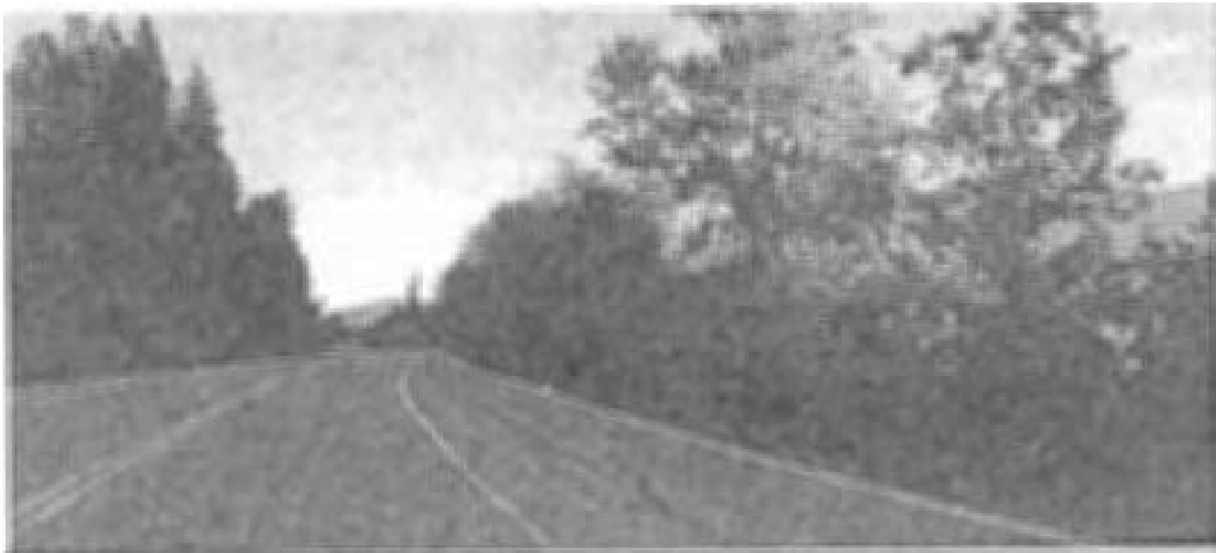
The contractor is also found to be non-conforming under PM1.07.-2 b) as the roadside barrier run just East of Dure Meadows Rd on Hwy 6 within the Armstrong foreman area. This has caused ponding after rainfall. When the white pavement marking was done in this area, a pond was forms at the bottom of the photo and it can be seen that this section was not painted. PM1.07.2-3 stipulating all drainage holes, scuppers, and barrier openings are to be cleaned annual has not been met in this area. The barrier run pictured below for instance has been blocked for over a year and free drainage has been impeded.

Hwy 6 East of Dure Meadows Rd- Drainage barrier blocked

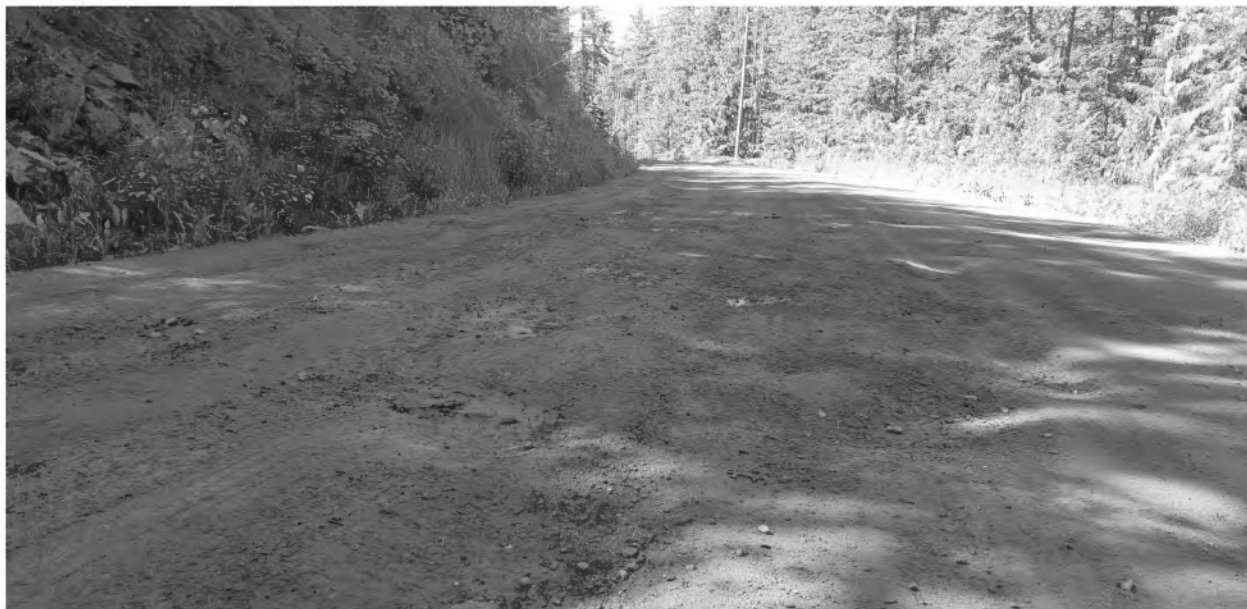
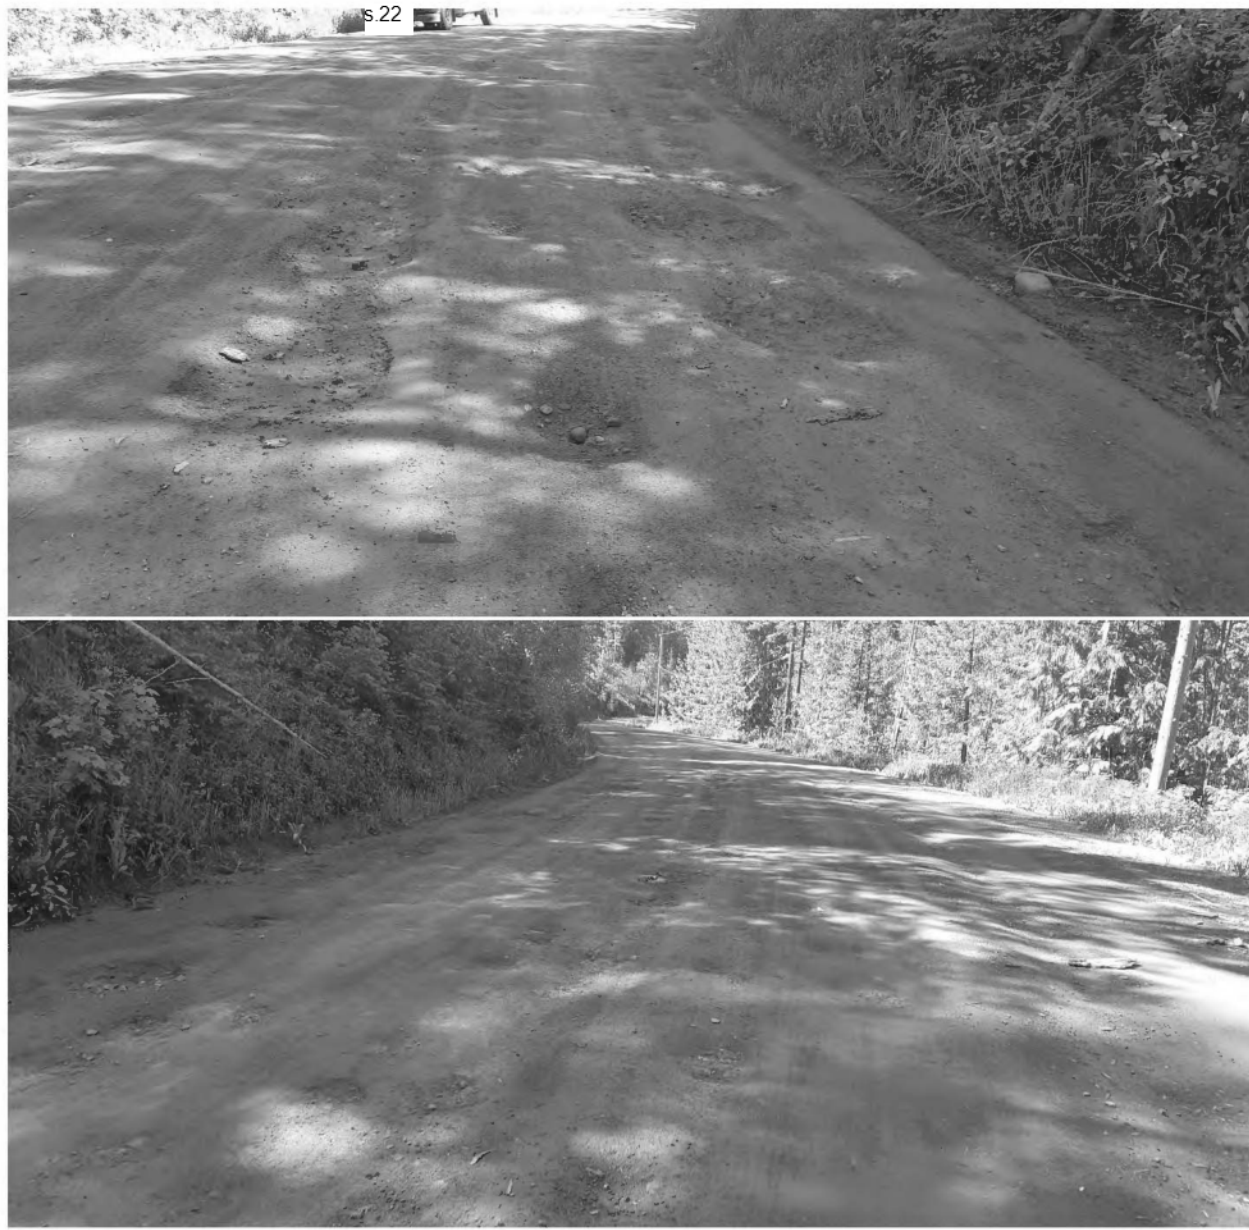
Trinity Valley Rd #130 is a Class 4 road that spans both the Cherryville and Armstrong foreman areas. The road was found to be in an acceptable condition on the Lumby (Cherryville yard) end, with minor infrequent potholes on the gravel portion. The Enderby (Armstrong yard) end was in a deplorable state, with frequent, high severity potholes that presented serious safety issues for road users.

The potholes averaged far more than 1 per 25 metres, and they spanned across the road width on many sections for well over 2 days. The response time for a Class 4 gravel road in this condition is 2 days to provide a safe, smooth, stable, compacted and free draining surface. MoTI was given a low level of confidence the road would be graded anytime in the near future due to the grader needing to be on other roads in the large Armstrong foreman area.
