Milburn Lake Hydrotechnical Assessment

June 7, 2021 | Revision 0 (DRAFT)

Submitted to: Ministry of Transportation and Infrastructure
Prepared by McElhanney

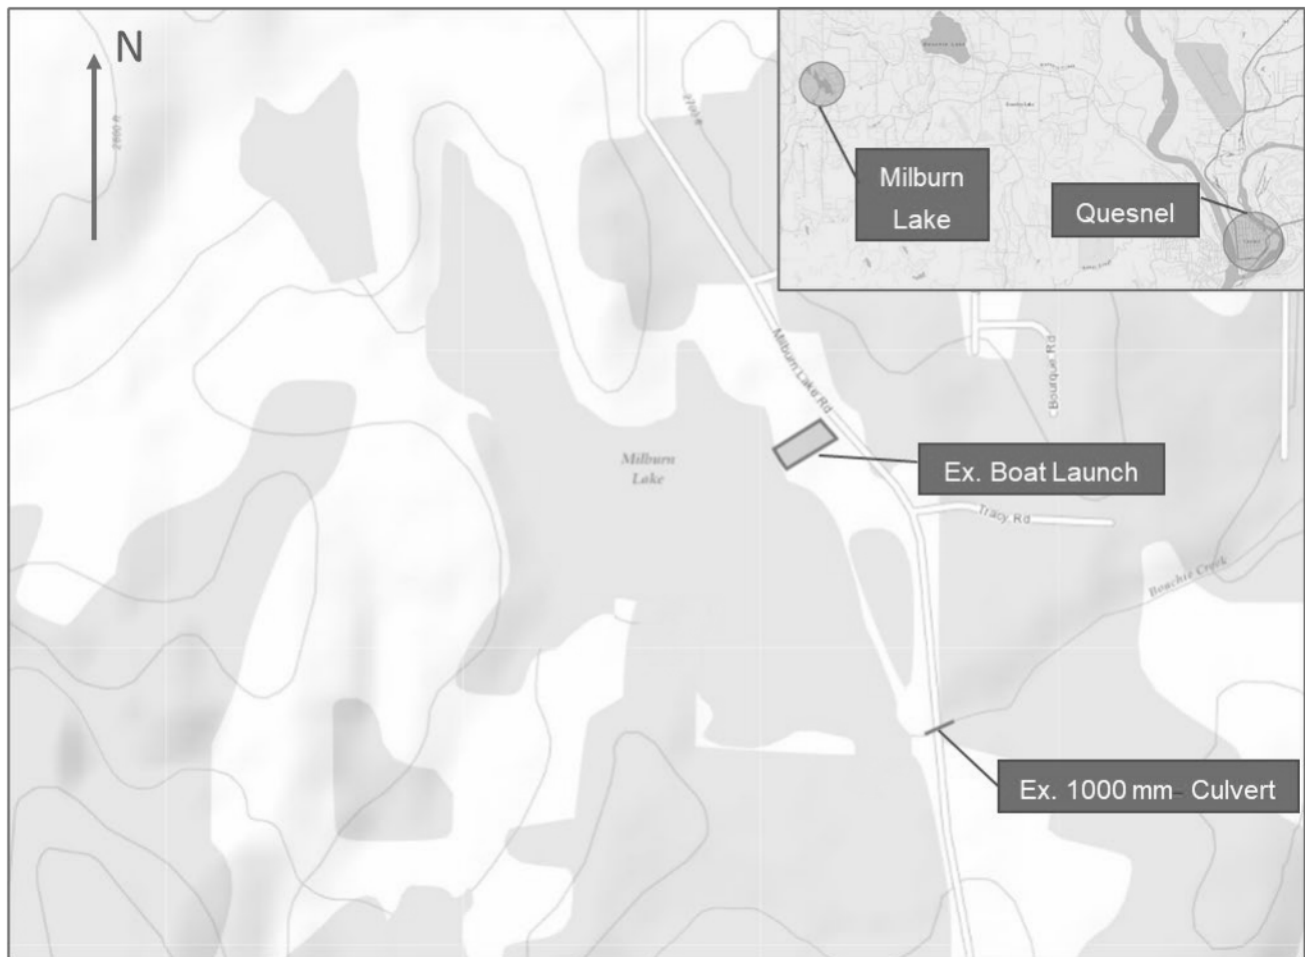
Figure 1: Location of Milburn Lake

Milburn Lake is located 20 km northwest of Quesnel, BC as shown in Figure 1. Two tributary streams flow into Milburn Lake on the west shore. Bouchie Creek is the main outlet, located at the southern tip of Milburn Lake. An existing 900 mm diameter culvert allows Milburn Lake Road to cross over Bouchie Creek at the outlet of the lake, shown in Figure 2. Downstream of Milburn Lake, an existing 1200 mm diameter culvert allows Rawlings Road to cross over Bouchie Creek, where Bouchie Creek then drains into Bouchie Lake.

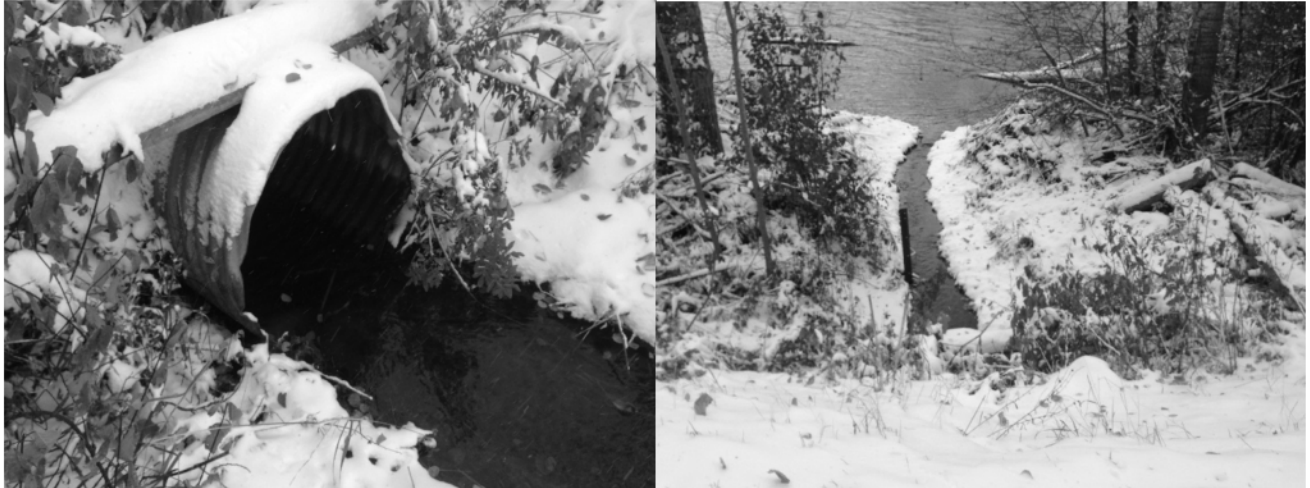
Figure 2: Inlet of 900 mm Diameter Culvert to Bouchie Creek

Milburn Lake Road Culvert

- The culvert crossing is at the lake outlet.
- One of the residents provided observations regarding the flooding.
- The road at the culvert crossing is not overtopped during peak flows. However, a low spot on the road further to the north is overtopped. Two residential properties are flooded. One is on the lakeside and the other one is across the road.

- About 30 m of the road was overtopped during the peak flows with approximately 0.3 m depth at the middle of the overtopped section.
- The water level at the culvert during the site visit was approximately 0.2 m above the inlet invert level.

- The low reach of the road is approximately 1.0 m above the invert of the culvert inlet.
- There is no flow in the culvert for extended periods.
- High water levels are associated with the freshet snowmelt.

- When the road was flooded, the water level was approximately 0.3m above the culvert crown.
- Observed peak flow from the lake is passed by both the culvert and the road. The road starts flooding when the water level is approximately at the culvert crown.

- The lakeside property starts flooding when the road is flooded, and the water level is approximately 1.2 m above the culvert inlet.
- Beaver activity is observed immediately upstream of the culvert. The middle section of the beaver dam was cleared.

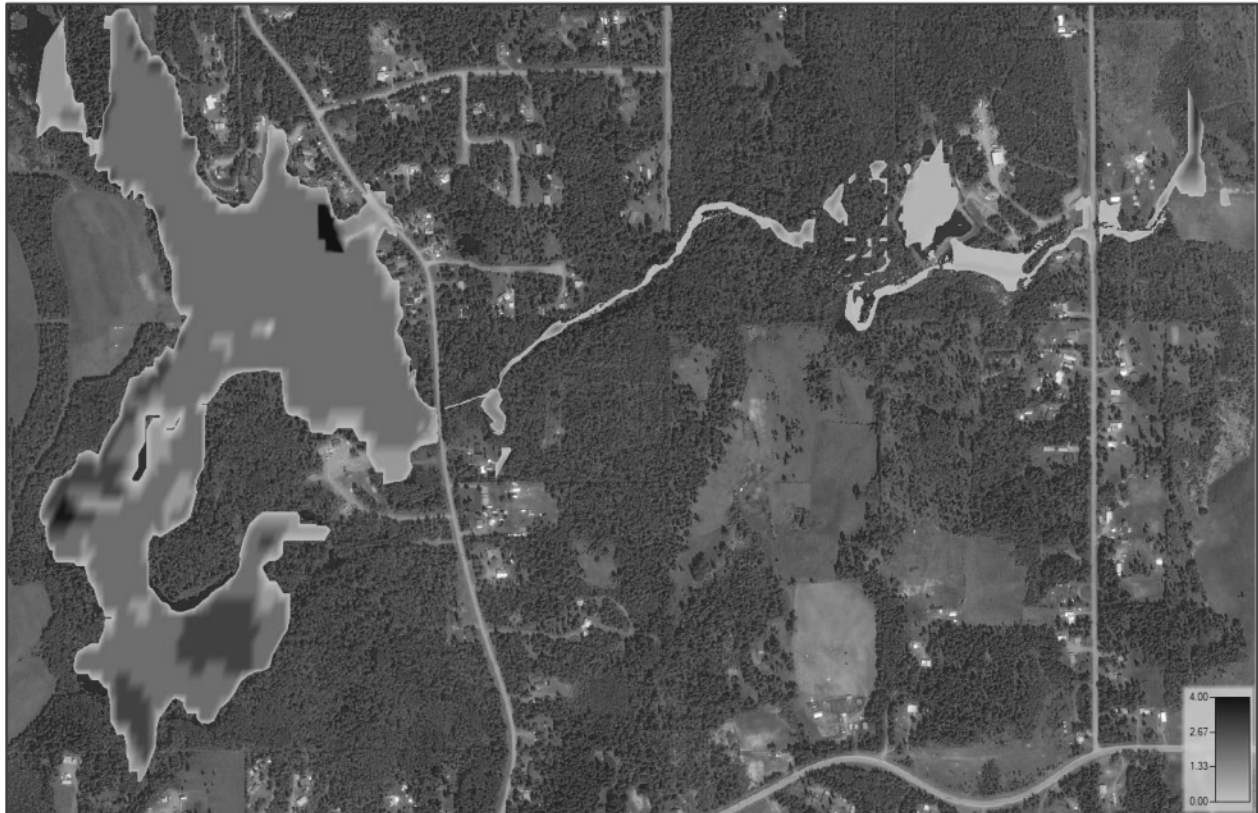
Figure 10: Depth profile for the existing conditions at Milburn Lake during the 100-year peak instantaneous flow overlain on Bing Imagery.

The existing 900 mm culvert at Milburn Lake Road and the two culverts at Rawlings Road: a 600 mm and a 1200 mm were modelled to analyze and identify baseline site conditions. Figure 10 shows the results of the 2D hydraulic model of the entire study area. Water depths around the areas located north of the culvert crossing and through the culverts are highlighted in Figures 11 to Figure 13.
