IRISH SPRING APPLN.

File: 3004857  
FNR-2013-0023  
1

Inspected Nov 21, 2008 by M. Edward

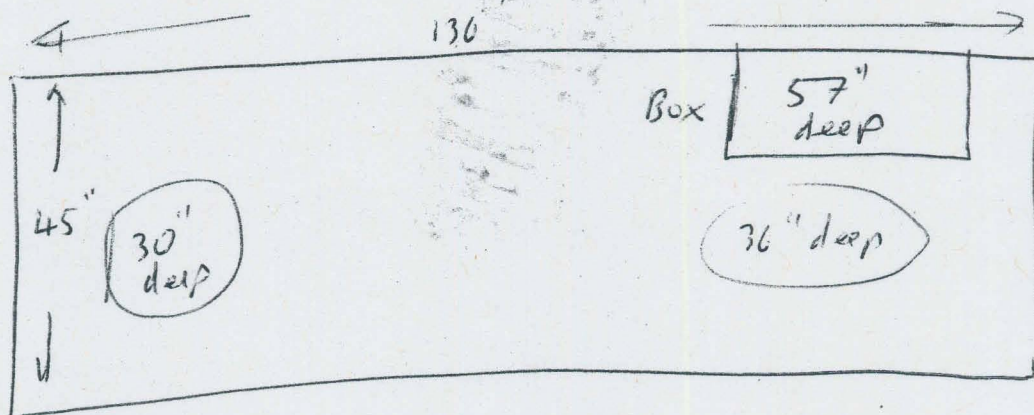
depth of water 30" @ downstream end } average depth  
36" @ upstream end } 33"

∴ volume of water in collection box = 117 cubic ft = 729 gals.

Applicant says box would refill overnight (12 hrs)

∴ estimated inflow = 1458 gpd.

Second tank (up of this box) had water level ~ 5 ft below ground level  
& would therefore be considered a groundwater source.

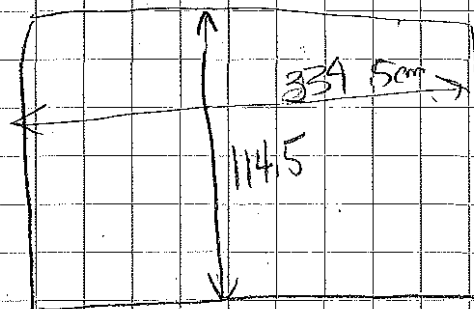
$$\begin{aligned}\text{recovered } 1 \text{ cm in } 2 \text{ hrs} &= 38,300 \text{ cm}^3 / 2 \text{ hr.} \\ &= 19,150 \text{ cm}^3 / \text{hr.} \\ &= 0.459 \text{ m}^3 / \text{d}\end{aligned}$$

- Enough water for laundry mat from this spring '60s

~ '08 Nigel + Caroline cut off
