INCIDENT INVESTIGATION REPORT

| Notice of incident number 2012161980018 | Date of incident January 20, 2012 | Location of incident 19479 Highway 16 East Burns Lake, B.C. |
| Lead investigating officer Paul Orr | Investigation file number 2012-0013 | Incident outcome FATAL (2) INJURY (20) |

| Employer | Name and address | Employer ID | Industry classification |
|---|---|---|---|
| | Babine Forest Products Limited 19479 Highway 16 East Burns Lake, BC V0J1E0 | 328321 | 714022 Sawmill |

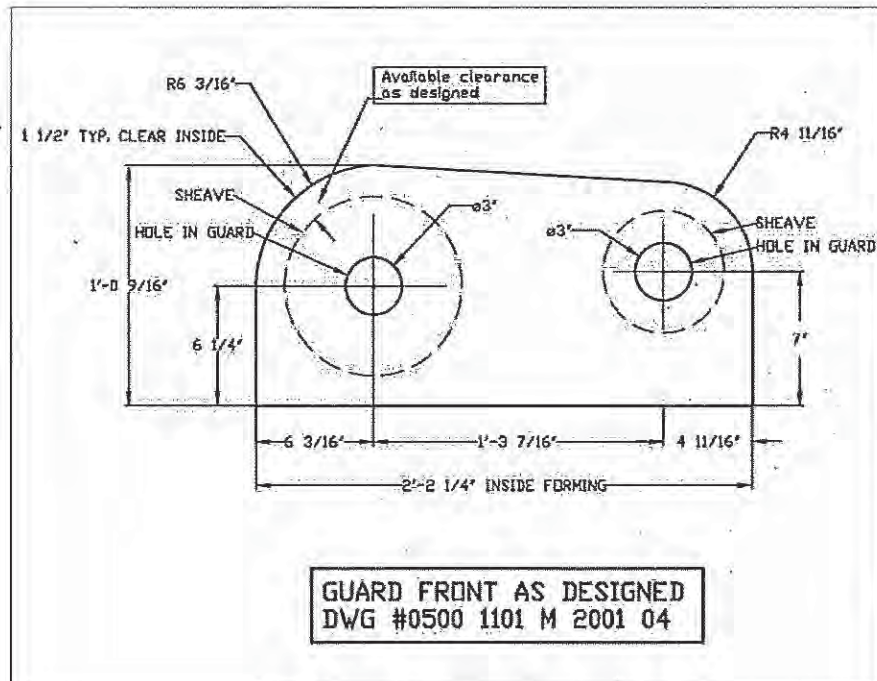
Internal measurements of the guard were taken and compared with the original design drawings for the available interior clearances and fit. The original design drawings indicate that there was a designed 1.5-inch circumferential clearance between the sheaves on the gear reducer and the interior wall of the guard (Figure 12). The actual clearance measured between the sheaves and the interior wall, however, was only between 0.125 and 0.5 inch (Figure 13), based on the slot cut into the rear of the guard where it was fitted over the shafts of both the motor and gear reducer. This is significantly smaller than the original design clearance for this area of the guard.

Figure 12: The original design drawing as re-created by WorkSafeBC. The red circles represent the sheaves within the guard. The gear reducer is to the left, while the motor is to the right.

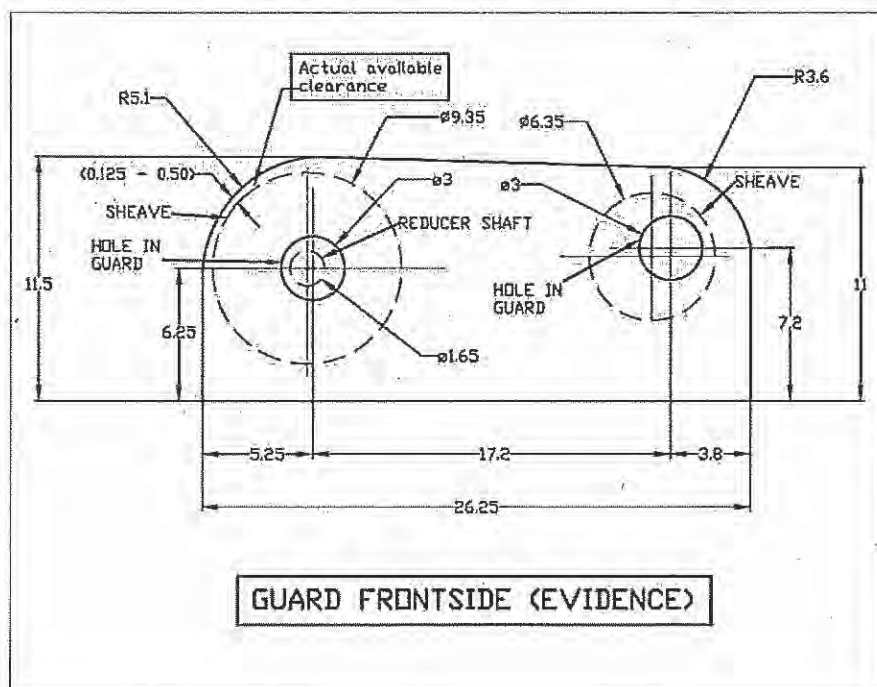
Figure 13: The actual clearance available within the guard as calculated by WorkSafeBC.

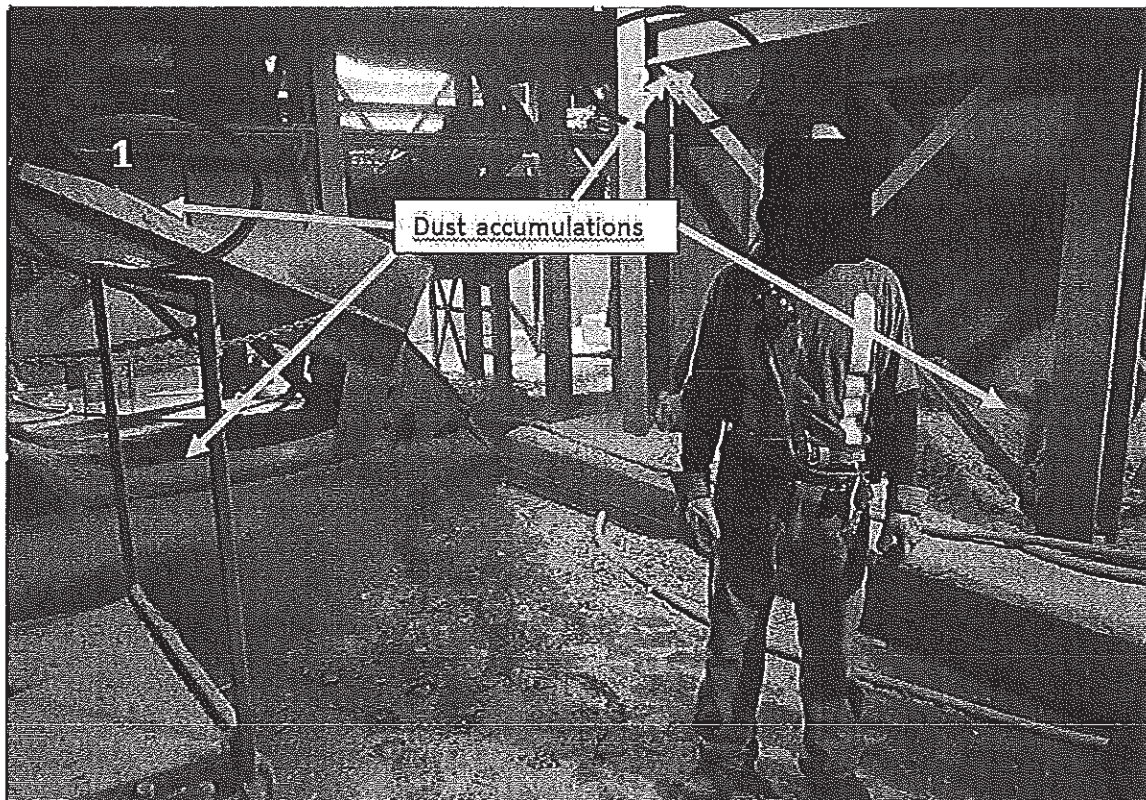
Figures 17 to 24 illustrate the unacceptable problem with dust accumulation at the sawmill.

Figure 17: Dust accumulations in the basement level of the sawmill. (Photograph by WorkSafeBC, November 22, 2011.)

NFPA Standard 664 advises that a hazard exists where this deflagrable wood dust has accumulated on surface areas in depths of 1/8 inch over 5% of the area of the facility. The photographs taken in November 2011, two months before the incident (Figures 17 to 24), and reports and statements from workers to investigators confirm that there were considerable accumulations of wood dust in the sawmill.

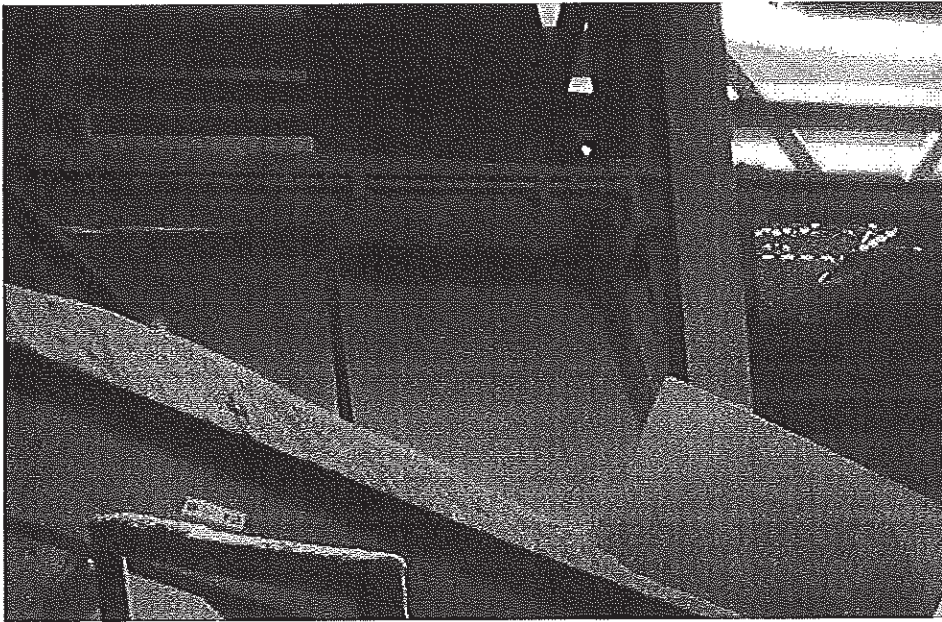
Figure 18: Dust on the conveyor labelled (1) in Figure 17. (Photograph by WorkSafeBC, November 22, 2011.)

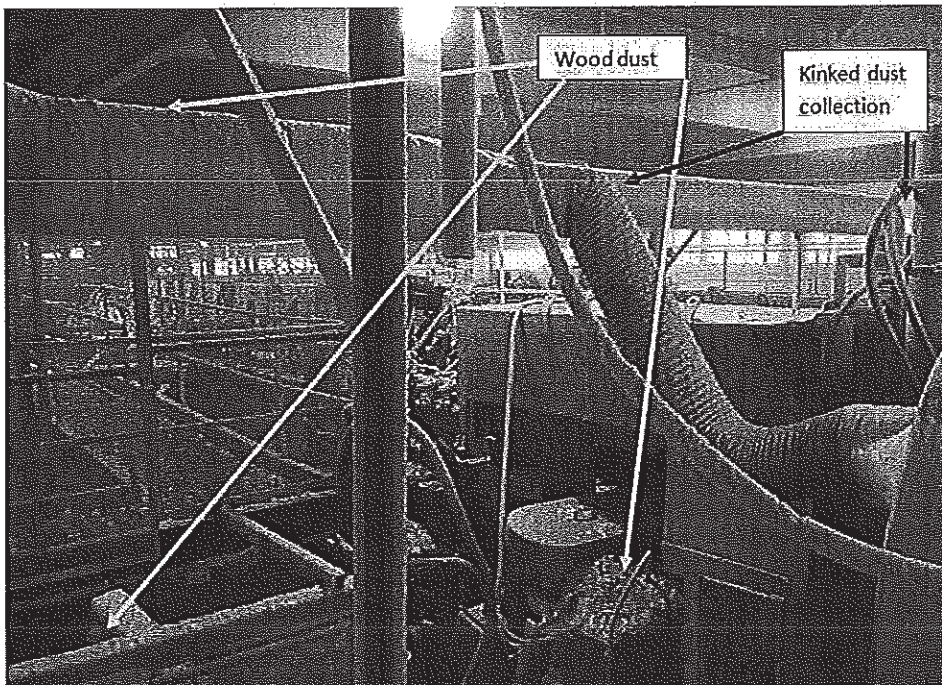
Figure 19: Wood dust on bandsaw equipment and ducting as well as the kinked areas which restrict flow. (Photograph by WorkSafeBC, November 23, 2011.)

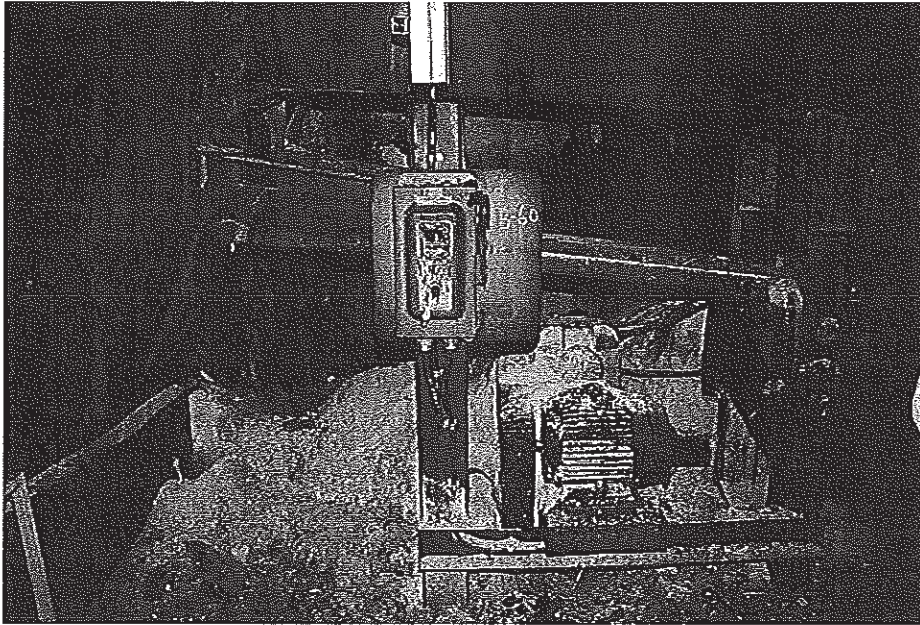
Figure 20: Wood dust and waste accumulations around the head-spool of waste conveyor 9-36 where it terminates and dumps into the main north wall waste conveyor 6-53 (C-25, Appendix 4). This wood waste was protected from the explosion travelling west over the conveyor structure. (Photograph by WorkSafeBC, following the explosion.)

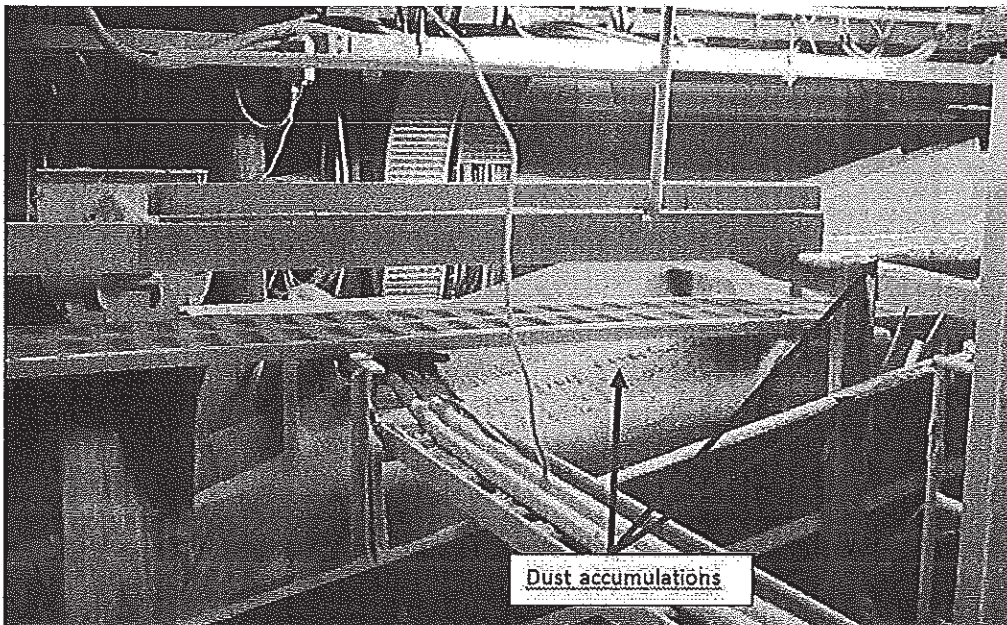
Figure 21: Dust accumulations near H1-23 (Appendix 4). (Photograph by WorkSafeBC, November 22, 2011.)

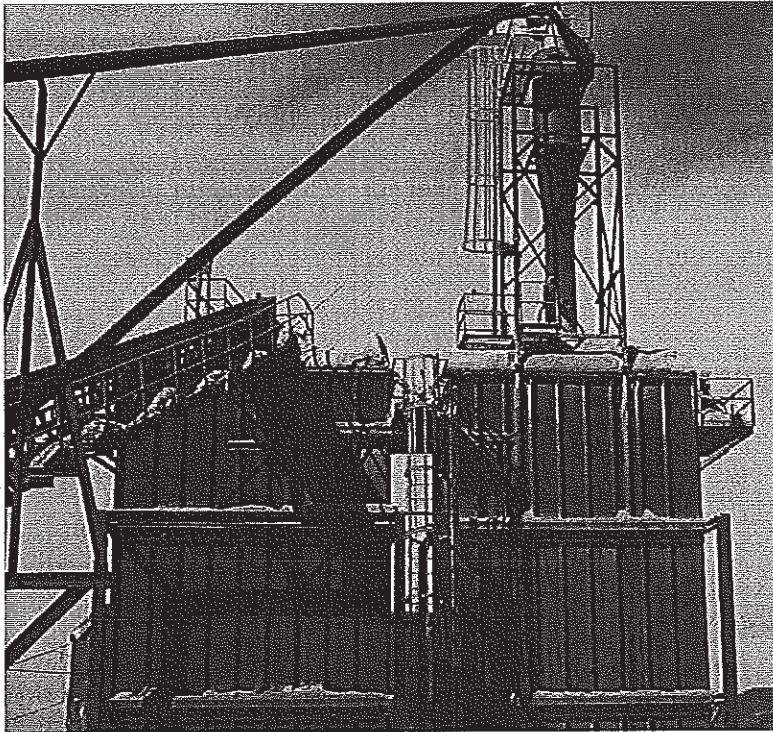
Figure 22: Storage bins to the west of the sawmill, with dust accumulations 2 to 3 feet high. (Photograph by WorkSafeBC, after the incident.)

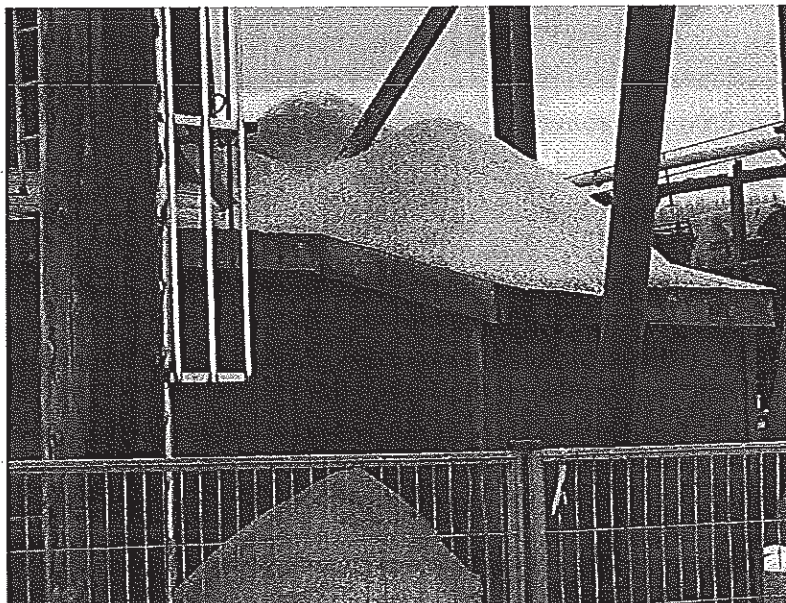
Figure 23: Dust accumulations in the area immediately south of the sawmill, beside the sorter wing. (Photograph by WorkSafeBC, after the incident.)

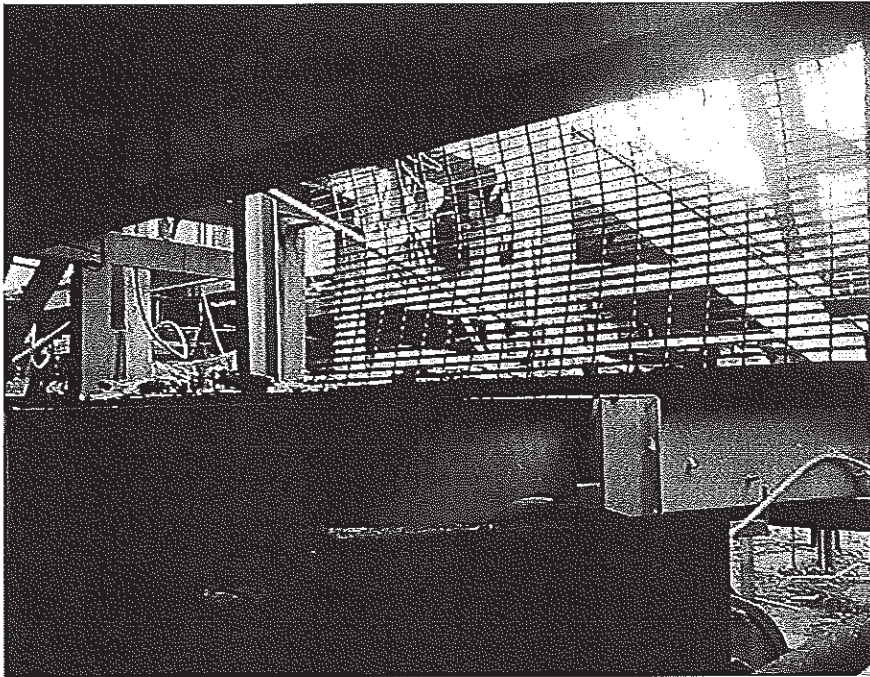
Figure 32: View from between the ignition point at the 8R-25 motor-reducer assembly and the #2 eliminator position. The grating was bent by the force of the explosion pressure.

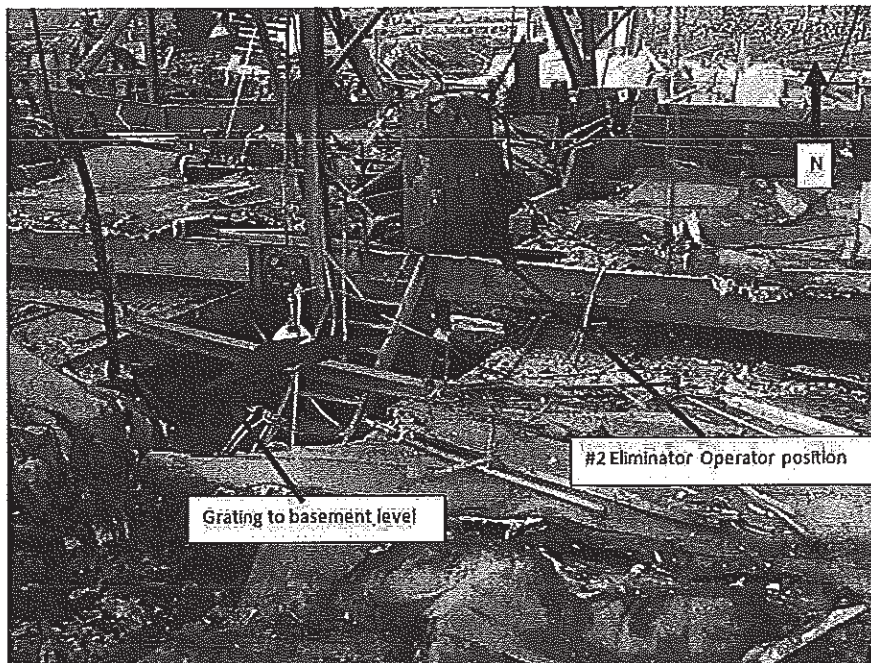
The #2 Eliminator Operator stated that he felt a strong rush of air and heat from behind and saw flames after feeling the shock wave. The explosion pressure beneath the eliminator tables vented through the walkway grating directly into the #2 Eliminator Operator's work area, approximately 30 feet to the northeast on the operating level (Figure 31). The bent grating is shown in Figure 32 and the path of the explosion in Figure 33. The floor under the eliminator tables was clean of all debris and wood waste due to this explosion pressure as discussed previously.

Figure 33: Photograph showing #2 Eliminator Operator's position and the path of the explosion.

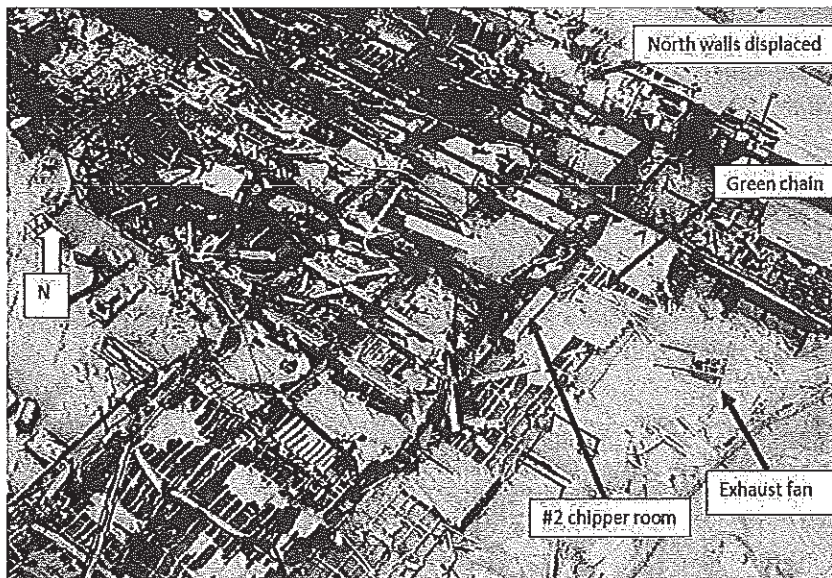
To the east, the sawmill wall was displaced and blown out into the log yard. The large exhaust fan was ripped from its attachment on that wall and thrown 60 feet out into yard along with the main sawmill structural members (Figure 35). The fan was 9 feet by 9 feet and very heavy. Even the lumber on the green chain outside the sawmill was displaced on this side of the mill as the overpressure escaped (Figure 36).

Figure 36: Aerial photograph of the east side of the sawmill. The large yellow arrow indicates the easterly direction of the explosion's expansion from the point of origin. Note that the lumber on the green chain is disturbed only where it was not protected by the #2 chipper building.

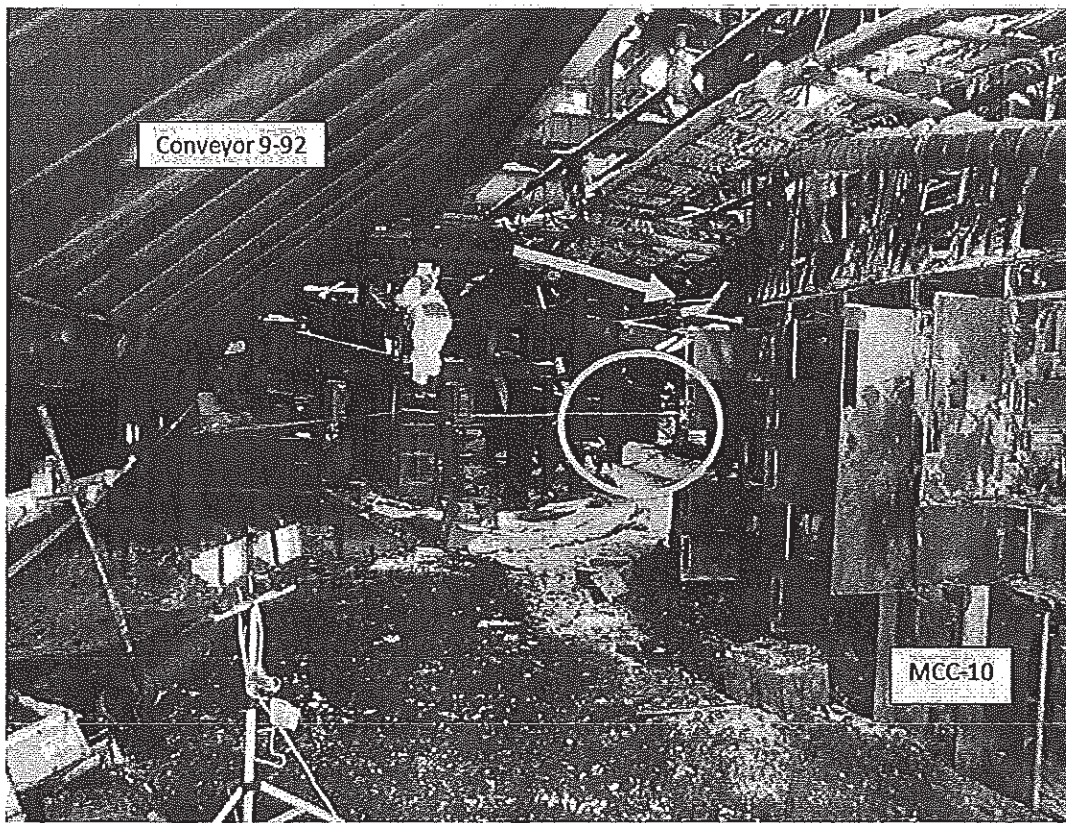
The structure and materials between the conveyors under production lines 2 and 3 were relatively undamaged except where affected by the sawmill fire. Figure 40 shows the corridor east of the PDC room, between the south wall and line 3. Note the large accumulations of wood waste remaining beneath conveyor 9-92. This indicates that the explosion did not originate here, and that it had little strength as the explosion pressure travelled from east to west through this area.

Figure 40: This view is looking east from in front of the boiler room. The explosion pressure and thermal front likely took a path travelling towards the reader from the east, under the conveyors and screens in the area outlined by the yellow circle. Other access was restricted by the conveyor structures. The yellow arrow indicates the location of the #1 chipper.

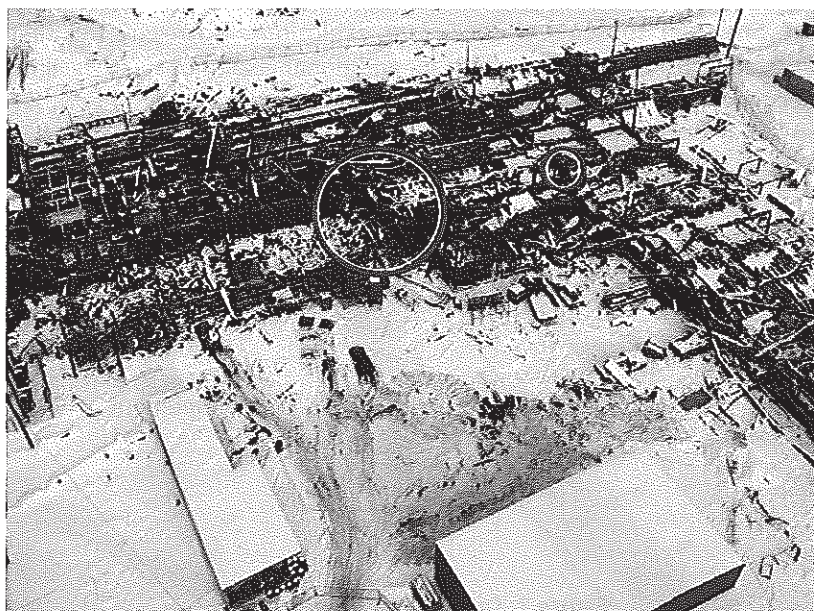
SAMAC Engineering Ltd. was contracted by the BC Safety Authority to provide fire and explosion investigation expertise. A possible area of explosion origin was identified in the basement below the band saw. This area's determination is discussed in the appended fire and explosion investigation report (Appendix A). WorkSafeBC identified a possible area of origin in the basement near a waste conveyor motor assembly labeled 8R-26³. On the evidence currently available, the BC Safety Authority accepts that the explosion could have originated from either of these areas. These areas are identified in Photograph 2.

Photograph 2: Aerial view of the sawmill site after the explosion and fire of January 20, 2012. The circles indicate the possible areas within the basement where the explosion originated.

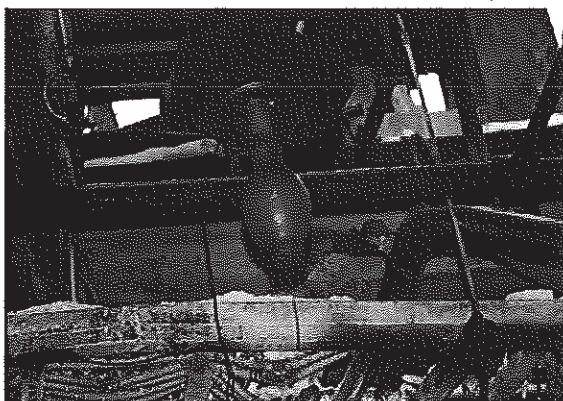
Photograph 6: Light assembly and metal halide bulb in front and above MCC #10

The light assembly shown in photographs 6 and 7 comprised of a ballast, 400 Watt metal halide bulb and a reflector. The reflector was found on the floor in front of MCC #10 and appeared to be an 'open' design, and no evidence of a shield was found in the area. The ballast and metal halide bulb were found in their installed locations above and in front of MCC #10, as shown in Figure 2 and Photographs 6 and 7. The bulb was intact and there was no evidence of electrical failure of the ballast or the bulb.

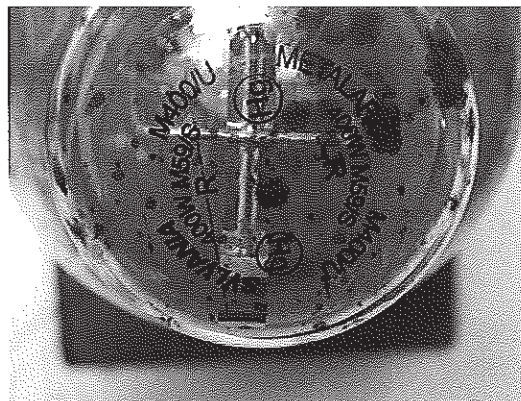
Photograph 7: Metal halide bulb product markings

Manufacturer's specifications associated with the bulb part number depicted in photograph 7 indicate a maximum bulb temperature of 400°C and a maximum base temperature of 250°C.

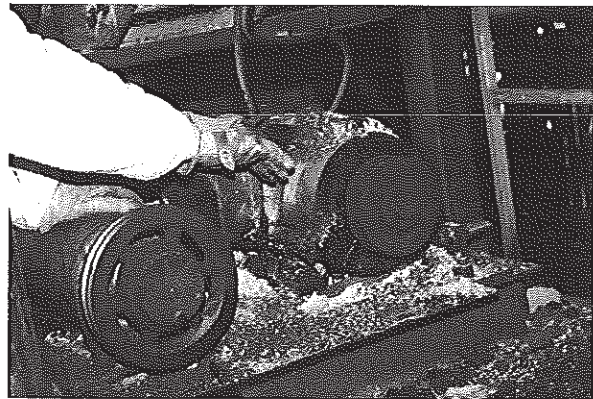
Photograph 9: Wood dust accumulation around conveyor motor labeled 8R-26.

No evidence of arcing or electrical failure was observed on any other electrical equipment found within either area of origin. A detailed evaluation of conveyor motor labeled 8R-26 was commissioned by WorksafeBC and BC Safety Authority investigators witnessed that the motor functioned with no indications of an appliance failure prior to the incident. Hazardous accumulations of wood dust were found within the junction box and cooling fins of the motor as shown in Photographs 8 and 9.

Electrical equipment found within the areas of origin consisted of disconnects, push buttons, hydraulic oil tank heaters, switches, motors and lights. There were no indications that any of the electrical equipment found was certified for use in a hazardous environment containing combustible dusts. It is possible that electrical equipment located within either identified area of the basement provided an ignition source for wood dust.

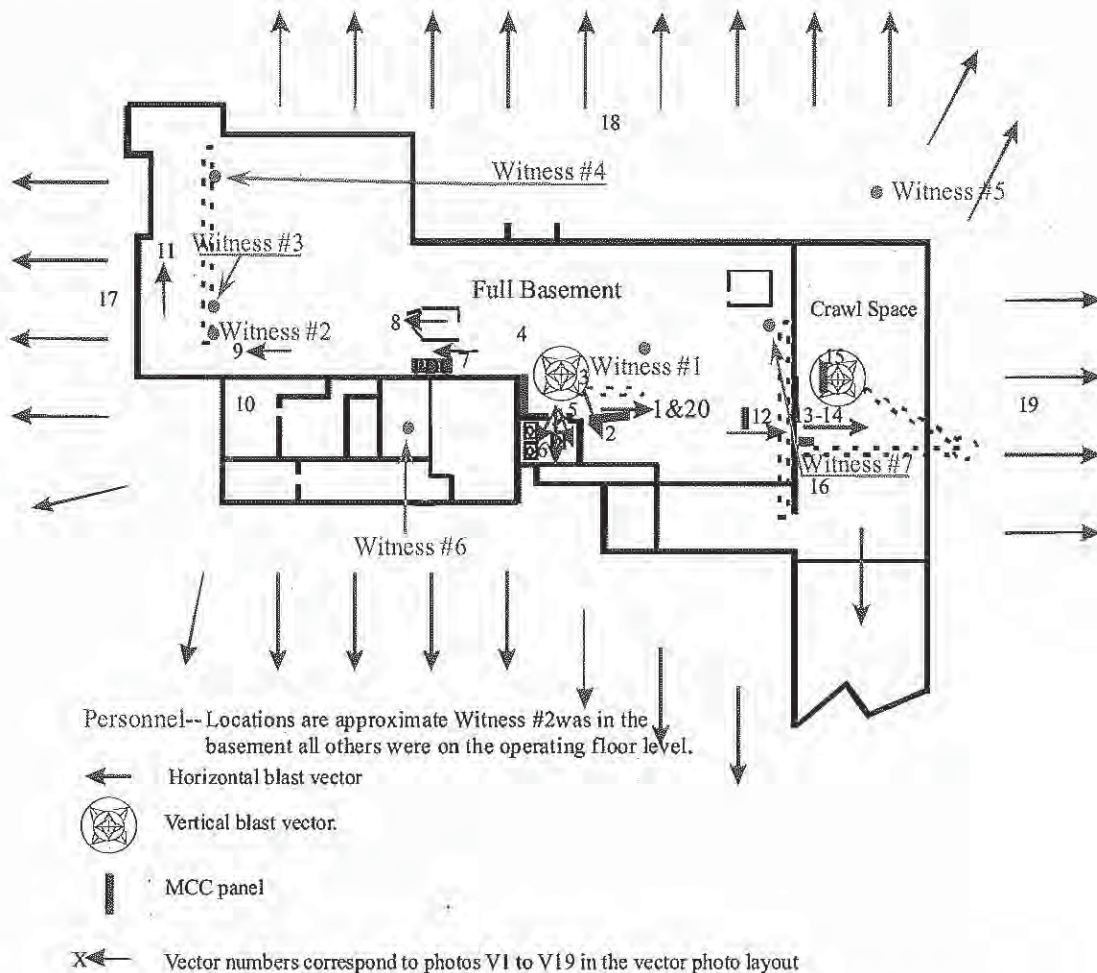
Figure 3 Partial building footprint showing blast vectors and witness locations
(Photographs V1 to V20)
(not to scale)

Analysis of the explosion damage (Figure 3) showed the blast expanding out from the area of the basement below the band saw near where the boiler room, MCC-9 and MCC-10 were located (Figure 1, circled area). This area was below the band saw operated by Witness #1. Evidence from Witness #1 was that the floor came up from below him and the roof went up. The blade cover for the band saw being lifted vertically out of position, and the south ends of the heavy roof timbers being shifted to the west, also place the origin of the blast in the basement as noted above. Information from Witness #6 that the floor in the millwright room came up also places

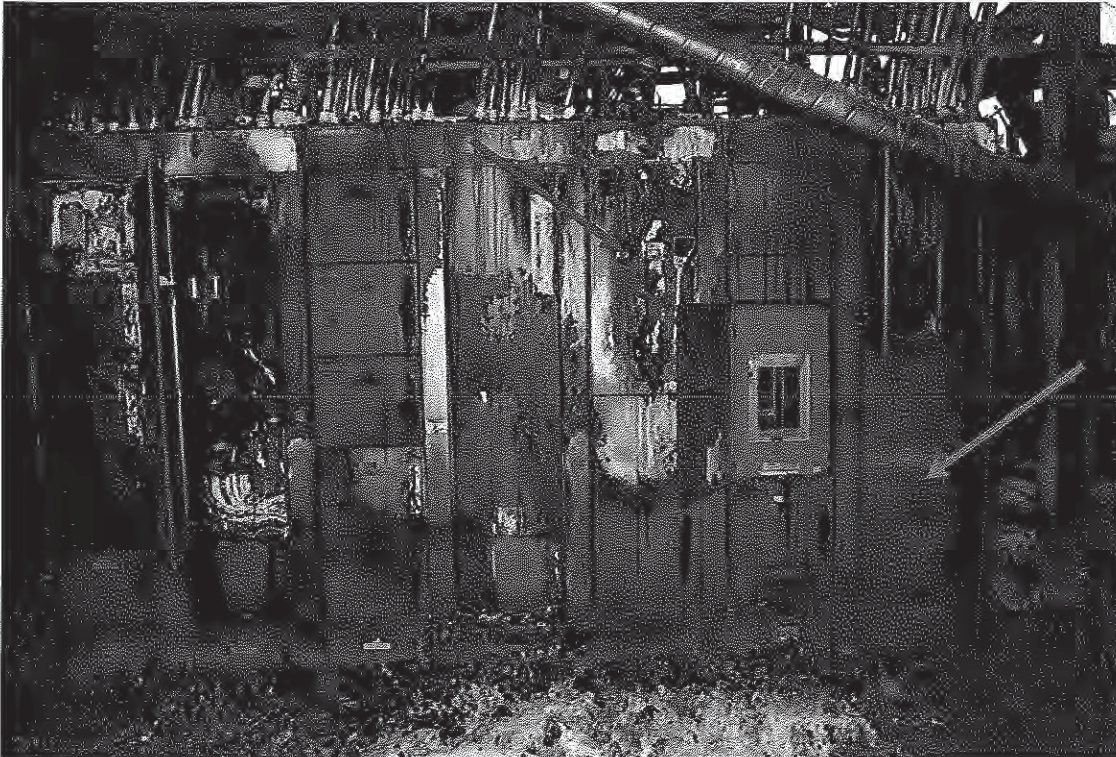
Photograph 5

In the area of origin a large electrical panel identified as MCC-10 stood out as a possible source of the primary explosion. In a major fire such as this it would be normal to see a relatively uniform horizontal burn pattern on the front of MCC-10, had it been a result of the main fire. However, the burn pattern on the front of MCC-10 (Photograph 5) was irregularly shaped and tended to follow the shapes of individual cabinets. MCC-9 was in the same general area as MCC-10 (Figure 1) yet, in contrast to MCC-10 there was a relatively uniform horizontal burn pattern on the front of MCC-9. This suggests the burn pattern on MCC-10 was the result of an internal fire. All of the cabinets were interconnected via raceways for wiring (Figure 4). It is likely that an internal fire or explosion occurred inside MCC-10 and only became established in certain cabinets, possibly those that contained more wood dust, and the internal burning produced the burn pattern observed on the outside.

Note: rather than being a uniform V pattern the burn pattern on the front of the panel follows the shapes of individual cabinets.

Note also: the locations of sub panels 10-31 (red arrow) and 10-13 (green arrow). Cabinet 10-13 is further referred to in Photograph 11,

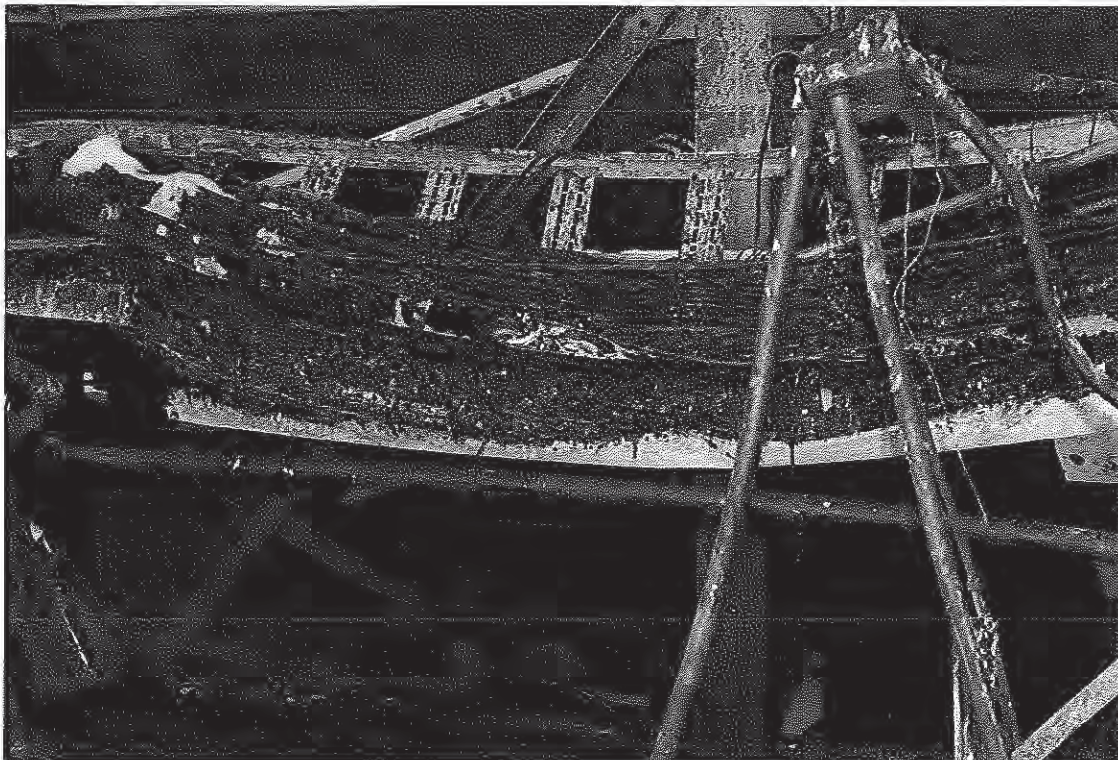
Photograph 8

- the wire cable trays in most of the basement were coated with charred wood dust on the upper side (Photograph 8); however, there was minimal charred wood dust on the cable trays above MCC-10 (Photographs 9 and 10),

Looking at an example of charred sawdust on wire cable trays. This is typical of the condition of cable trays in the basement of the mill.

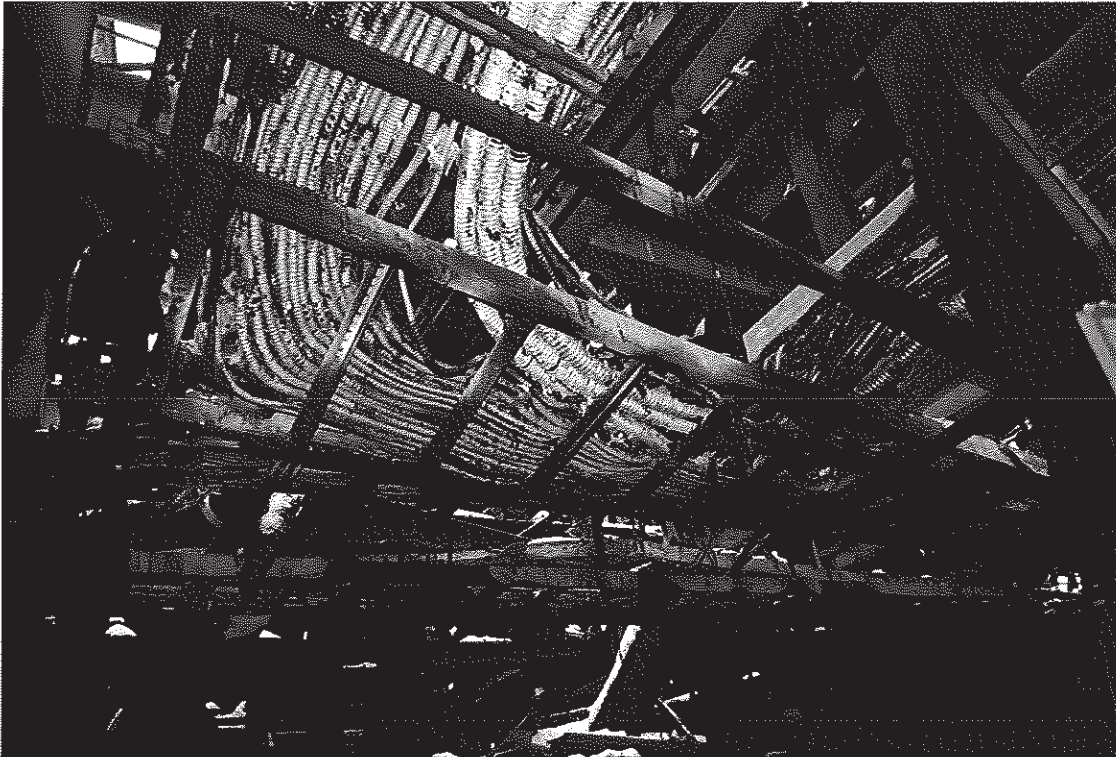
Photograph 9

Looking at the cable trays above MCC-10.

Note: the absence of charred sawdust.

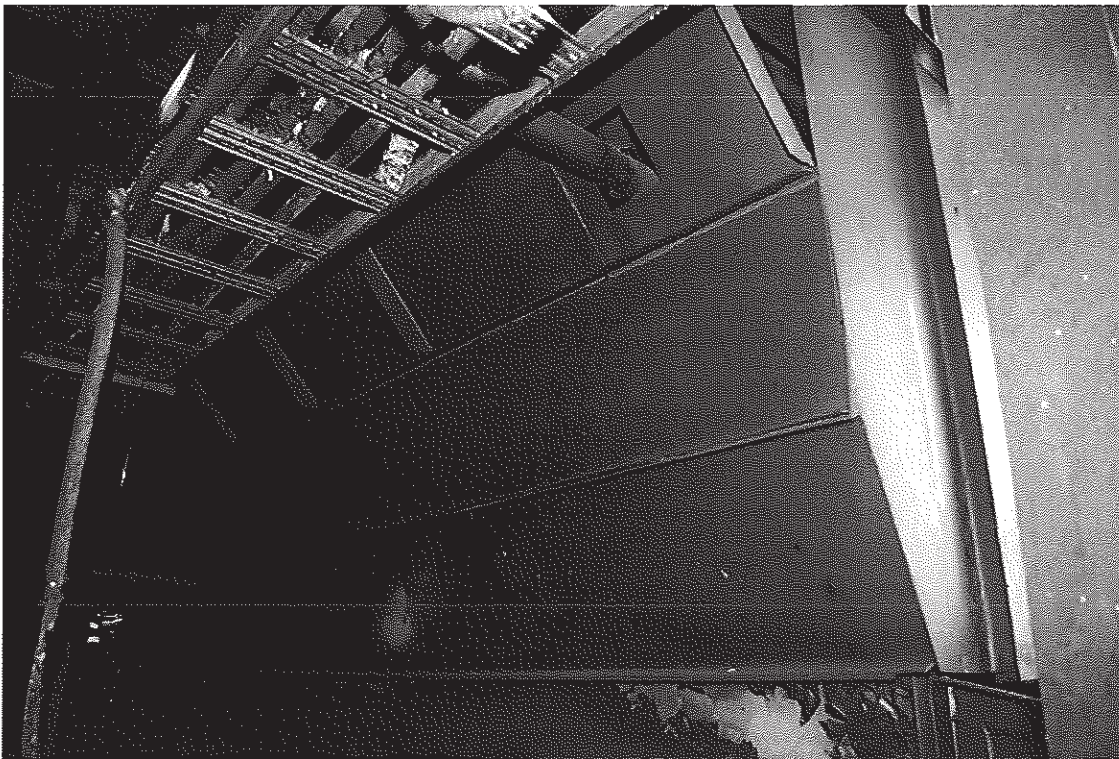
Photograph 10

Looking at the cable trays by the conveyer next to MCC-10.

Note: the absence of charred sawdust.

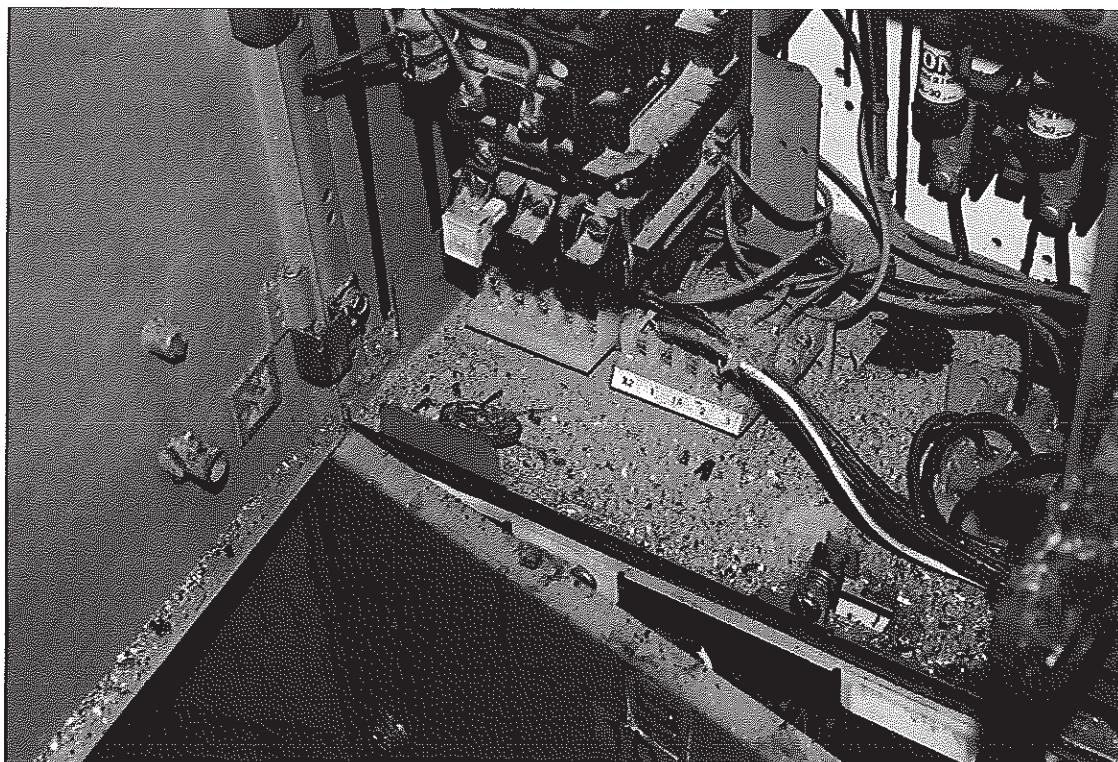
Photograph 11

Most of the wood dust inside MCC-10 was burned away. However, wood dust accumulations were present in the less damaged cabinets of MCC-10 (Photograph 11) and wood dust deposits were observed in MCC-9 and MCC-12 which were less damaged. The intake for the air pressurizing system for MCCs 9 and 10 was on the floor next to MCC-10. Because the intake was in the dust contaminated environment, the pressurizing system could have introduced wood dust into the MCCs had it been used prior to the explosion without conducting a cleaning of the cabinets.

Looking at the accumulation of sawdust inside MCC-10, sub panel 10-13.

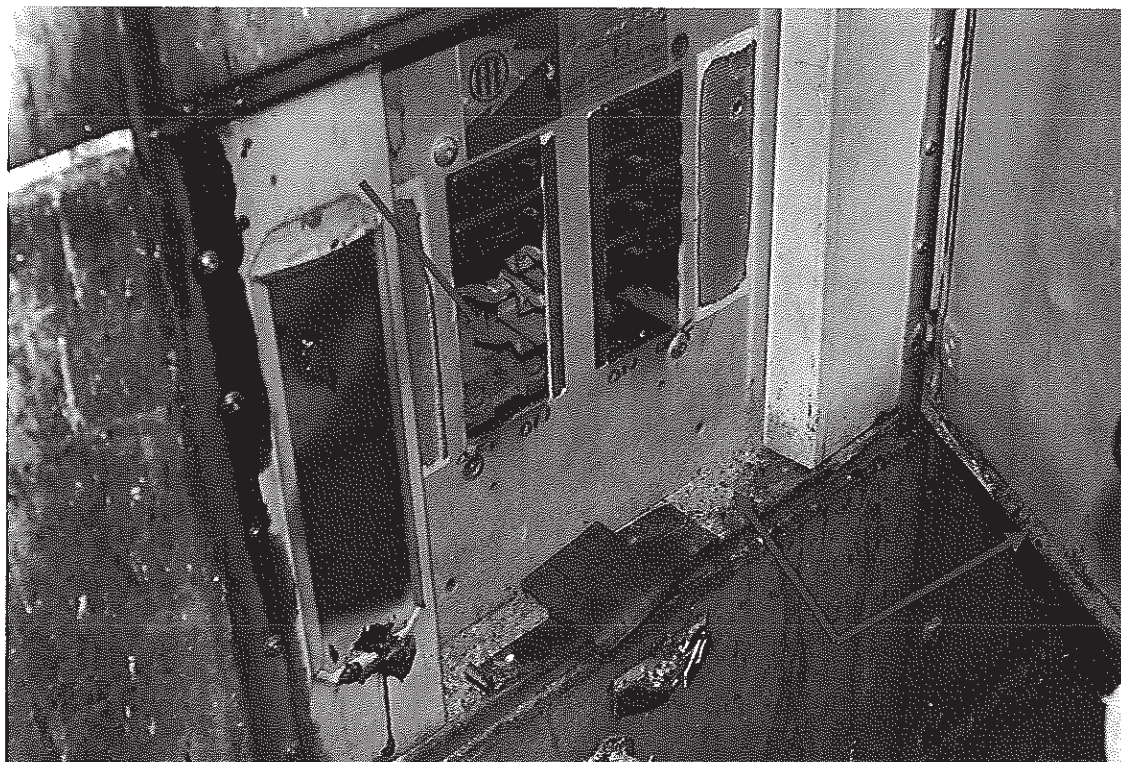
Photograph 12

Looking at the accumulation of sawdust inside MCC-9 (arrows).

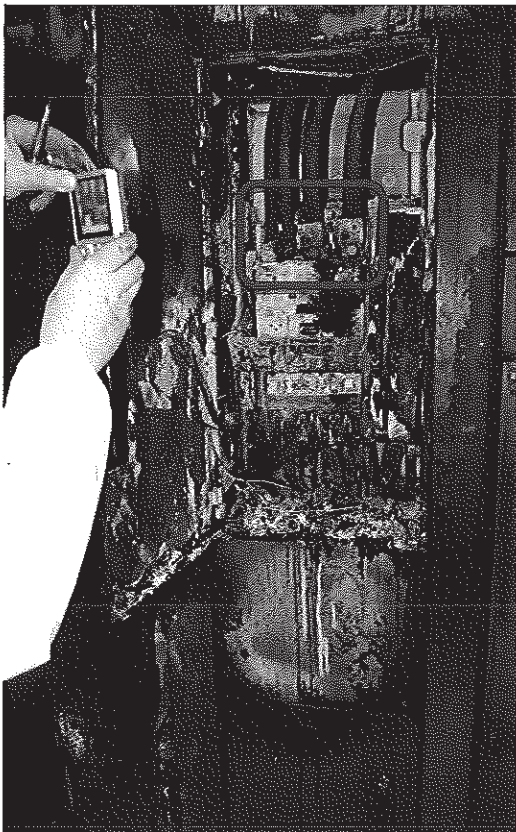
Photograph 14

Looking at the interior of MCC-10, subpanel 10-31.

Note: the location of the three lugs (red outline).

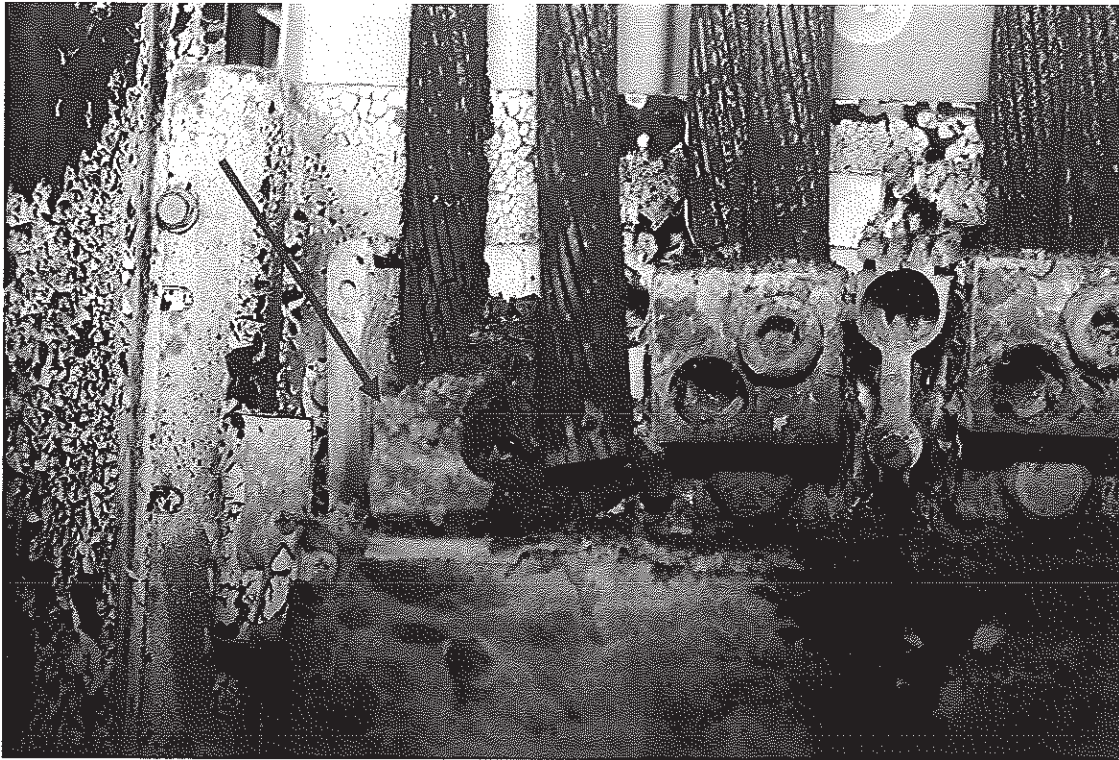
Photograph 15

Looking at a closer view of the three lugs in subpanel 10-31.

Note: two lugs are intact but the third (arrow) is broken up.

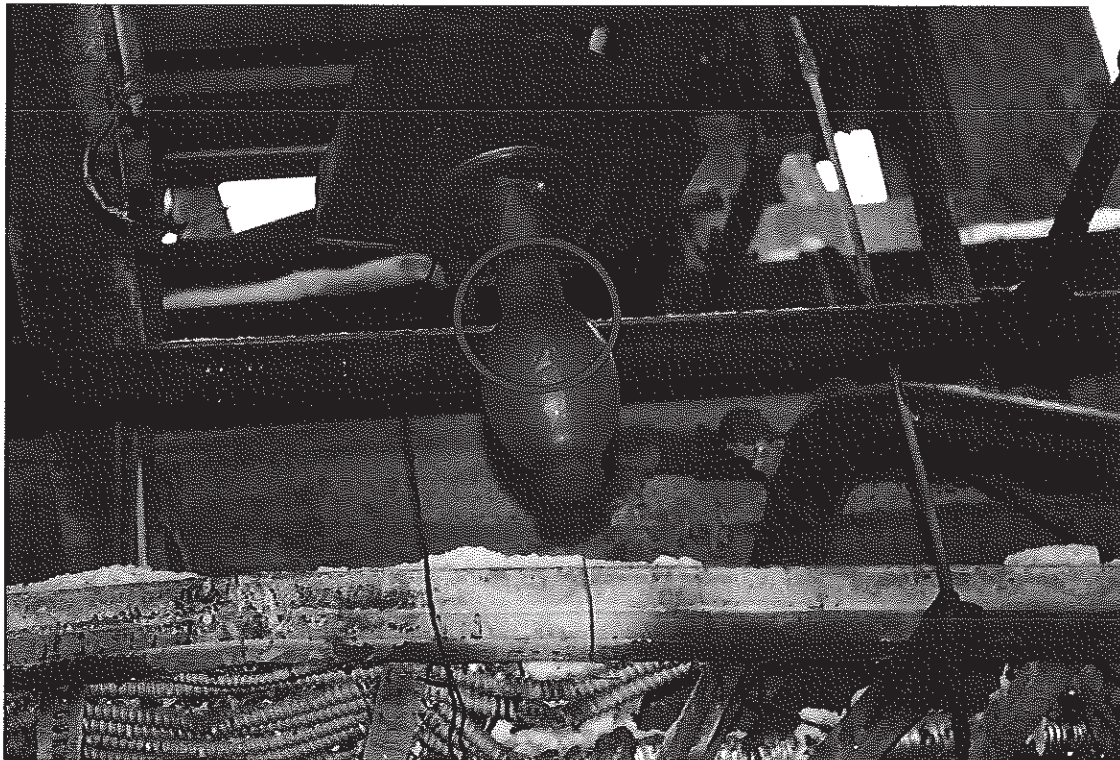
Photograph 16

Looking at the metal halide light above MCC-10.

Note: residue on the upper bulb surface (circle).

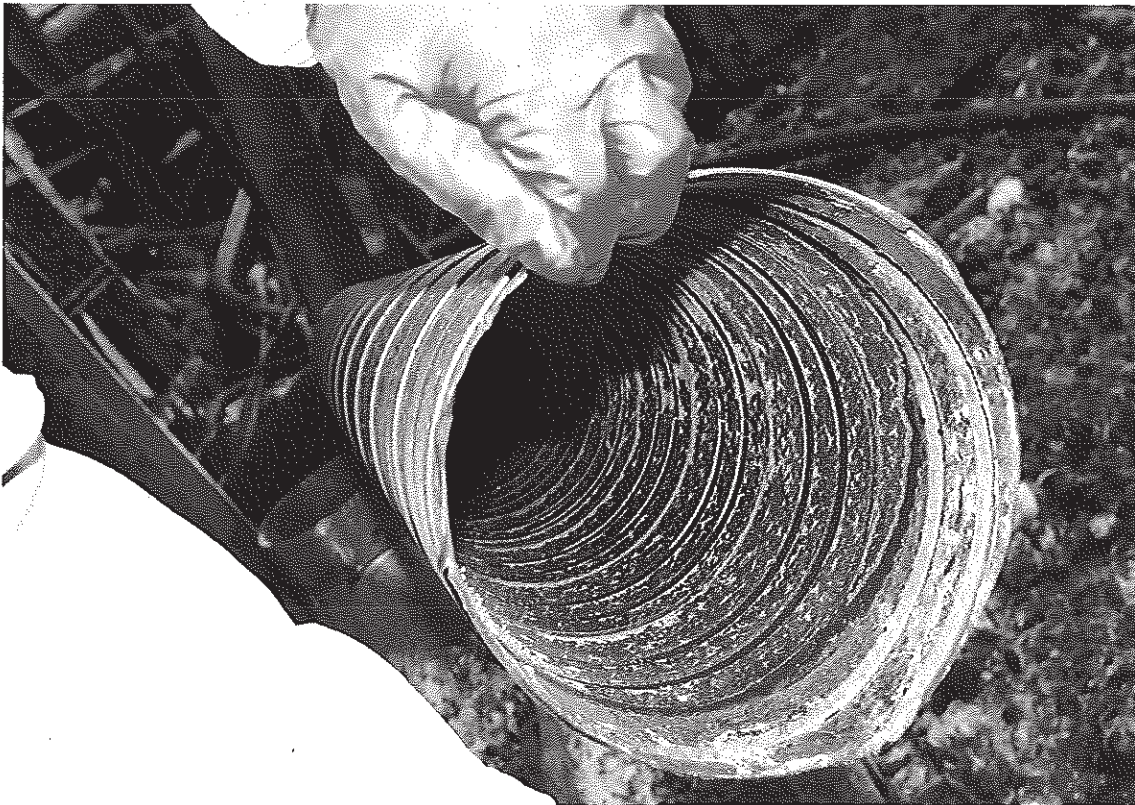
Photograph 18

Looking at the interior of the ventilation ducting for MCC-10.

Note: the charred deposits on the inner surface.

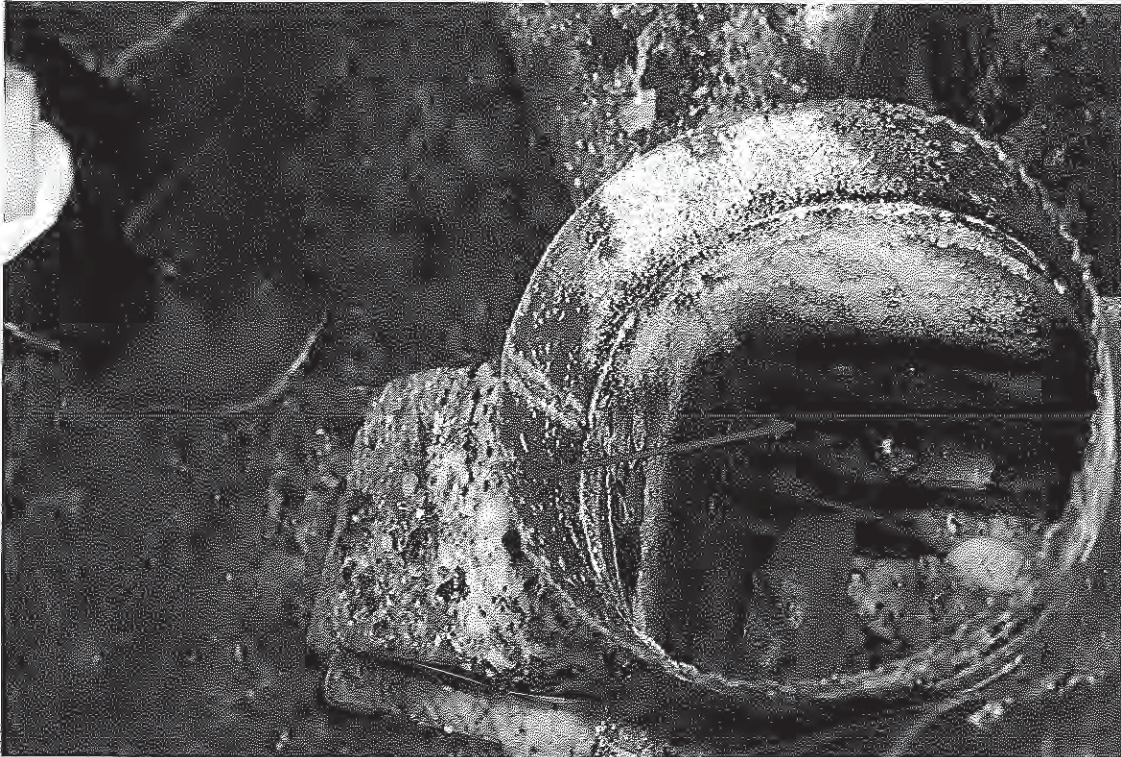
Photograph 19

Looking at the interior of the transition on the blower for the ventilation system for MCC-10.

Note; the charred deposits on the inner surface (arrow).
