INCIDENT INVESTIGATION REPORT

| Notice of incident number 2012161980018 | Date of incident January 20, 2012 | Location of incident 19479 Highway 16 East Burns Lake, B.C. |
| Lead investigating officer Paul Orr | Investigation file number 2012-0013 | Incident outcome FATAL (2) INJURY (20) |

| Employer | Name and address | Employer ID | Industry classification |
|---|---|---|---|
| | Babine Forest Products Limited 19479 Highway 16 East Burns Lake, BC V0J1E0 | 328321 | 714022 Sawmill |

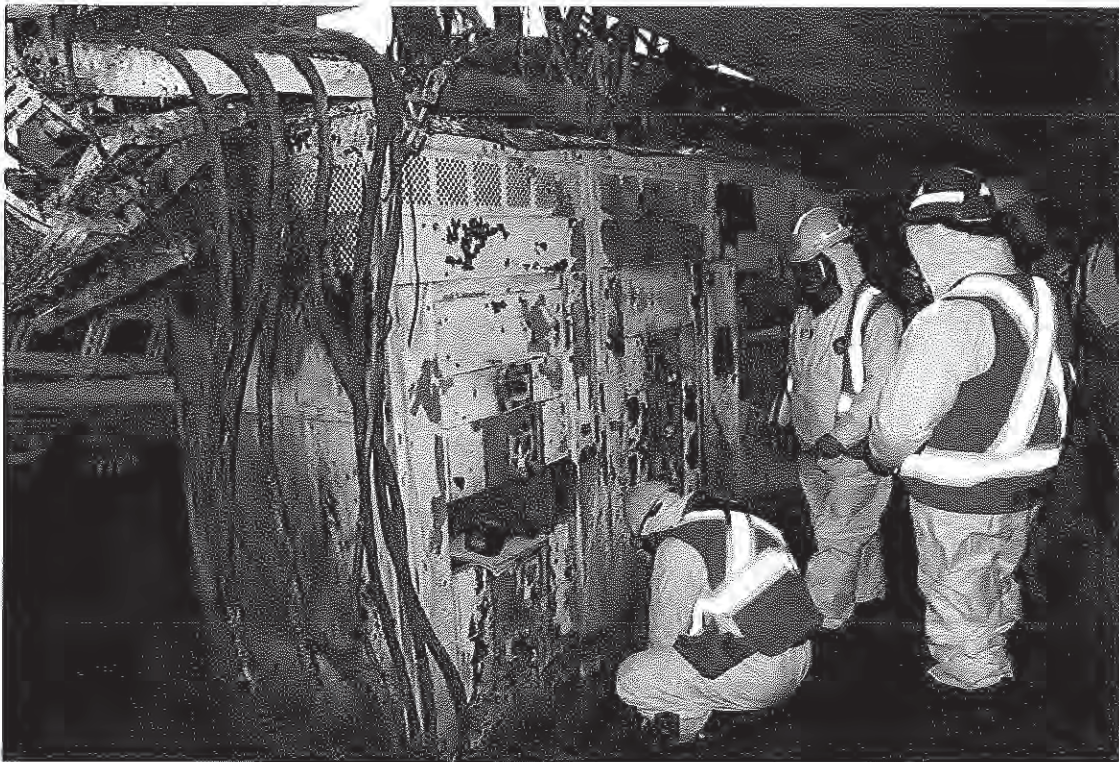
Photograph 20

Looking at the PDC.

Note: before the explosion the PDC was in a fully enclosed room.

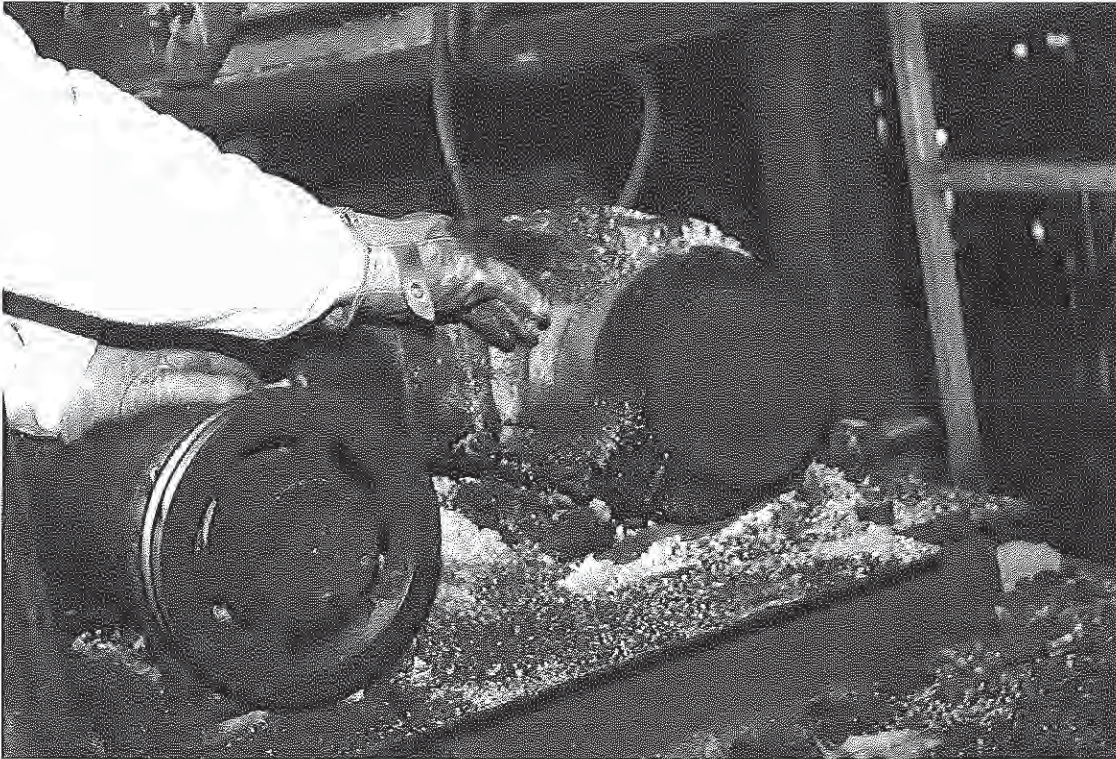
Photograph 21

Looking at the motor taken into evidence by Worksafe BC from the east side of the mill basement.

Note: the sawdust on and around the motor.

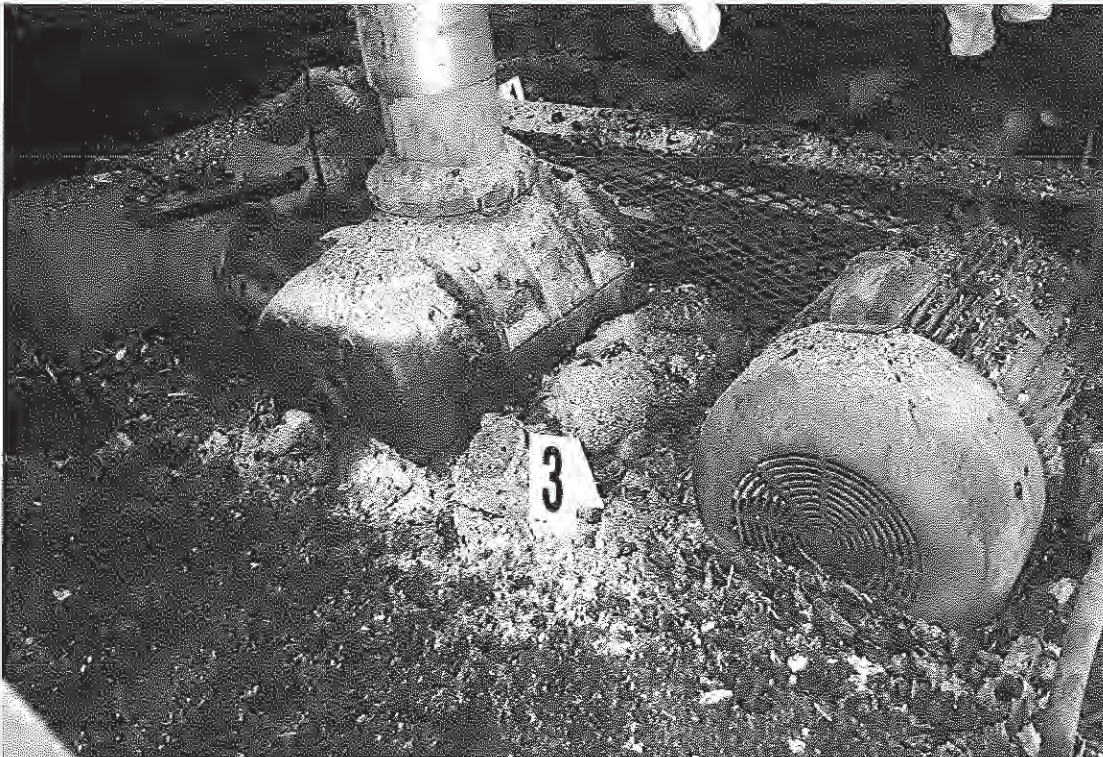
Photograph 22

Looking at an example of the dust levels in the basement of the mill. This photograph was taken in the east side of the basement.

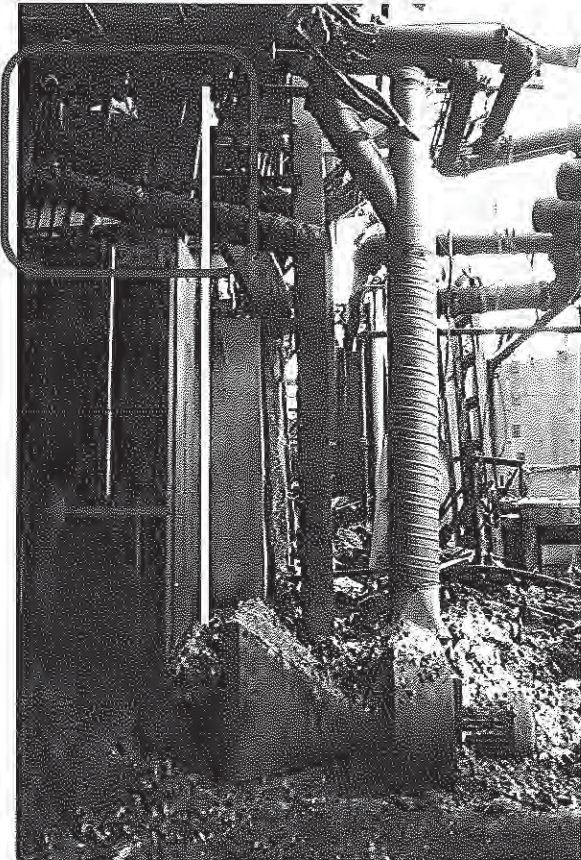
Photograph V1

Looking at the west end of MCC-10 from the front.

Note: the angle of the wires at the top of the panel (red outline) indicates an eastward movement of the panel.

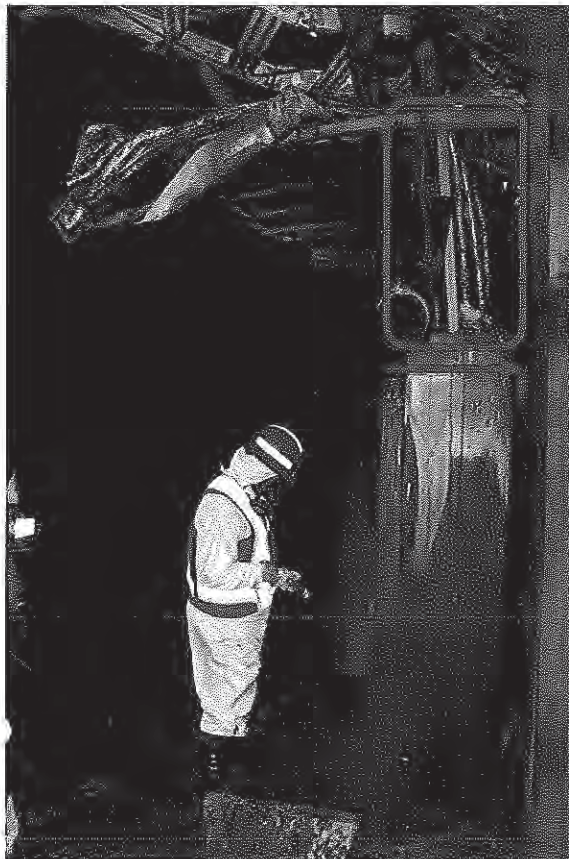
Photograph V2

Looking at the west end of MCC-10 from the end.

Note: the angle of the wires at the top of the panel (red outline) indicates a southward movement of the panel.

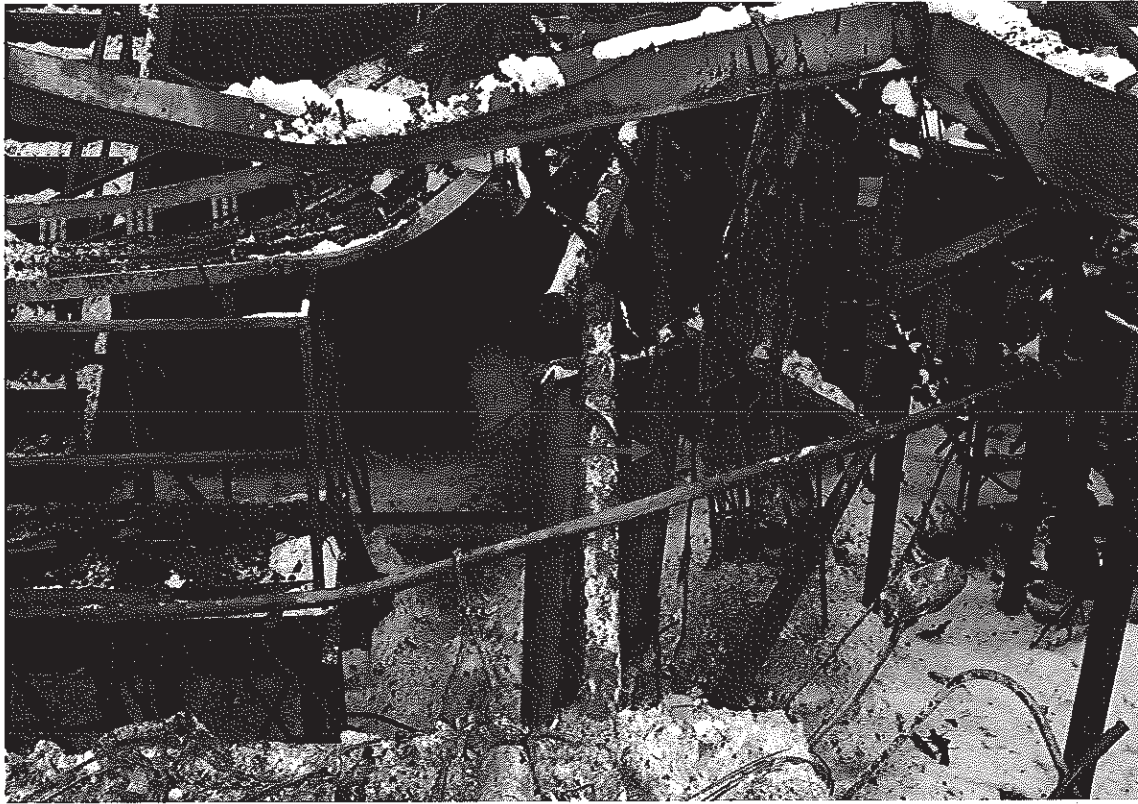
Photograph V5

Looking at the door to the boiler room.

Note: the door which would normally have opened out, was found open into the boiler room as indicated by the red vector arrow.

Note also: before the explosion the boiler room was completely enclosed.

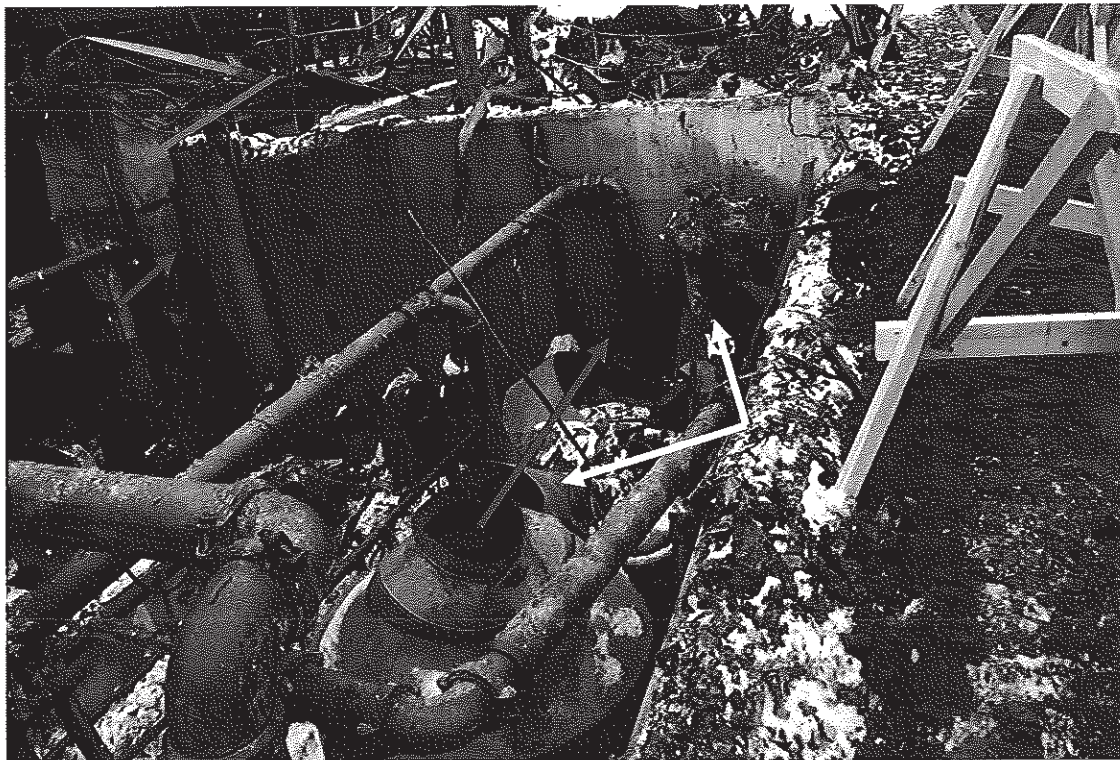
Photograph V6

Looking at the boiler room from the south side.

Note: the makeup air duct (green arrow) and the boiler exhaust ducts (yellow arrows) were pushed to the south of their normal positions.

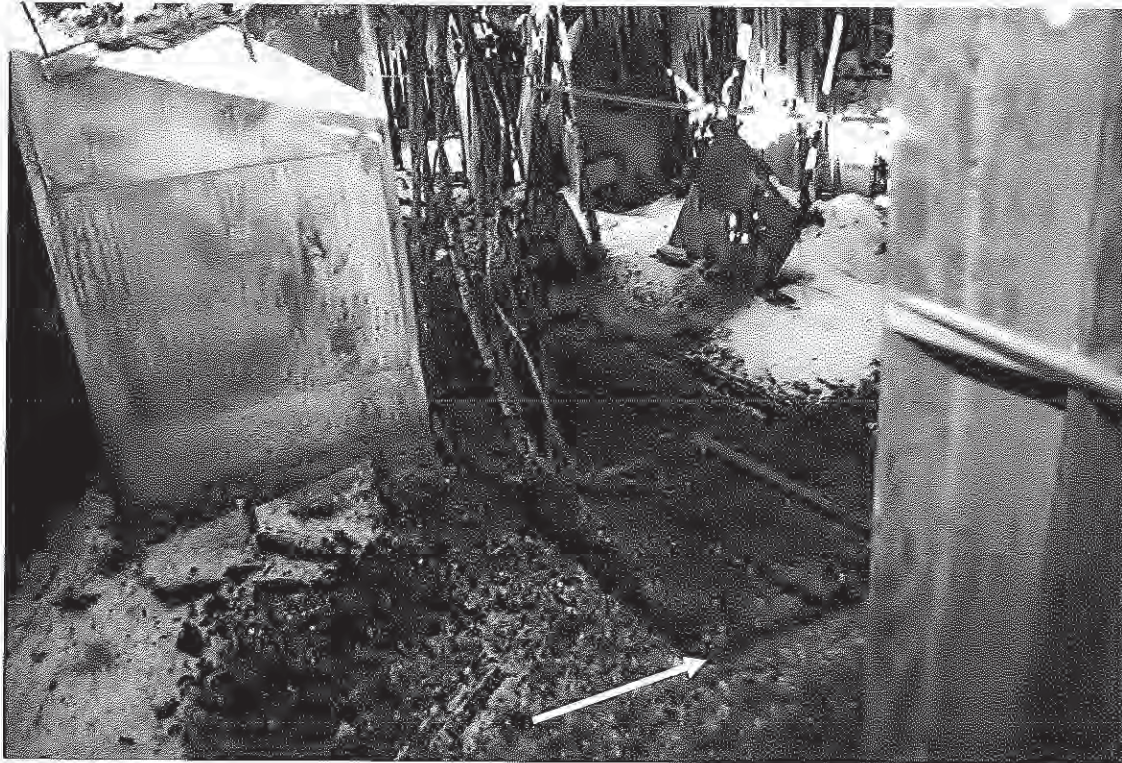
Photograph V7

Looking at the framing of the east wall of the PDC room (green arrow).

Note: the base of the framing (yellow arrow) is in its normal location however, the top has been pushed over to the west.

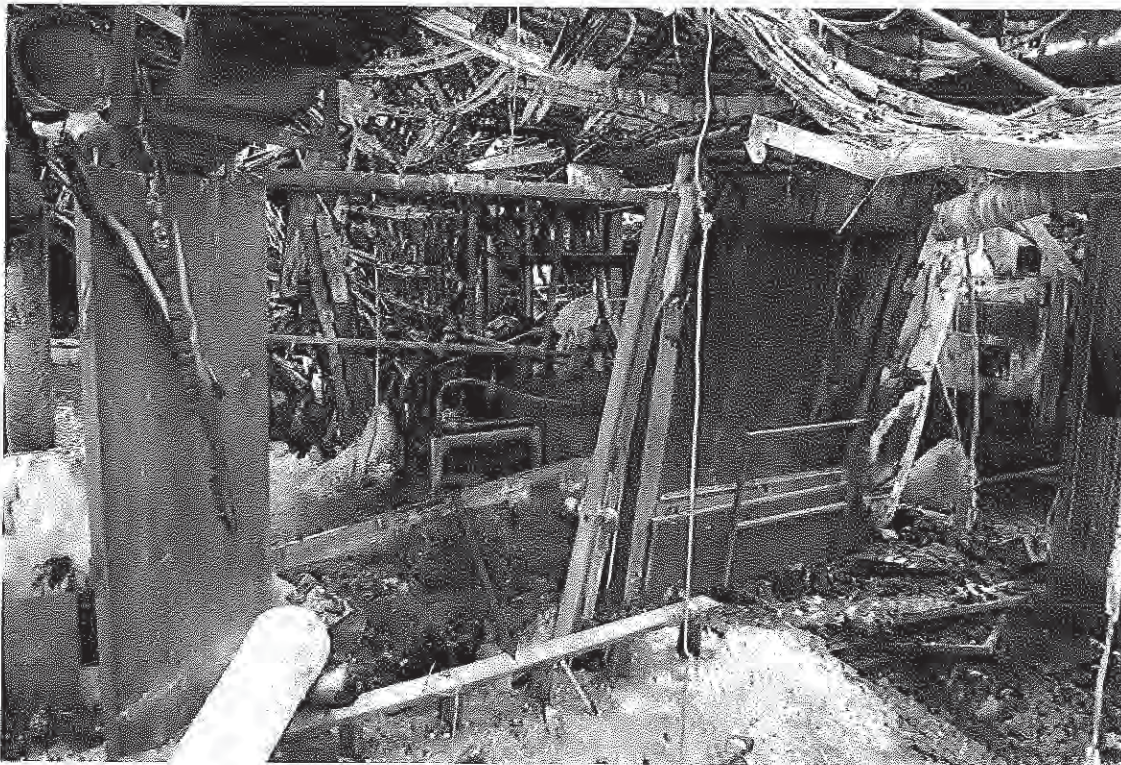
Photograph V8

Looking at the doors to the hydraulic room by the PDC room blown open to the west.

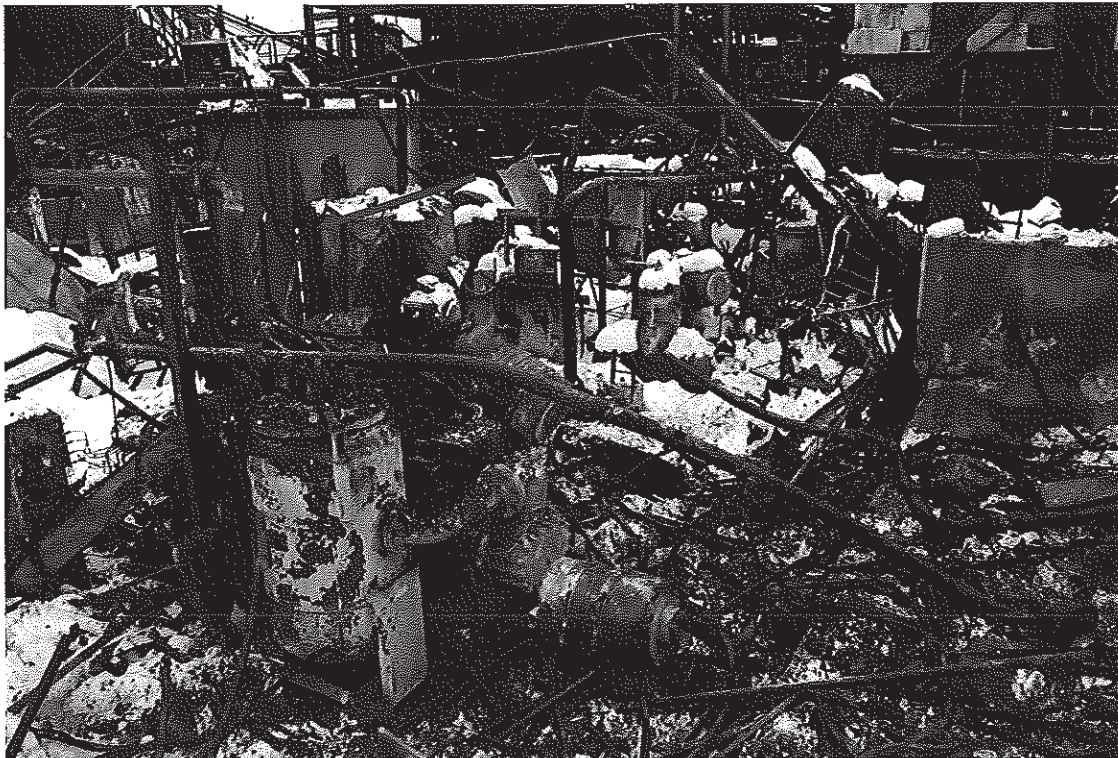
Photograph V10

Looking at the compressor room through which Witness #2 escaped.

Note: before the explosion this room was completely enclosed with no exit to the outside.

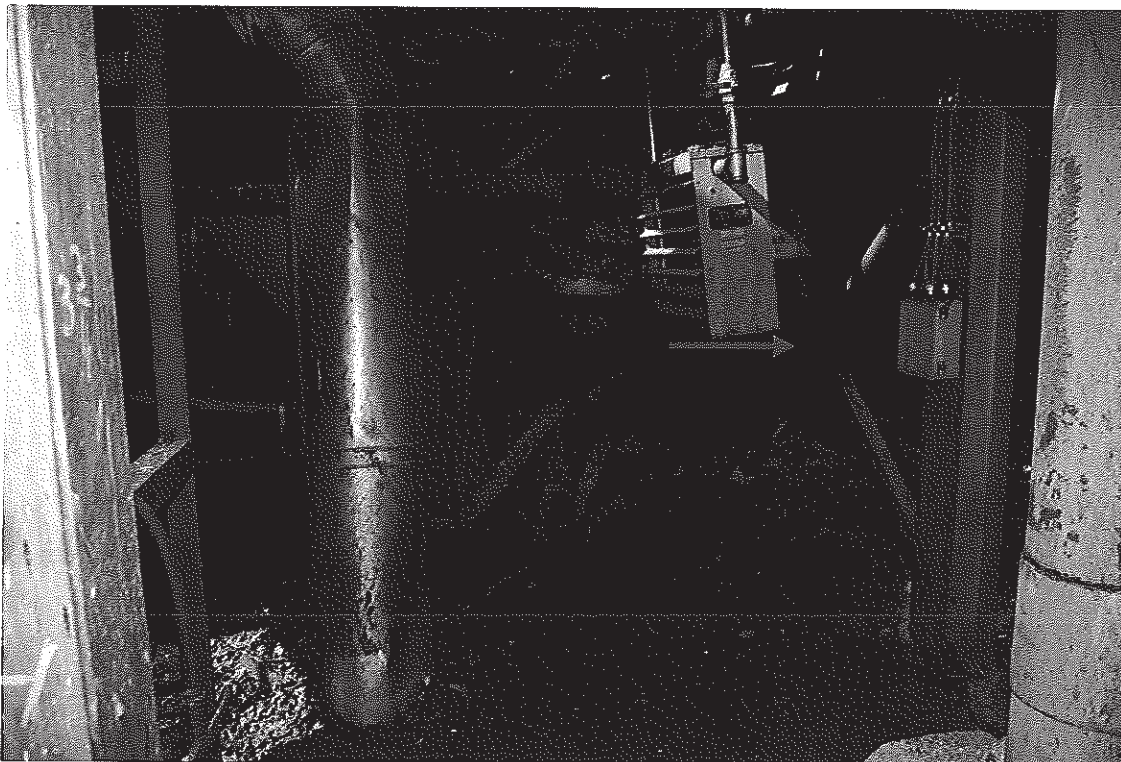
Photograph V12

Looking at a heater in the east end of the basement.

Note: the bottom of the heater was pushed to the east.

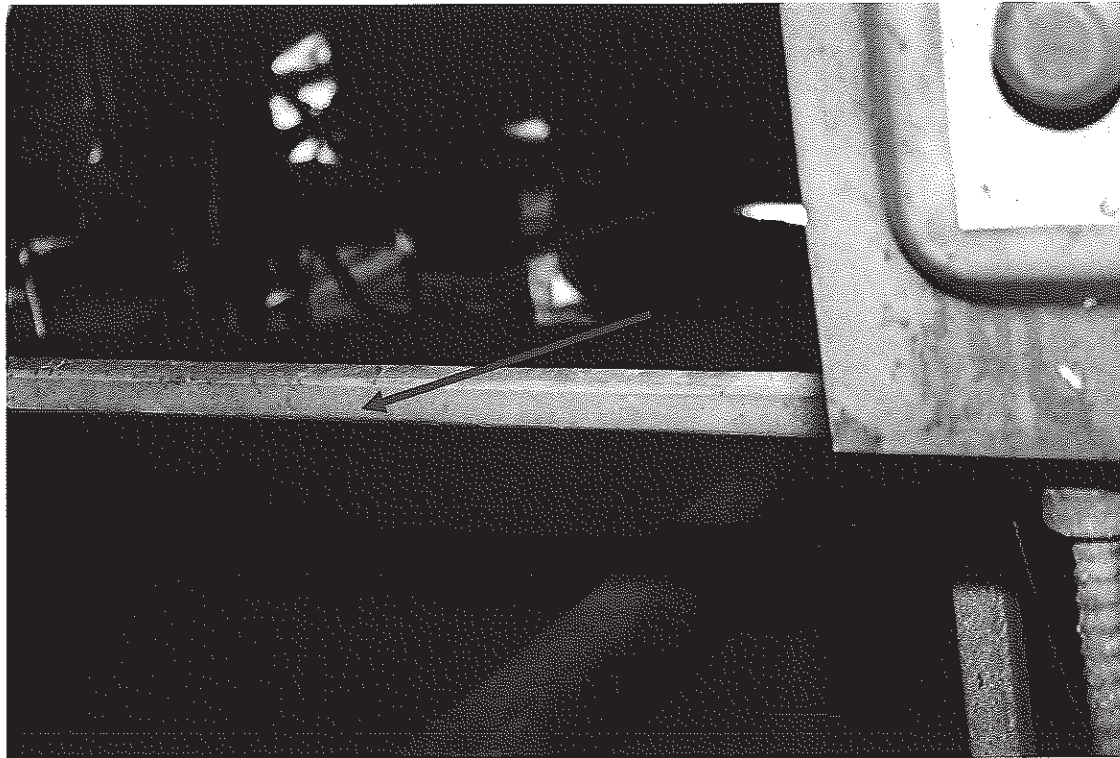
Photograph V13

Looking at the east side of the guardrail used to prevent personnel from falling from the crawl space, in the east side of the mill into the basement.

Note: this side of the rail is relatively clean compared to the opposite side (Photograph V14).

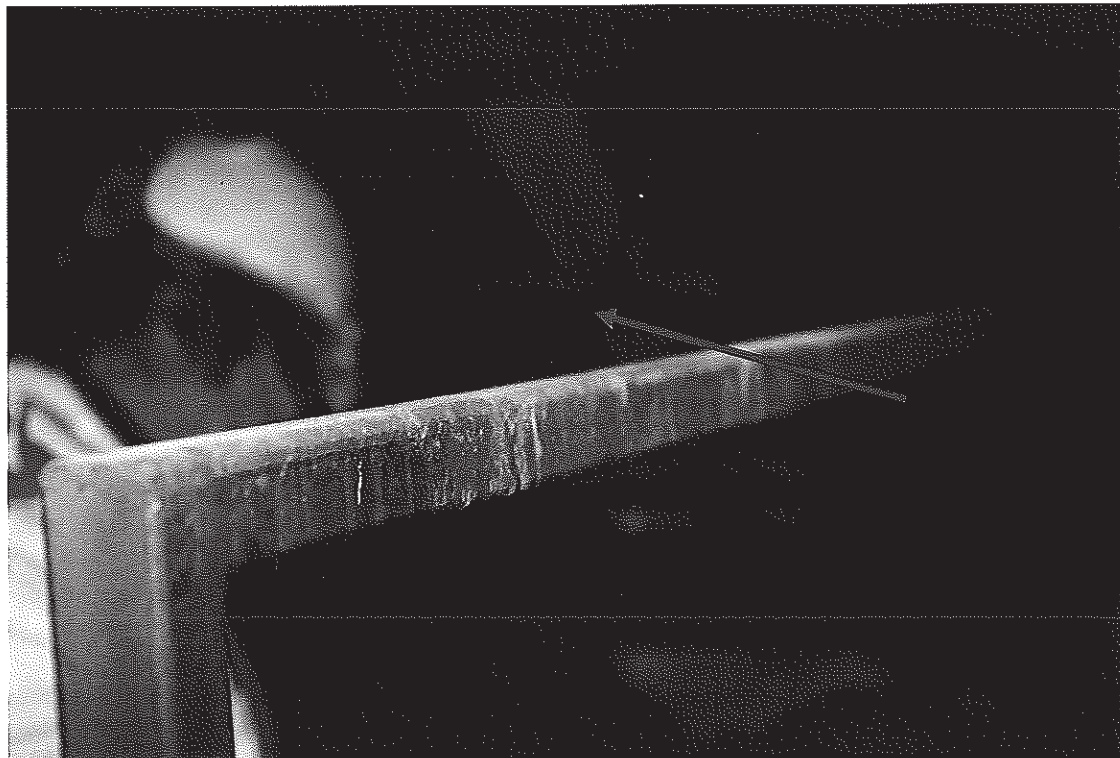
Photograph V14

Looking at the west side of the railing shown in photograph V13.

Note: the condition of this side of the rail in comparison to the other side.

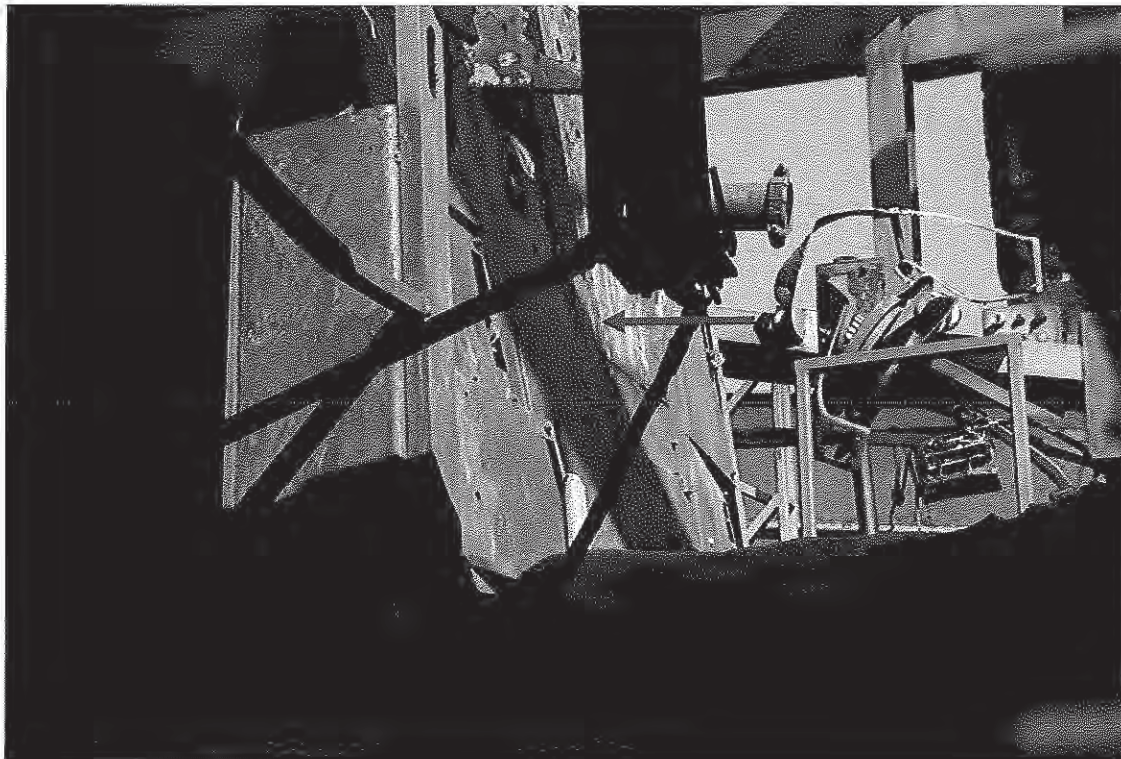
Photograph V15

Looking at the MCC panel for the eliminator.

Note: this panel was in the east side of the building and the top of the panel was pushed toward the west (arrow).

Note also: this photograph was taken through the opening through which a blast from the basement would have travelled striking the MCC panel.

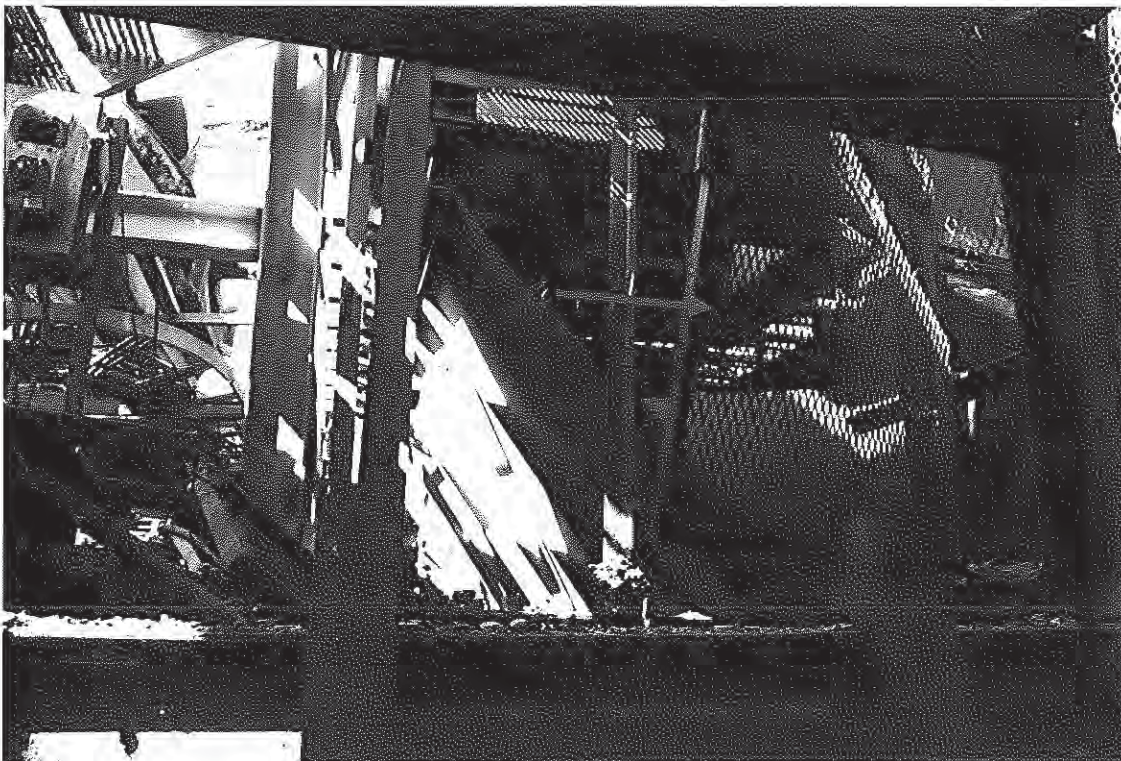
Photograph V16

Looking at a machine guard on a conveyor in the southeast wing of the mill.

Note: the direction of the blast was from north to south (arrow).

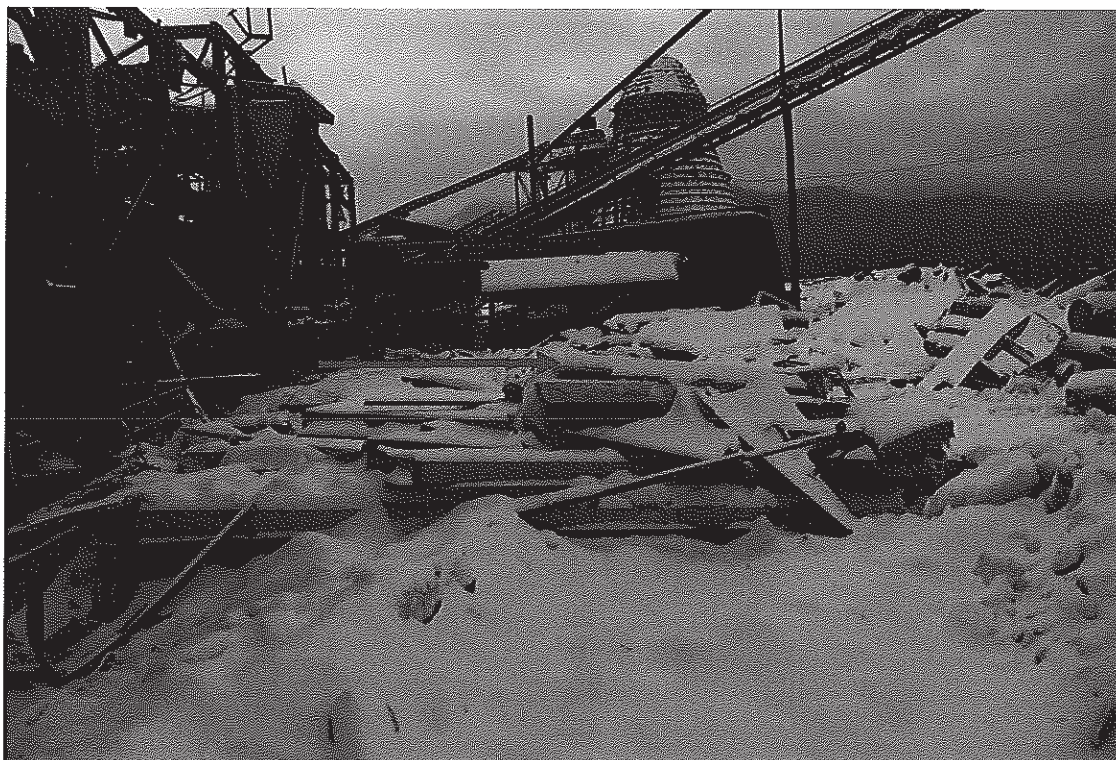
Photograph V17

Looking at the west end of the mill.

Note: the debris on the ground is the west exterior wall which was blown out to the west.

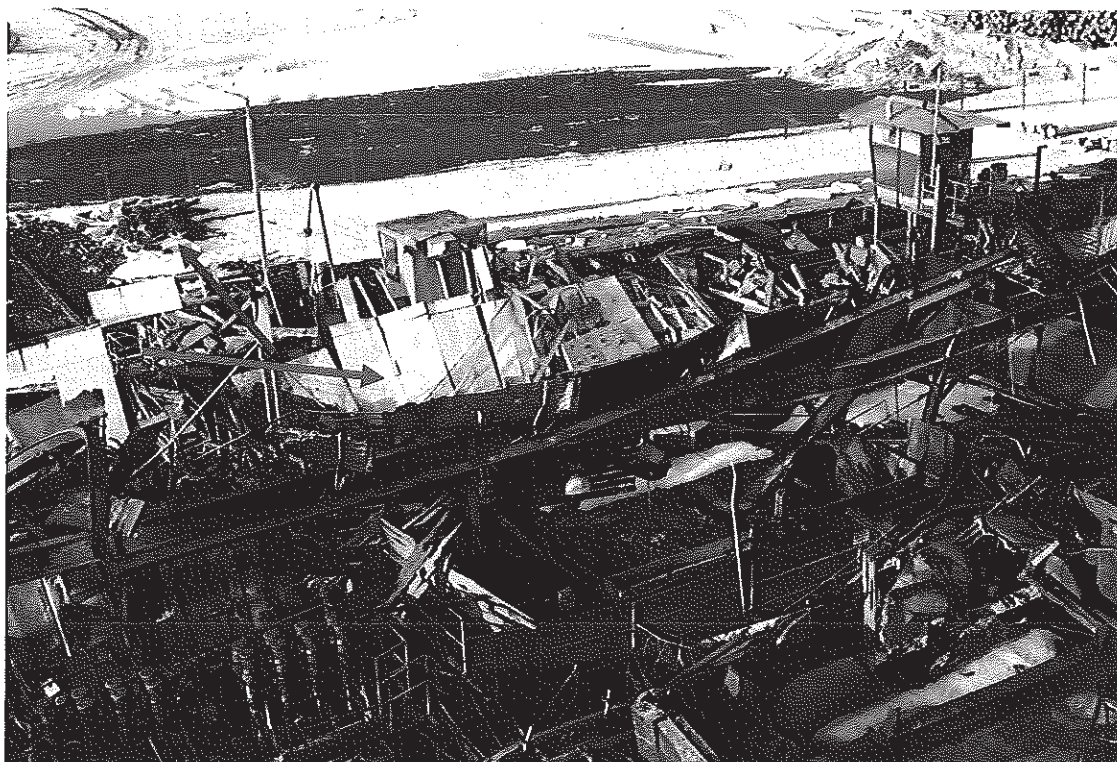
Photograph V18

Looking north from above the mill.

Note: the north walls (green arrow) were blown out to the north.

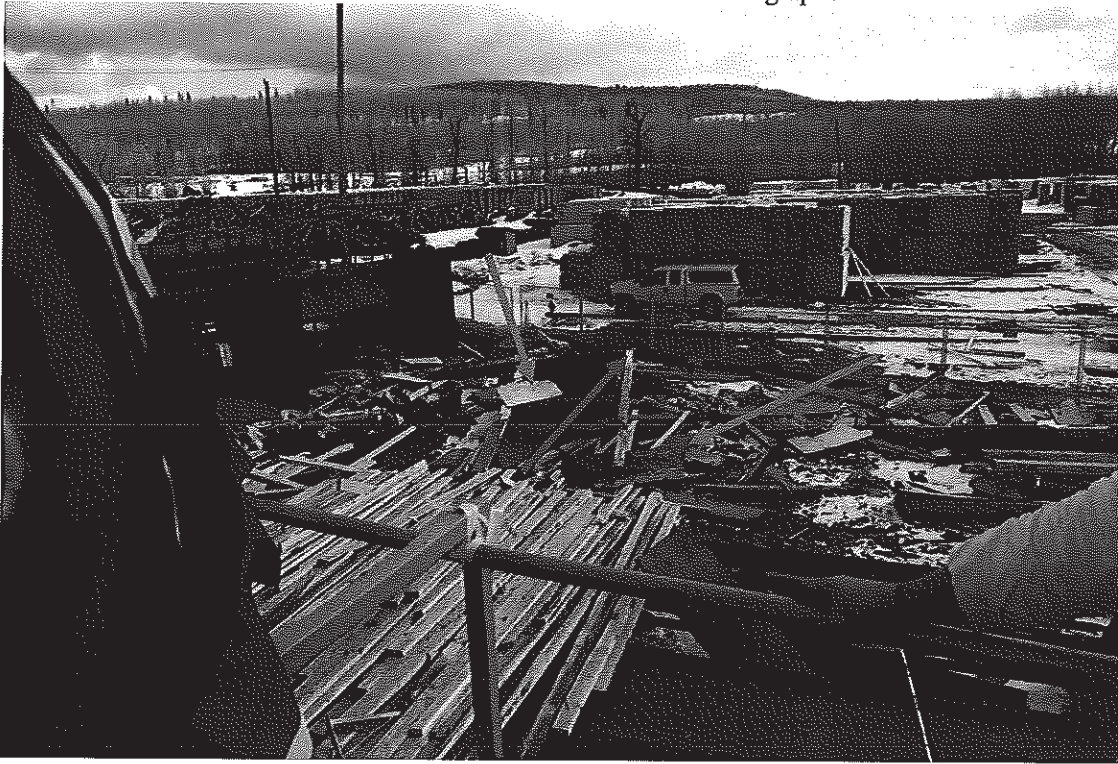
Photograph V19

Looking east from the east end of the mill.

Note: the east walls (green arrows) were blown out to the east.

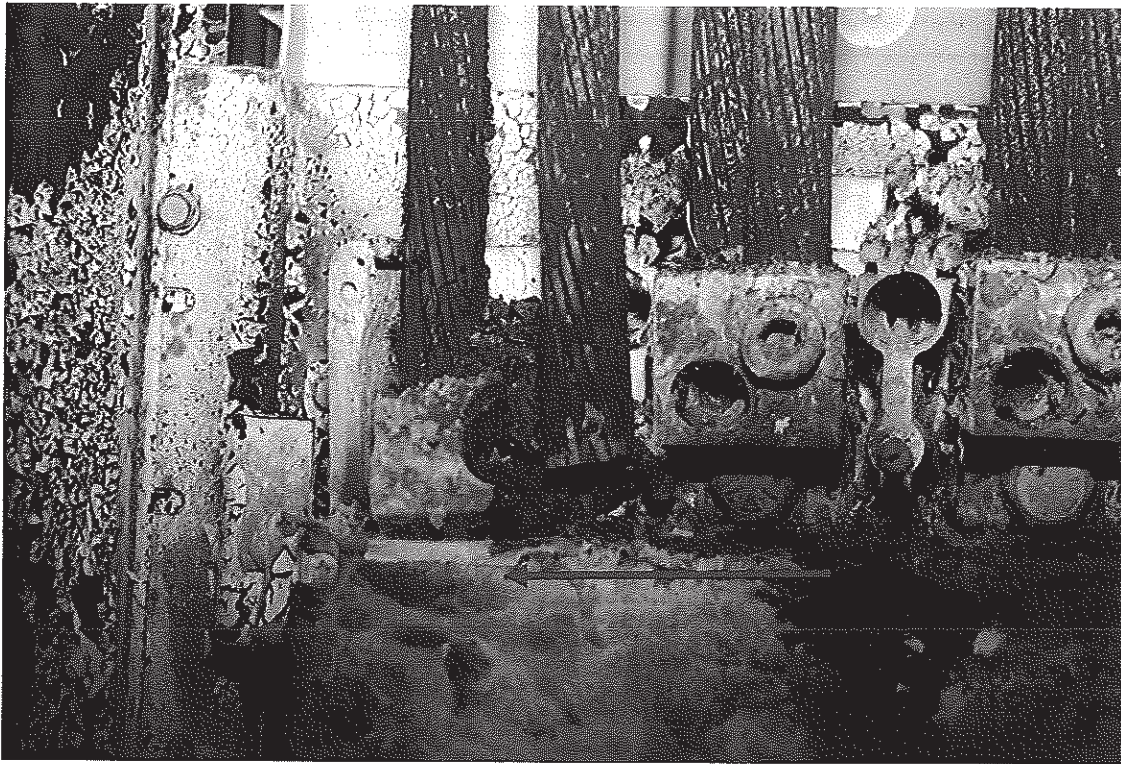
Photograph V20

Looking at the damaged lug in cabinet 10-31.

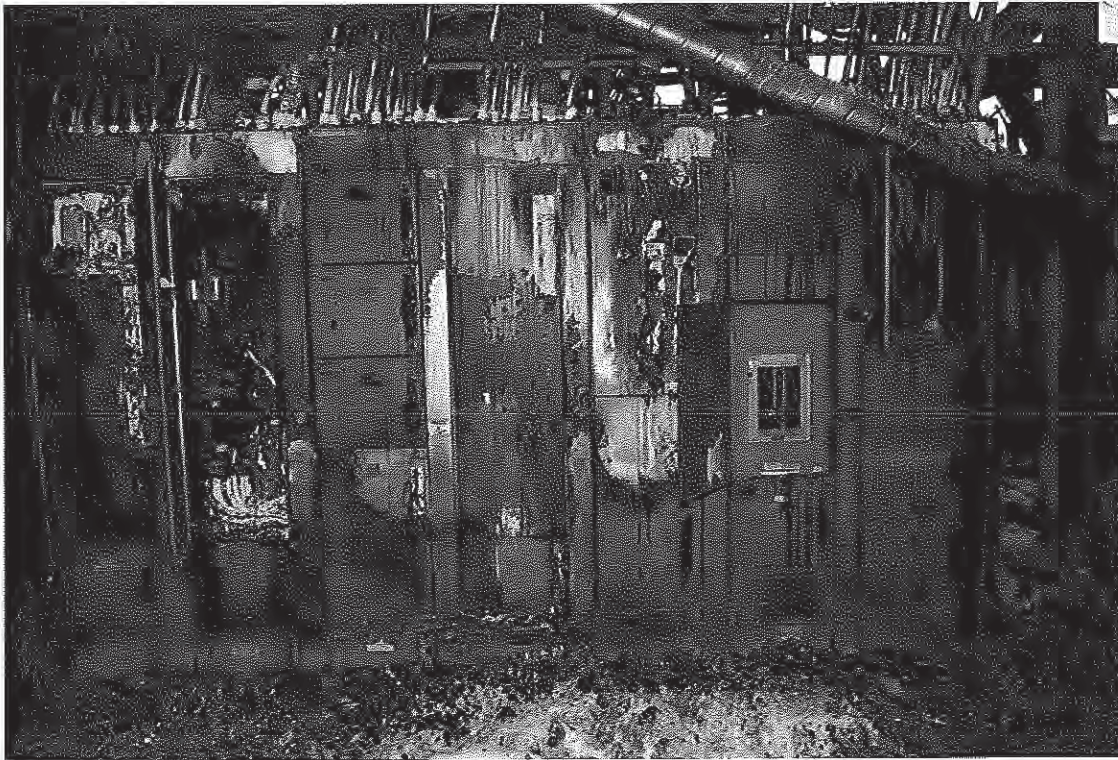
Photograph M1

Looking at the front of MCC-10.

Note: the burn pattern on the front of the MCC.

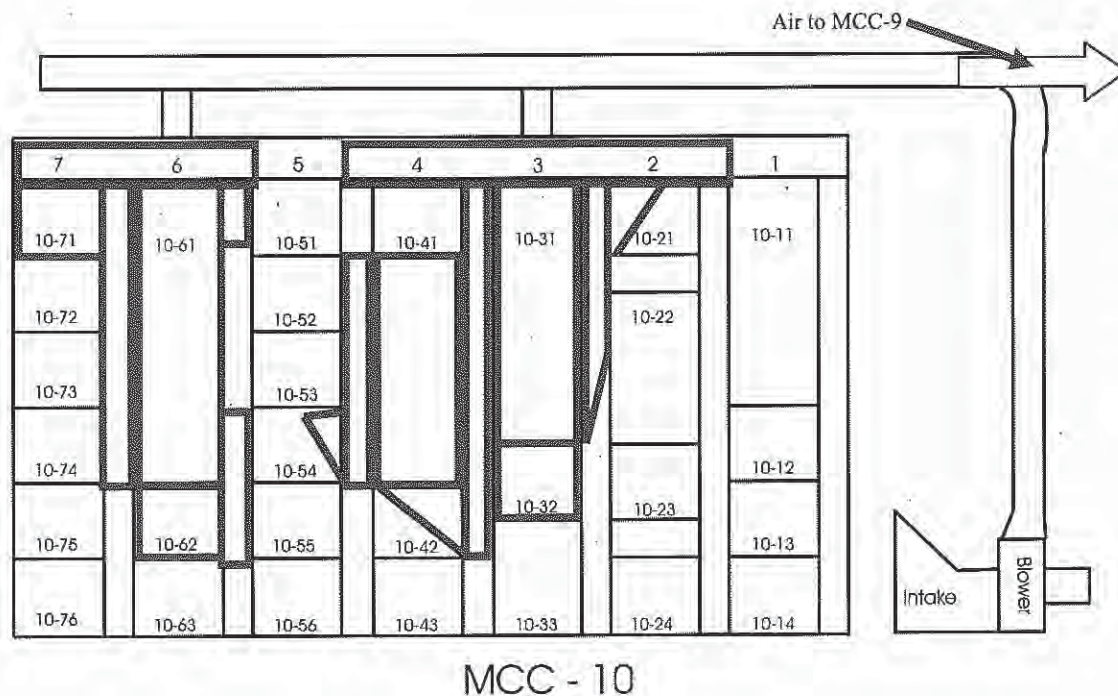
Photograph M2

Looking at a line drawing of MCC-10.

Note: the red outlines are intended to duplicate the burn pattern on the MCC as shown in Photograph M1.

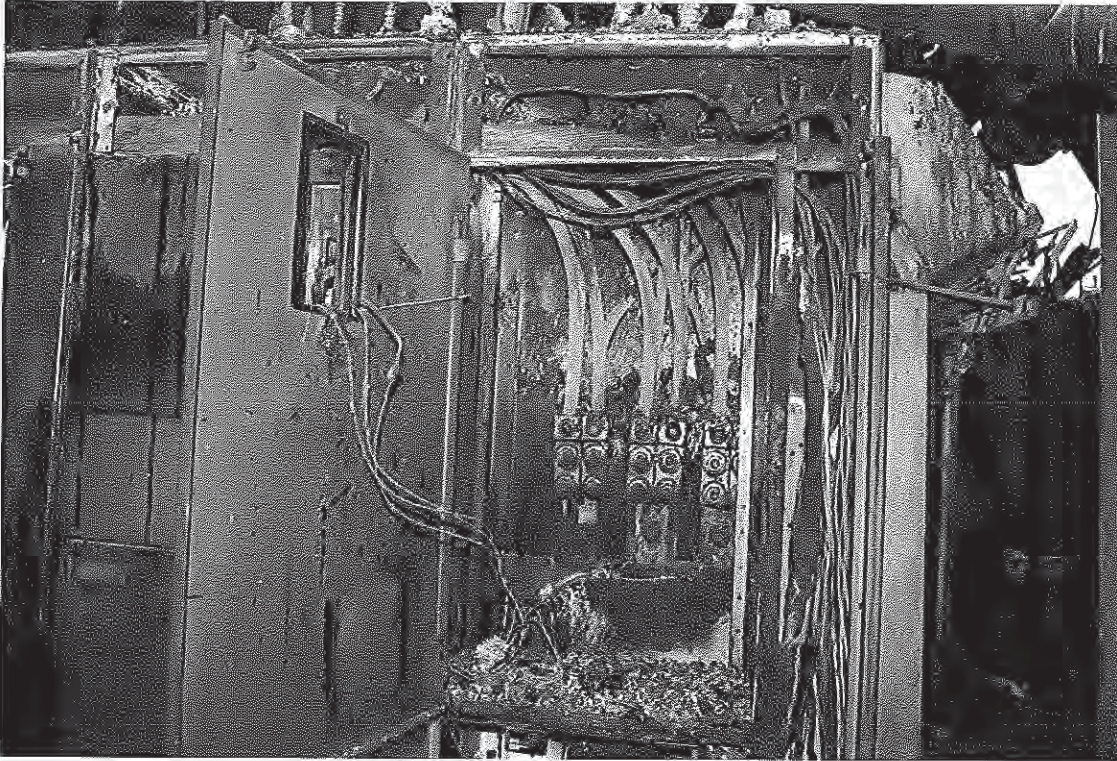
Photograph M3

Looking at cabinet 10-11.

Note: the interior of this cabinet was extensively burned.

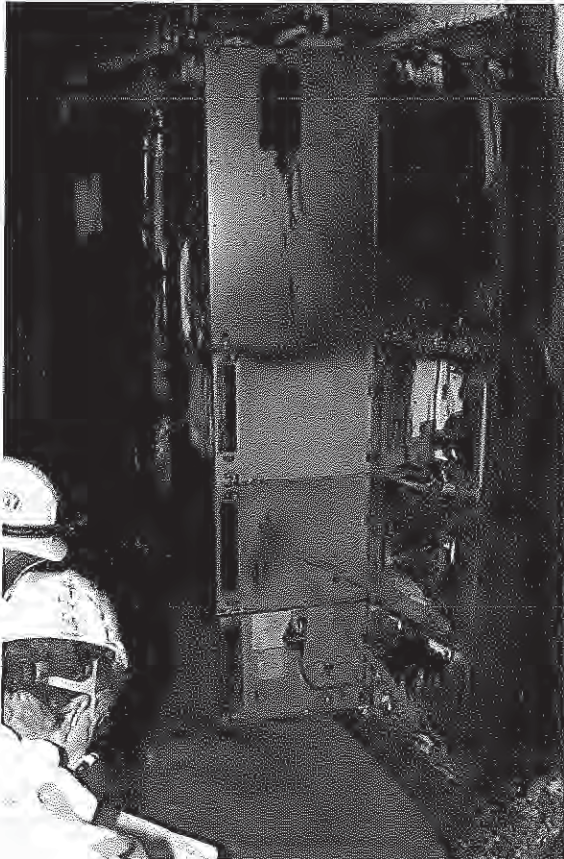
Photograph M4

Looking at cabinets 10-11 (top) to 10-14 (Bottom).

Note: the condition of cabinets 10-12 to 10-14 as compared to 10-11.

Note also: wood dust can be seen in the bottom two cabinets (arrows).

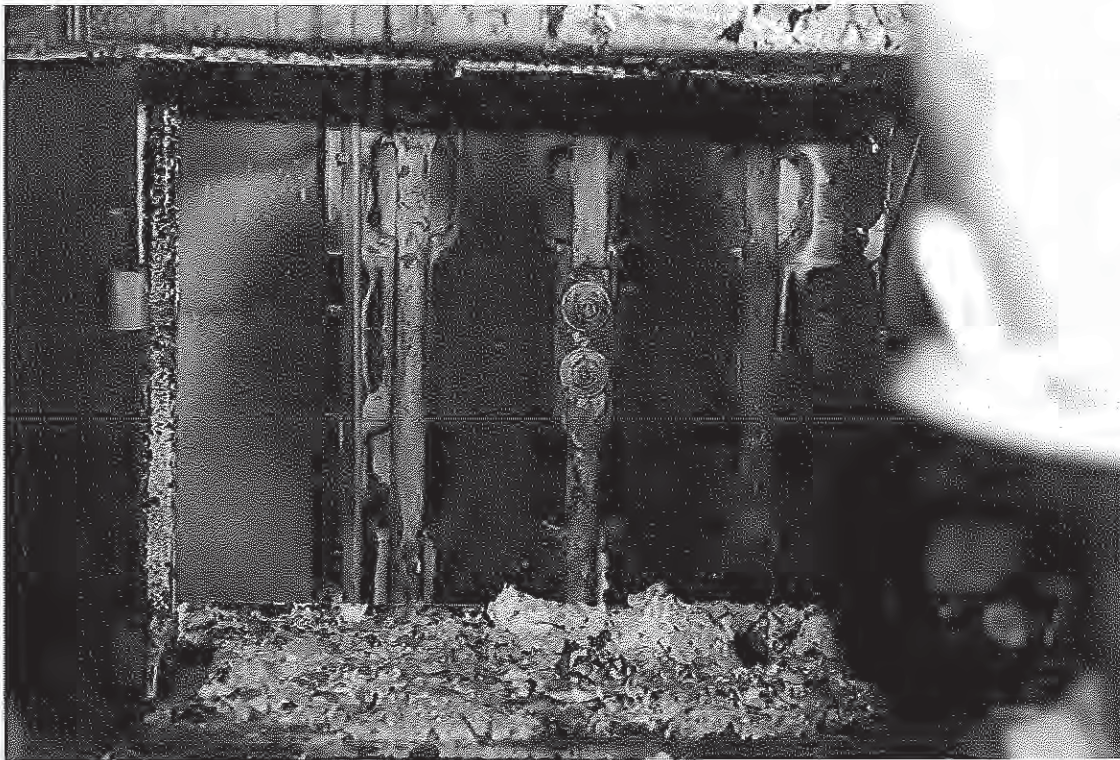
Photograph M5

Looking at the interior of cabinet 10-32.

Note: the extensive burn damage.

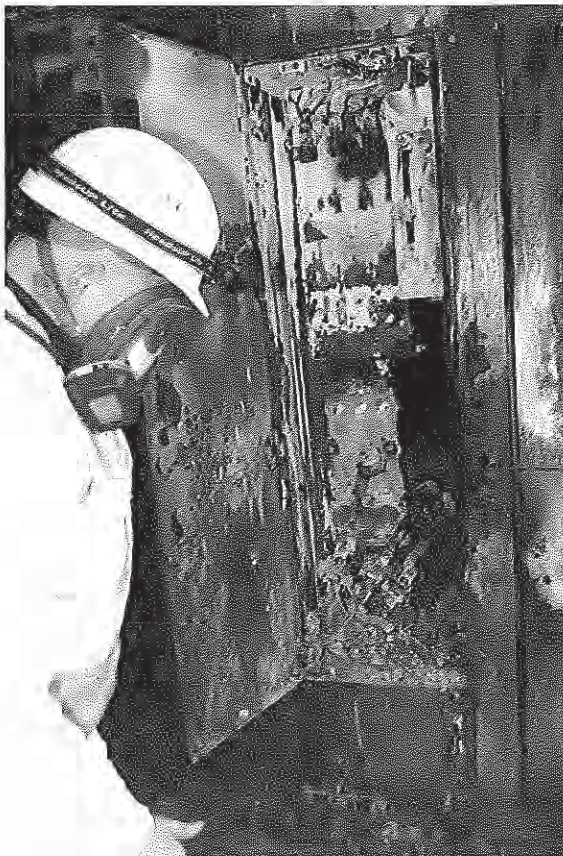
Photograph M6

Looking at cabinet 10-41

Note: when the door of this cabinet was opened the contents fell out.

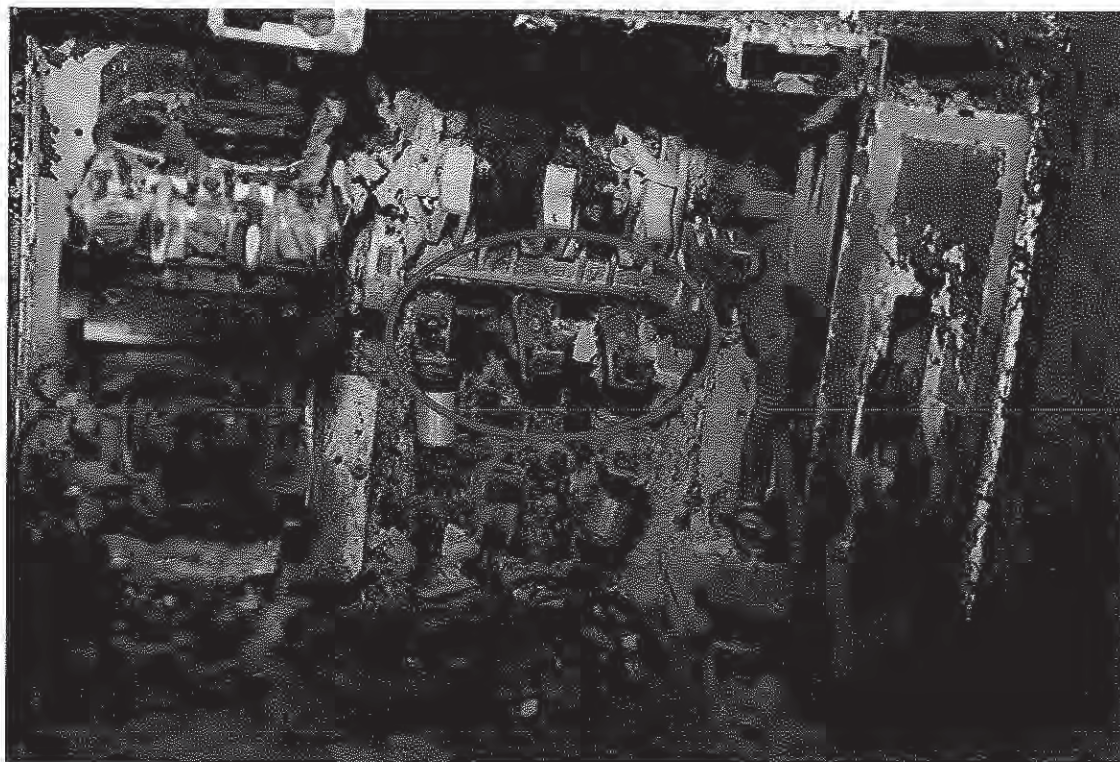
Photograph M7

Looking at cabinet 10-42.

Note: the interior of the cabinet was completely burned and the tops of the fuse holders were pushed out toward the front of the panel (circle).

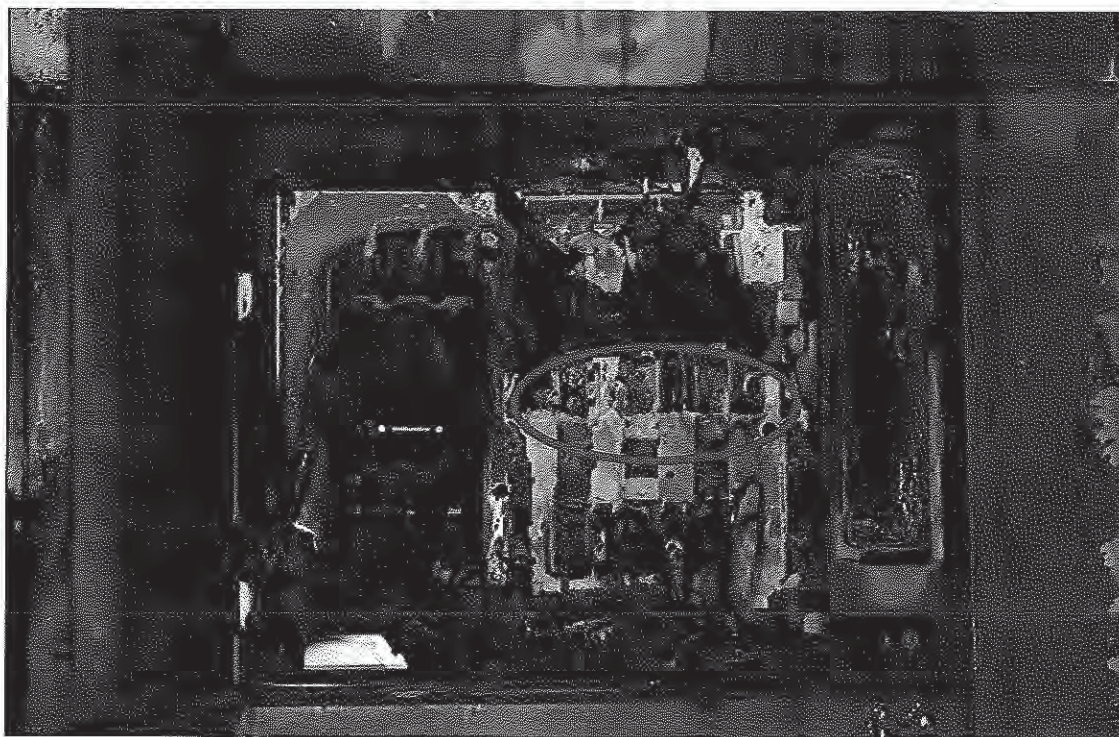
Photograph M8

Looking at cabinet 10-51.

Note: the interior of the cabinet was completely burned however all components were present; also the fuse holders (circle) were separated from the base.
