INCIDENT INVESTIGATION REPORT

| Notice of incident number 2012161980018 | Date of incident January 20, 2012 | Location of incident 19479 Highway 16 East Burns Lake, B.C. |
| Lead investigating officer Paul Orr | Investigation file number 2012-0013 | Incident outcome FATAL (2) INJURY (20) |

| Employer | Name and address | Employer ID | Industry classification |
|---|---|---|---|
| | Babine Forest Products Limited 19479 Highway 16 East Burns Lake, BC V0J1E0 | 328321 | 714022 Sawmill |

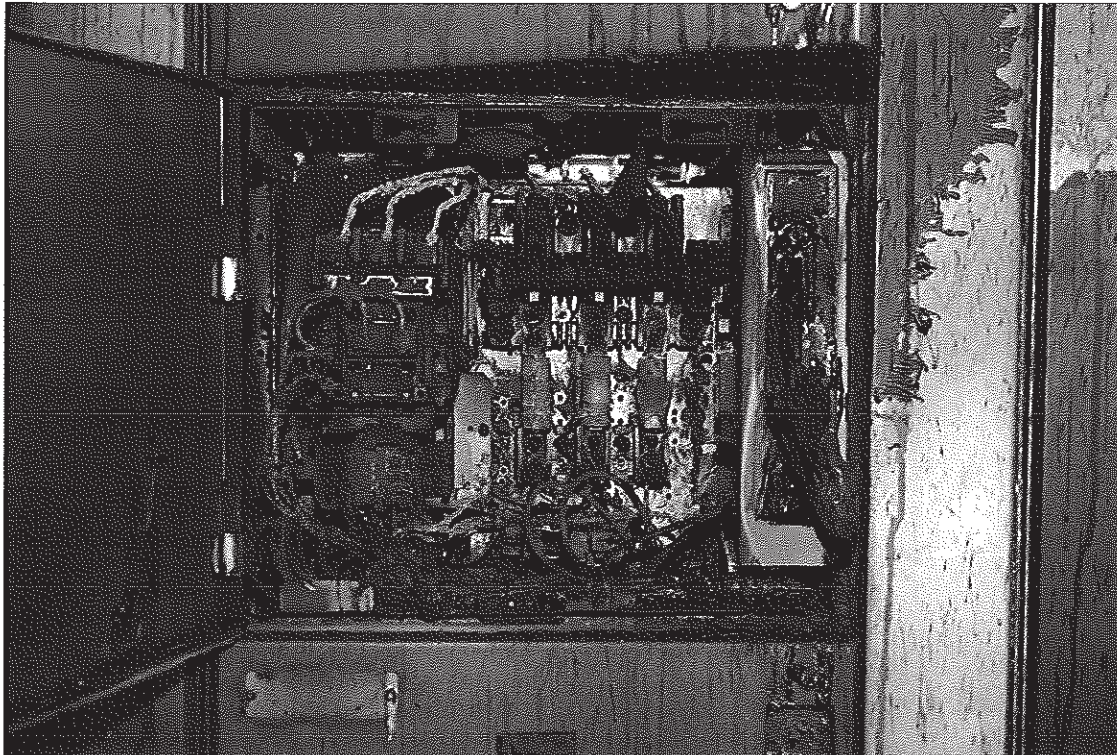
Photograph M9

Looking at cabinet 10-52.

Note: the condition of this panel was slightly less damaged than cabinet 10-51.

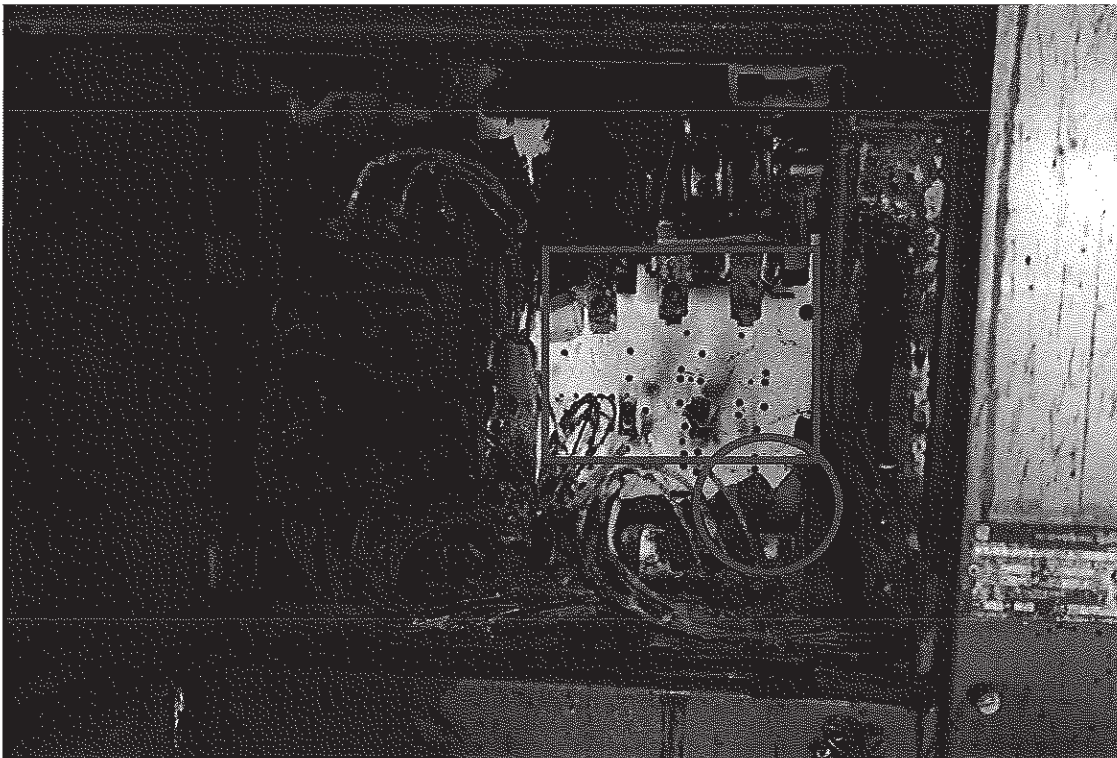
Photograph M10

Looking at cabinet 10-53.

Note: in this cabinet the fuse mountings were destroyed (rectangle), two fuses were present (circle) and one fuse was missing.

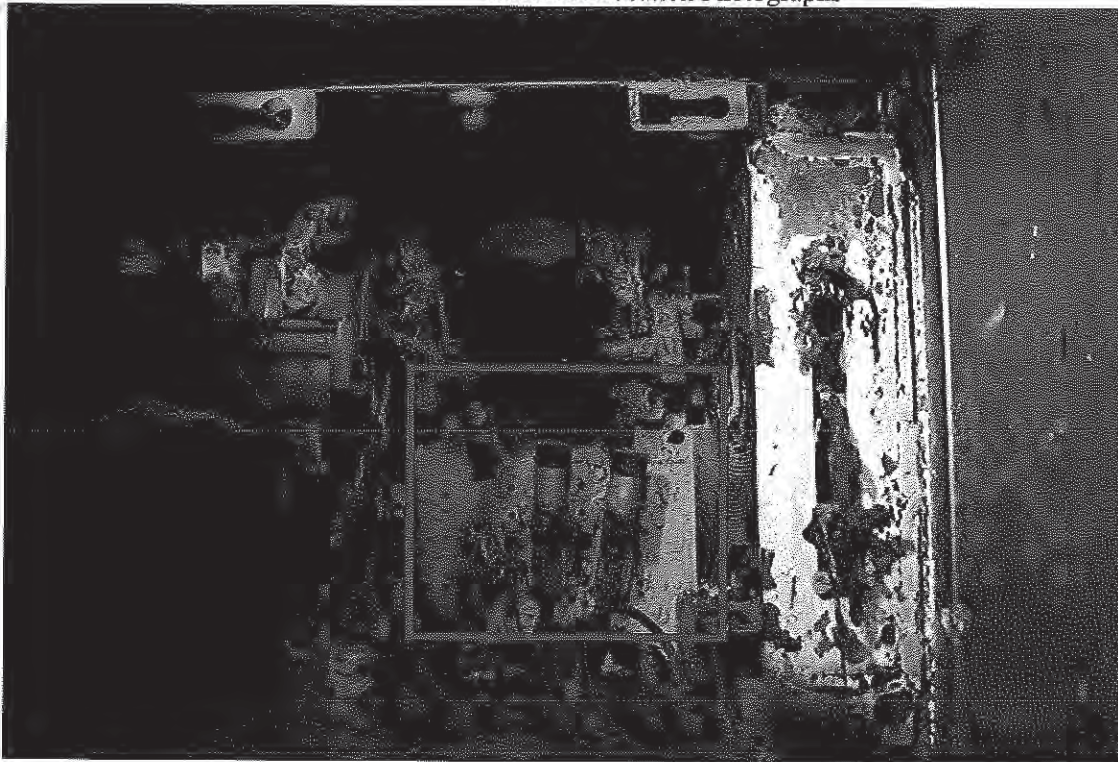
Photograph M11

Looking at cabinet 10-54.

Note: the interior of the cabinet is heavily damage and the fuse holders are disrupted (rectangle).

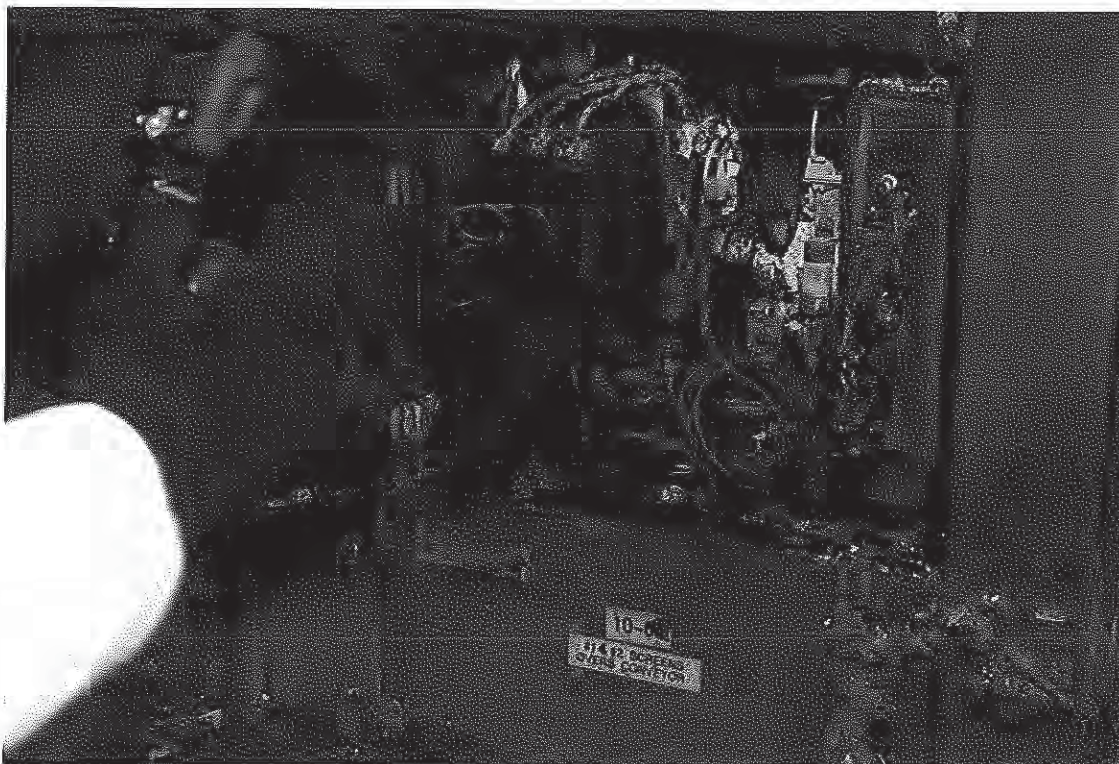
Photograph M12

Looking at cabinet 10-55.

Note: as with the previously shown cabinets the interior of this one was heavily damaged.

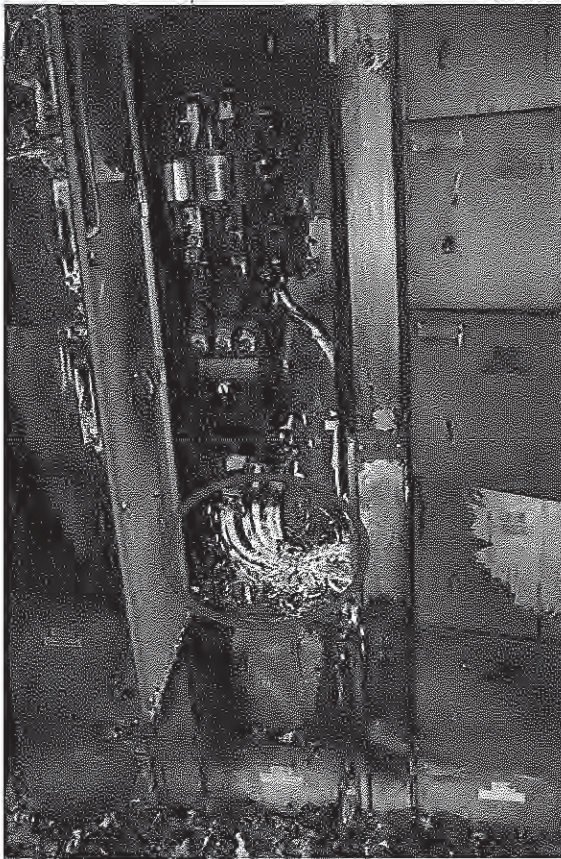
Photograph M13

Looking at cabinet 10-61.

Note: damage to this cabinet was primarily at the bottom (circle).

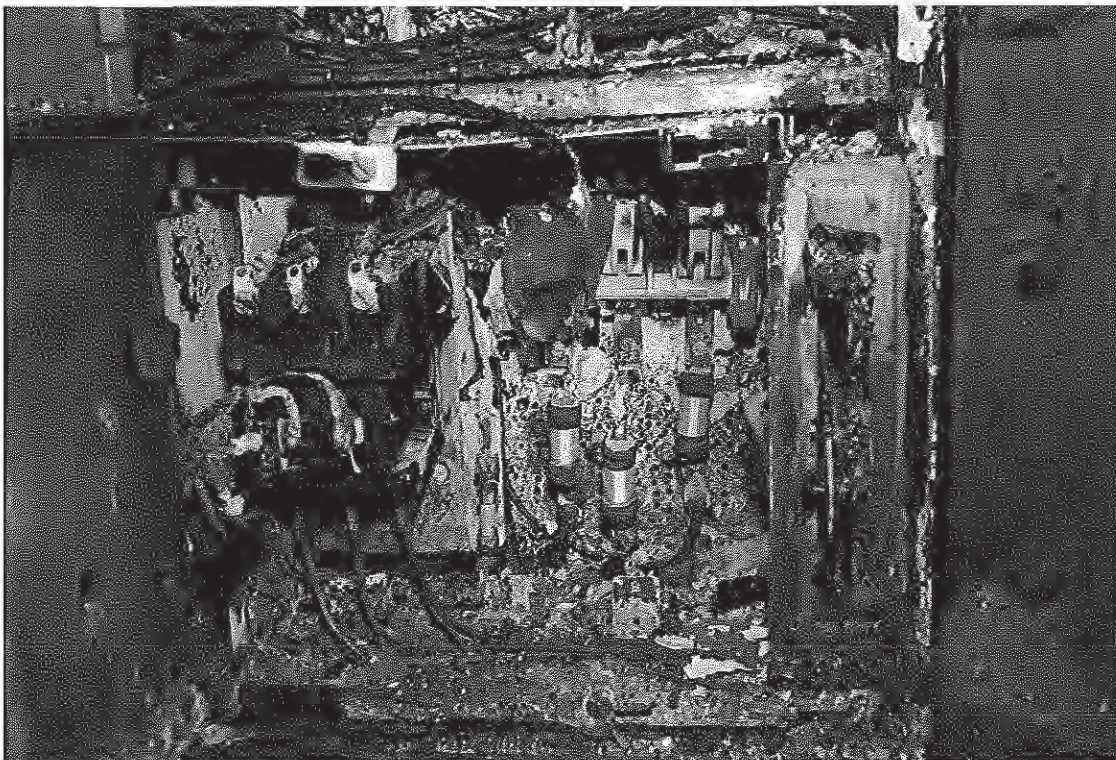
Photograph M14

Looking at cabinet 10-62.

Note: damage to this cabinet coincides with the damage to the bottom of cabinet 10-61.

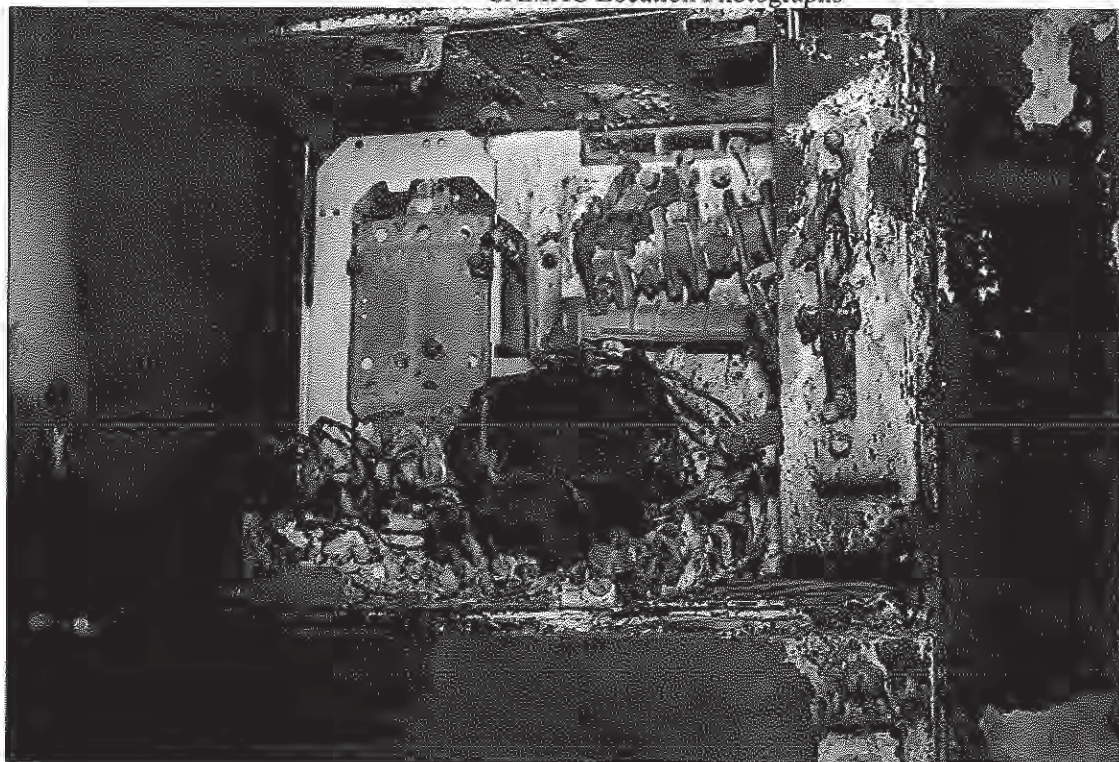
Photograph M15

Looking at cabinet
10-71.

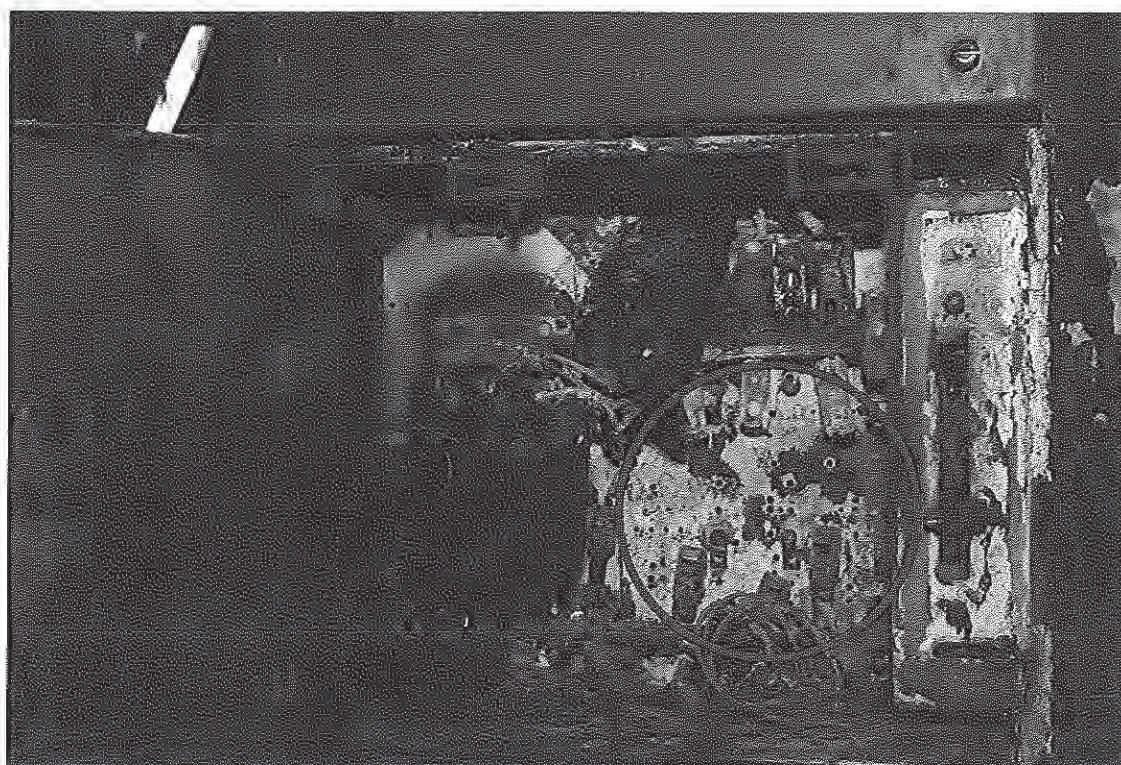
Photograph M16

Looking at cabinet
10-72.

Note: the extensive
damage and
destruction of the
fuse mounts
(circle).

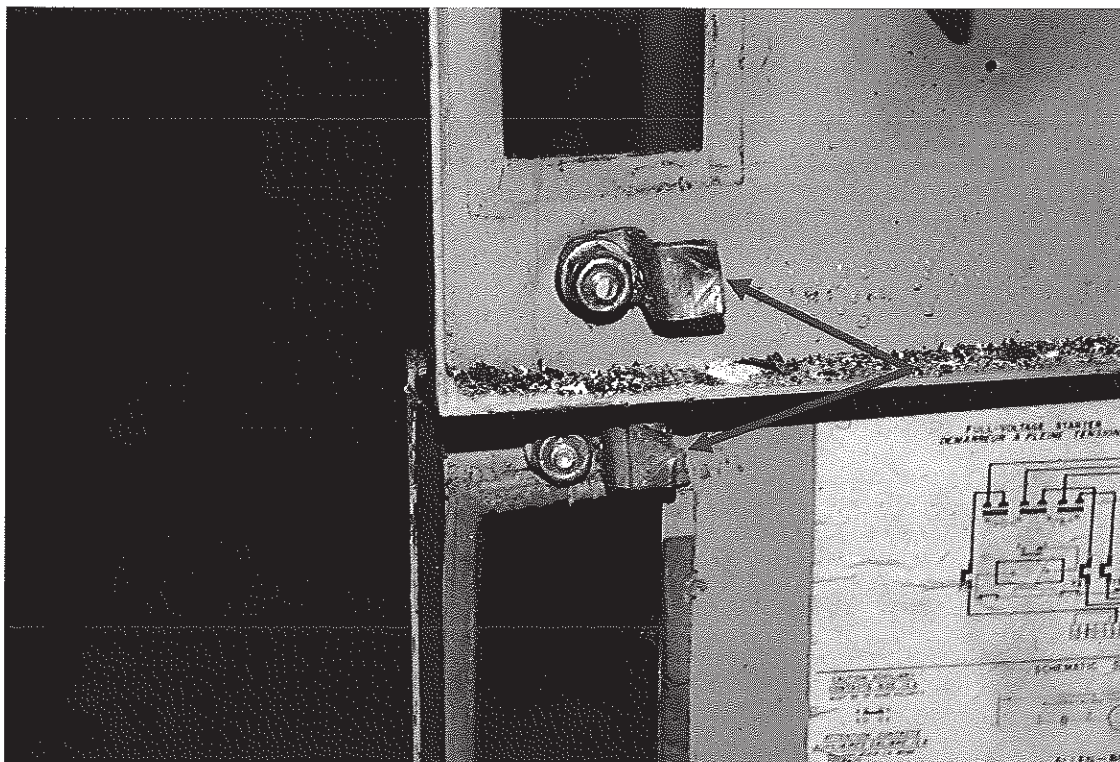
Photograph M20

Looking at the door latch bars on cabinets 10-12 and 10-13.

Note: the V shape of the latch bars (arrows).

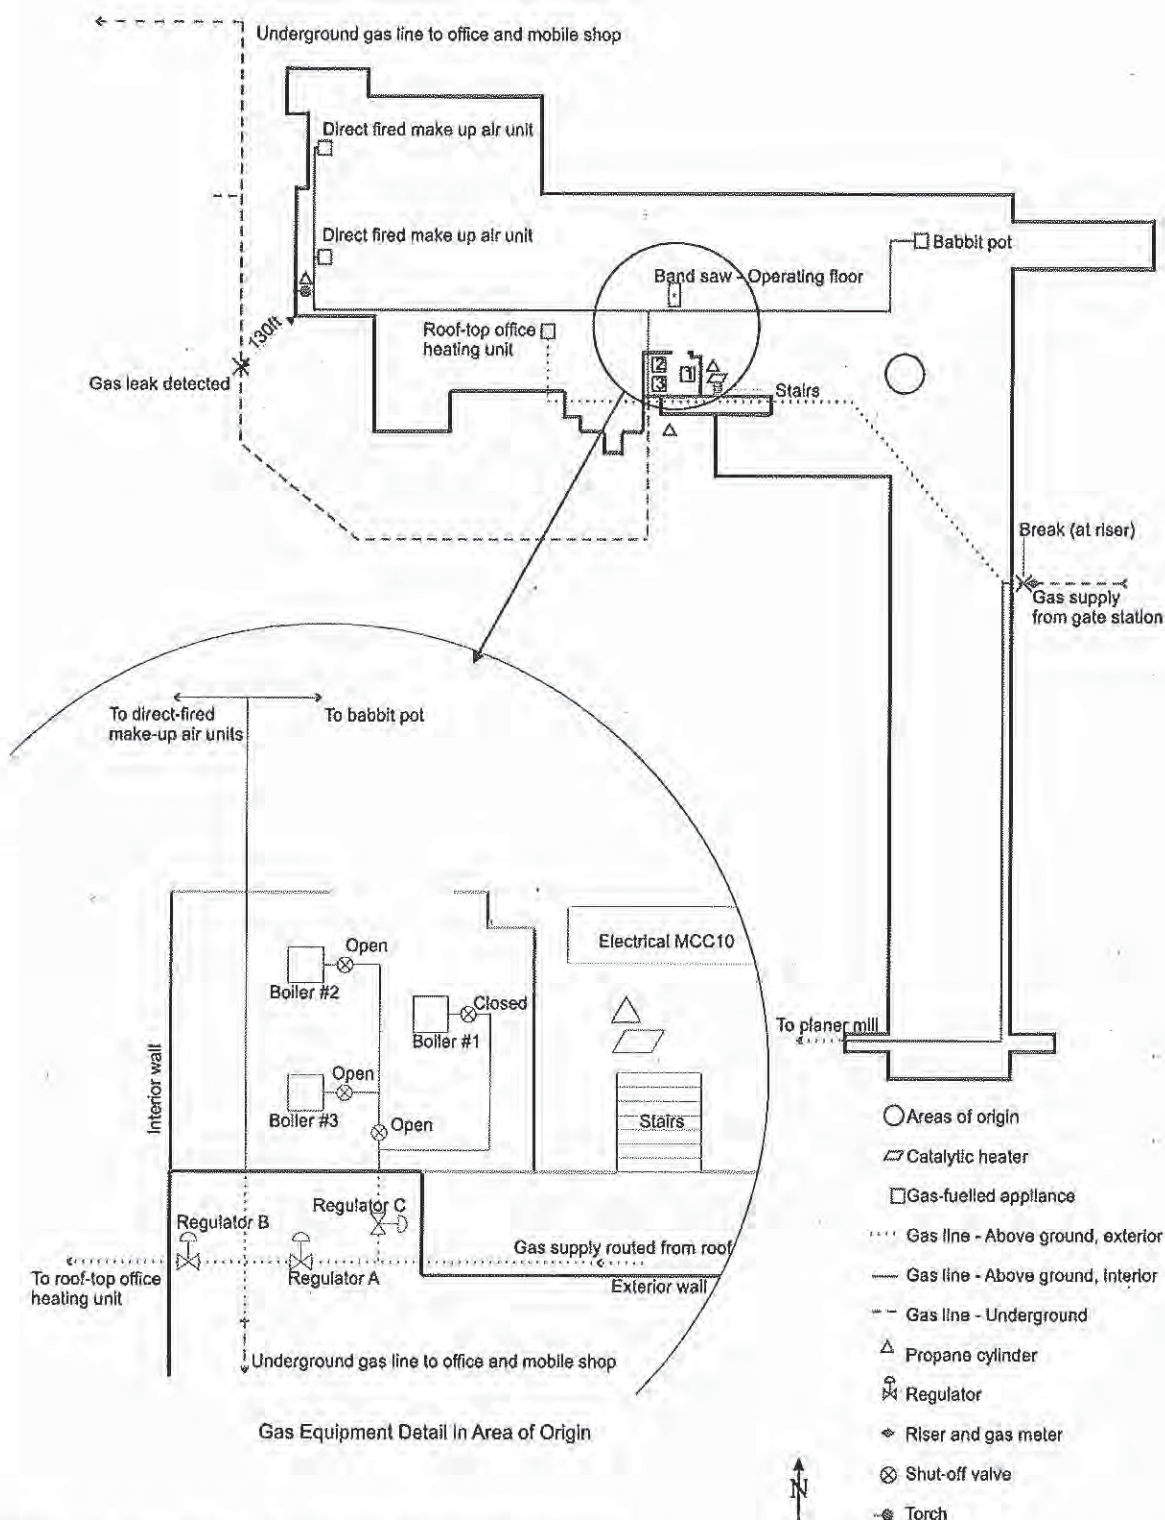
Figure B1: Plan view of mill - gas system and equipment

Underground gas piping outside of the sawmill was pressurized and tested for leaks. One leak was detected west of the sawmill, approximately 40m (130ft) from the structure (and 150m (500ft) from the nearest potential area of origin) as indicated in Figure B1. The underground leak was found to be venting to the surface, next to a hydrant shed. The leakage rate was estimated in the field to have been approximately three cubic feet per hour. The investigation revealed no migration paths into the sawmill structure other than through atmosphere.

This natural gas leak did not supply a combustible fuel mixture to the area of origin in the sawmill basement.

Gas regulator assemblies installed on the outside wall of the sawmill, near the area of origin as shown in Figure B1, were found destroyed or severely damaged.

Although near the area of origin in the basement under the band saw, the regulators were installed outside of the sawmill structure. There was no evidence suggesting a possible leak from a regulator assembly prior to the incident. Any leakage from a regulator assembly prior to the incident would likely have been vented to outside atmosphere as there were no likely migration paths into the sawmill from this location. The location of the regulators against the outside wall of the area under the band saw exposed them to the effects of the explosion. The explosion probably caused the regulator assembly damage.

The natural gas supply line was found broken at the riser location, outside of the sawmill along the east wall approximately four feet above ground as shown in Figure B1.

The sawmill gas supply riser travelled directly from the riser to the roof outside of the east wall of the sawmill. A leak at this location would be vented directly to atmosphere. During interviews, witnesses stated that the sawmill roof was lifted several feet in the air by the explosion which could have applied a vertical force to the natural gas supply pipe at the riser location.

It is unlikely that a natural gas leak at this location could have supplied a combustible fuel mixture to the areas of origin in the sawmill basement.

It is likely that the explosion caused the break in the natural gas supply pipe at this location.

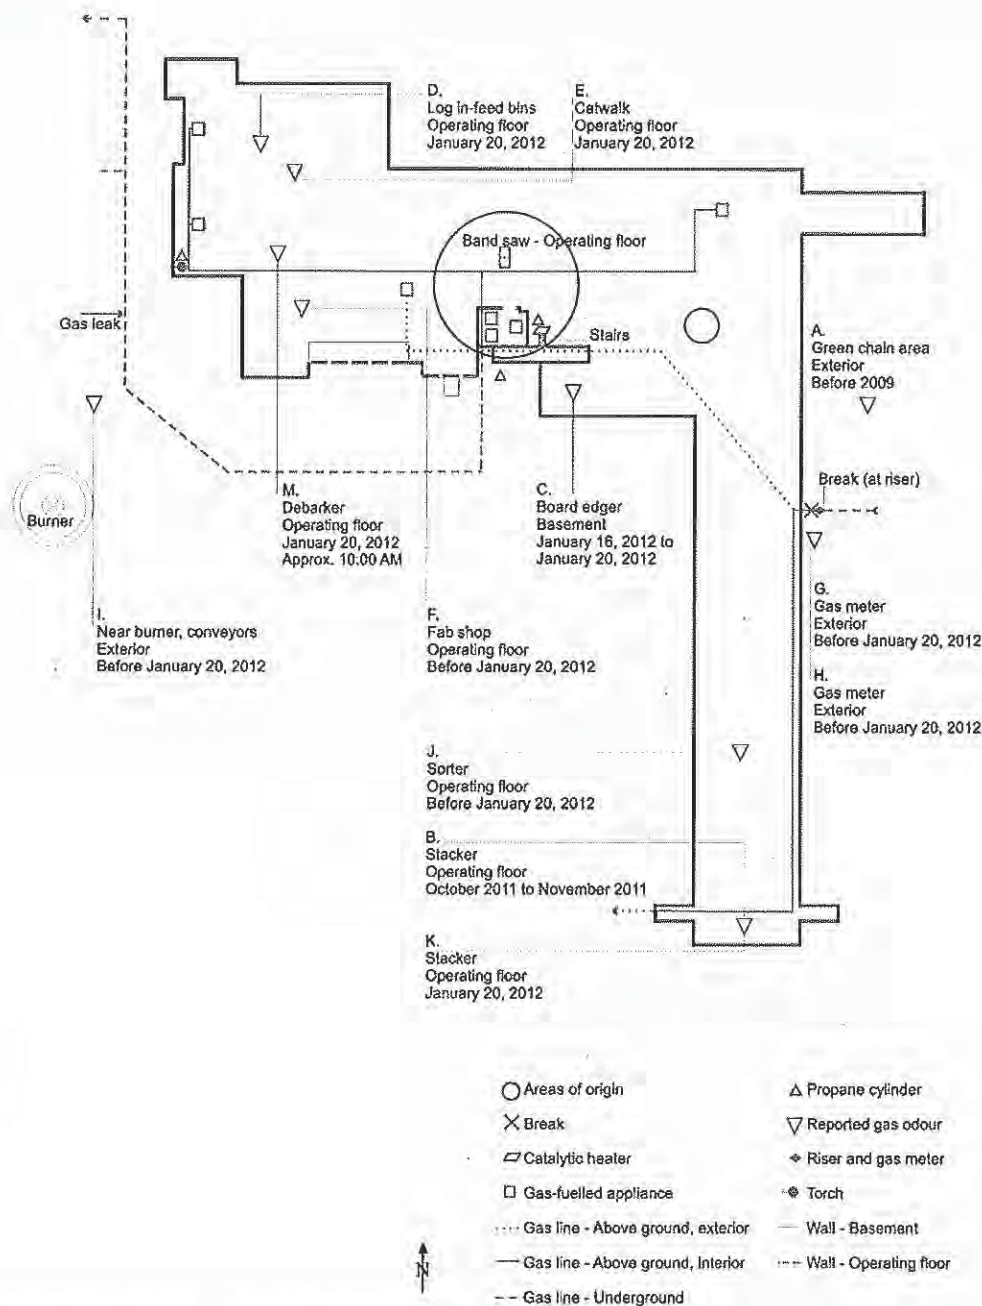
Figure B2: Plan view of mill - gas odor reports from interview statements

During interviews, twelve employees reported smelling a gas like odor at the sawmill before or on the date of the incident. A total of 46 employees stated they did not notice any gas odors prior to or on the day of the incident. Figure B2 represents the general areas associated with these odor reports.
