A	<p>Licensee/ Tenure Holder: THOMPSON CREEK MINING LTD.</p> <p>BAG 4001 FRASER LAKE BC V0J3A0</p> <p>Operator/Contractor: THOMPSON CREEK MINING/ SCOTT M In Attendance: James Smith/ Tony Carrol/ Chris Parks/ Clayton Gross/ Julie Orban/ Scott Morrison/ Andrew Chewter</p> <p>Compliance Summary Comments: Inspection of the Thompson Creek/ Mt Milligan Project was conducted by the EAO staff as well as FLNRO C&E staff to inspect for compliance with Mt Milligan, EA certificate and EMP's and CEMP's. Plans used to assist in the inspection criteria were the Table of Commitments, the EMP, and the CEMP as well as spill and prevention and contingency plan, sediment and erosion control plans.</p> <p>6.34 Archaeological and cultural heritage resource management plan main objectives are identify, record and assess any of these features with-in or adjacent to the project. There was no other features found on location other than the pre-identified j-3/GgRs-5 which had low impact and required no mitigation. The proponent has done a Archaeological Impact Assessment pre construction 2007 and has managed this requirement.</p> <p>6.3.3 Air Quality Management Plan has been developed to protect and manage a

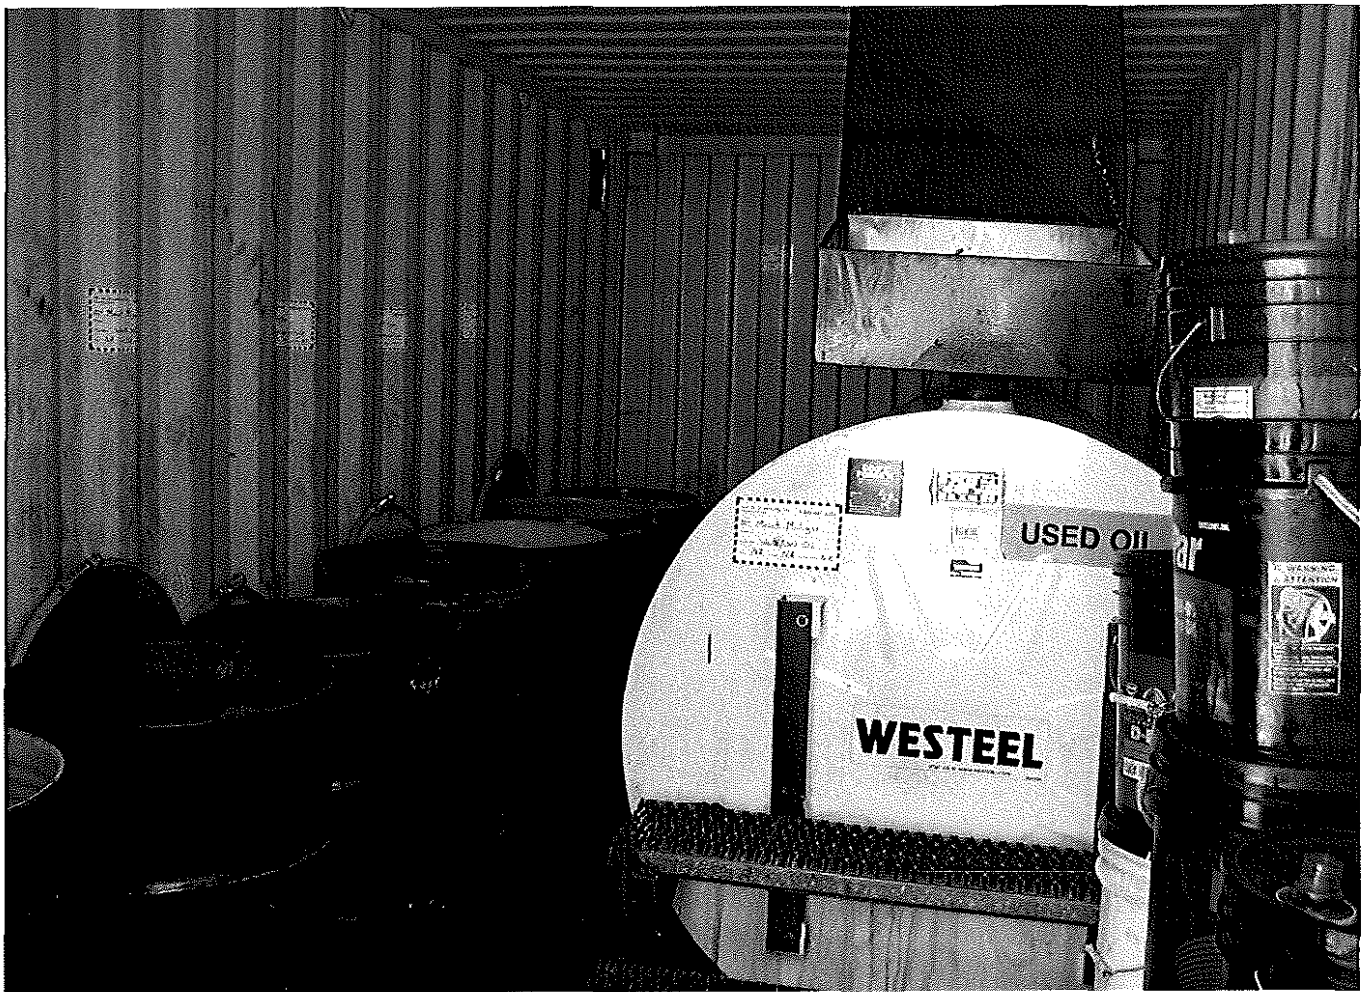
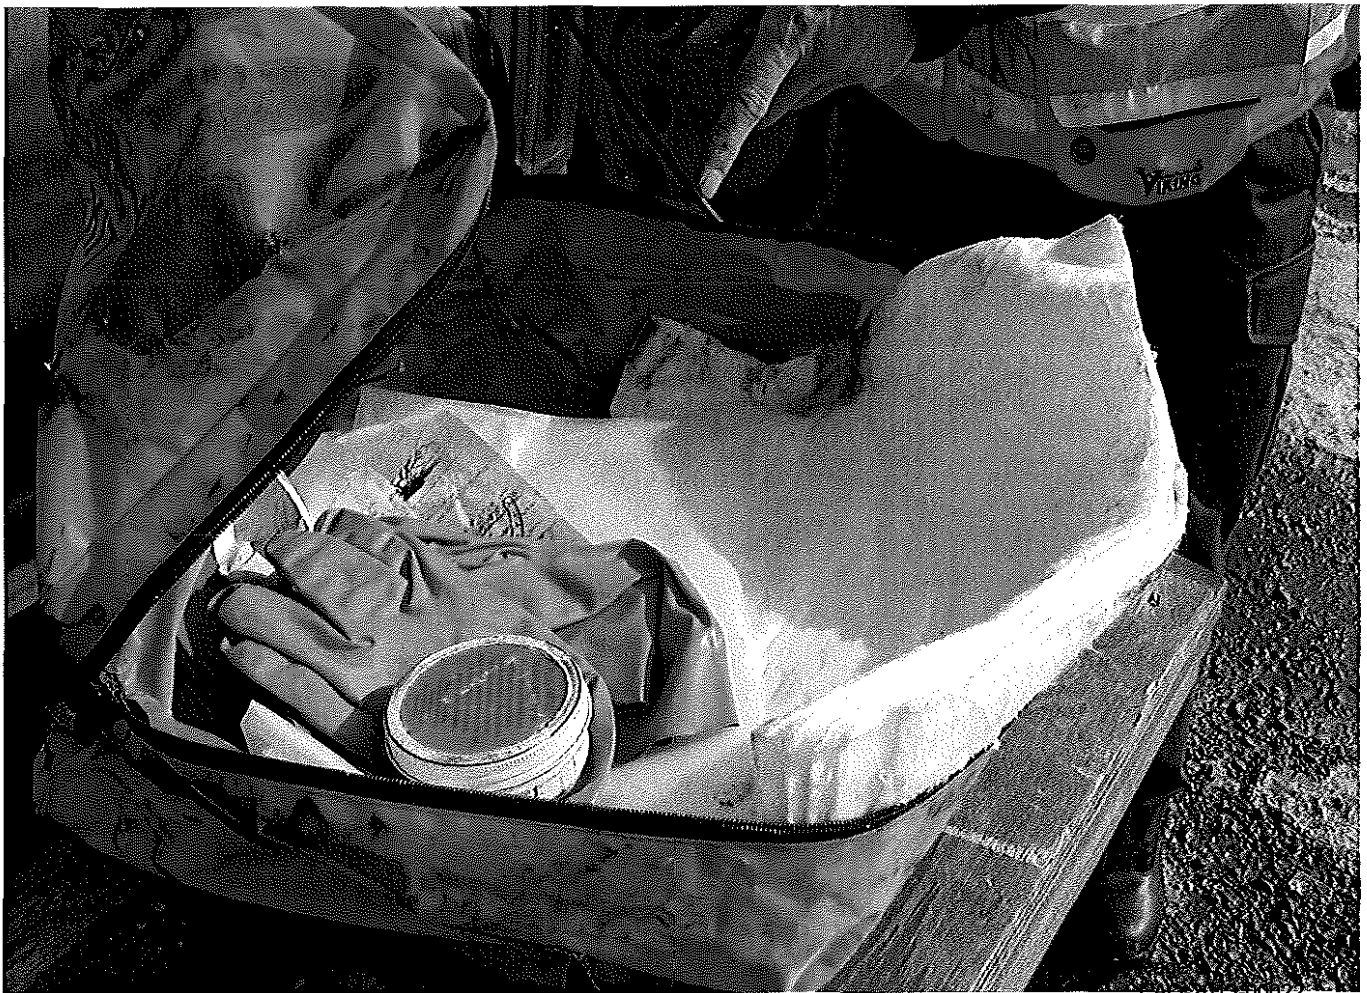
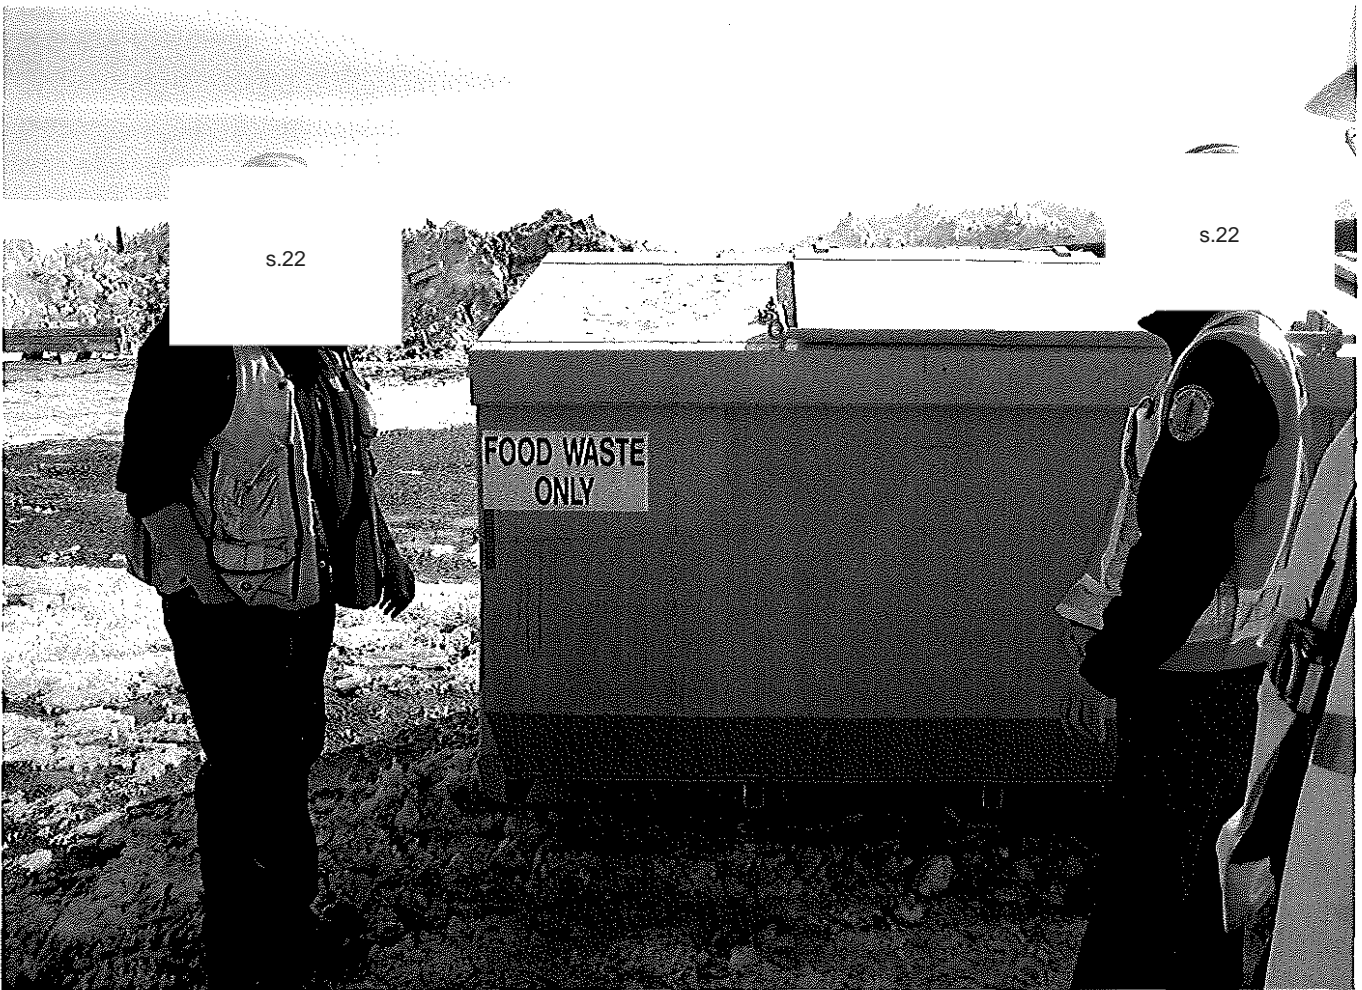
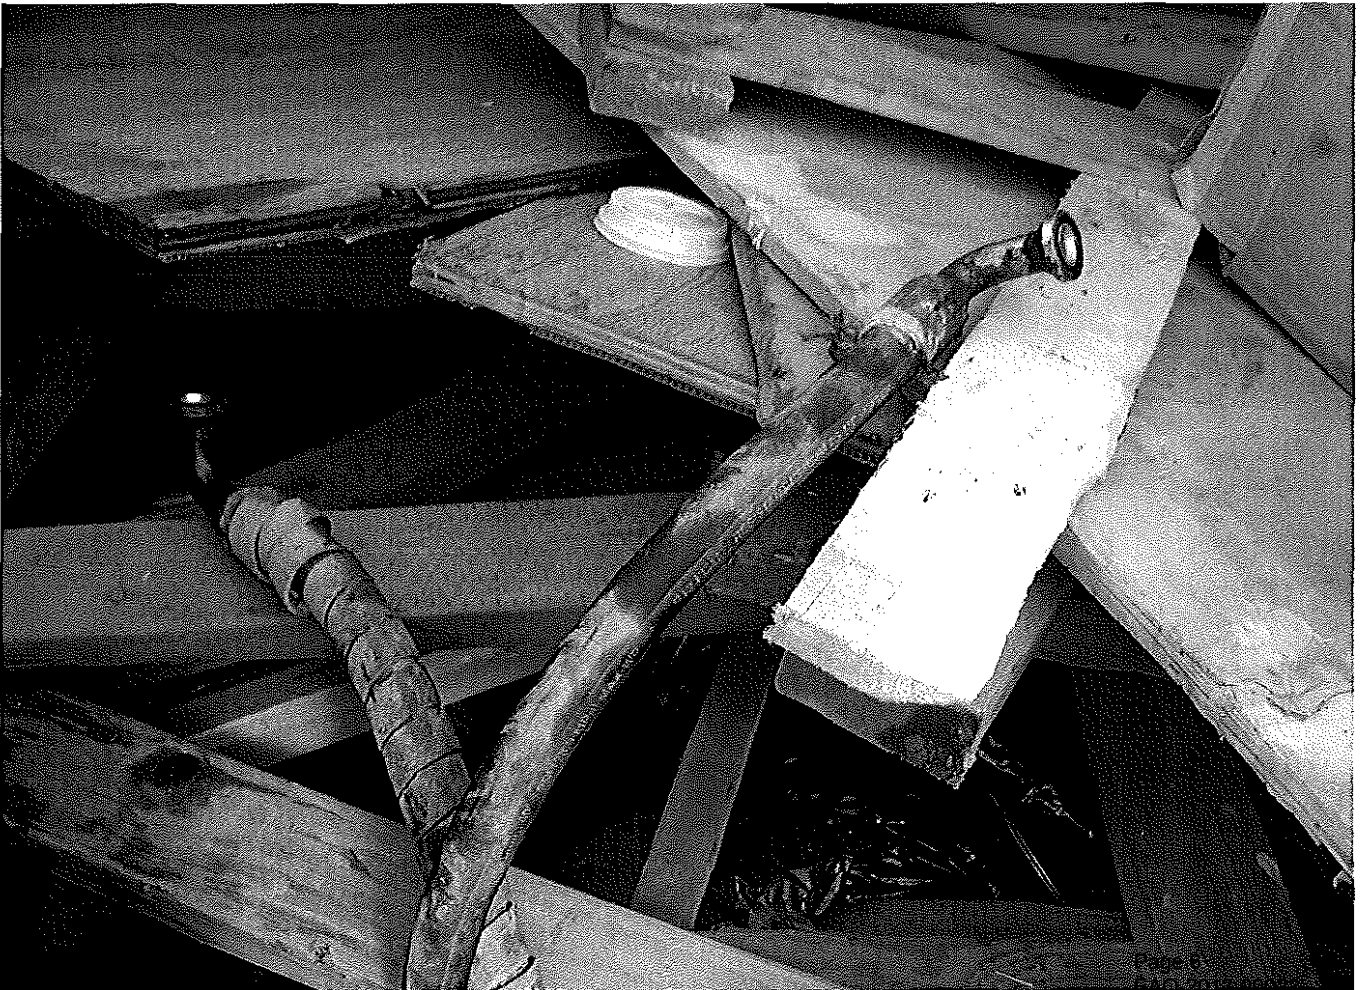
These kits are to be stored in a visible location, weather resistant container and regular inspections of the kits are to be preformed. In most parts the proponent was in none non-compliance with this as kits were hard to find if found at all by their staff, were left open and were wet and dirty and contaminated, and do to the fact so many kits were incomplete i am sure no regular inspection of the kits were done.

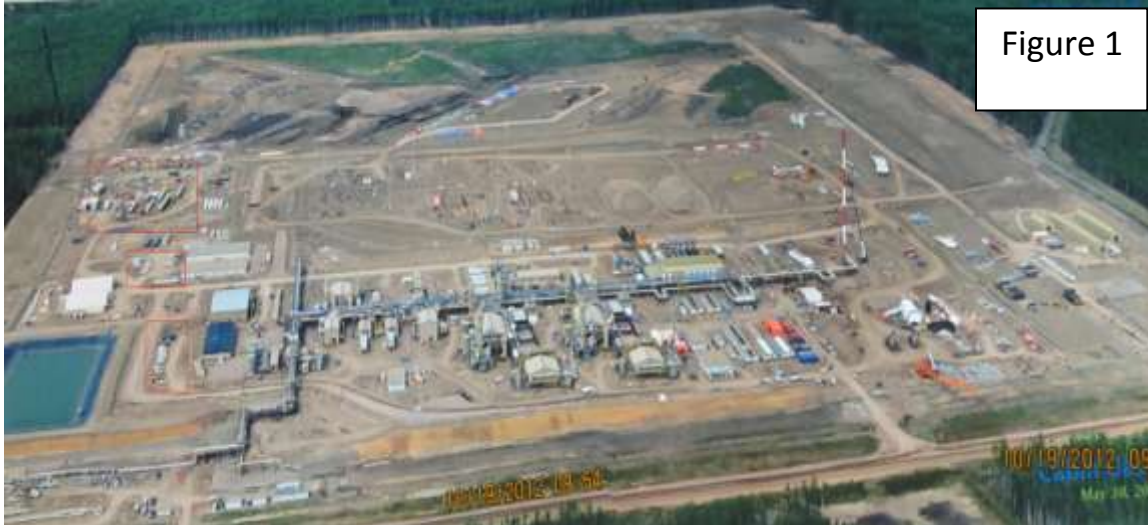
Figure 1 is an air photo from spring 2012. It accurately shows the designated parking areas as of the inspection date. The three locations for parking are marked by red boxes on the air photograph. The upper left area identifies the location of the maintenance shop and heavy duty equipment parking area. This area is surfaced with compacted gravel. Center left in figure 1 is the office parking currently surfaced with wood pallets. Lower left is the location of the permanent plant parking. This last area is surfaced with compacted gravel. These areas are identified on the Cabin Gas Plant Key Sketch Map. (See: Appendix I photos 320, 325, 326, 327, 328, & 384). (See: Appendix II Key Sketch Map and Appendix III Permanent parking detailed construction map),

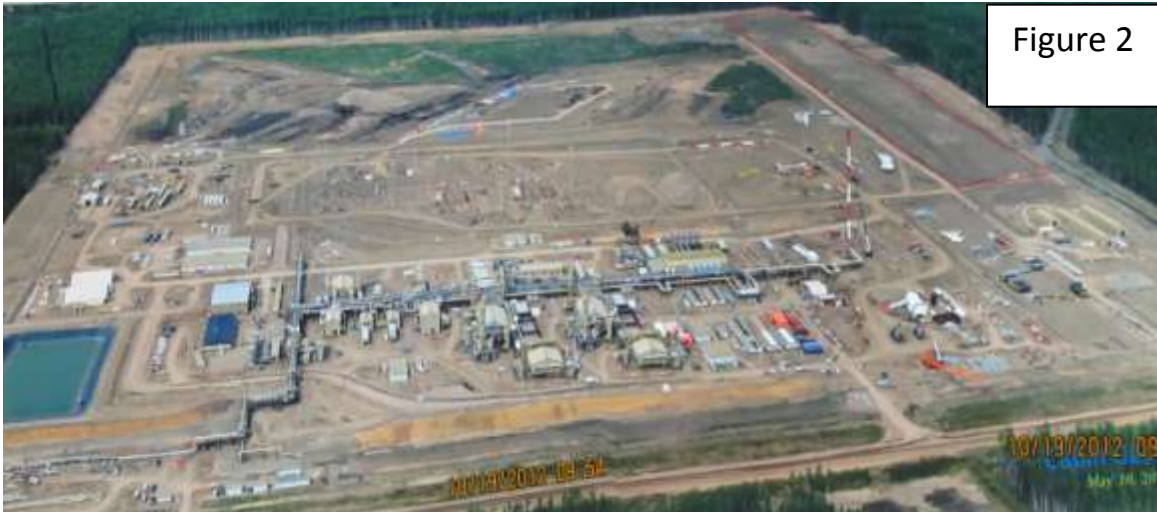
Figure 2

The stockpile is in place and located according to the Cabin Gas Plant Key sketch map. Some topsoil appears to be incorporated in the berm that extends around the perimeter. This could not be confirmed due to a light snow cover and frozen ground. The undeveloped area also appears to have many temporary spoil piles that may have a topsoil component. When the subject of the spoil material was brought up with EnCana supervisory staff, it was mentioned by Ron Langlois Co-site Manager that this material is to be used as fill for an onsite pit. There is also a low area that will need to be filled in. The present stockpile appears to be at maximum capacity.

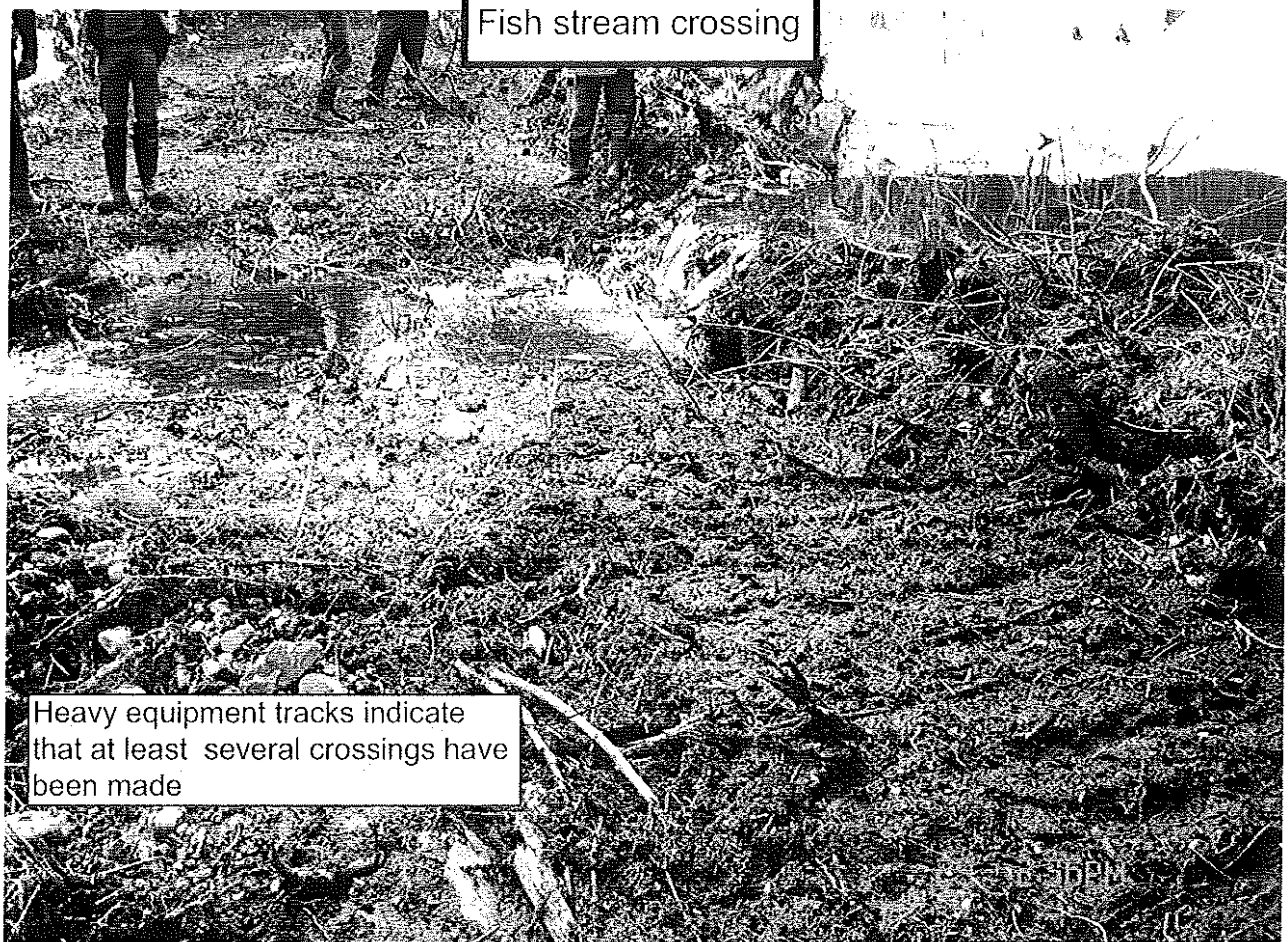
Heavy equipment tracks indicate that at least several crossings have been made

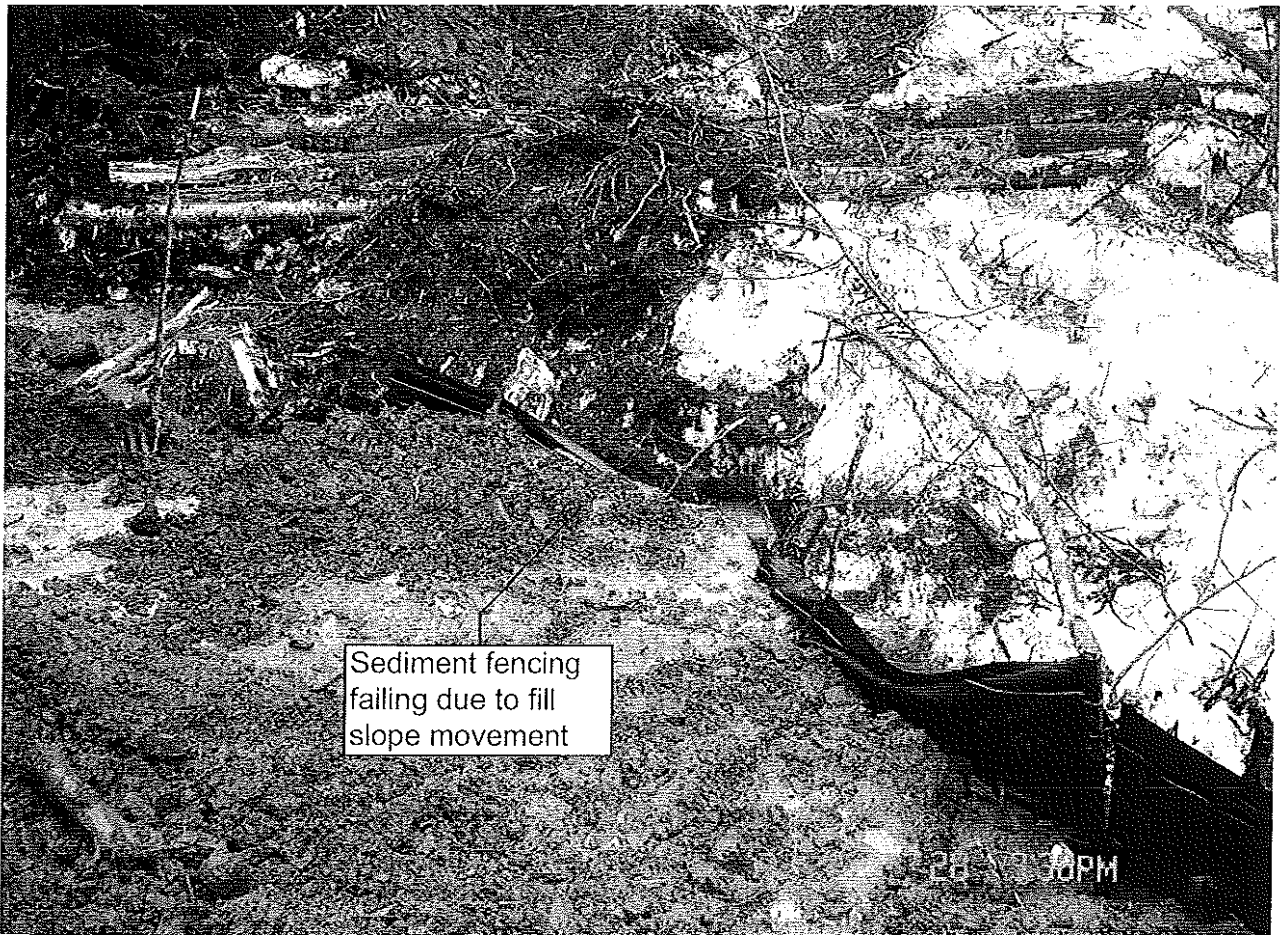
Sediment fencing failing due to fill slope movement

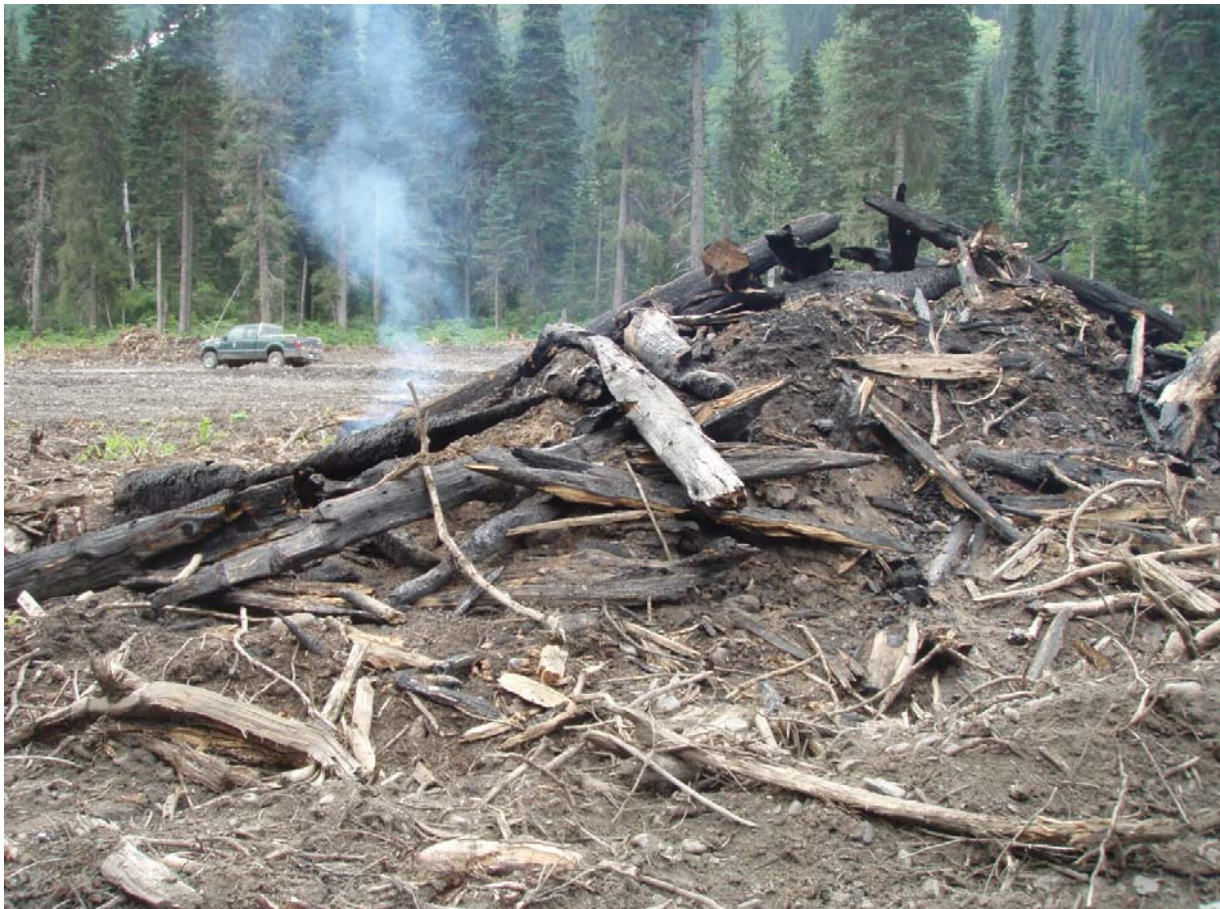
Debris piles located on roads 310 & 311 continued to smoulder during a prohibition. The piles were lit prior to the prohibition issued by the Wildfire Management Branch. On July 23rd the Valard company reps were aware of the fires and were monitoring the piles attempting to extinguish with water. On July 24th aerial flight showed that the partially burnt debris piles were still smoking. On July 27th instructions were given to Gord Piddock to have the piles completely extinguished. The NTL project was in contravention of sec 10(3) of the Wildfire Act.
