BRIEFING NOTE

- Update on the explosions and fires at the Babine Forest Products mills at Burns Lake
Not Responsive

- In November 2012, WorkSafeBC completed its investigations into the explosion on January 20, 2012 at the Babine Forest Products Company in Burns Lake
Not Responsive

This incident investigation report sets out WorkSafeBC's analysis and conclusions with respect to the cause and underlying factors leading to the workplace incident of January 20, 2012, at the Babine Forest Products Limited sawmill located at 19479 Highway 16 East in Burns Lake, British Columbia. The purpose of this report is to identify and communicate the findings of this incident to support future preventive actions by industry and WorkSafeBC.

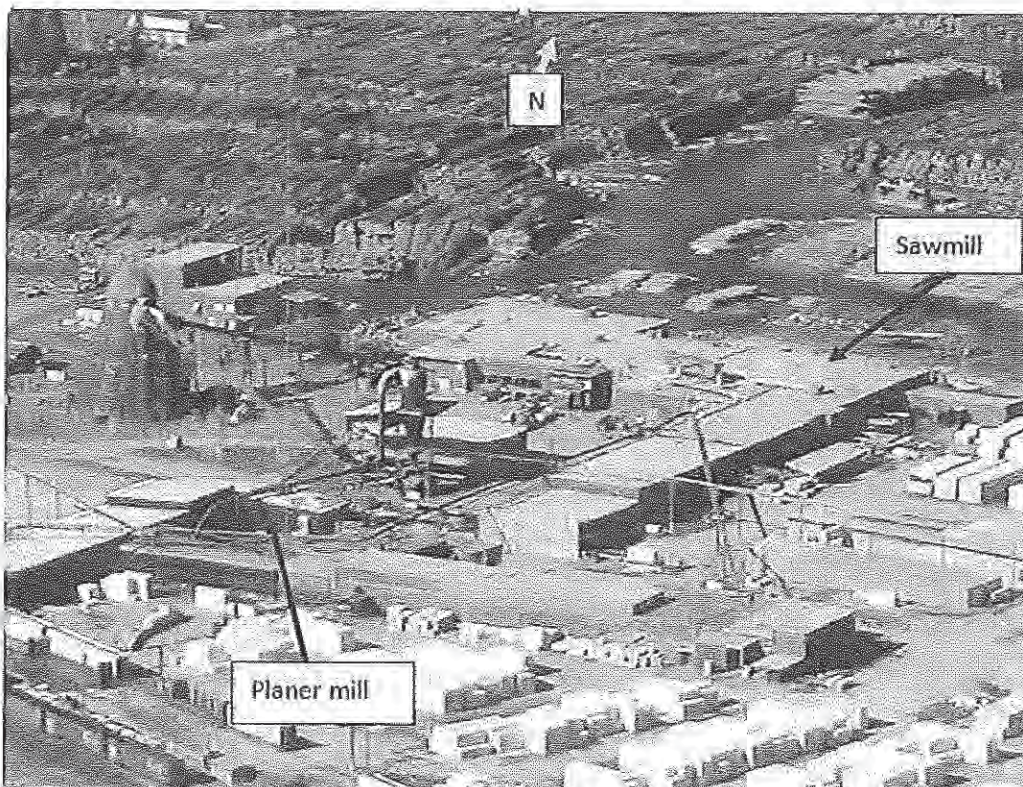
Figure 1: The Babine Forest Products sawmill prior to the incident.
Source: Babine

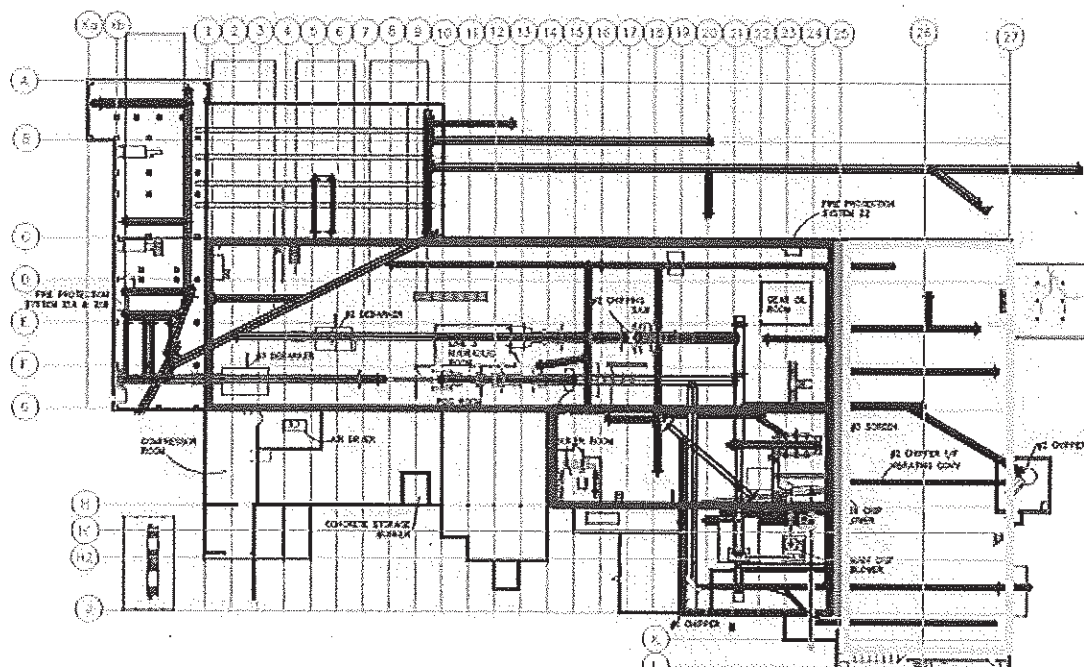
Beneath the sawmill's main operating floor was a full basement with a total depth from floor slab to ceiling of approximately 14 feet (an additional 8 foot below the half-basement level). The full basement and half-basement were divided by the full basement's concrete wall running north to south from C-25 to J-25 (Appendix 4). This is shown in Figure 3.

Figure 3: Detail from Appendix 4 showing the sawmill basement levels. The red outline indicates the full-basement; the yellow outline indicates the half-basement referred to in this report. The basement dividing wall is shown in green. North is the top of the drawing.

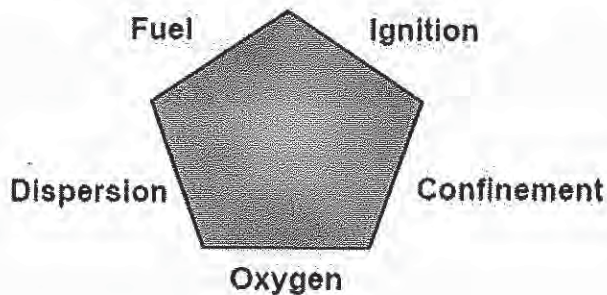
Figure 25: The dust explosion pentagon.

There is no doubt that a dust explosion occurred at the Babine sawmill on January 20, 2012. It is likely that the hazardous situation had arisen at the sawmill many times previously, perhaps in many areas of the sawmill, without incident because one or more of these five components was absent. On the day of the incident, however, all components were present and the explosion occurred.

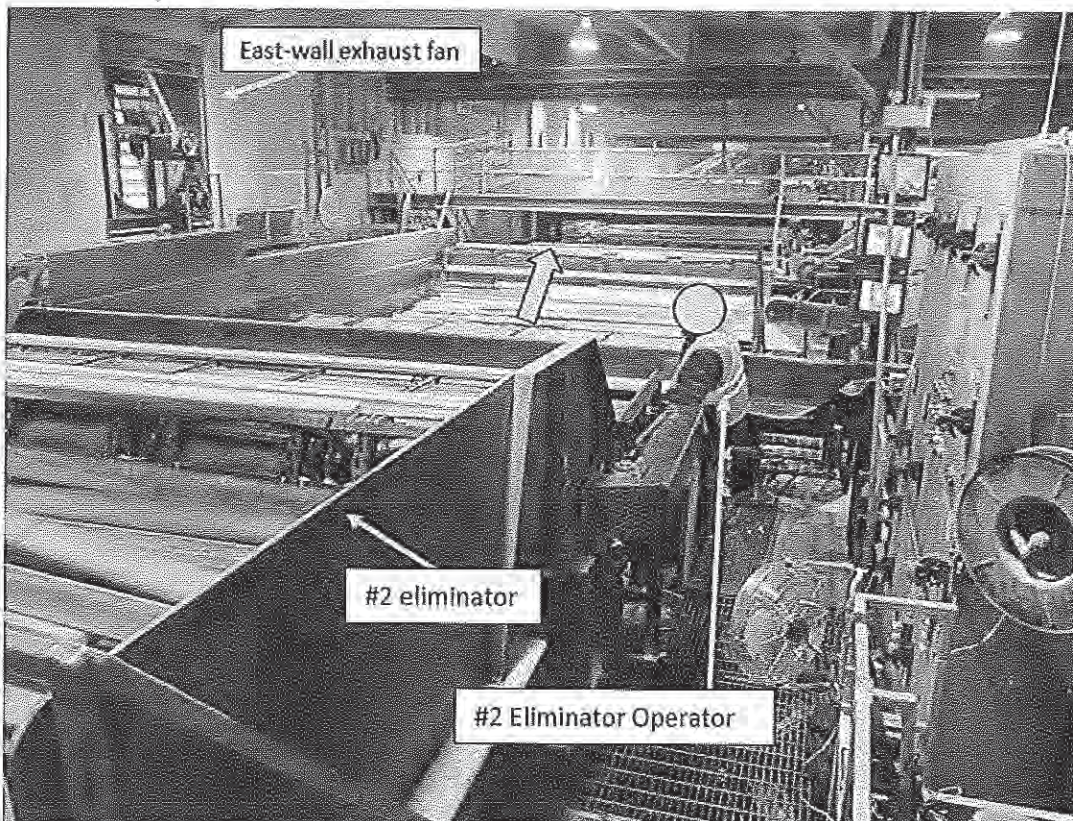
The #2 Eliminator Operator stated that he felt a strong rush of air and heat from behind and saw flames after feeling the shock wave. The explosion pressure beneath the eliminator tables vented through the walkway grating directly into the #2 Eliminator Operator's work area, approximately 30 feet to the northeast on the operating level (Figure 31). The bent grating is shown in Figure 32 and the path of the explosion in Figure 33. The floor under the eliminator tables was clean of all debris and wood waste due to this explosion pressure as discussed previously.

Figure 31: The #2 eliminator position prior to the explosion. The large yellow arrow points south. (Photograph by WorkSafeBC, November 22, 2011.)

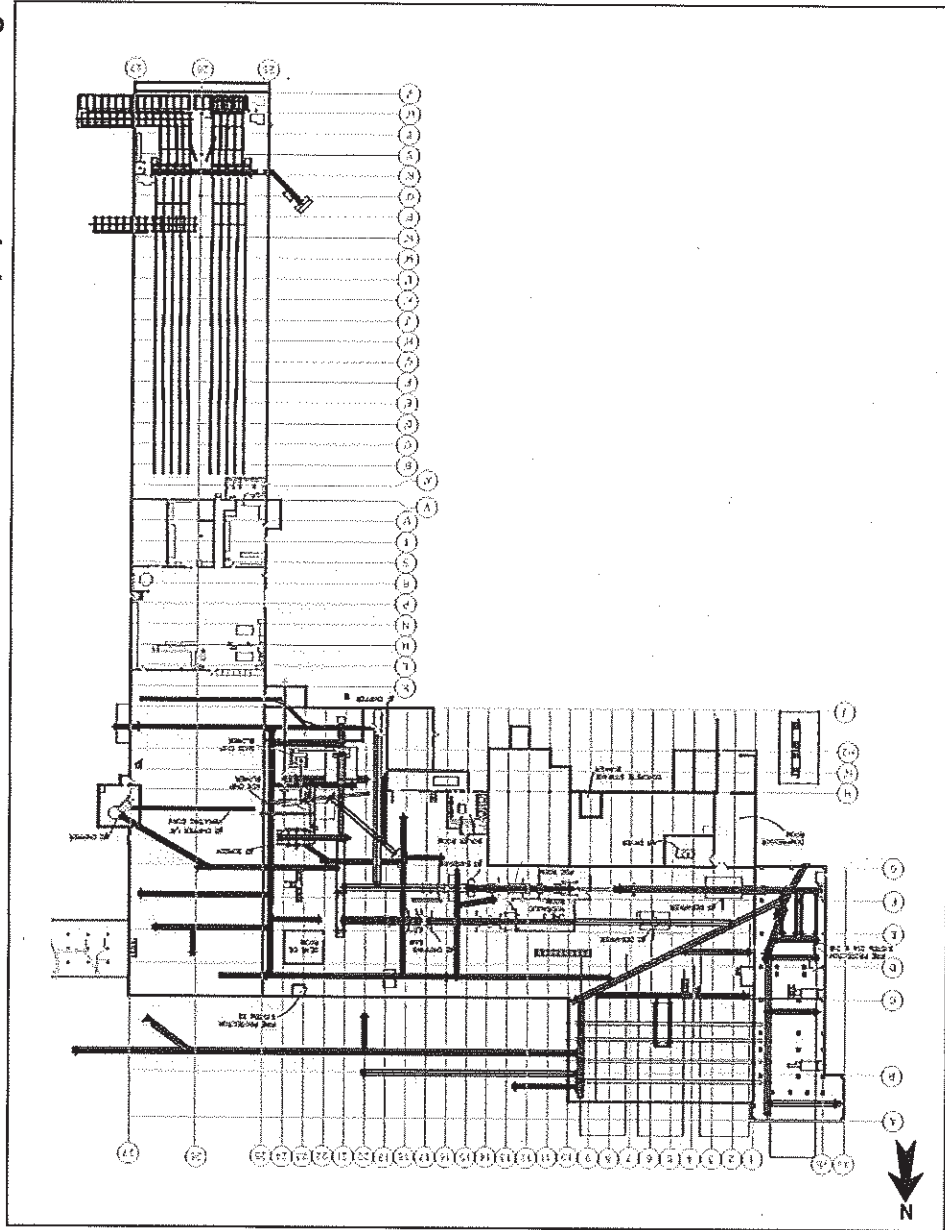
Appendix 4, Basement Level Drawing with Grid References and Equipment Labelling

Basement Attendant 1 was in the basement level trying to restart waste conveyor 2A-14 (approximately F-2, Appendix 4) when the lights went out and he was hit by the explosion pressure. He lost consciousness for a short period of time and awoke with his clothing on fire. He managed to escape out of the sawmill but suffered serious burn injuries.
