Bedwell River Trail

Ministry of Forests
South Island District

Traverse & Trail Assessment

Central Westcoast Forestry Society
September, 97

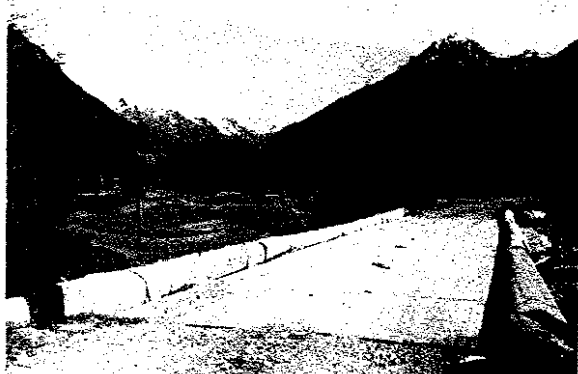
Fig. 1, Shot #6, pkg. #2

0+000 of tie point traverse The first photo below was shot from the opposite end of the bridge used to geo-reference the traverse. It shows the bridge, estuary and the start of the road at the landing where hikers begin their journey along this trail. The second photo was taken about 100m further down the road, it shows the landing & dock at this bridge. Just barely captured, on the extreme right, is the mouth of the Bedwell River. *and Mt. Arden is in the background*

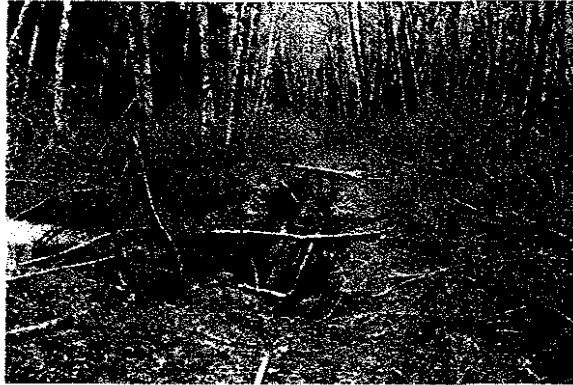
Fig. 7, Shot #24, pkg. #2

The two previous photos were taken from each end of this structure. The photo below was taken looking back down the trail and captures a glimpse of the creek on the left.

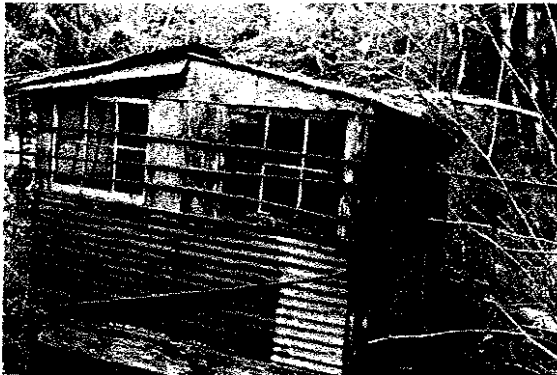
- 2+365.3 A road junction of two spurs to the right of the trail has potential to be developed as a camping area or for optional side trails. The potential may exist to extend these into the Ursus Creek Valley, but were never explored to determine this.
- 2+429.4 A spur leading to two small cabins approximately 100 m away beside the Bedwell river. They are believed to be the prospector's cabins of Mr. Walter Guppy who currently resides in Tofino. Several photos of these dilapidated cabins were taken, the two pairs below are two views of each cabin.

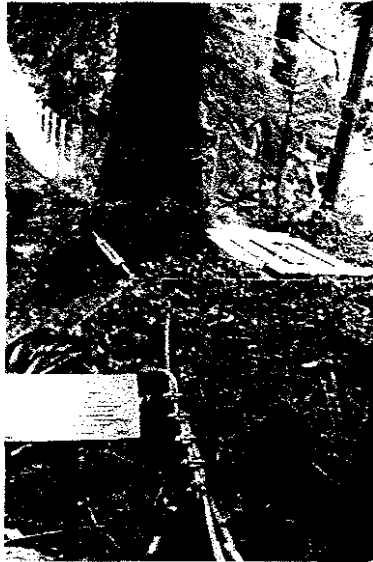
Fig. 25, Shot #14, pkg. #4

3+782.9 Memorial plaque at the Gayle McGee Bridge. The photo below is of this plaque and the bridge is partially shown beyond.
