Post-Crash Vehicle Inspection Report

2012-23079

04-20120514-043

Date: May 25, 2012

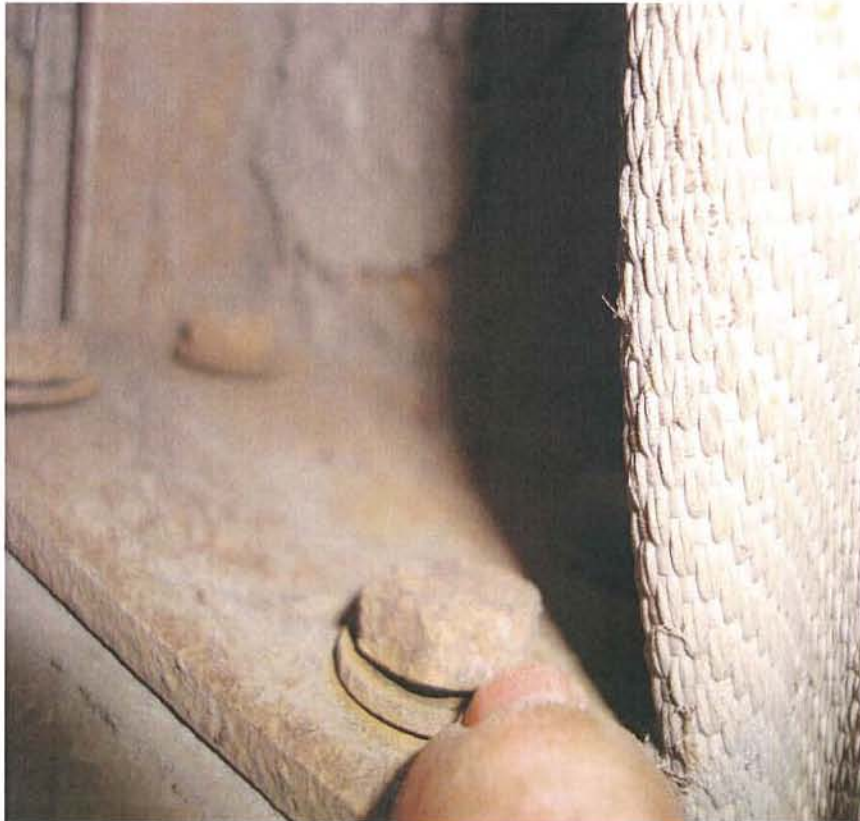
Unserviceable – Trailer #2 -numerous cracks in trailer frame, sub frame and cross members
- numerous loose body mounting bolts

- The rear spring pins and bushings on axle #1 were worn excessively (Div #7 Schedule #19).
- Trailer #2 had numerous cracks in frame, sub frame and cross members as well as loose body/frame bolts (MVAR Div #7 Schedule #11)

Photo # 16 – trailer #2 –loose frame bolts
