NOTICE OF EMERGENCY WORKS | SLOPE FAILURE AT MANTLE CREEK | LAFARGE COQUITLAM SAND AND GRAVEL, COQUITLAM, BC

SUPPLEMENTARY EMERGENCY WORKS, SLOPE FAILURE AT MANTLE CREEK LAFARGE COQUITLAM SAND AND GRAVEL, COQUITLAM, BC

COQUITLAM SAND AND GRAVEL PROGRESSIVE RECLAMATION 2013 REVIEW

COQUITLAM SAND & GRAVEL DAM INVENTORY

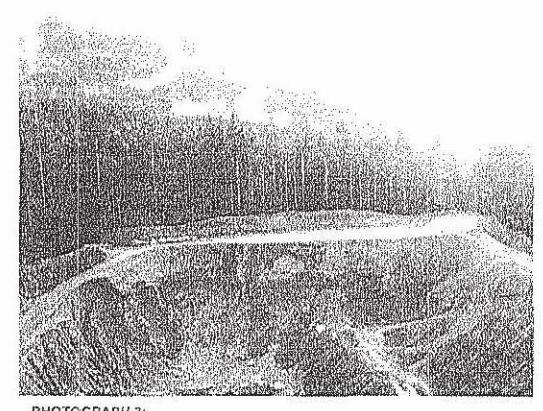
Lafarge excavated fine-grained soils from the plateau area located above the eastern pit slopes for use as impermeable cover material during reclamation of the upper reaches of the Fines Storage Area. After the excavation of the fine-grained cover material, this area was graded to promote drainage and hydro-seeded with grass seed (Figure A1 Photograph 3).

PHOTOGRAPH 3: GRADED AND HYDRO-SEEDED PLATEAU IN THE MAIN DIG SITE.

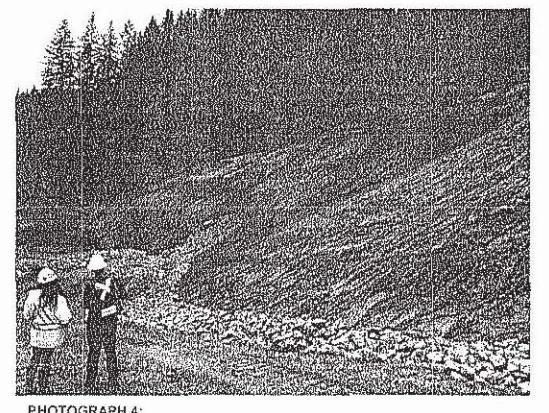
The upper (western) reach of the Red Bench Area was sloped, benched and hydro-seeded in 2012. A portion of the upper reach Red Bench area was planted with trees during 2013 as part of the Pilot Tree Planting Program. The lower (eastern) section of the Red Bench Area was sloped, benched and hydro-seeded in 2013 (Figure 1 and Figure A1 Photographs 4 and 5).

PHOTOGRAPH 4: GRADED AND HYDRO-SEEDED AREA WITHIN THE RED BENCH AREA.

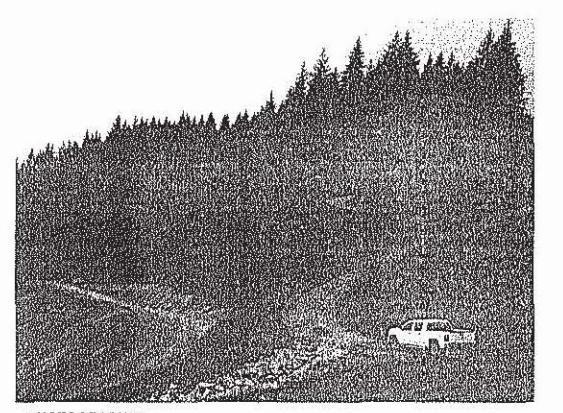
PHOTOGRAPH 5: PILOT TREE PLANTING PLOT WITHIN A PREVIOUSLY HYDRO-SEEDED PORTION OF THE RED BENCH AREA.

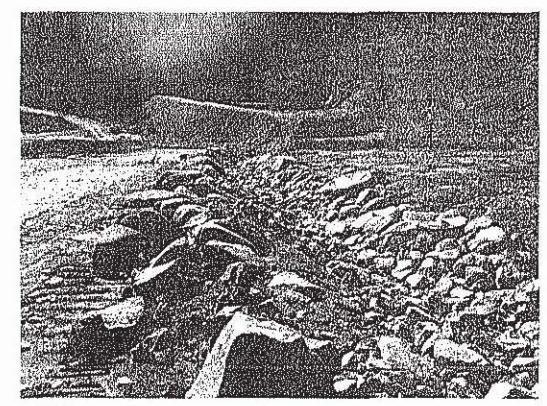
An eroded ditch located along the eastern edge of the Red Bench Area was re-established and armored with angular riprap in 2013 (Figure A1 Photograph 6).

PHOTOGRAPH 6: RE-ESTABLISHED AND ARMORED DRAINAGE DITCH WITHIN THE RED BENCH AREA.

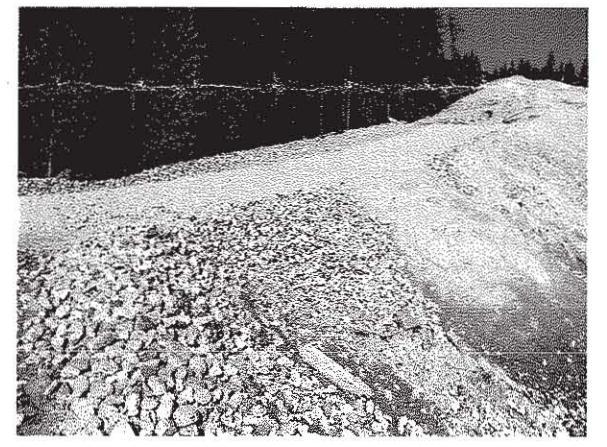
It was noticed that the main ramp towards the upper pit digging area has a drop off of more than 3 meters on both sides, did not have adequate shoulder barrier. This section of the haul road shall not be used until it is provided with adequate shoulder berms on both sides having a height of at least ³/₄ the height of the largest tire on any vehicle used on this road. The manager is reminded that the berms shall be maintained while this section of the road is used as a haul road.

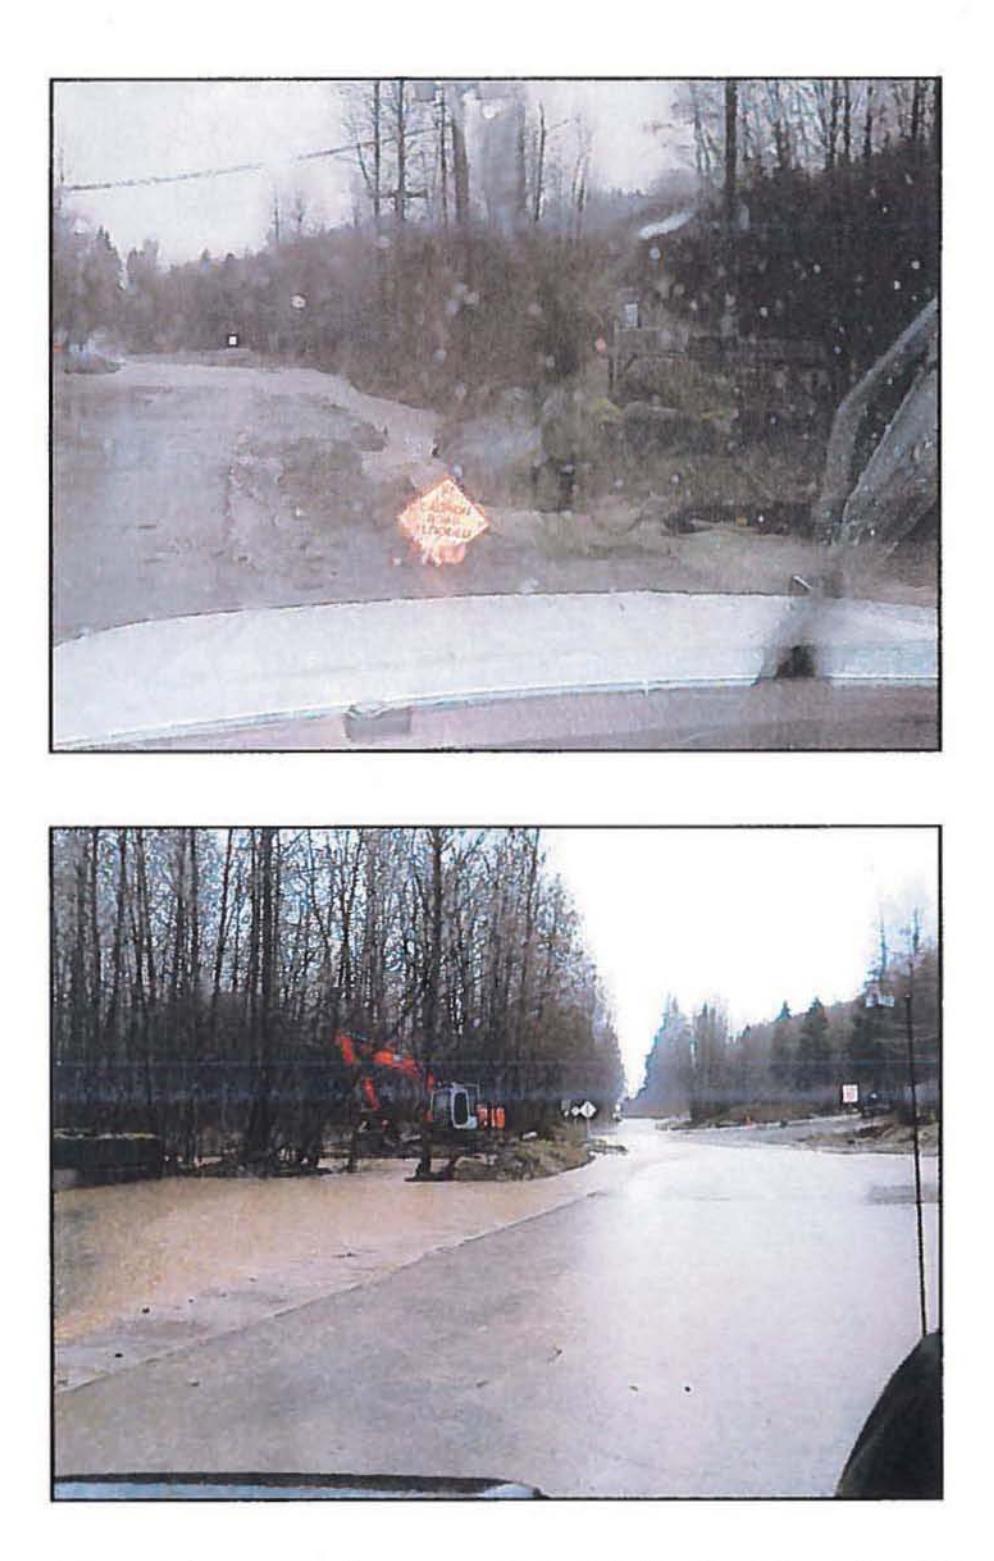
Pictures taken on March 13, 2013 at 1875 Pipeline Road, Coquitlam, BC.

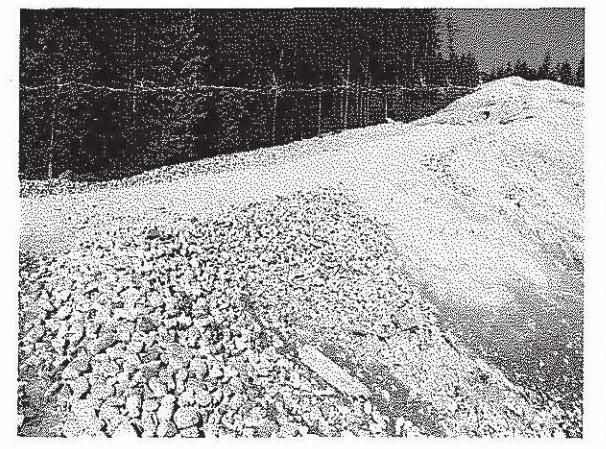
It was noticed that the main ramp towards the upper pit digging area has a drop off of more than 3 meters on both sides, did not have adequate shoulder barrier. This section of the haul road shall not be used until it is provided with adequate shoulder berms on both sides having a height of at least 34 the height of the largest tire on any vehicle used on this road. The manager is reminded that the berms shall be maintained while this section of the road is used as a haul road.
