FIRE DEPARTMENT

Re: Issuance of Fire Services Act Section 25(3)

Subject Property:
Three Gables Hotel
Harbans Randhawa
360 Martin St.
Penticton B.C.
V2A 5K4

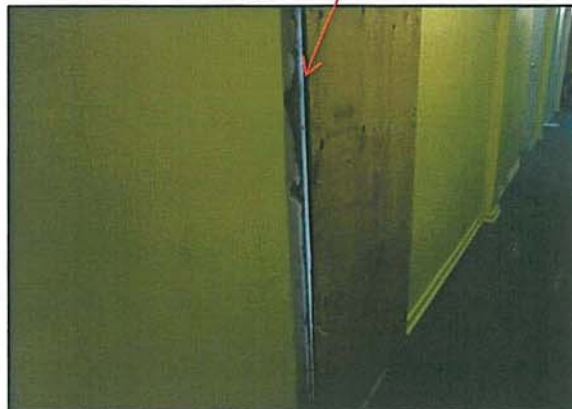
Photo 4

From ongoing pressure from the Penticton Fire Department the owner attempts to secure the suites with broken doors by using plywood to block access to the suites.(photo 3) However due to the lack of presence by the owner, transients are able to enter the hotel and pry the plywood open and occupy these suites.(photo 4) At any given time the owner could not accurately tell you how many tenants he has or how many rooms are occupied.(photo 5) In previous fire inspection I have found people sleeping in the boiler room.

Non Residents that
have pried open the
plywood to access suite
