2021 WET WEATHER/ FREEZE-THAW SHUTDOWN GUIDELINES TRANSFER STATION – QUADLING ROAD, ABBOTSFORD, BC (Use BCTS Chinook Area Wet Zone):

We are pleased to attach our design report for the Evans Quarry Debris Management and Drainage Improvements project. The report includes information gathered from various site visits held in 2021 and 2022. The report Appendices contains the Issue for Permit (IFP) drawing set, a copy of a memo sent to MOTI regarding the temporary drainage and infiltration tests done on site, as well as recommendations for site shutdown in inclement weather.

The overall scope of the work was to assess the residual landslide geotechnical hazard on the MOTI site, provide geotechnical and hydrotechnical recommendations relative to removal of the debris on the MOTI site and to undertake permit level design for the restoration of drainage across the site.

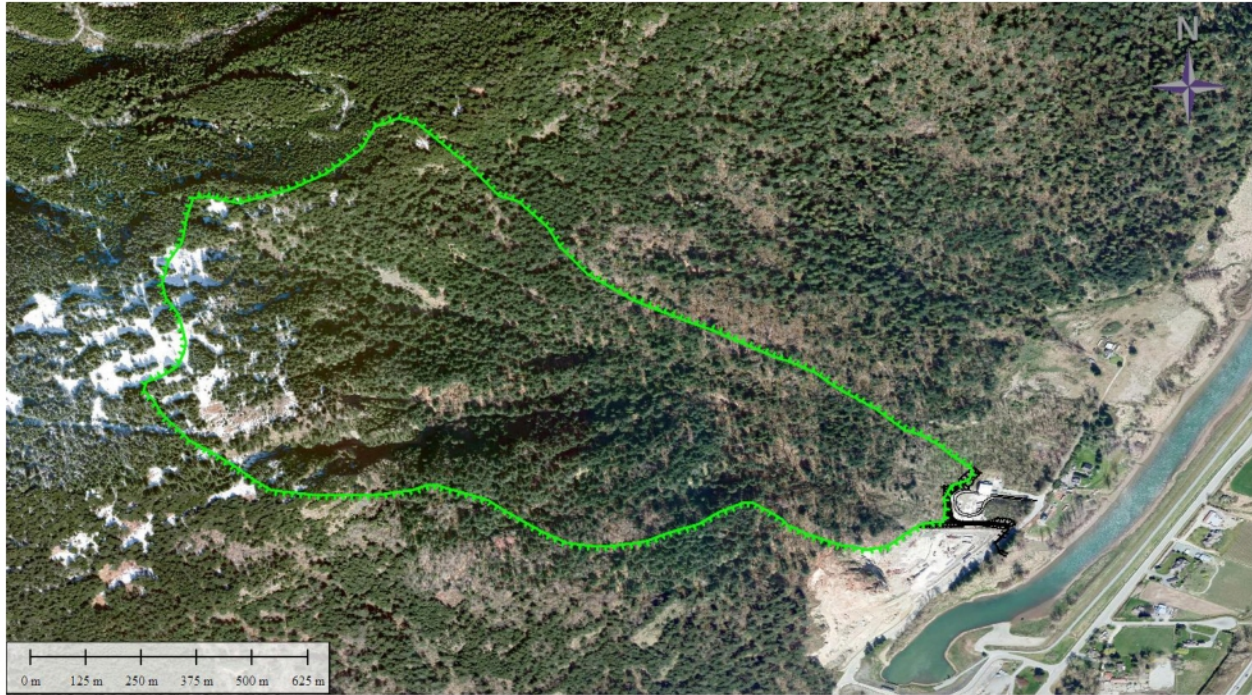
Figure 5 Catchment Area to Site

- **Drainage Area:** The total drainage area to the site, shown in Figure 5 below, was derived from Light Detection and Ranging (LiDAR) topographic data. The catchment area was estimated to be 0.67 km^2 or 67 hectares.
- **Rainfall depth:** Two nearby Environment Canada Intensity Duration Frequency curve locations were considered for estimating rainfall depth. The site is close to Mission West Abbey (1105192) and Huntingdon

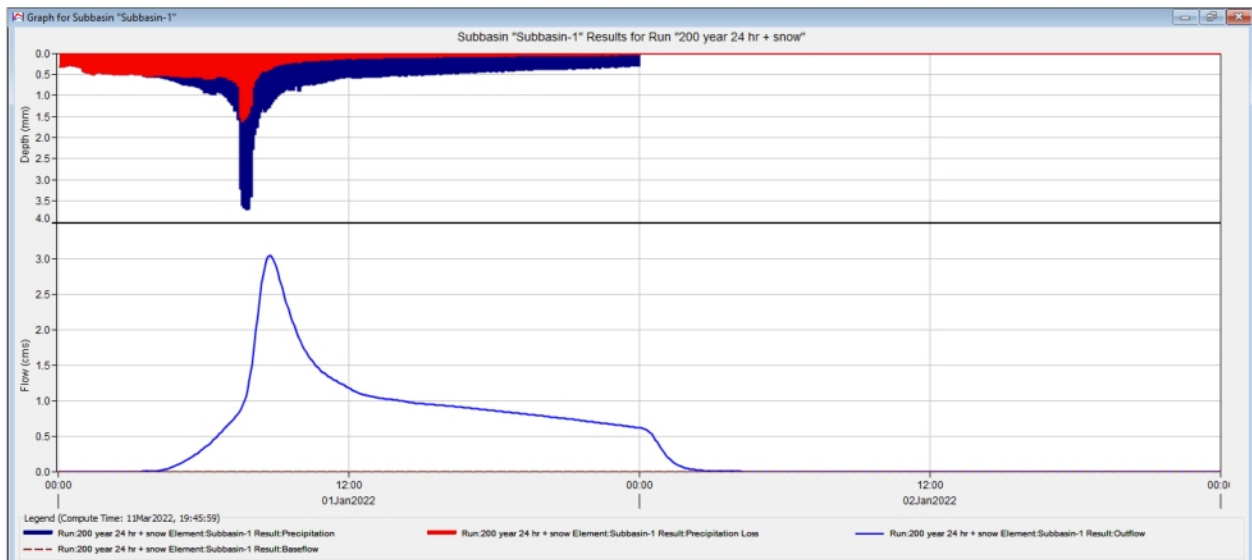
Figure 6 Modelled 1 in 200 Year plus Snowmelt Runoff Hydrograph

Using HEC-HMS, the peak discharge was estimated to be 3.0 m³/s for a 1 in 200-year storm with an additional allowance for snowmelt. The rainfall hyetograph and flow hydrograph for a 24-hour rainfall event are shown in Figure 6.

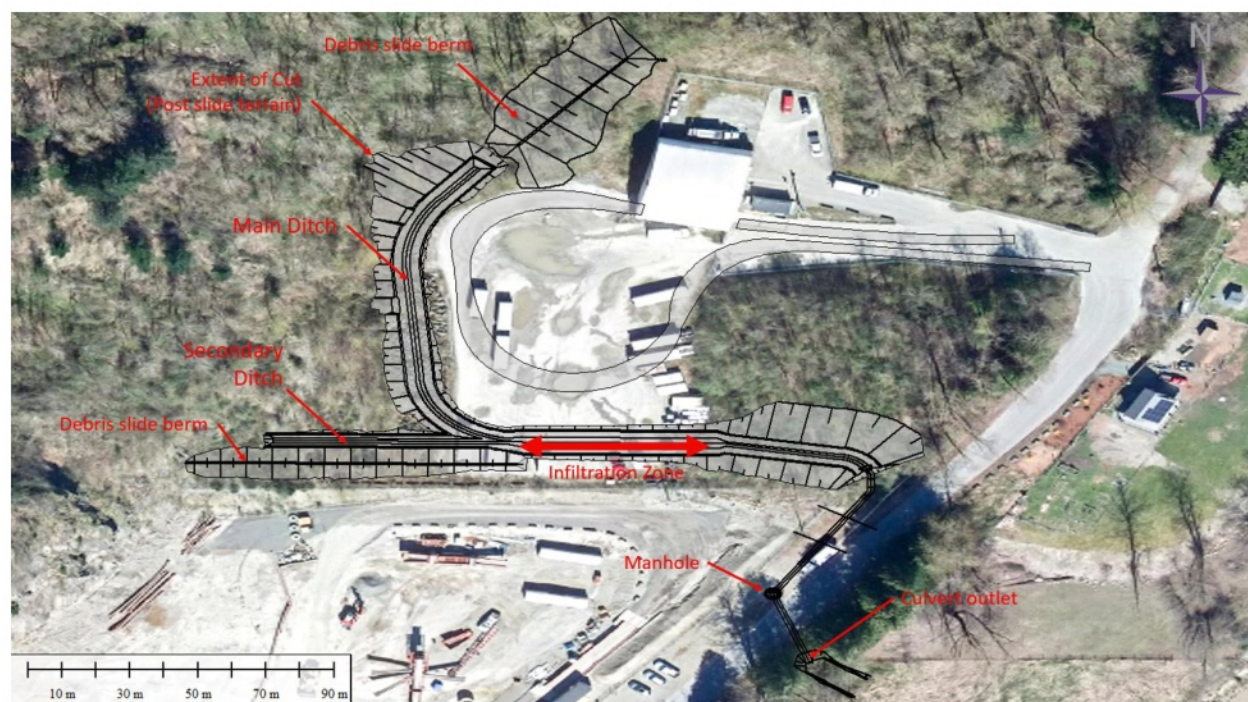
Figure 7 Drainage Features

WSP has prepared issue for permit (IFP) drawings that show the proposed layout and configuration of ditches and berms. These are included in Appendix B. Figure 7 shows an overview of the various component on the site. The main ditch upstream of the confluence with the secondary ditch has the following geometric properties and rationale for the design:

The main channel is designed with a trapezoidal channel shape with 1.5 m wide bottom width and 1.2 m minimum depth. Side slopes are 1.7H:1V. Upstream of the infiltration zone, the channel will be lined with geomembrane to reduce seepage losses resulting from the slack gradient. Over the geomembrane, a protective geotextile layer will be covered with 100 mm to 200 mm cobbles to provide ballast for the lining and to provide armour protection to the ditch which will be constructed over easily erodible materials.

- The secondary channel will have similar geometric characteristics however the gradient will vary between 15% and 7% depending by following the terrain to connect to the main ditch.

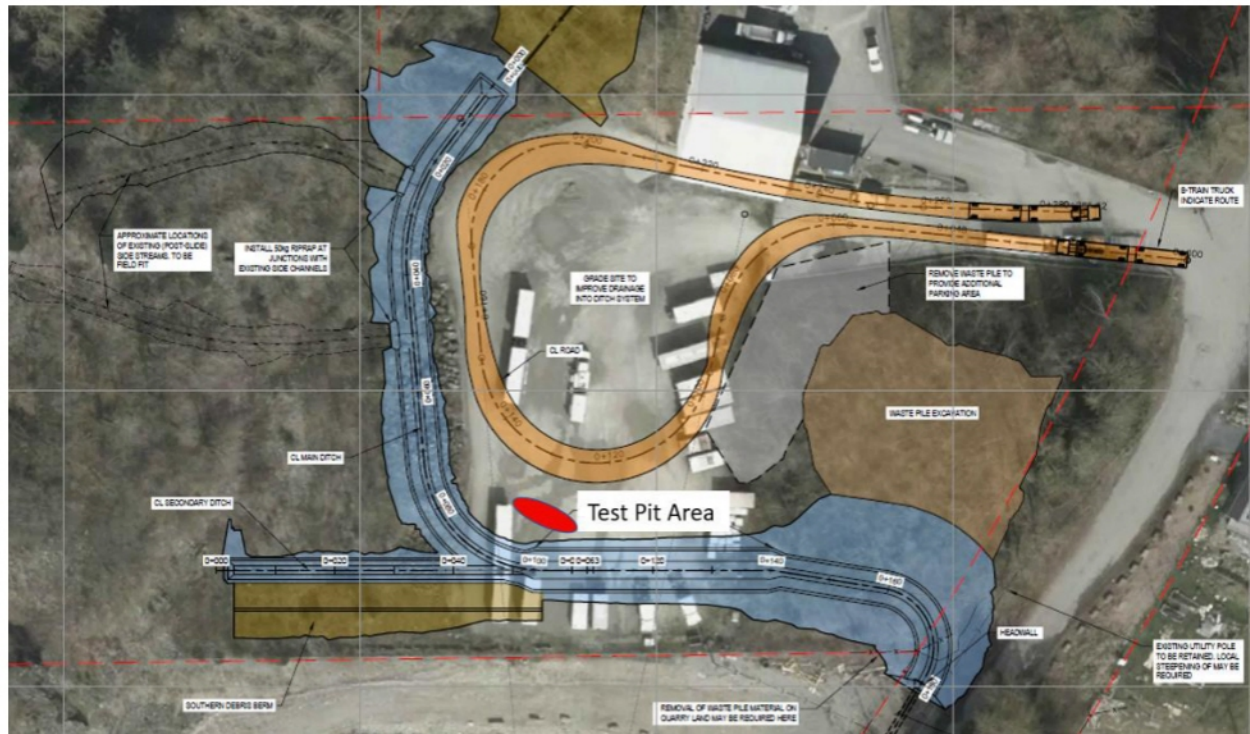
WSP staff arrived on site at approximately 9am and met with a survey crew from McElhanney. Weather was clear and sunny. After a tailgate safety meeting, the surveyors were asked to lay out the proposed ditch as shown in blue on Figure 1. The surveyors were also asked to survey levels on the existing ditch that flows northeast across the back of the site and to collect general topography around the ponded area.

At approximately 10am, contractor McDonald Ross arrived with a John Deere 245 excavator to excavate test pits at the locations shown in red on Figure 1. The test pits could not be excavated perfectly in line with the ditch because of wood debris and other material piled on the site that was in the way and also to keep the infiltration pit as far from the adjacent quarry as practical.

Figure 1 Image showing extent of proposed ditch on Evans Quarry site

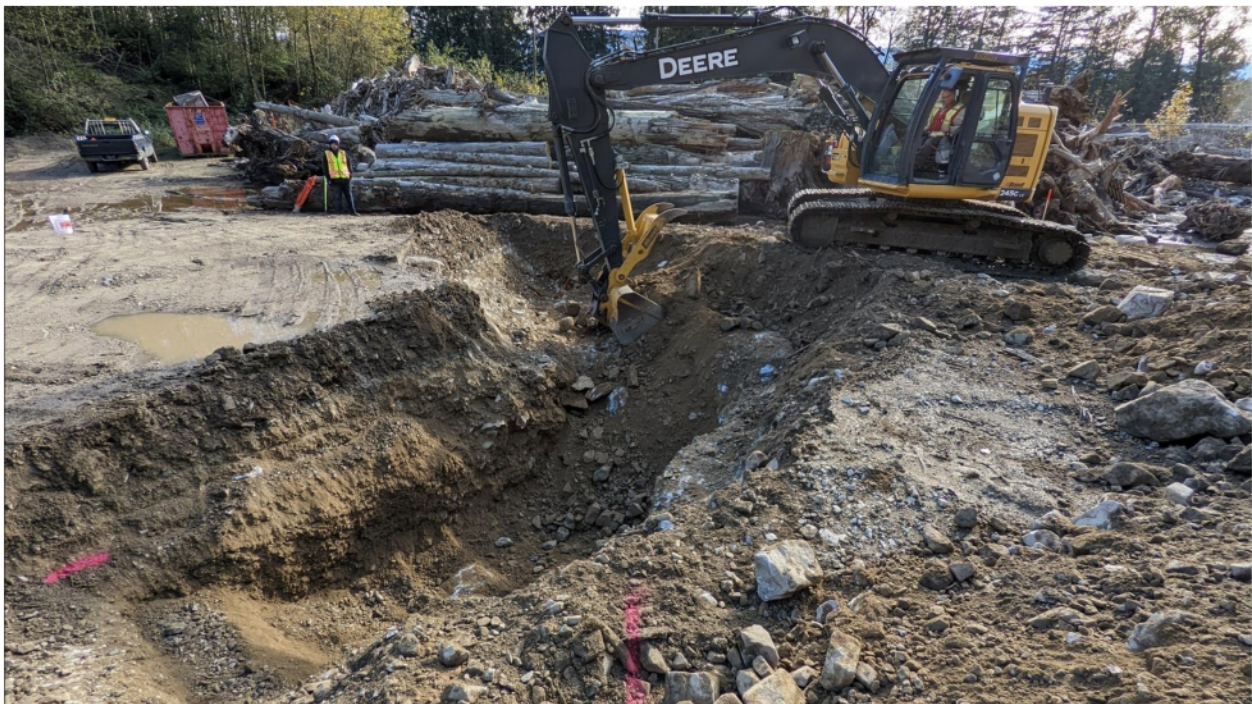
Figure 3 Excavating the test pit

1. A large pit was excavated to the desired depth for the soakaway which, in this case, was level with the bottom of the adjacent quarry floor (Elevation 9.1 m). The pit was approximately 2.7 m deep. The pit walls appeared stable; however, to allow safe entry for testing, the sides of the pit were battered back at an approximate 2H:1V slope above 1.2m from the pit floor. As shown in Figure 3, the pit was dry and there were no visible seeps or wetting of the soil.

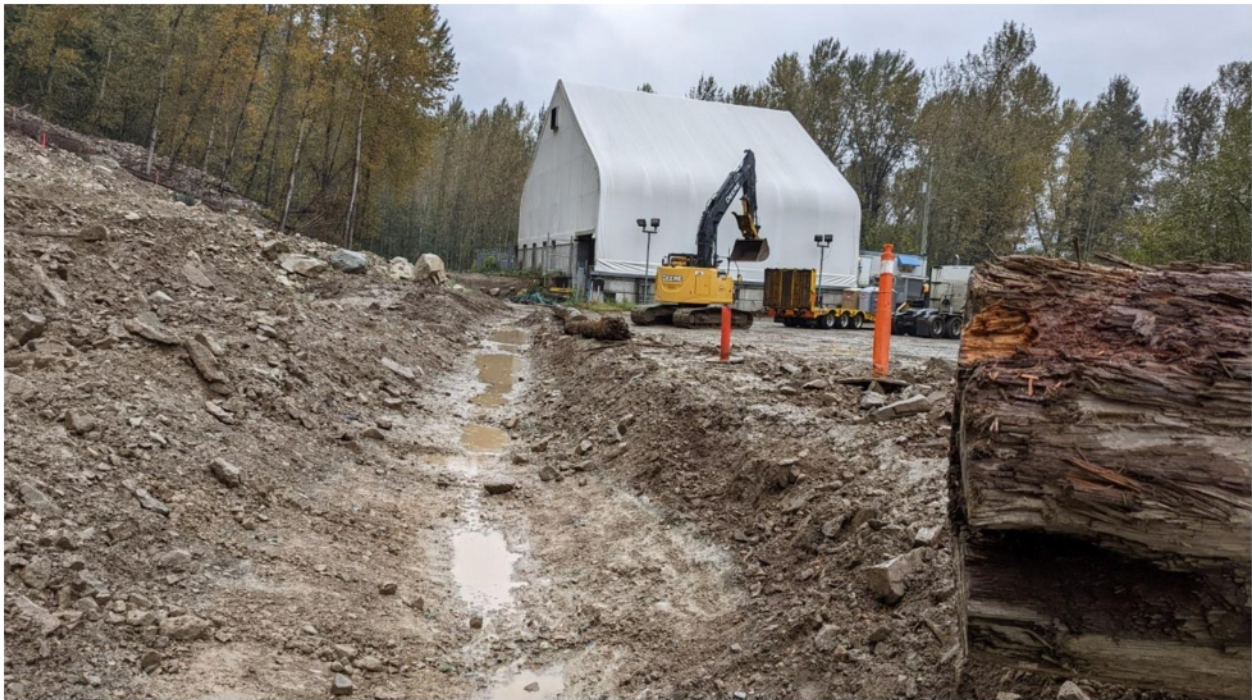
Upon determining that the underlying soil conditions were suitable for a soakaway, the focus turned to providing a temporary drainage solution for the site. To achieve this, the surveyors were asked to survey the flooded area to determine the low point which would be the "outlet" for the ponded area and the start of a ditch connecting to the soakaway. From this point, a ditch with approximate gradient of 1:100 (1%) was dug across the back of the site to connect to the soakaway pit (Figure 4).

Figure 4 Looking back along the ditch from near the soakaway entrance
