MOUNT POLLEY MINING CORPORATION		
MOUNT POLLEY MINE		
TAILINGS STORAGE FACILITY MAIN EMBANKMENT FOUNDATION DRAIN FLOWS		
<b><i>Knight Piésold</i></b> CONSULTING	PROJECT NO. 11162/13	REV.
	REF. NO.	REV.
FIGURE 5.8

TAILINGS STORAGE FACILITY  
STAGE 3 TAILINGS EMBANKMENT  
INSTRUMENTATION  
SECTIONS - SHEET 2 OF 2

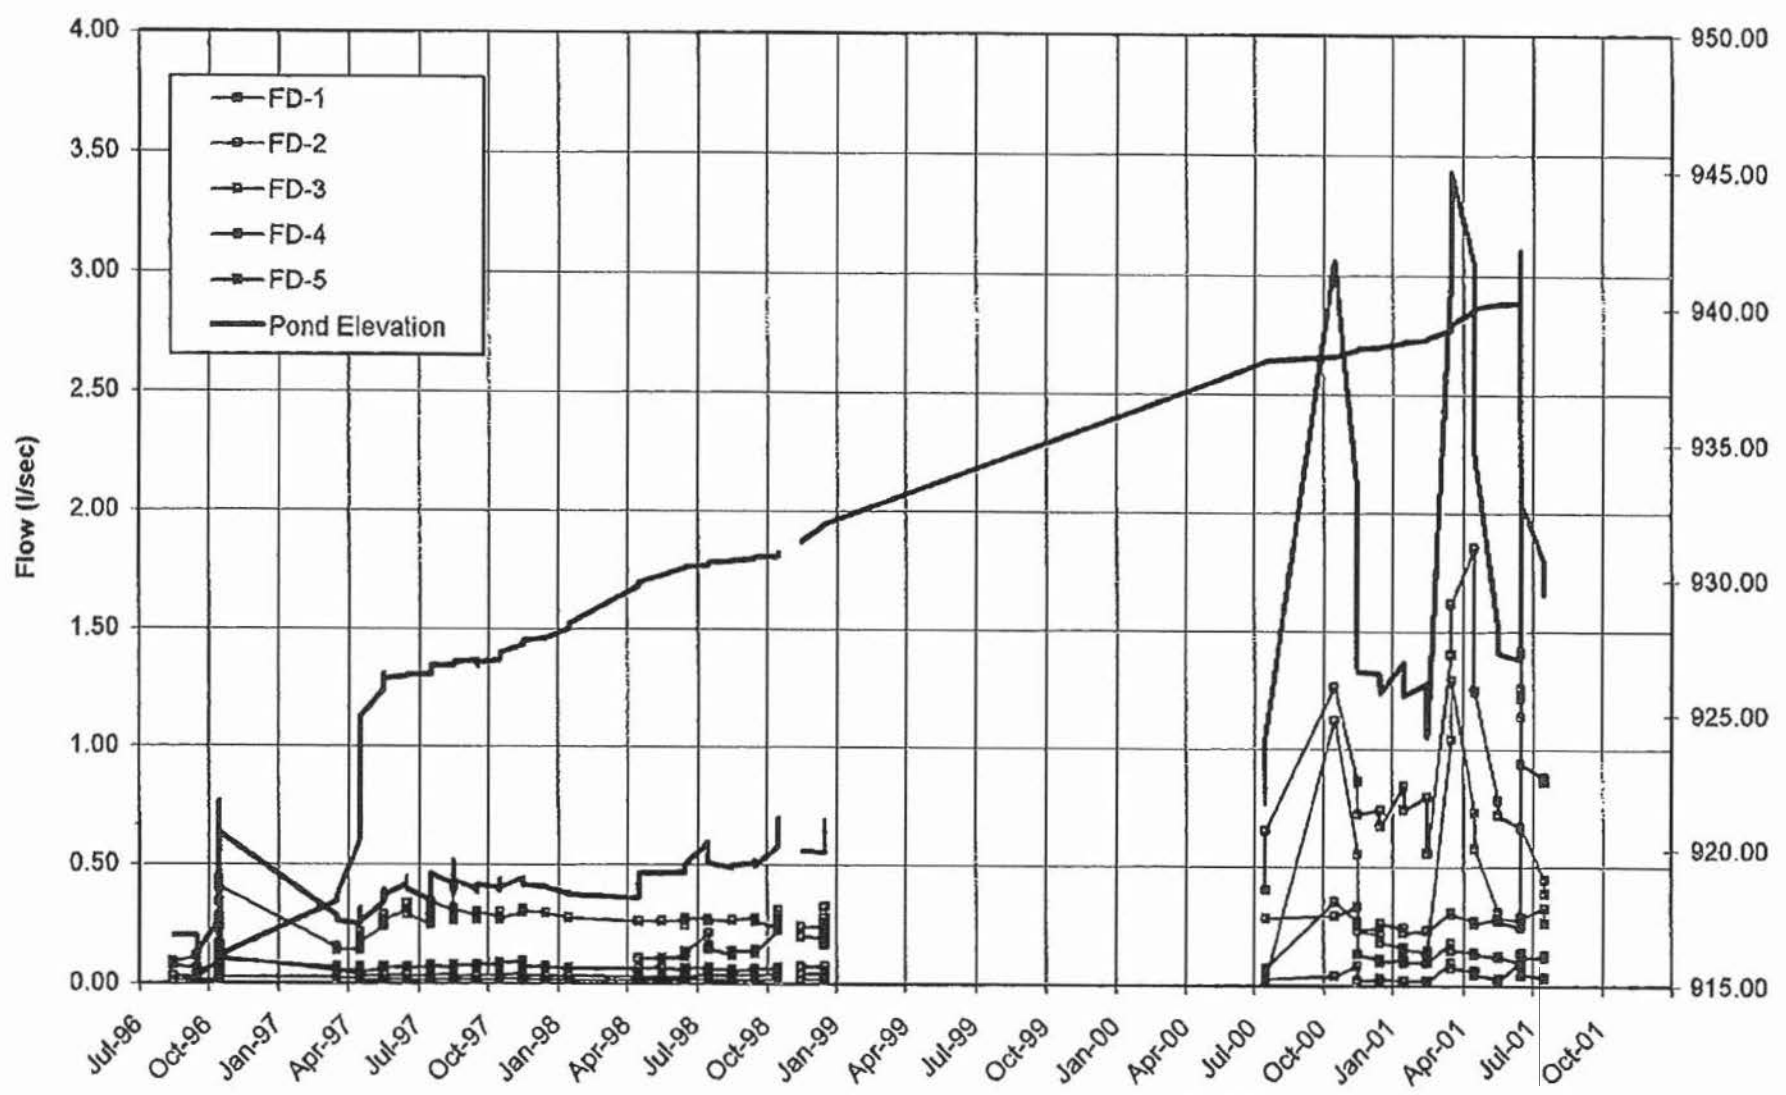
Drains flows were recorded on July 6, 2001. The results from the foundation drains and upstream toe drain are shown on Figures 5.8 and 5.9.

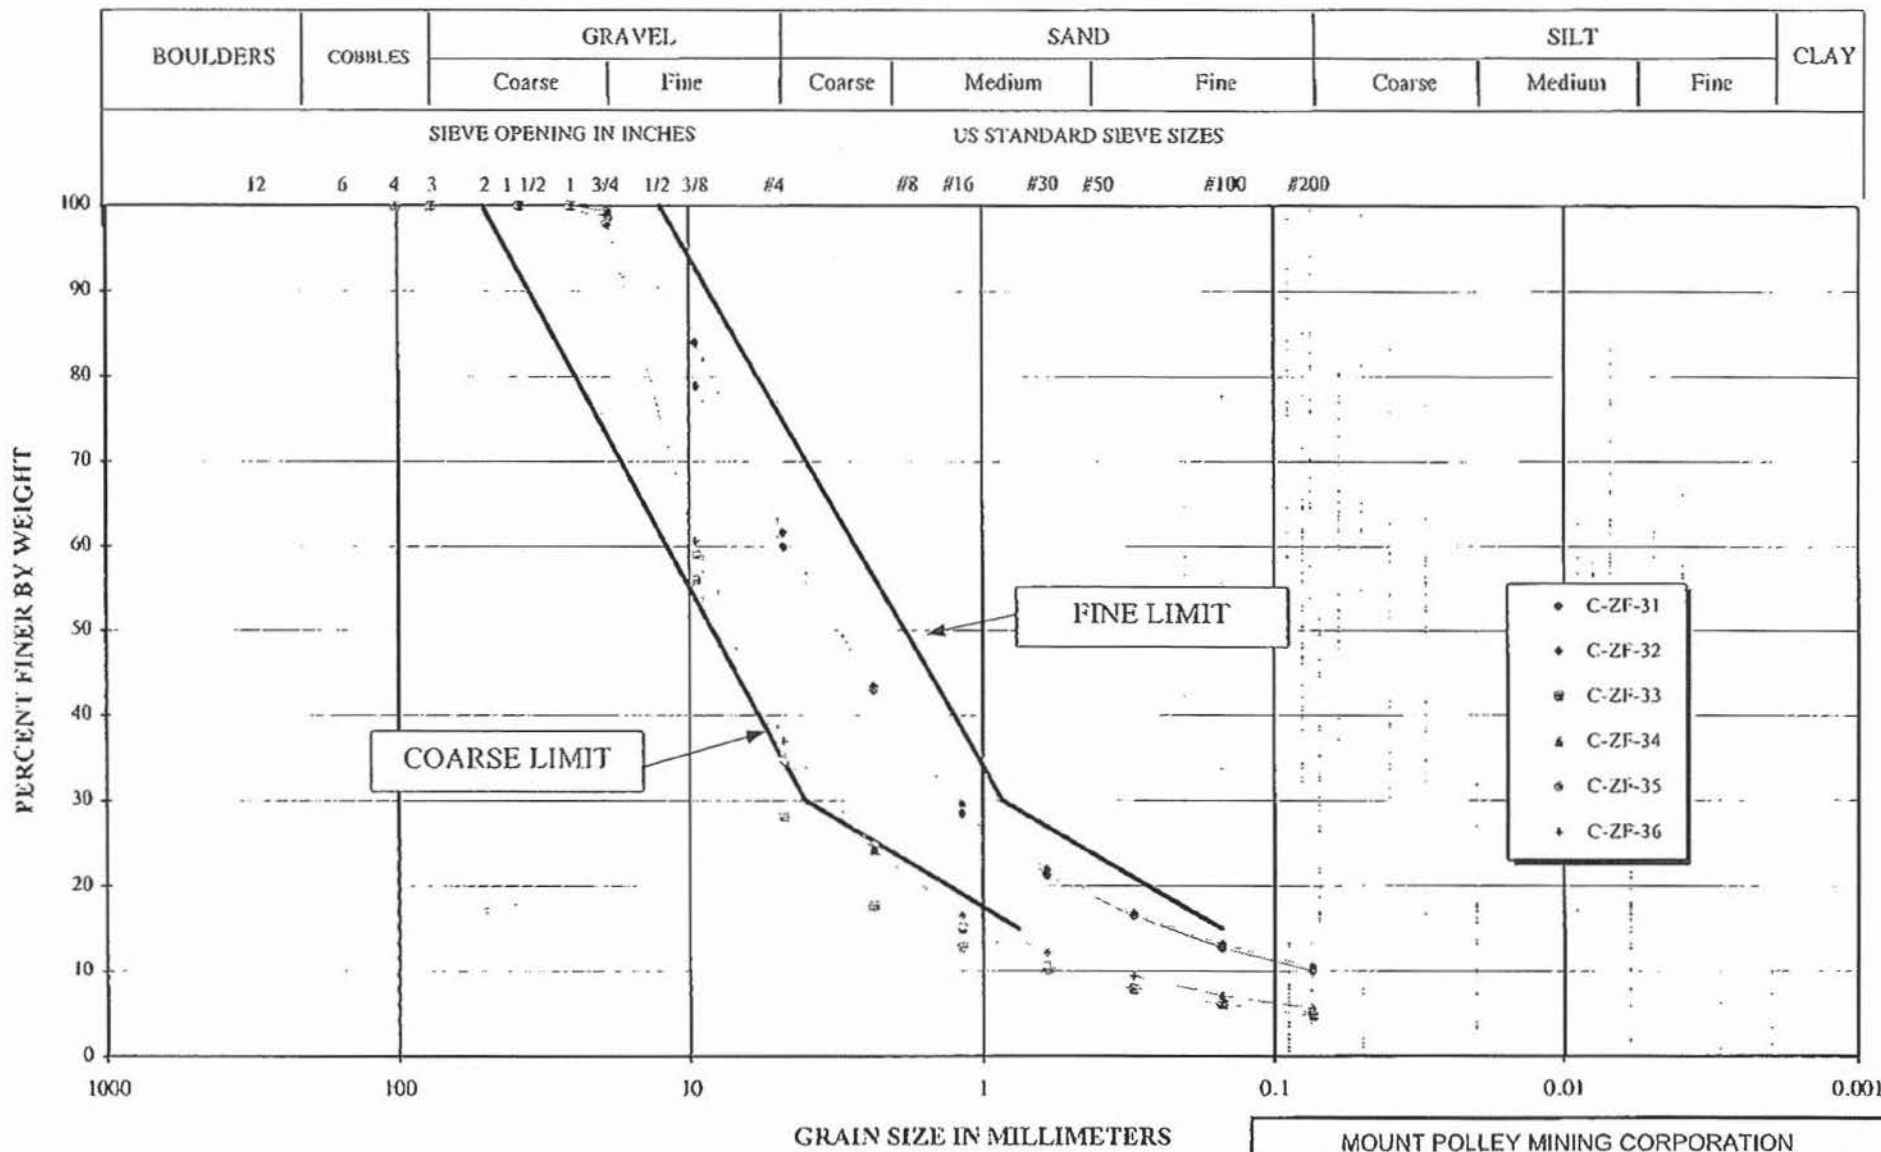
MOUNT POLLEY MINING CORPORATION		
MOUNT POLLEY MINE		
TAILINGS STORAGE FACILITY - STAGE 3B CONSTRUCTION - ZONE F CONTROL SAMPLES GRADATION CURVES		
<b>Knight Piésold</b> CONSULTING	PROJECT NO	REF. NO.
	11162/14	
		REV.
		FIGURE 4.1

All three control samples carried out on Zone F failed the grain size specification on the #'s 8, 16 and 30 sieves. The curves were sent to the KP Vancouver office for filter relationship analyses. The results of the analyses show that the latest Zone F samples have a filter relationship with the Zone S that is present in the Perimeter Embankment but do not have a filter relationship with the cycloned sand. As a result, KP gave permission to MPMC to use this material against the Zone S.

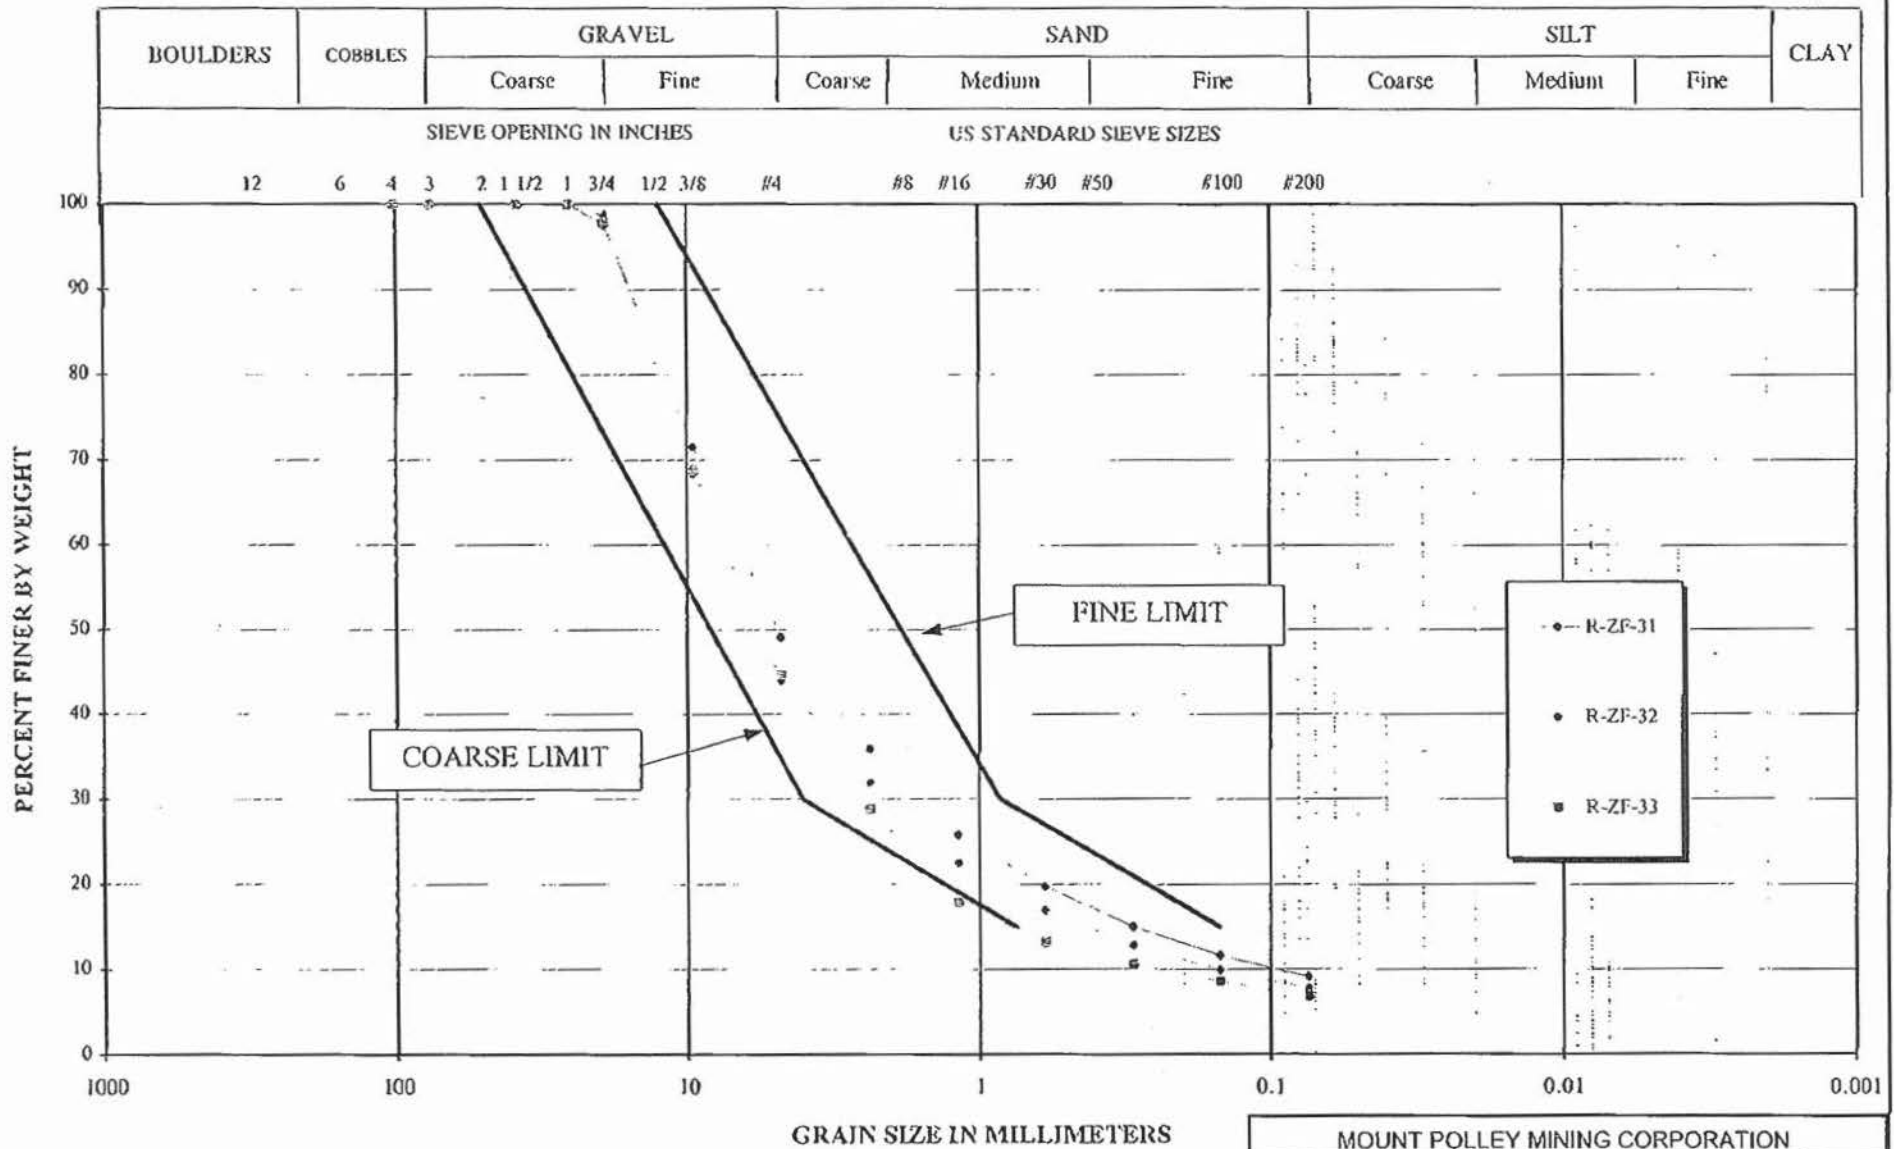
MOUNT POLLEY MINING CORPORATION		
MOUNT POLLEY MINE		
TAILINGS STORAGE FACILITY - STAGE 3B CONSTRUCTION - ZONE F RECORD SAMPLES GRADATION CURVES		
<b>Knight Piésold</b> CONSULTING	PROJECT NO.	REF. NO.
	11162/14	
REV		
FIGURE 4.2

The subsequent record test failed the grain size specification on the # 16 sieve only. Due to the above discussion, this material was allowed to remain in place.

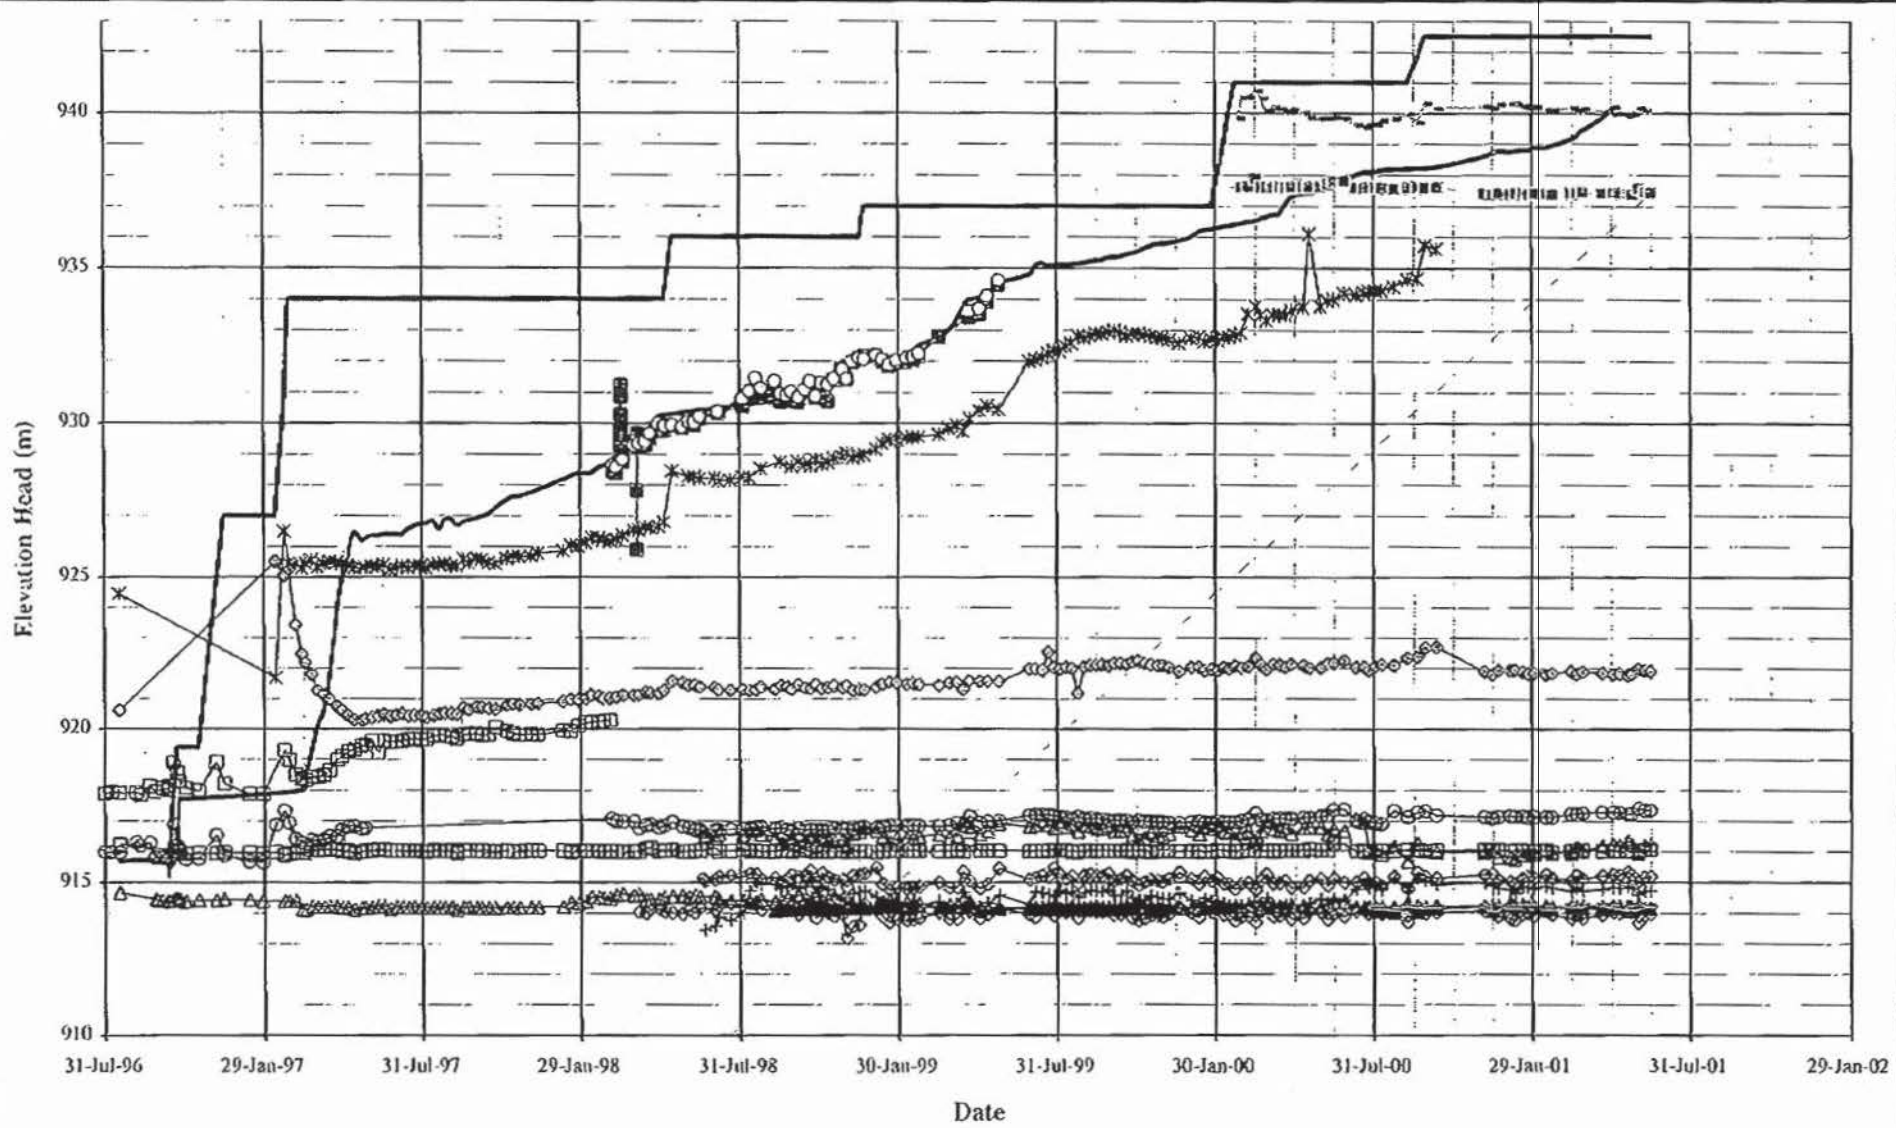
MOUNT POLLEY MINING CORPORATION		
MOUNT POLLEY MINE		
TAILINGS STORAGE FACILITY		
PLANE C PIEZOMETERS		
GRAPH OF ELEVATION vs. TIME		
<b><i>Knight Piésold</i></b> CONSULTING	PROJECT NO. 11182/14	REF. NO REV
FIGURE 5.3

Piezometer C2-PE2-05 is also located in the Stage 1A glacial till fill. This instrument historically showed little or no reaction to construction, but indicated a slow, steady increase in pore pressure over time. This suggests that pore pressures in the fill around C2-PE2-05 are reaching a steady state condition as the phreatic surface moves through the fill. It should be

noted that the pressure head registered by this piezometer is approximately 10 m. This is similar to other piezometers located in comparable locations in the glacial till fill.

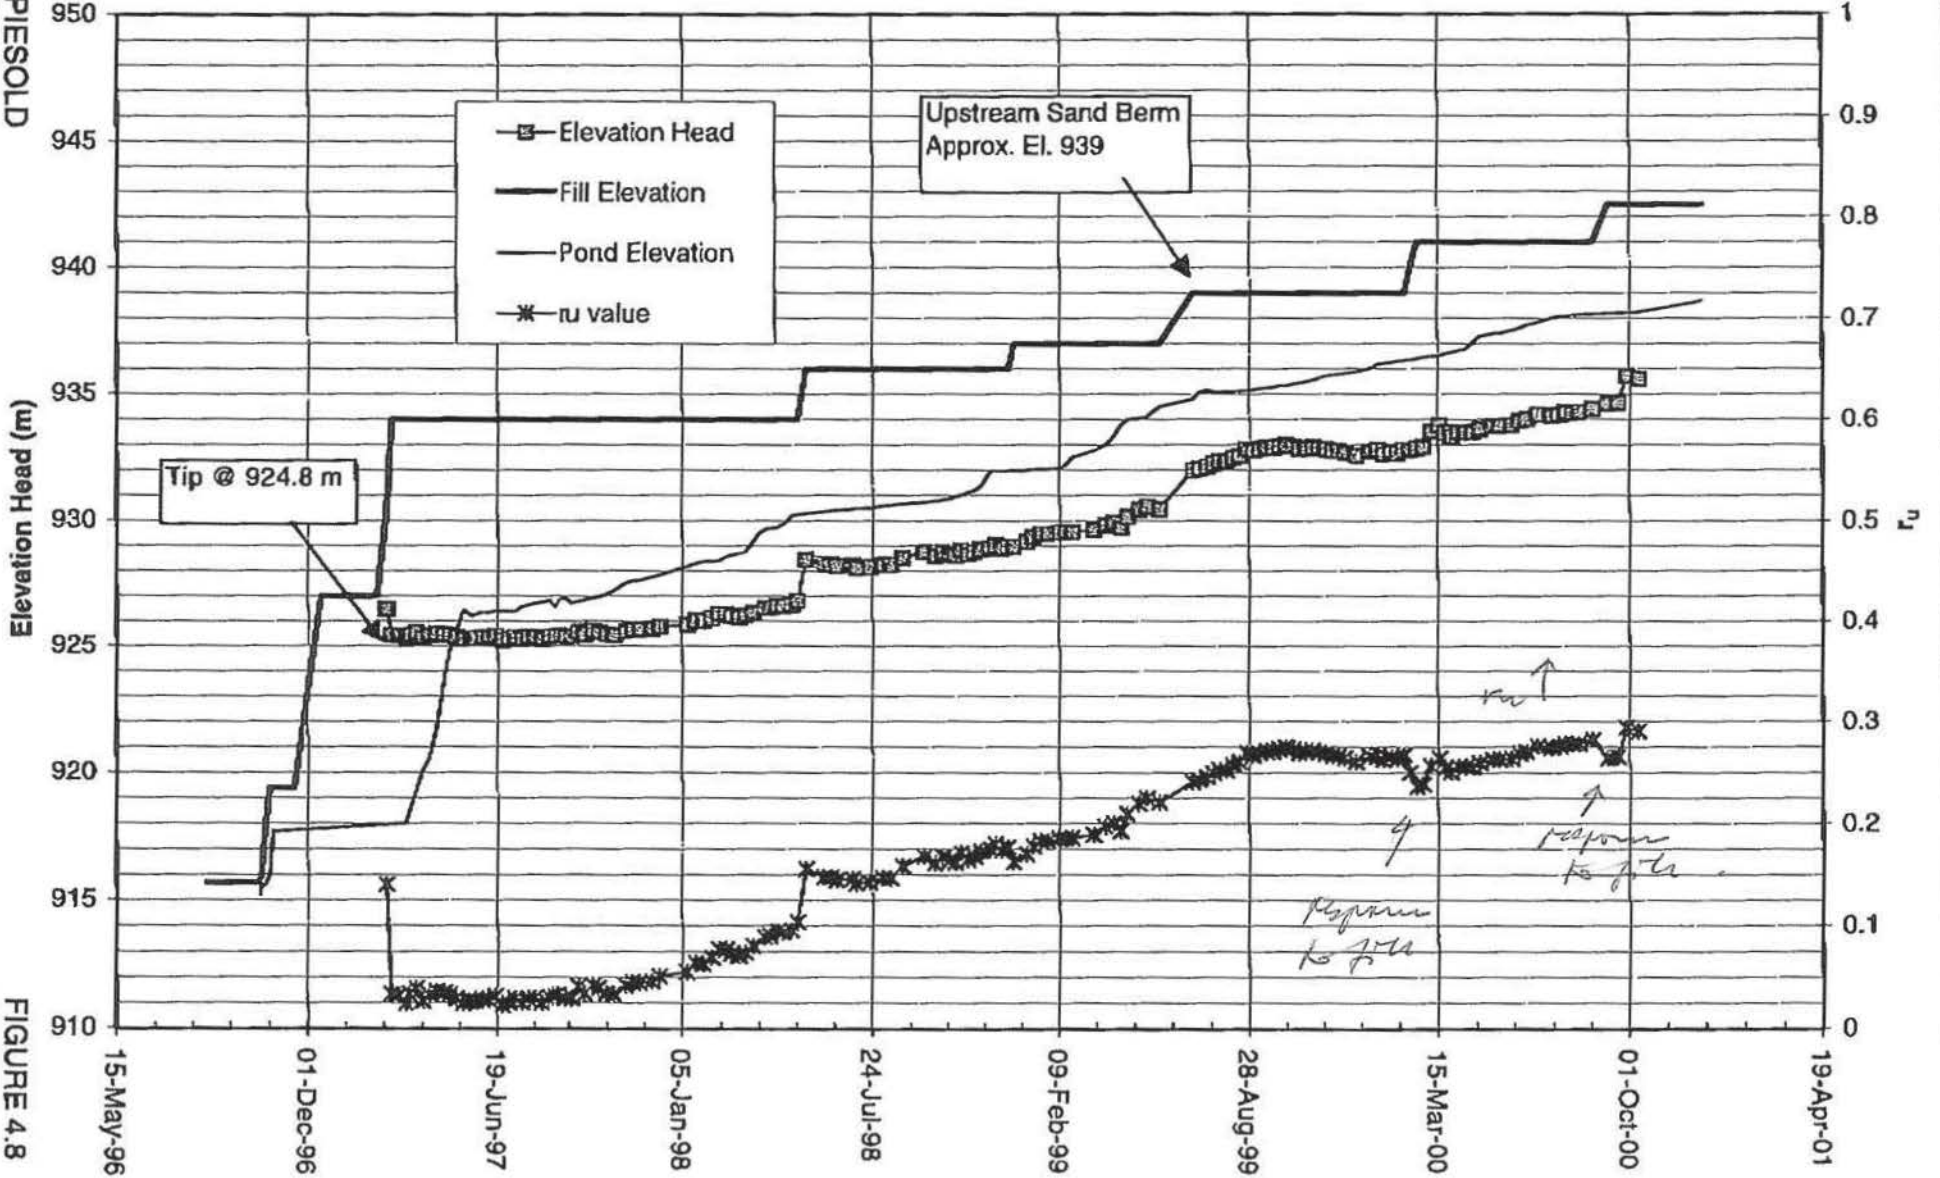
FIGURE 4.8

Piezometer C2-PE2-05 is also located within Stage 1a glacial till fill. This instrument historically showed little or no reaction to construction, but rather indicated a slow, steady increase in pore water pressure over time. This suggests that pore water pressures in the fill around C2-PE2-05 are reaching a steady state condition as the phreatic surface moves through the fill. It should be noted that the pressure head registered by C2-PE2-05, approximately 10 m, is similar to other piezometers located in comparable positions within glacial till fill.

Plots of elevation head and  $r_u$  with time for B2-PE2-03 and C2-PE2-05 are presented in Figures 4.7 and 4.8.

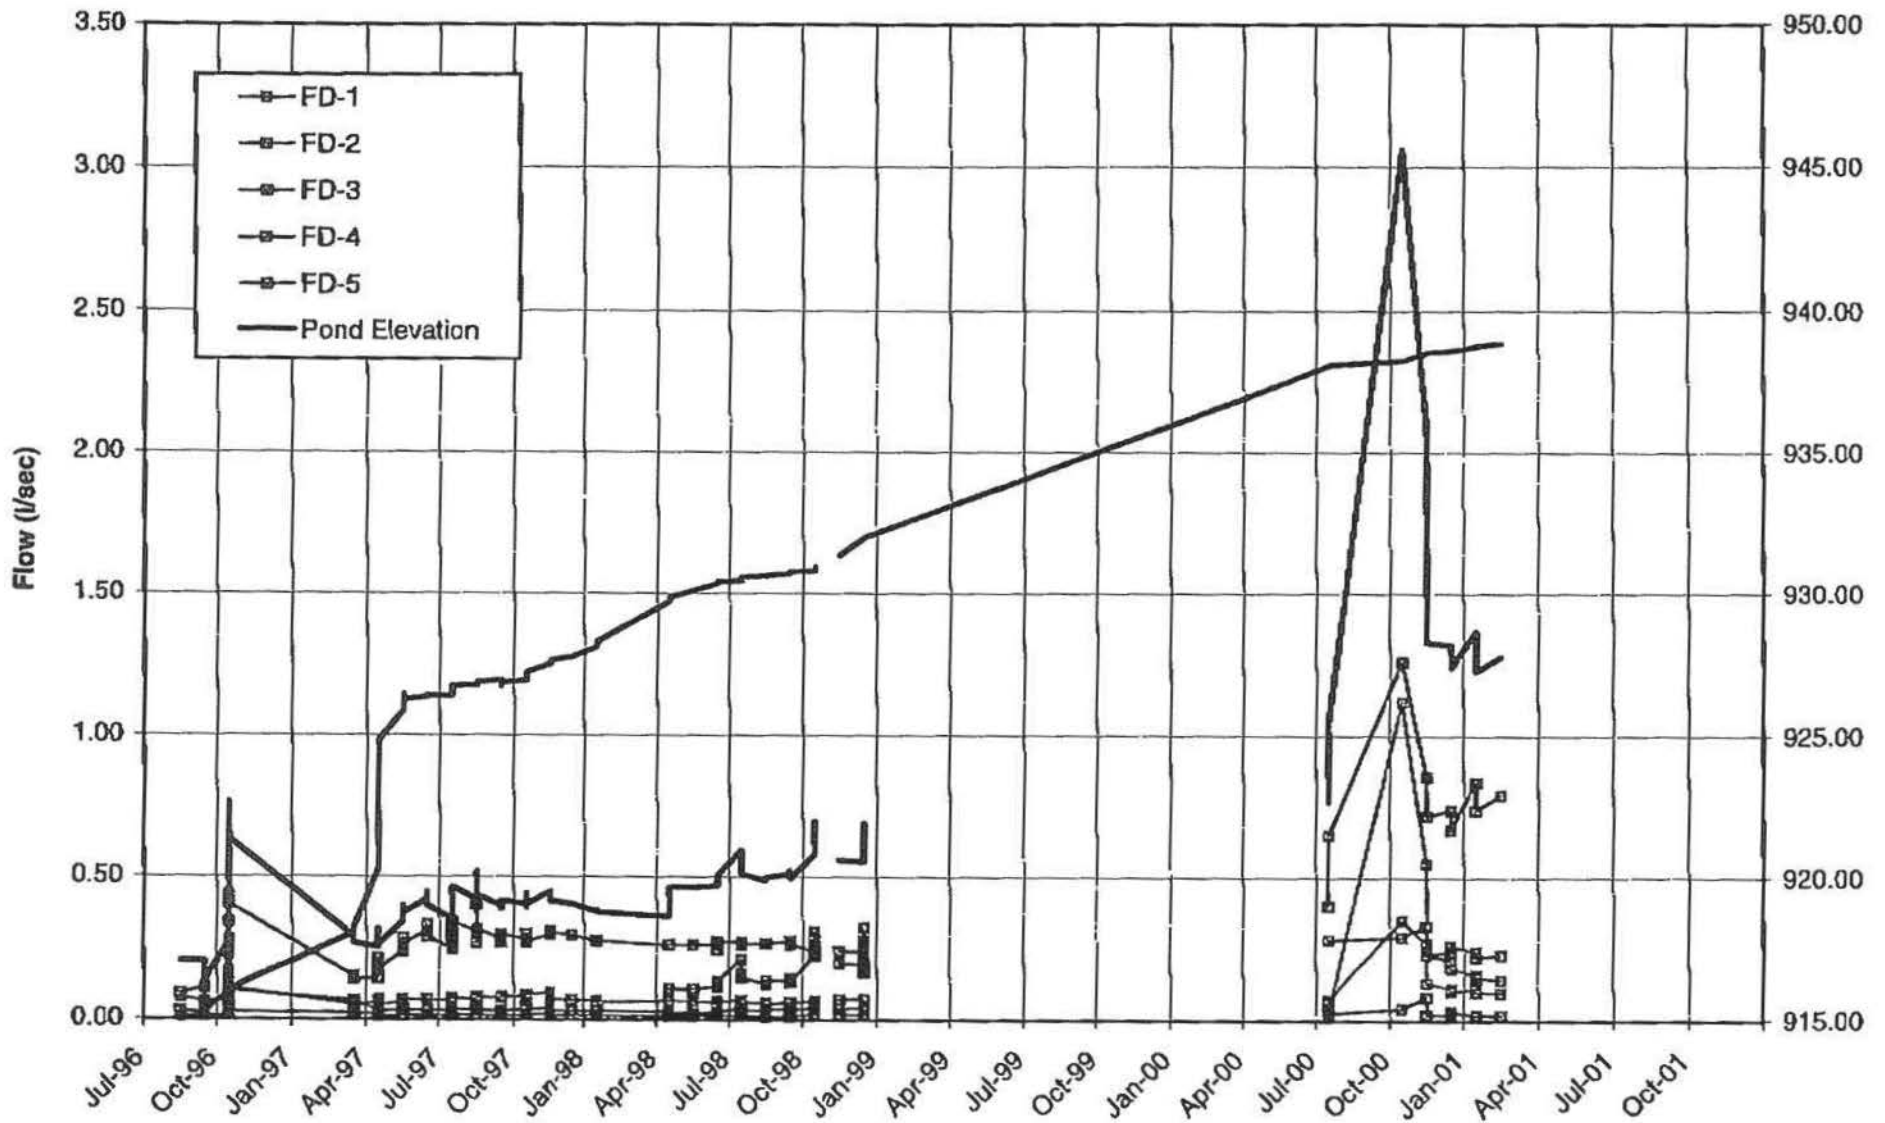
MOUNT POLLEY MINING CORPORATION		
MOUNT POLLEY MINE		
TAILINGS STORAGE FACILITY		
MAIN EMBANKMENT		
FOUNDATION DRAIN FLOWS		
<b><i>Knight Piésold</i></b>		PROJECT NO. 11162/13
CONSULTING		REF. NO. REV.
FIGURE 4.9

Results of foundation drain outlet monitoring are shown on Figure 4.9. Results of monitoring of the upstream toe drains outlets are shown on Figure 4.10.

The readings in all cases show a significant decrease from the anomalous high values observed on October 24, although some of the readings still remain slightly above the range of previously recorded values. There has been no visible sediment in the flows from the foundation drains.

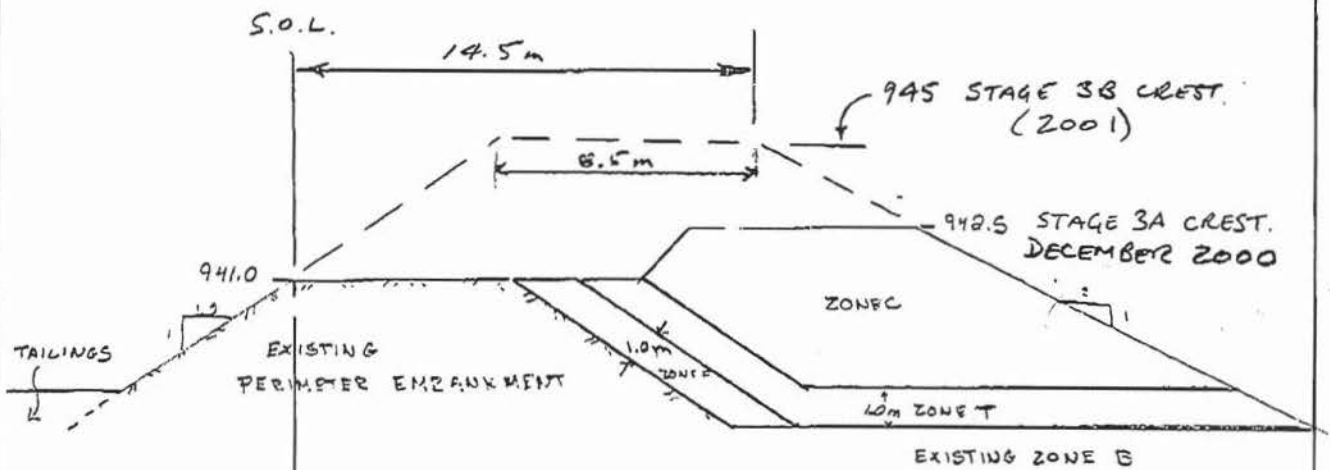
PERIMETER EMBANKMENT  
BETWEEN SS 156  
CH 28+00 - 32+00  
 TYPICAL SECTION

*This is not as per  
 design given in May 2000*

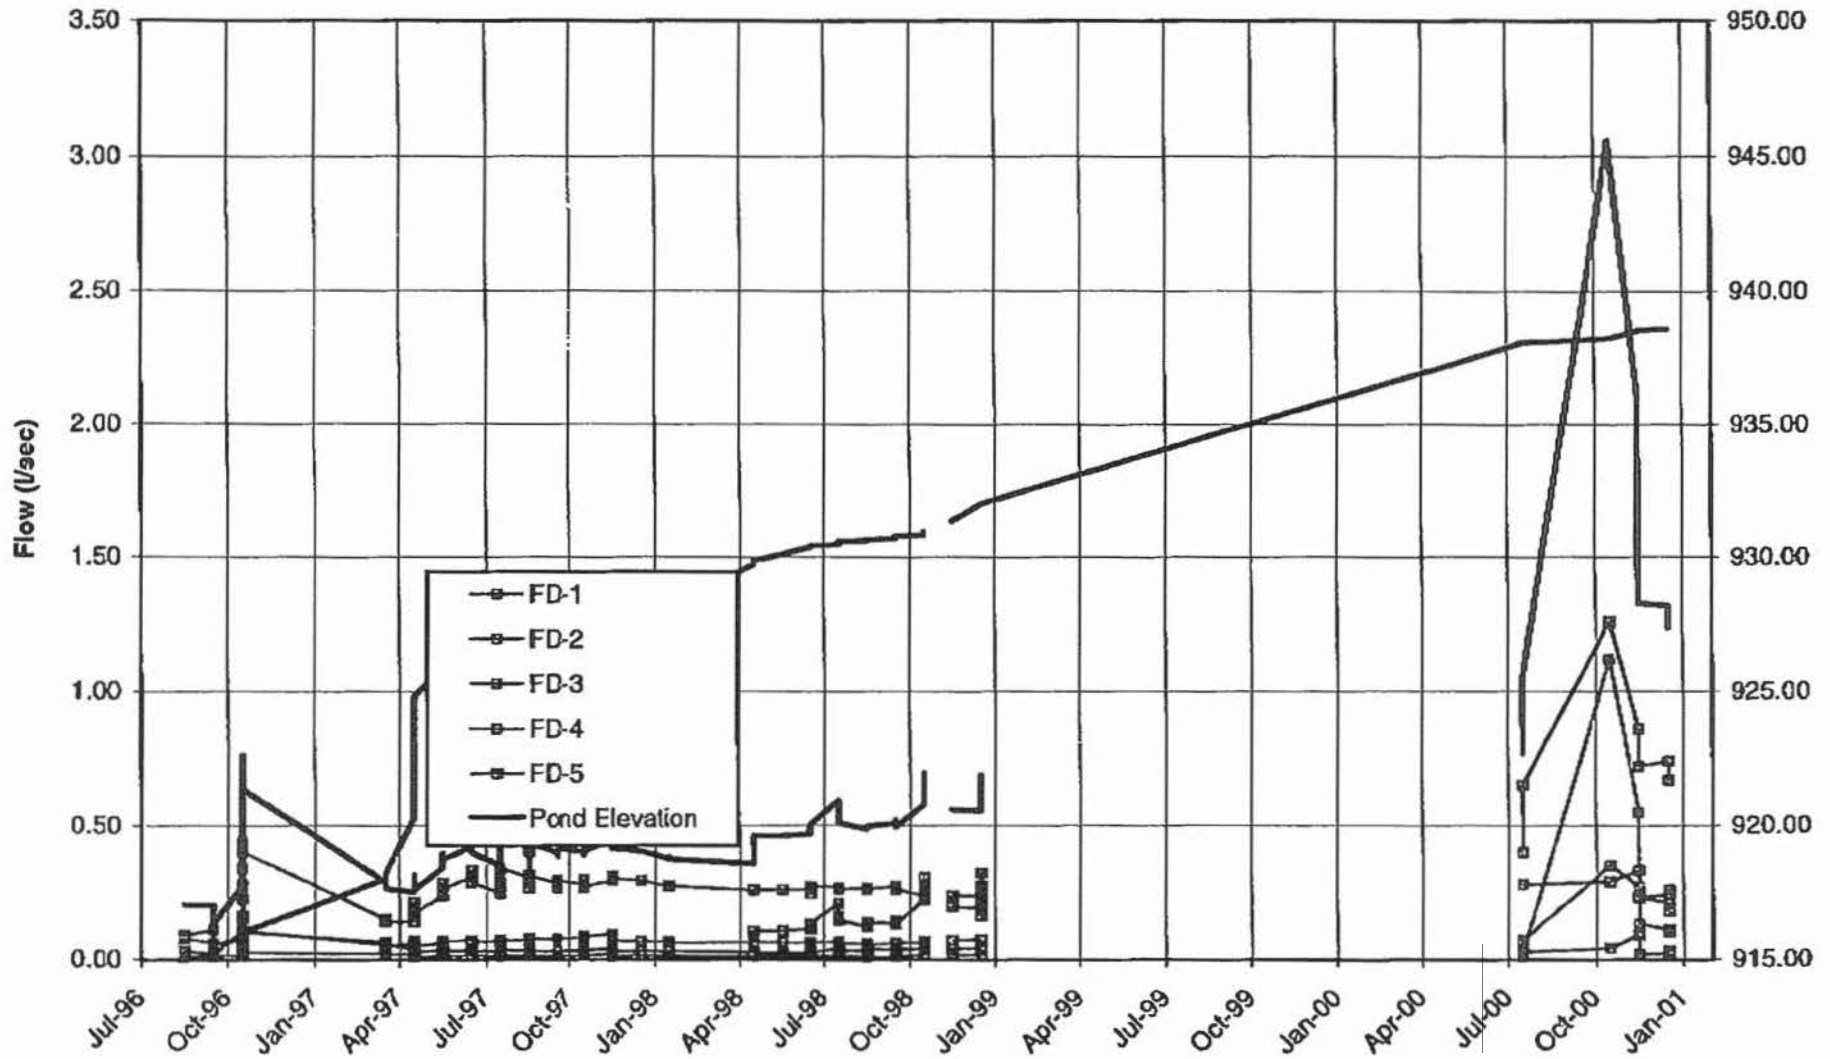
MOUNT POLLEY MINING CORPORATION		
MOUNT POLLEY MINE		
TAILINGS STORAGE FACILITY MAIN EMBANKMENT		
FOUNDATION DRAIN FLOWS		
<b><i>Knight Piésold</i></b> CONSULTING	PROJECT NO.	REF. NO.
	11162/13	02934
	REV.	0
FIGURE 4.6

Results of foundation drain outlet monitoring are shown on Figure 4.6. Results of monitoring of the upstream toe drains outlets are shown on Figure 4.7.

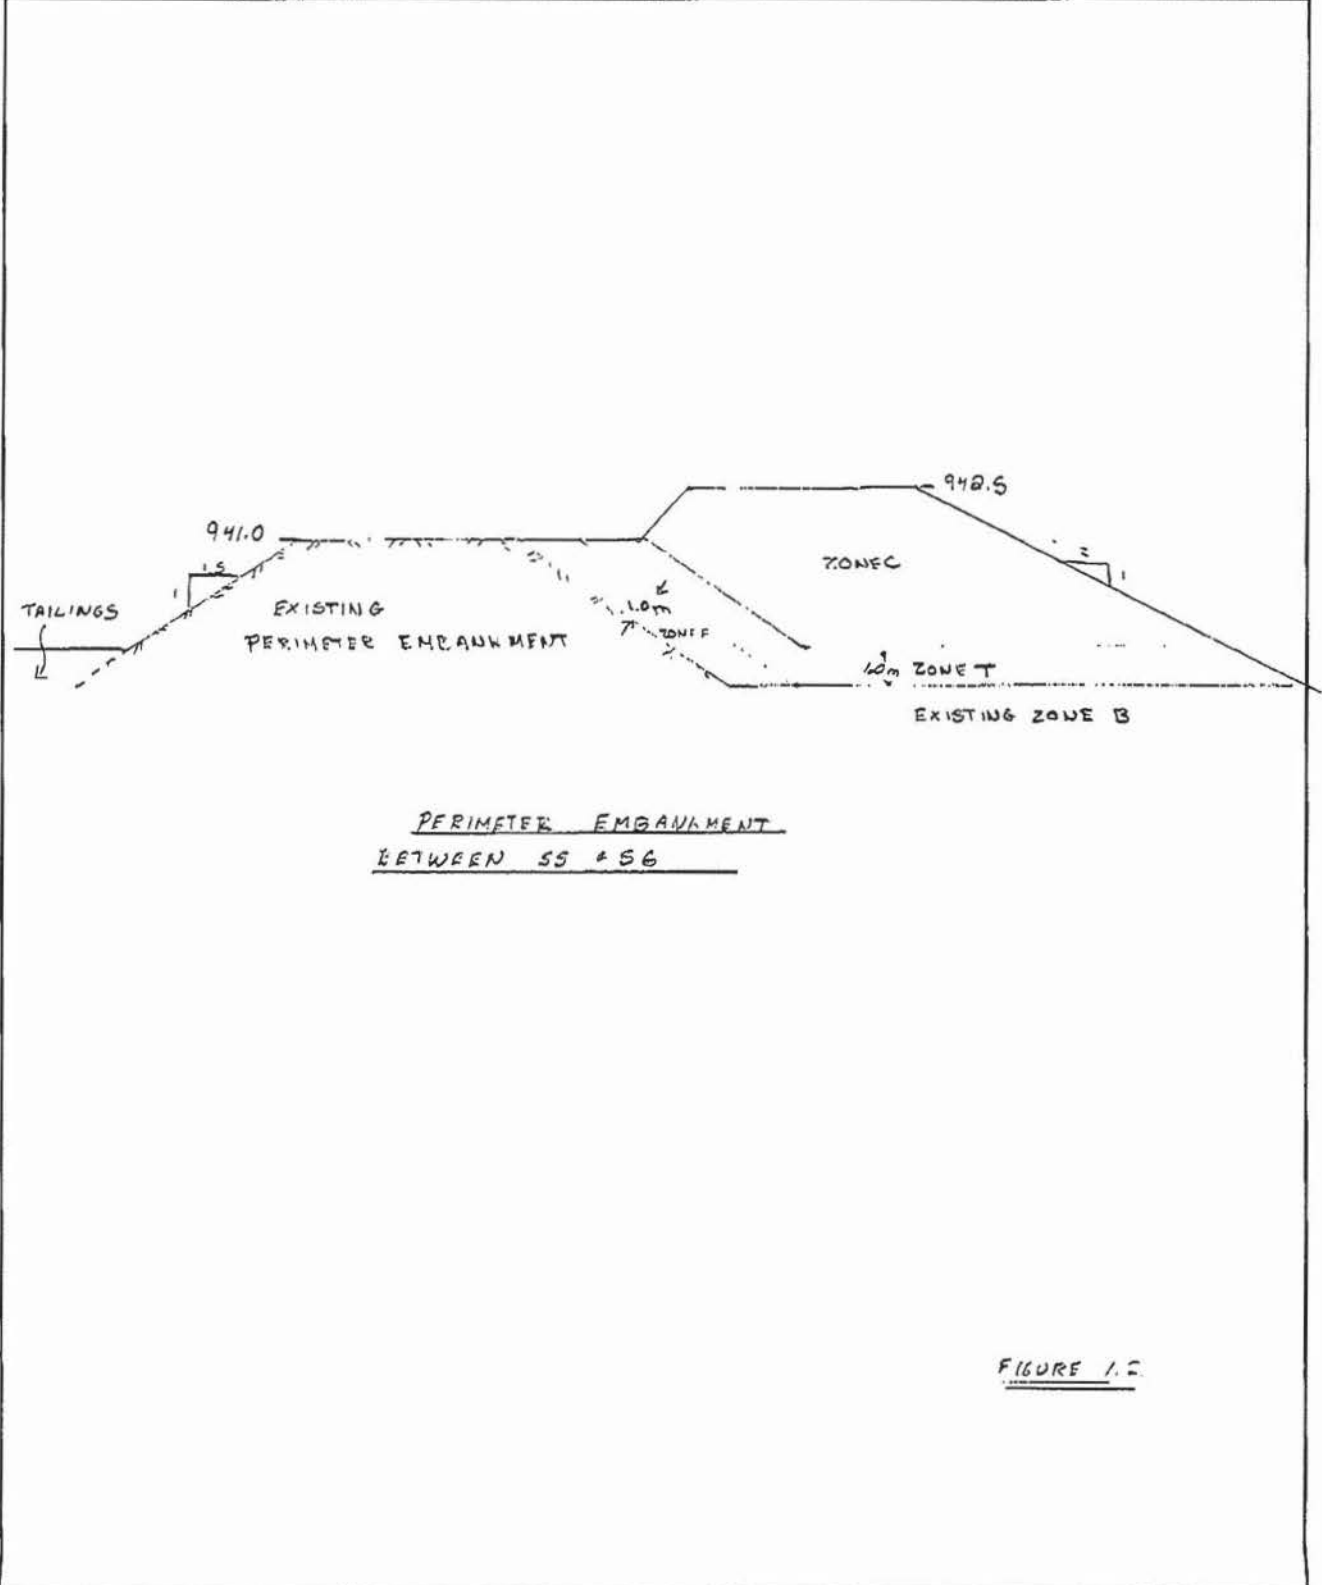
FIGURE 1.2

Along the south 400m, between Setting Out Points S5 and S6, MPMC has provided the required freeboard by downstream placement of filter sand and rockfill to the configuration shown on Figure 1.2.

The Perimeter Embankment Zones T and C have been constructed to El. 942.5 m between setting out points S5 and S6 as shown on Figure 1.2. The Zone F chimney drain has been constructed to 941.0 m in this area, and will be extended as necessary during the next stage of construction.

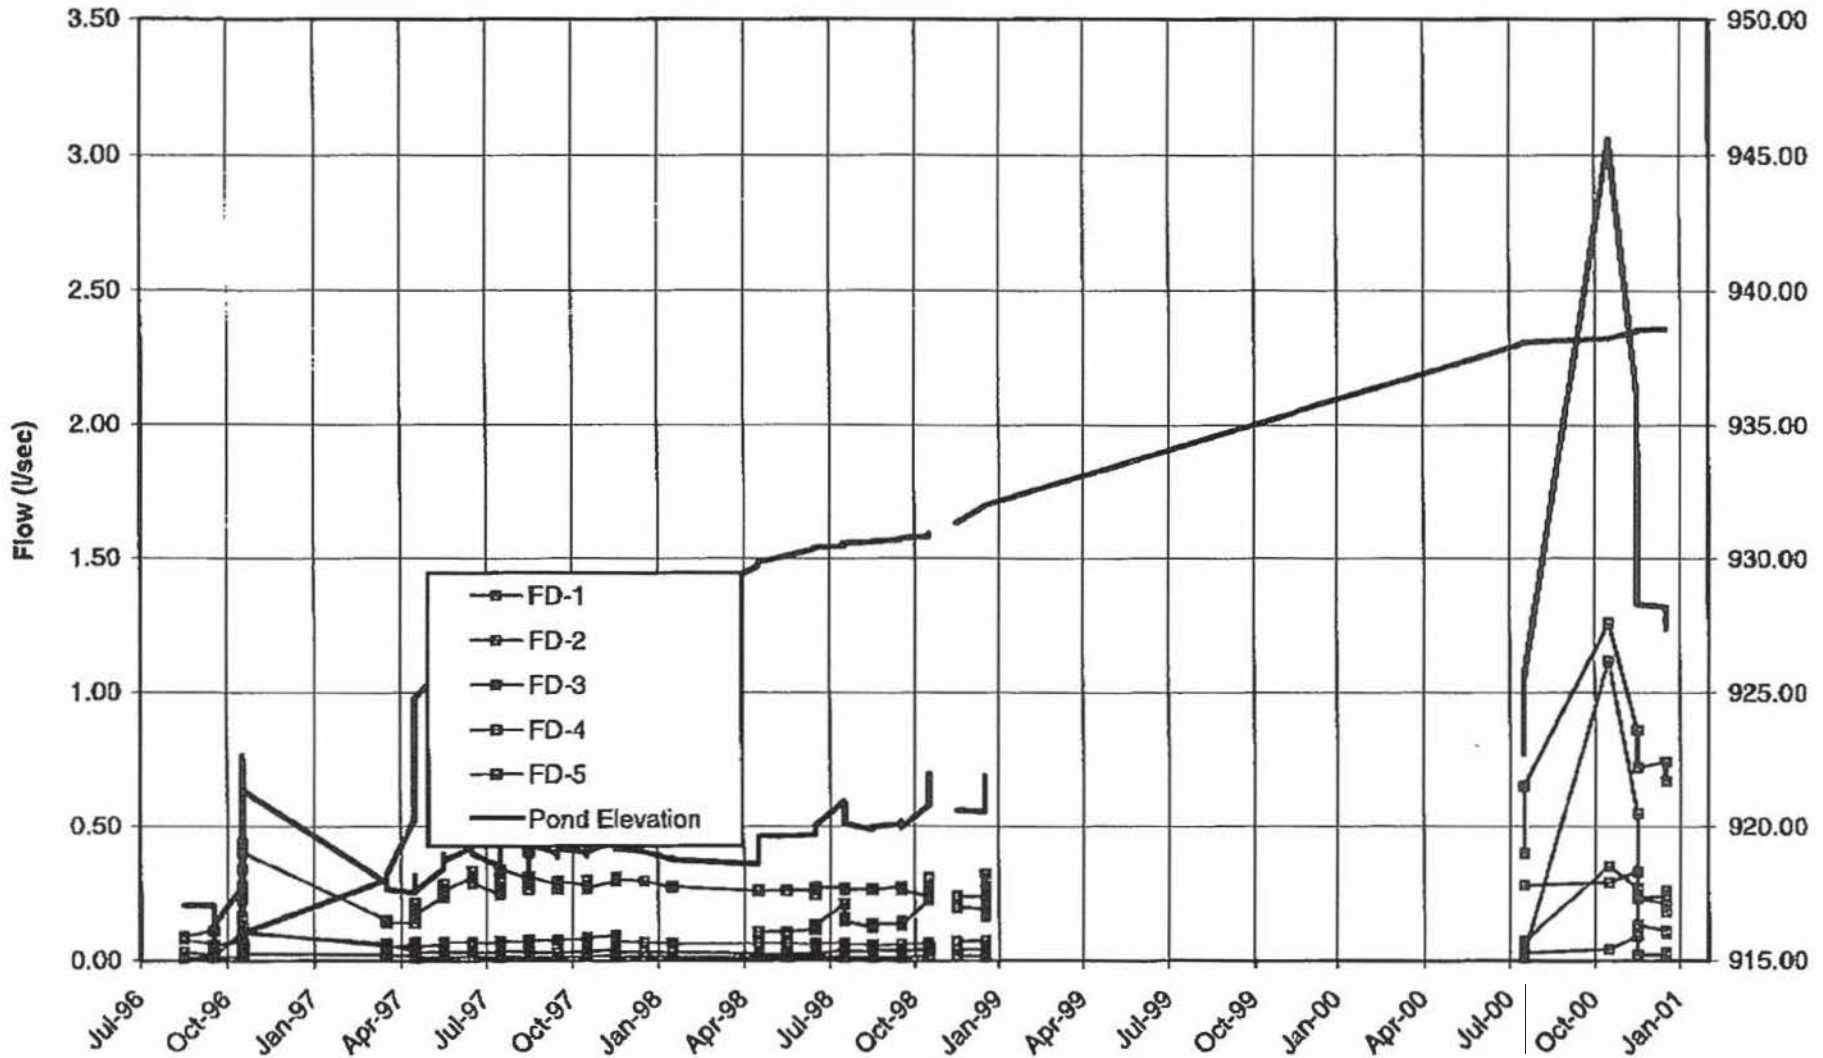
MOUNT POLLEY MINING CORPORATION			
MOUNT POLLEY MINE			
TAILINGS STORAGE FACILITY MAIN EMBANKMENT FOUNDATION DRAIN FLOWS			
<b><i>Knight Piesold</i></b> CONSULTING	PROJECT NO.	REF. NO.	REV.
	11162/13	0/2934	0
FIGURE 4.6

As noted in Progress Report No. 6, drain flows recorded on October 24 showed anomalously high flow rates for several of the Foundation drains, possibly due to surface water inflows or to a high pond level in the Recycle Pond which is believed to have caused water to back up and flood the drains and backfill. Four sets of readings have been obtained since, with the latest set taken December 12. These latter readings indicate that the fill is draining and the rates are returning to previous low rates.

The readings in all cases show a significant decrease from the anomalous values, although some of the readings still remain slightly above the range of previously recorded values. There has been no visible sediment in the flows from the foundation drains.

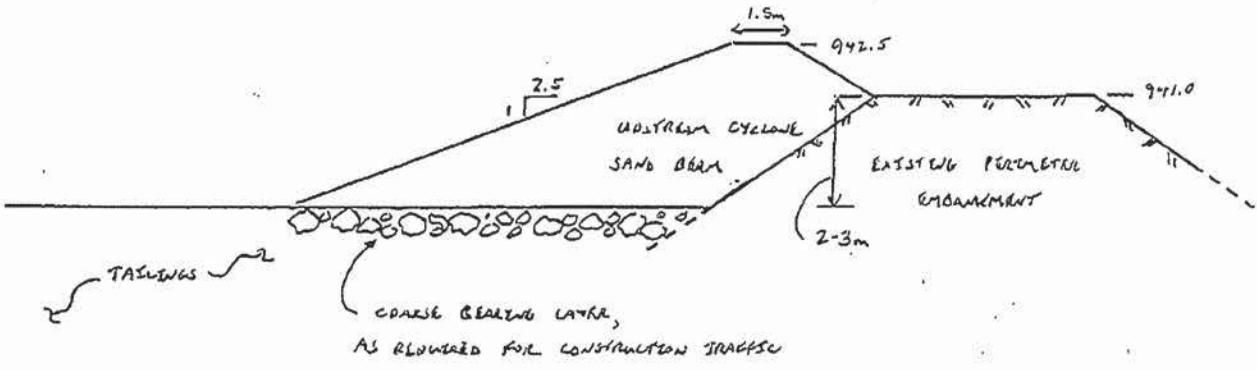
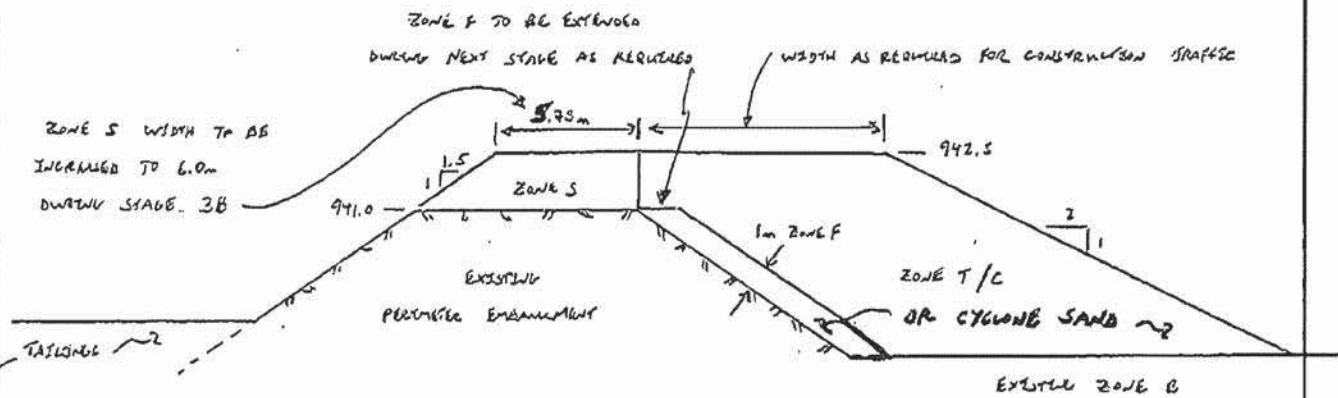
ALTERNATIVE OPTIONS FOR RAISING OF PERIMETER EMBANKMENT BETWEEN 55 + 56

If, however, freezing conditions prevent cycloning and completion of the berm by this method, the section of the embankment between setting out points S5 and S6 will be constructed by one of the two methods shown on Figure 1.3. The first method (A) involves mechanical placement of the upstream sand berm, using a coarse bearing layer as necessary to support construction traffic. The second method (B) involves downstream construction of Zone F, T, and C fills, or cycloned sand, and may include raising of the embankment Zone S core against the downstream fill.

- Complete cycloning along designated embankment section. Remove cyclones from crest and smooth out top of hydraulically placed sand.
- Move tailings line onto sand.
- Prepare crest of existing embankment (grade off unsuitable material) in preparation for Zone S placement along low areas.
- Place Zone S till on crest as required to raise to 941.0 m.
- Shape upstream sand berm to configuration shown on Figure 1.2.
- If freezing conditions do not permit completion of hydraulically placed upstream berm, raise section between S6 and S5 using one of the methods shown on Figure 1.3.
