MOUNT POLLEY MINING CORPORATION		
MOUNT POLLEY MINE		
TAILINGS STORAGE FACILITY MAIN EMBANKMENT FOUNDATION DRAIN FLOWS		
<b><i>Knight Piésold</i></b> CONSULTING	PROJECT NO. 11162/13	REV.
	REF. NO.	REV.
FIGURE 5.8

TAILINGS STORAGE FACILITY  
STAGE 3 TAILINGS EMBANKMENT  
INSTRUMENTATION  
SECTIONS - SHEET 2 OF 2

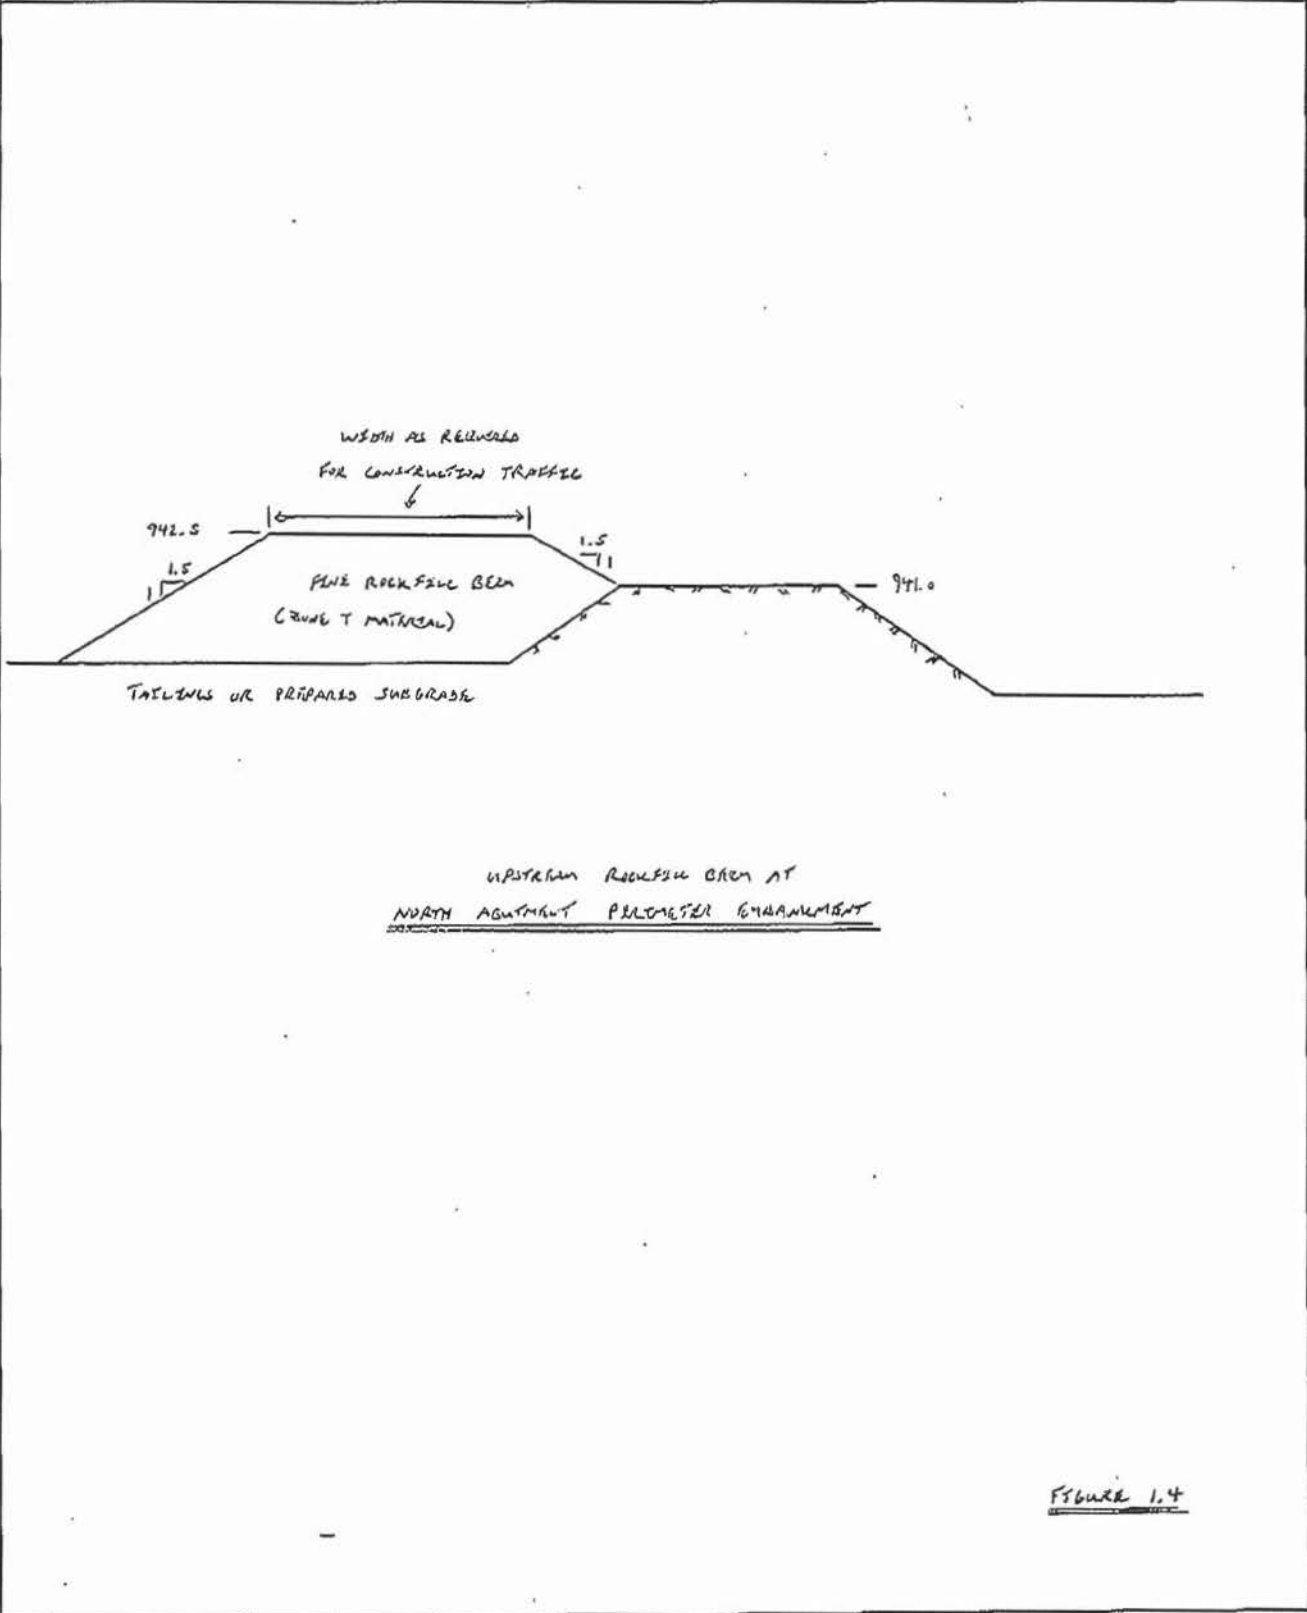
FIGURE 1.4

At the north abutment of the embankment, an approximately 75 m long section of the berm has been constructed from fine rockfill (Zone T material) to the approximate configuration shown on Figure 1.4. The reason for this is that the cyclones could not properly reach this area and were trapping water and slimes against the abutment.

- Move tailings line and prepare foundation at north abutment of embankment. Construct upstream rockfill berm to configuration shown on Figure 1.4.
- Construct ramps on downstream side of embankment as necessary to access embankment crest.

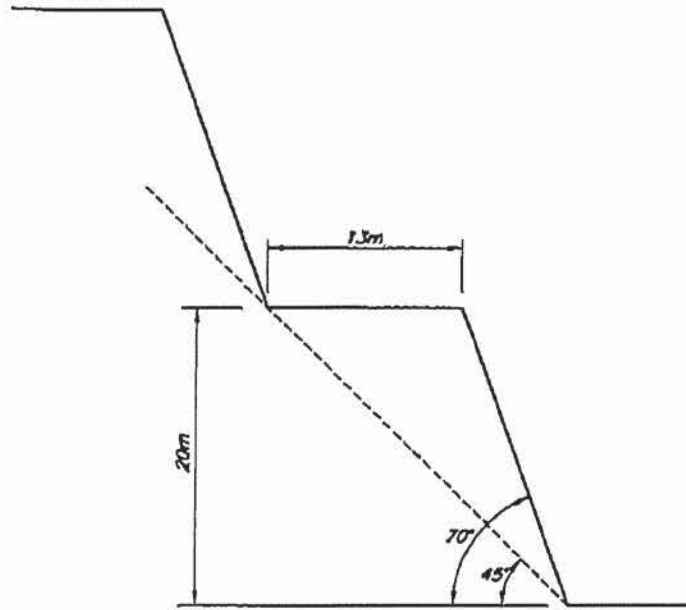
NORTHWEST WALL

NOTE: Plane A dipping at 45° out of northwest wall may result in partial loss of berm.

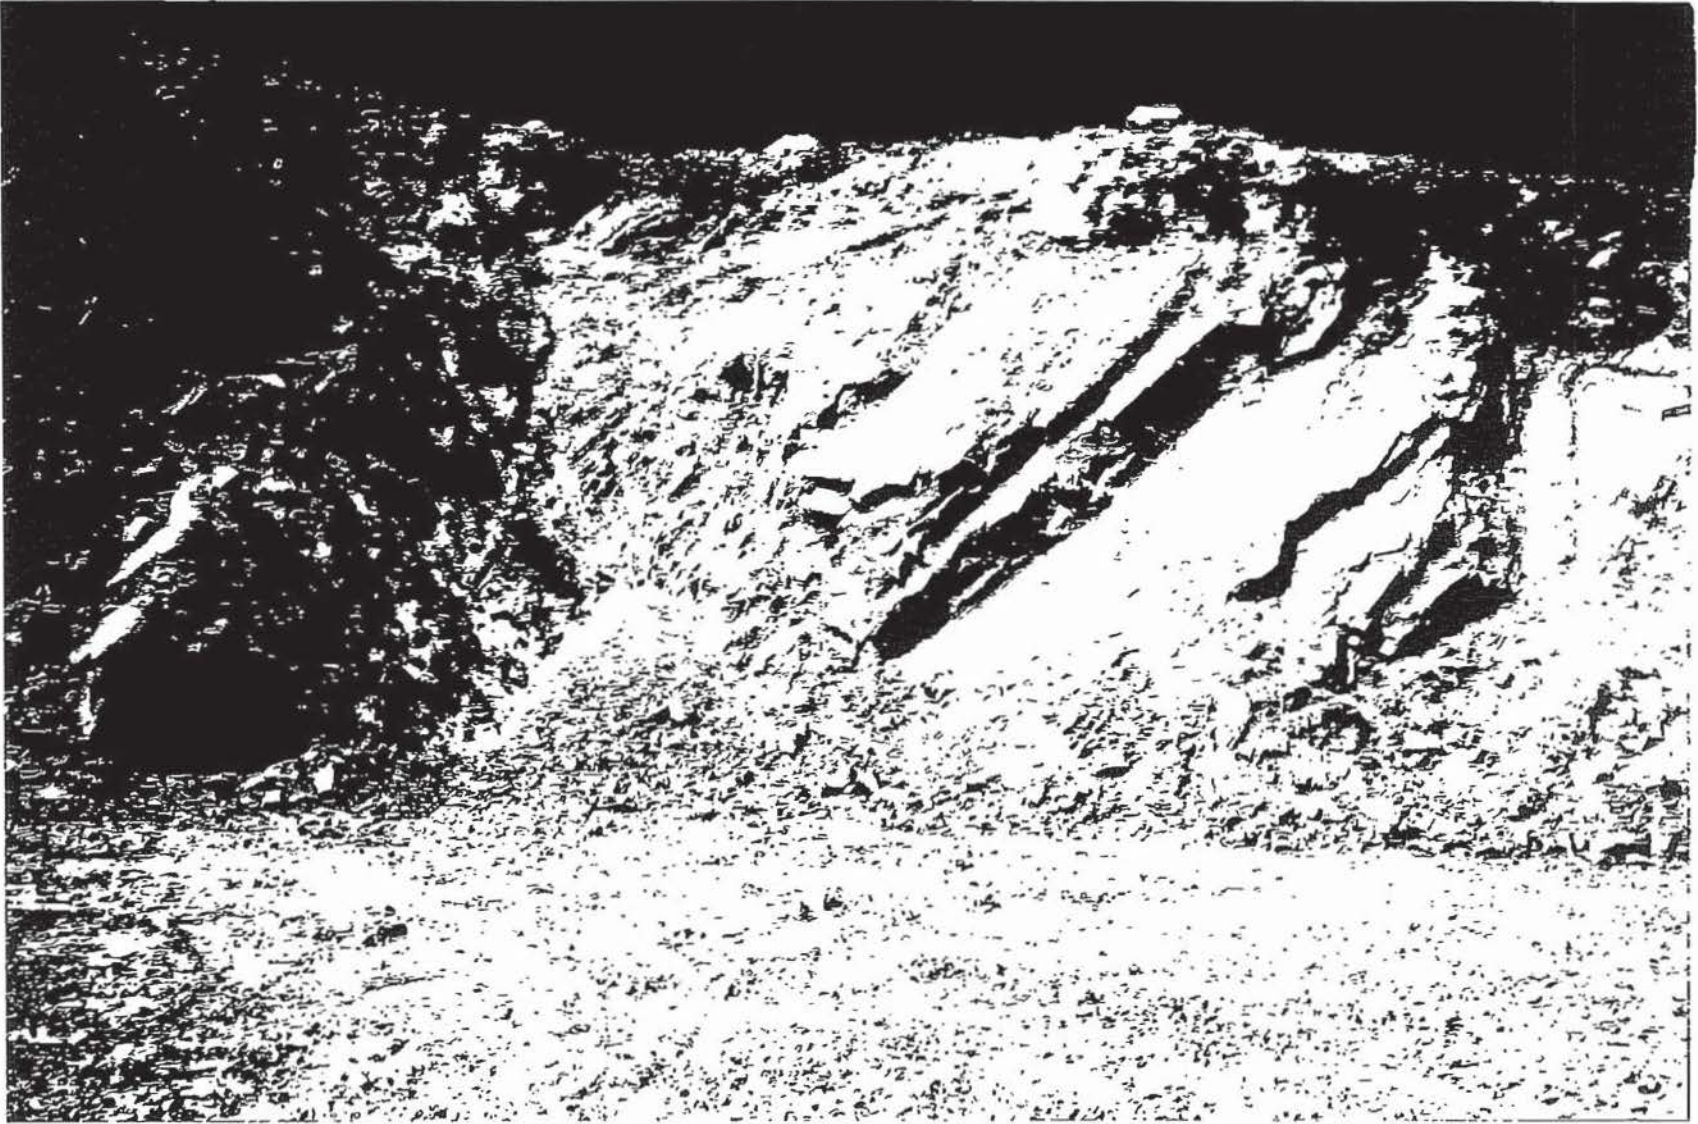
The type of instability along the northwest wall is characterized by planar sliding due to Plane A that strikes sub-parallel to and dips out of this wall as illustrated in Photograph 1. This type of instability results in slabs sliding into the Rock Borrow, although the close joint spacing of Plane A limits the size of the slabs. The proposed MPMC design bench configuration with a 10m berm (and bench height 20m) results in an inter-ramp angle approximately equal to the average dip of Plane A (49 degrees). The proposed design can be expected to give rise to further sliding and slabbing with subsequent excavation of the lower benches.

Photograph 1: Northwest Wall. 70 degree bench face angle undercuts Joint Set A causing sliding and slabbing.

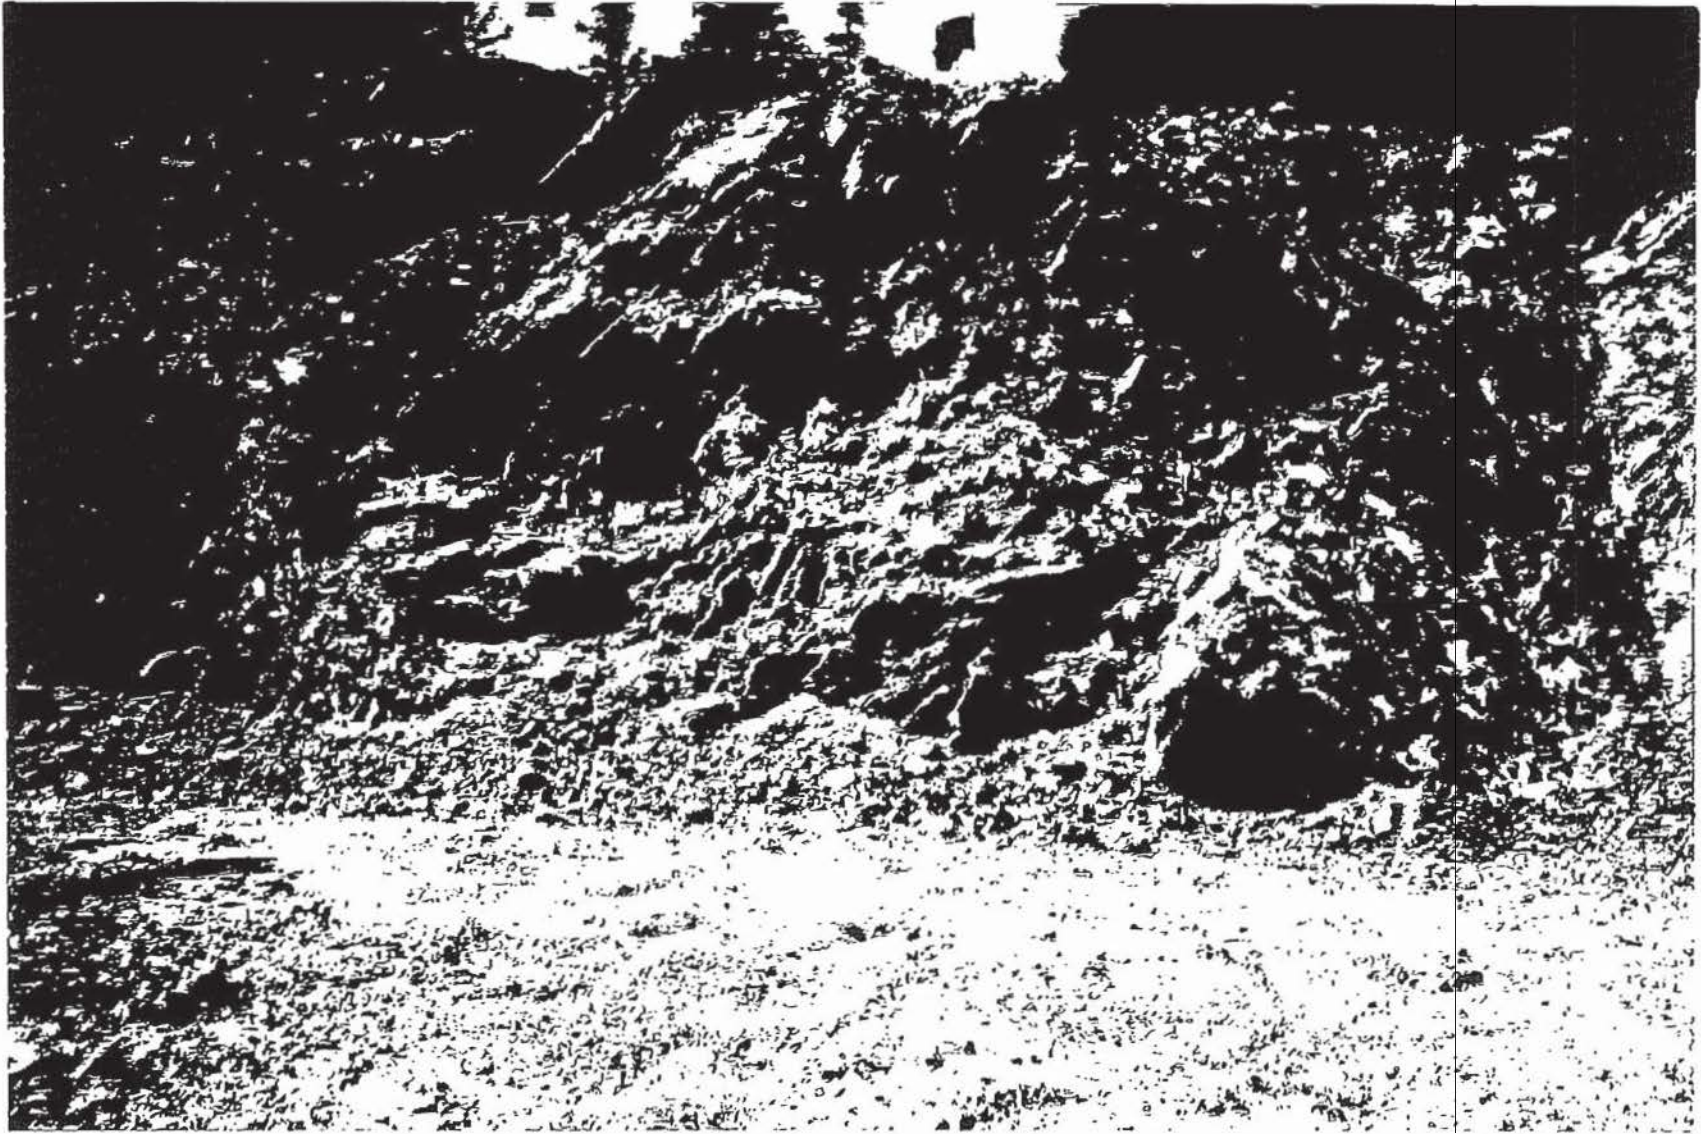
spacing of Plane B limits the size of the wedges. This is illustrated in Photographs 2 and 3. The current MPMC design bench configuration with a berm width of 10m will serve to catch all small wedges and raveling along the southwest wall.

Photograph 2: Southwest Wall. Joint Set B strikes sub-parallel to the wall and forms a back plane for small wedges.

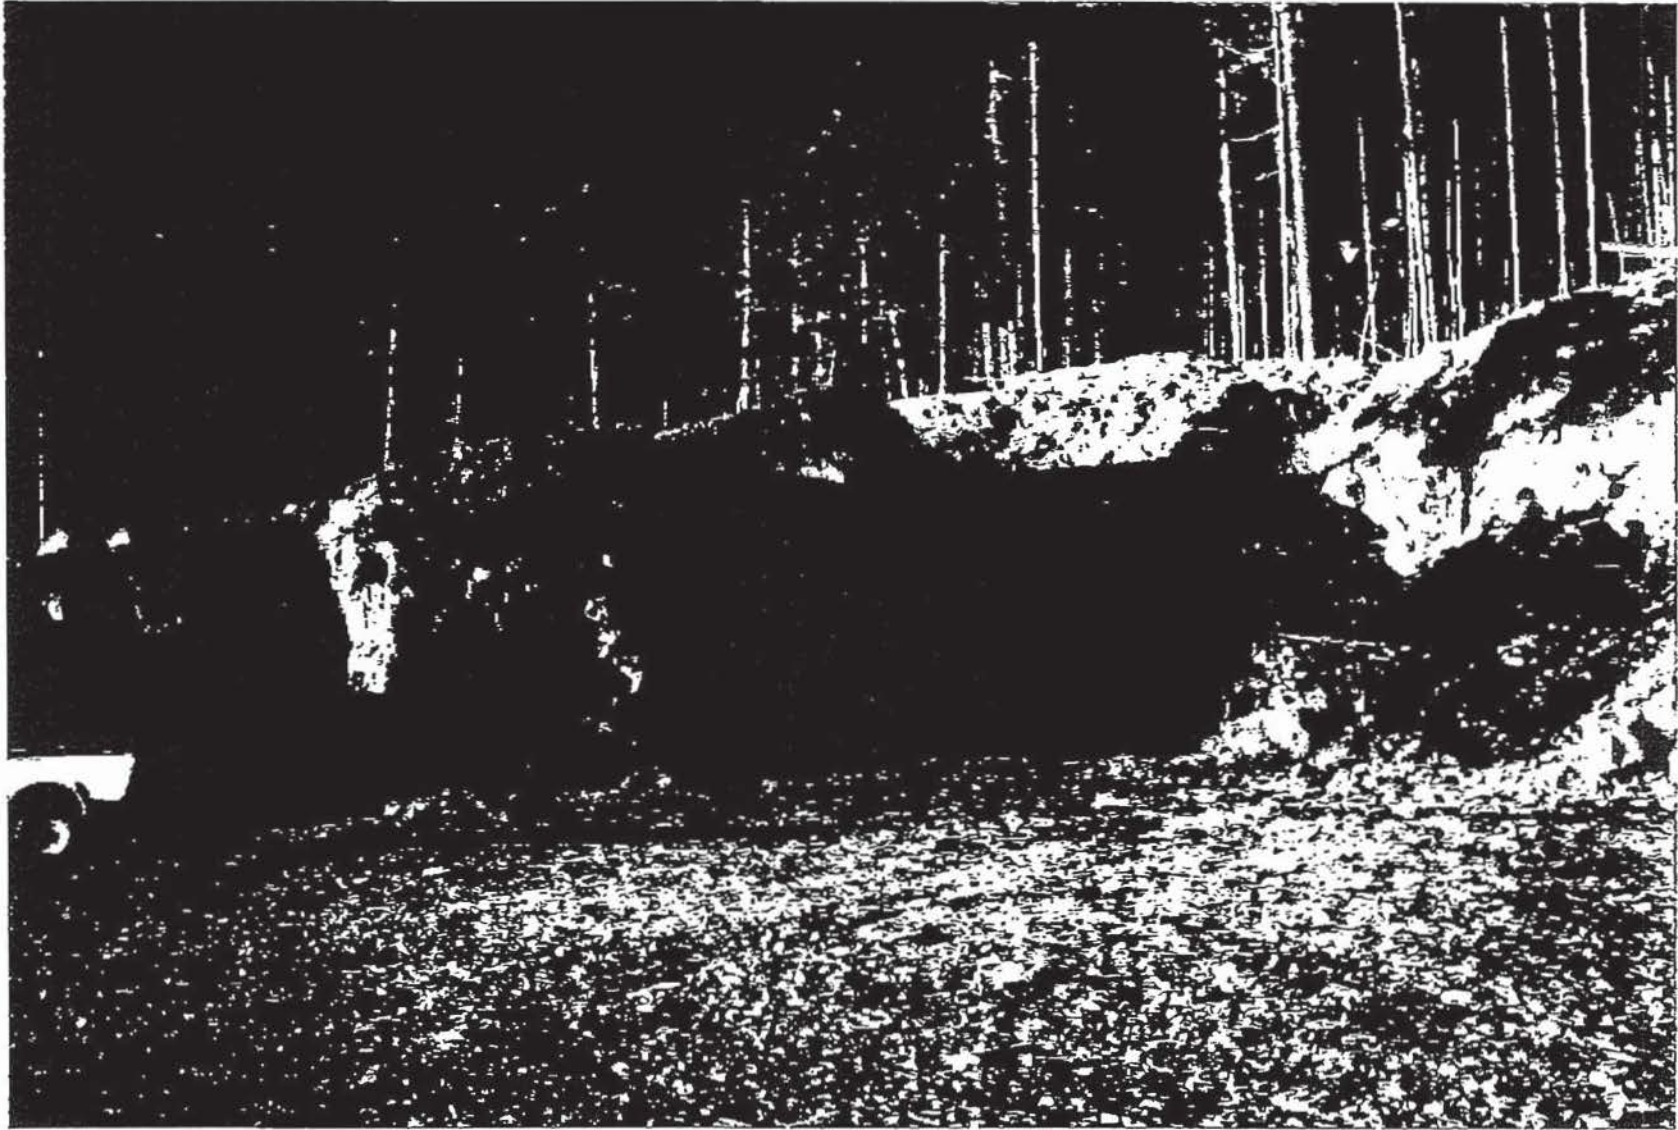
No types of failure or instabilities have been observed or are anticipated along the southeast wall since the dominant joint sets are favourably oriented as shown in Photograph 4.

Photograph 4: Southeast wall. Joint sets dip into the wall.
