From:	Luke Moger
To:	<u>Jim Kuipers (jkuipers@kuipersassoc.com);</u> "Chris Carr" s.22
Cc:	Demchuk, Tania MEM:EX; Adams, Rick MEM:EX; Don Parsons
Subject:	KCB Laboratory Reports
Date:	Wednesday, January 7, 2015 12:41:54 PM
Attachments:	image001.png 150105-RH14-10 SS01 33" 400 kPa - Static Simple Shear.pdf 150105-RH14-10 SS01 33" 800 kPa - Static Simple Shear.pdf 150105-RH14-22 SS02 30.5" 400 kPa - Static Simple Shear.pdf 150105-SH14-10A 06 400 kPa - Static Simple Shear.pdf 150105-UGLU Block Sample 400 kPa - Static Simple Shear.pdf 150105-UGLU Block Sample 800 kPa - Static Simple Shear.pdf 150105-RH14-03A SS03 400 kPa - Static Simple Shear.pdf

Breach Repair and Perimeter Embankment Buttress Design for 2015 Embankment]

Chris Carr, P. Eng. Geotechnical Mines Inspector On behalf of Ministry of Energy and Mines

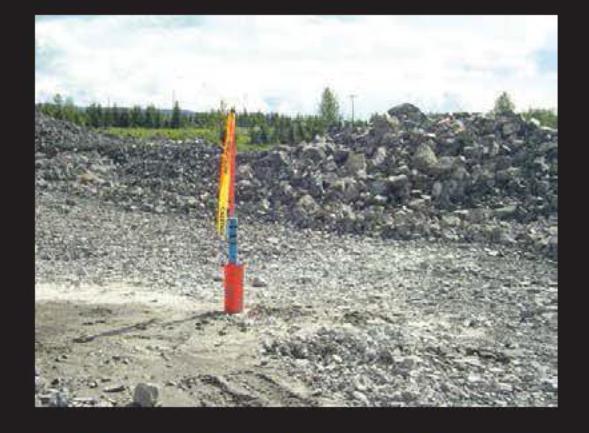
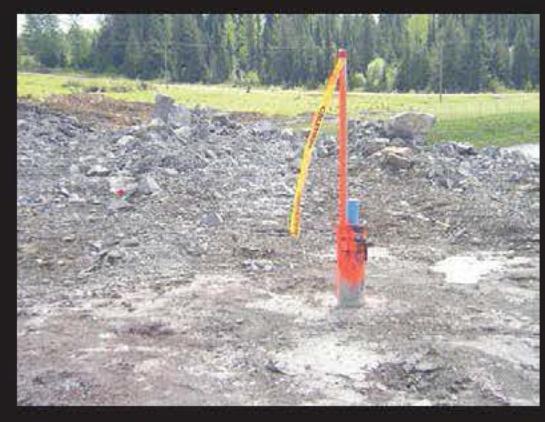
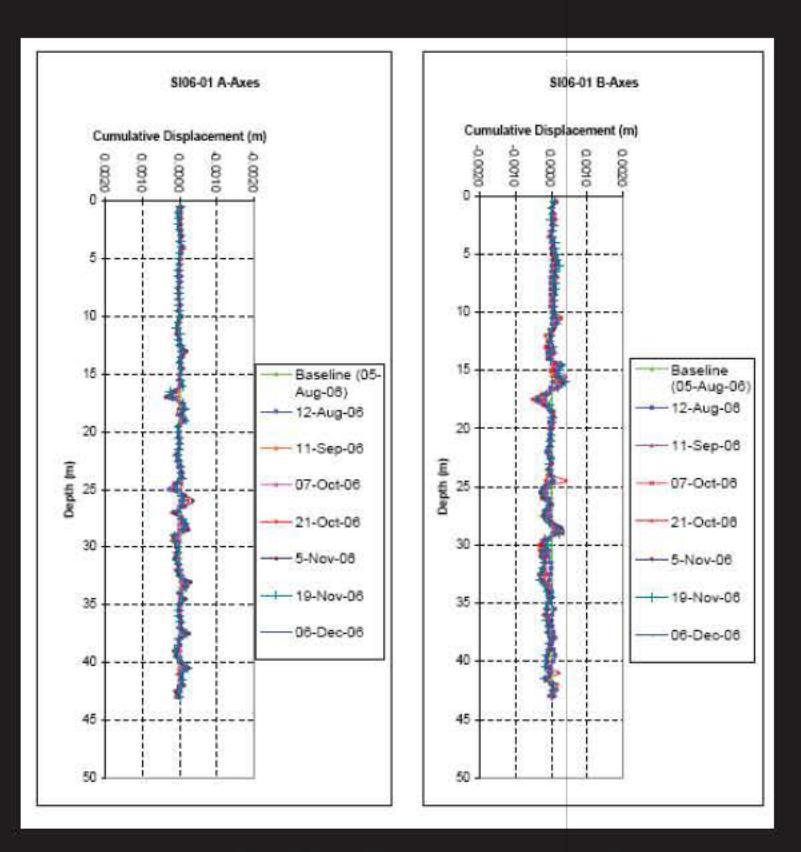
Inclinometer readings

Typical inclinometer reading

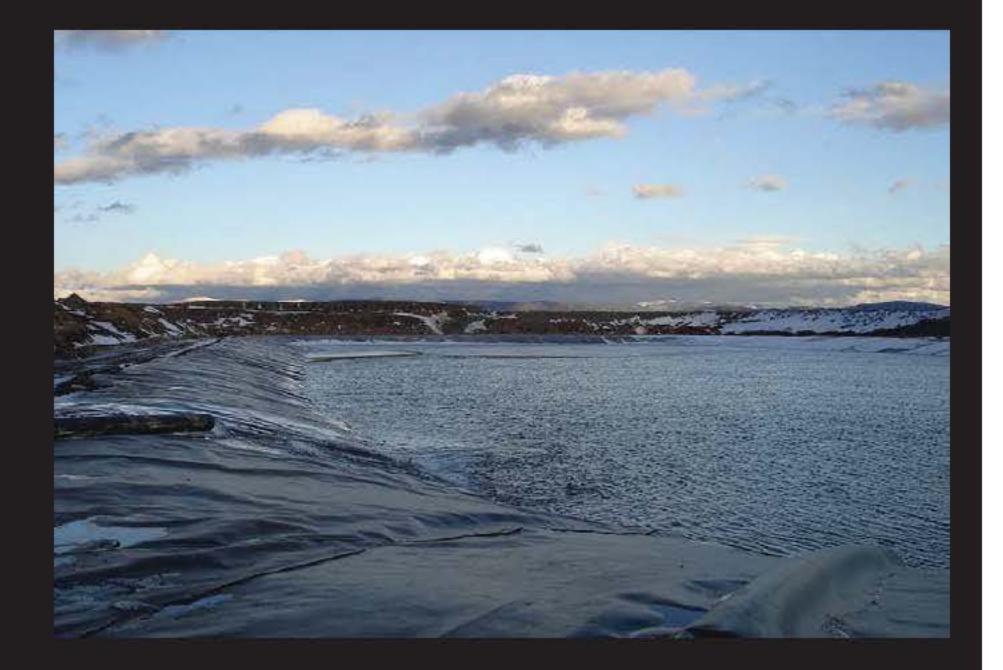
Test Heap Leach Pad - Overview

- Constructed between August and November 2006.
- Hydrostatic Test was passed in December 2006,
 - Items to complete:
 - Drainage pipe collection system
 - Protective drainage layer.

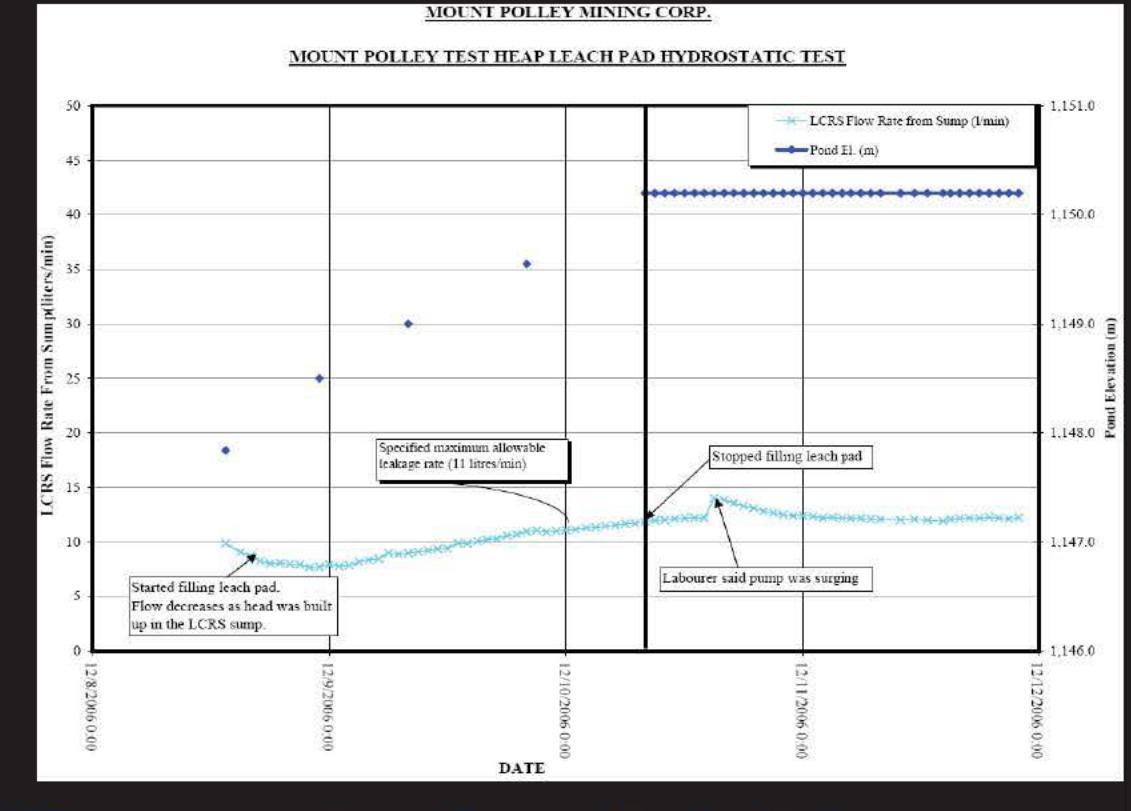
Test Heap Leach Pad -Hydrostatic Test

Filled with water pumped from the Cariboo Pit.

Test deemed complete when leakage rate stabilized at 12 l/min after 24 hours.

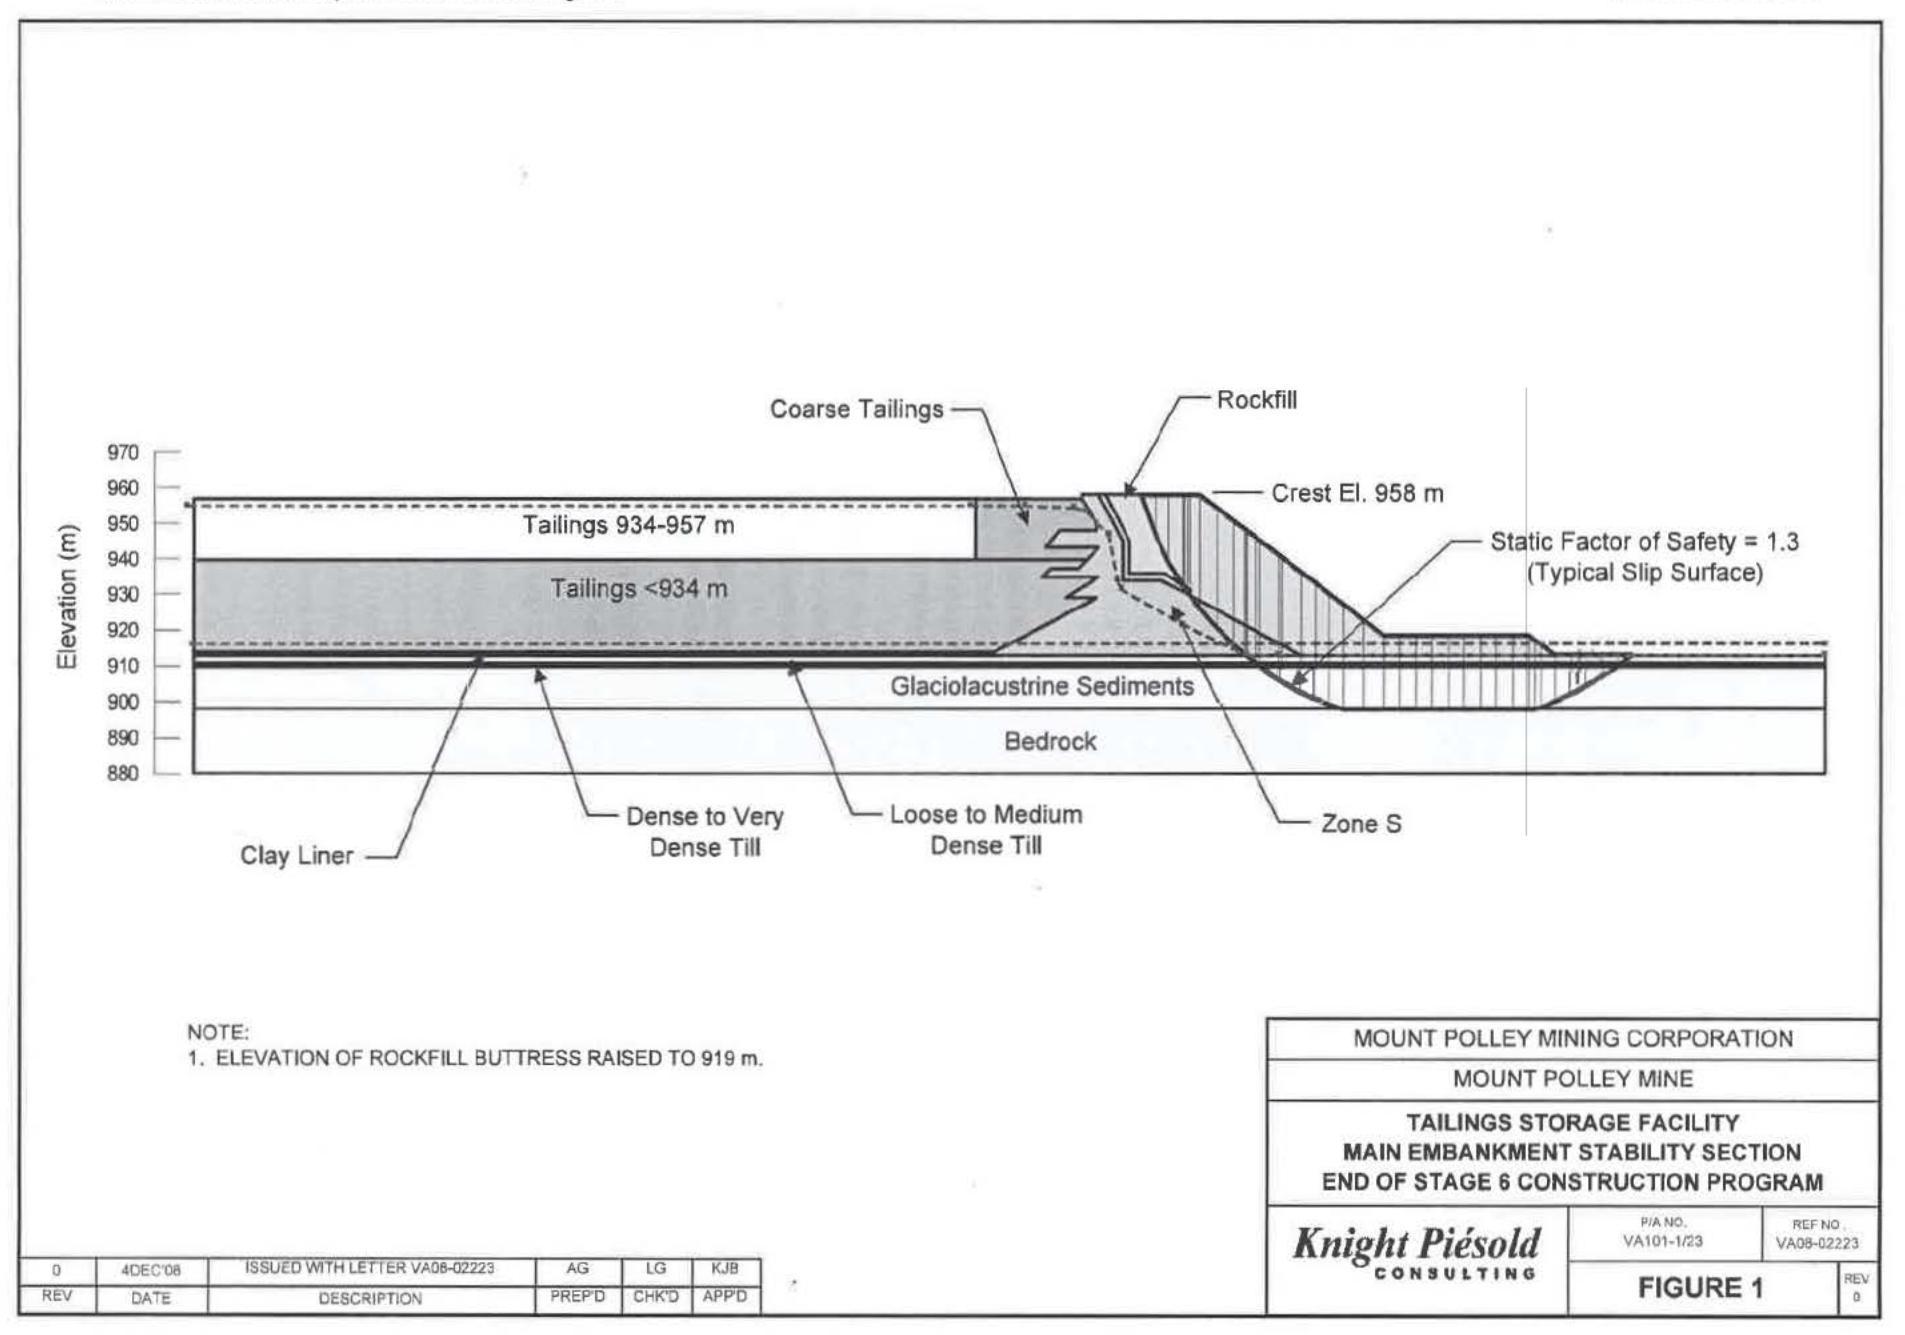
VA08-02223 December 5, 2008 M:\1\01\00001\23\A\Correspondence\VA08-02223\Figure 1

The cross-section used for the stability analysis for the Main Embankment is shown on Figure 1. The cross-section includes the following:

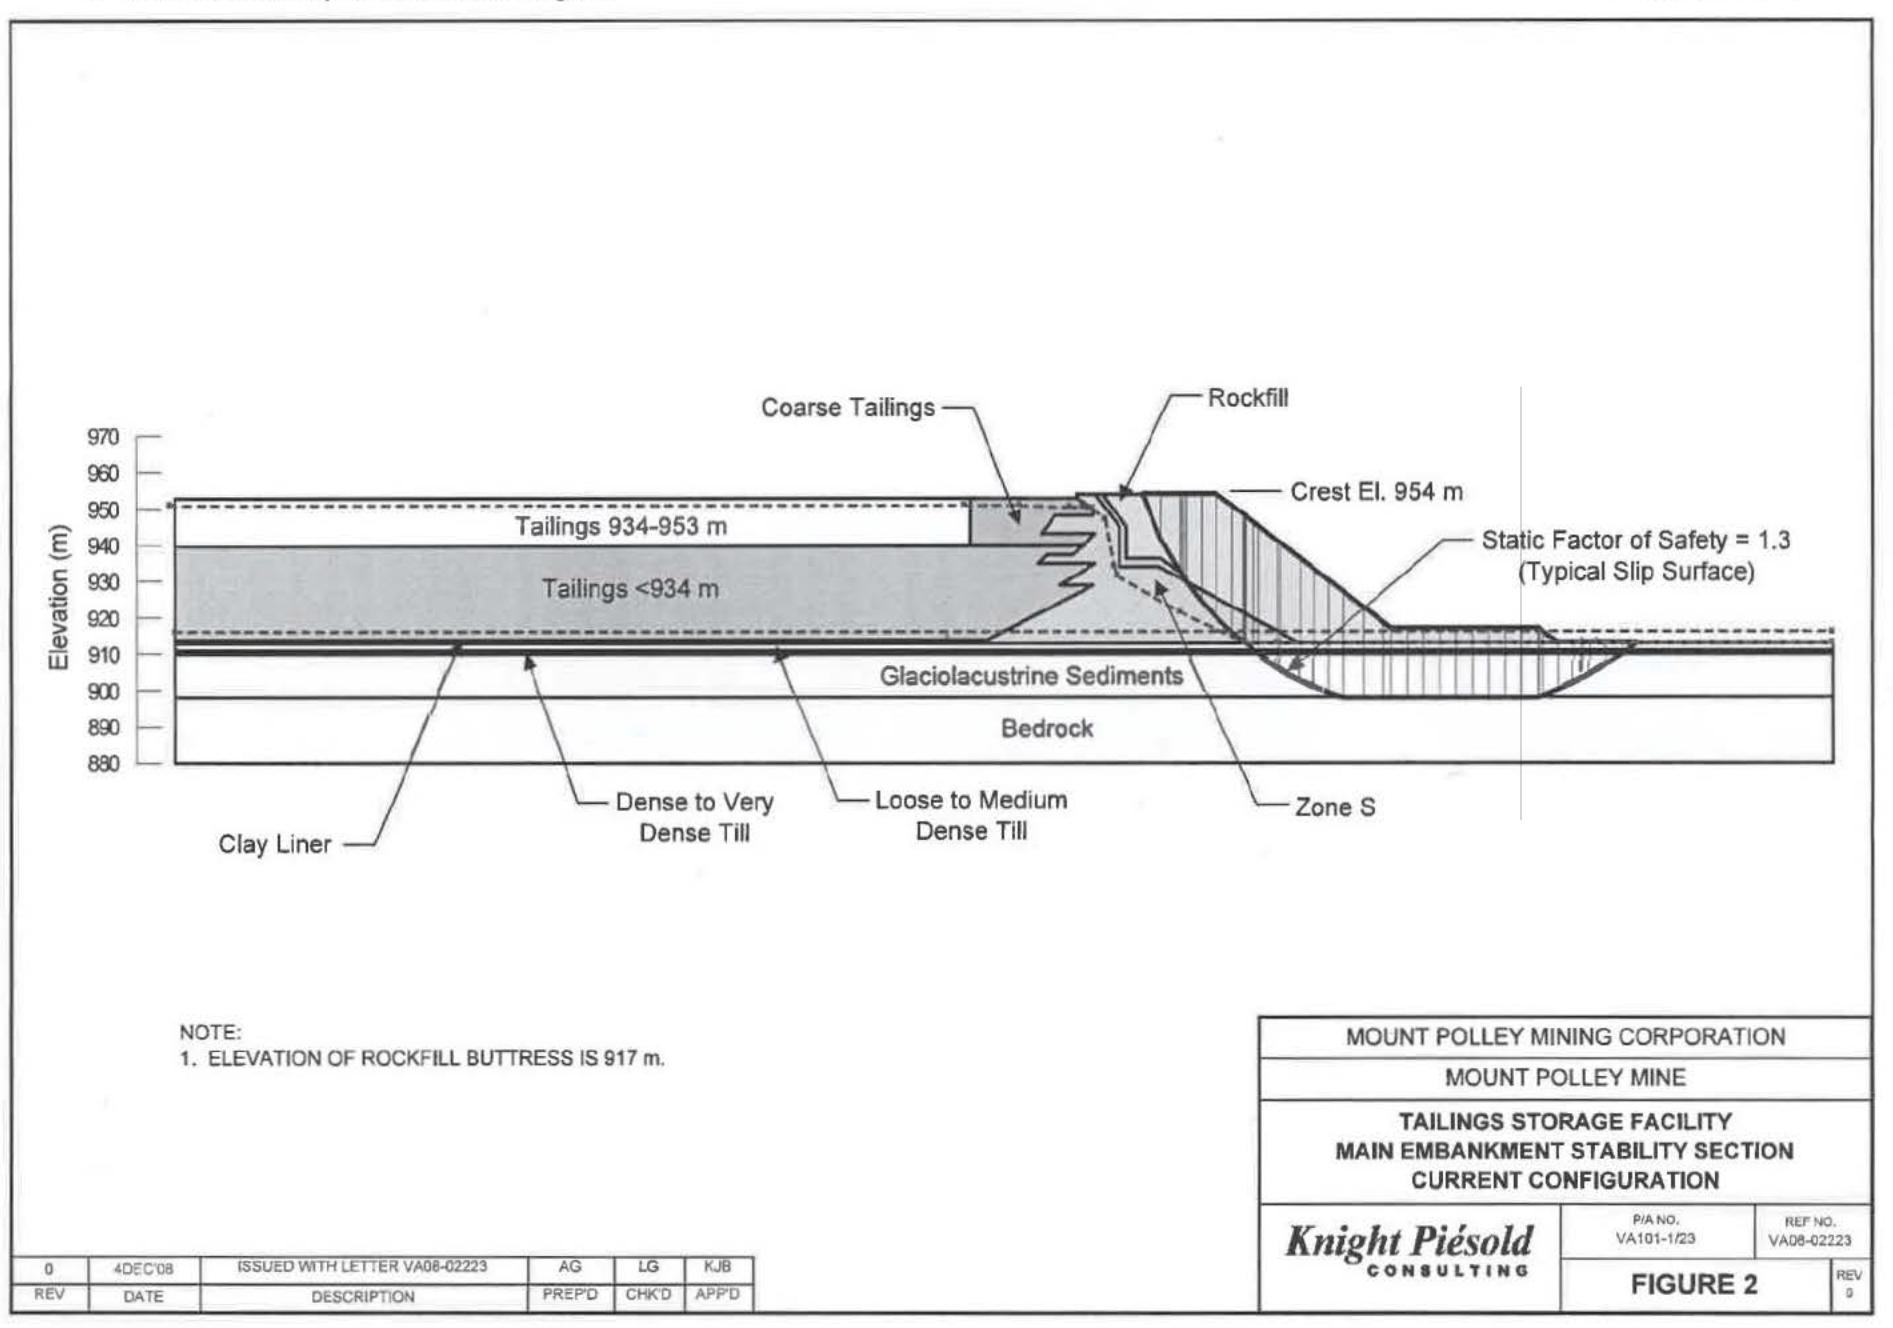
EMAILS_Part 6-1 Page 202 of 400
M:\1\01\00001\23\A\Correspondence\VA08-02223\Figure 2

The slope stability model mentioned above was also utilized to determine the static factor of safety of the Main Embankment with the current elevation of the embankment crest. The cross-section used for this stability analysis is shown on Figure 2. The cross-section includes the following:

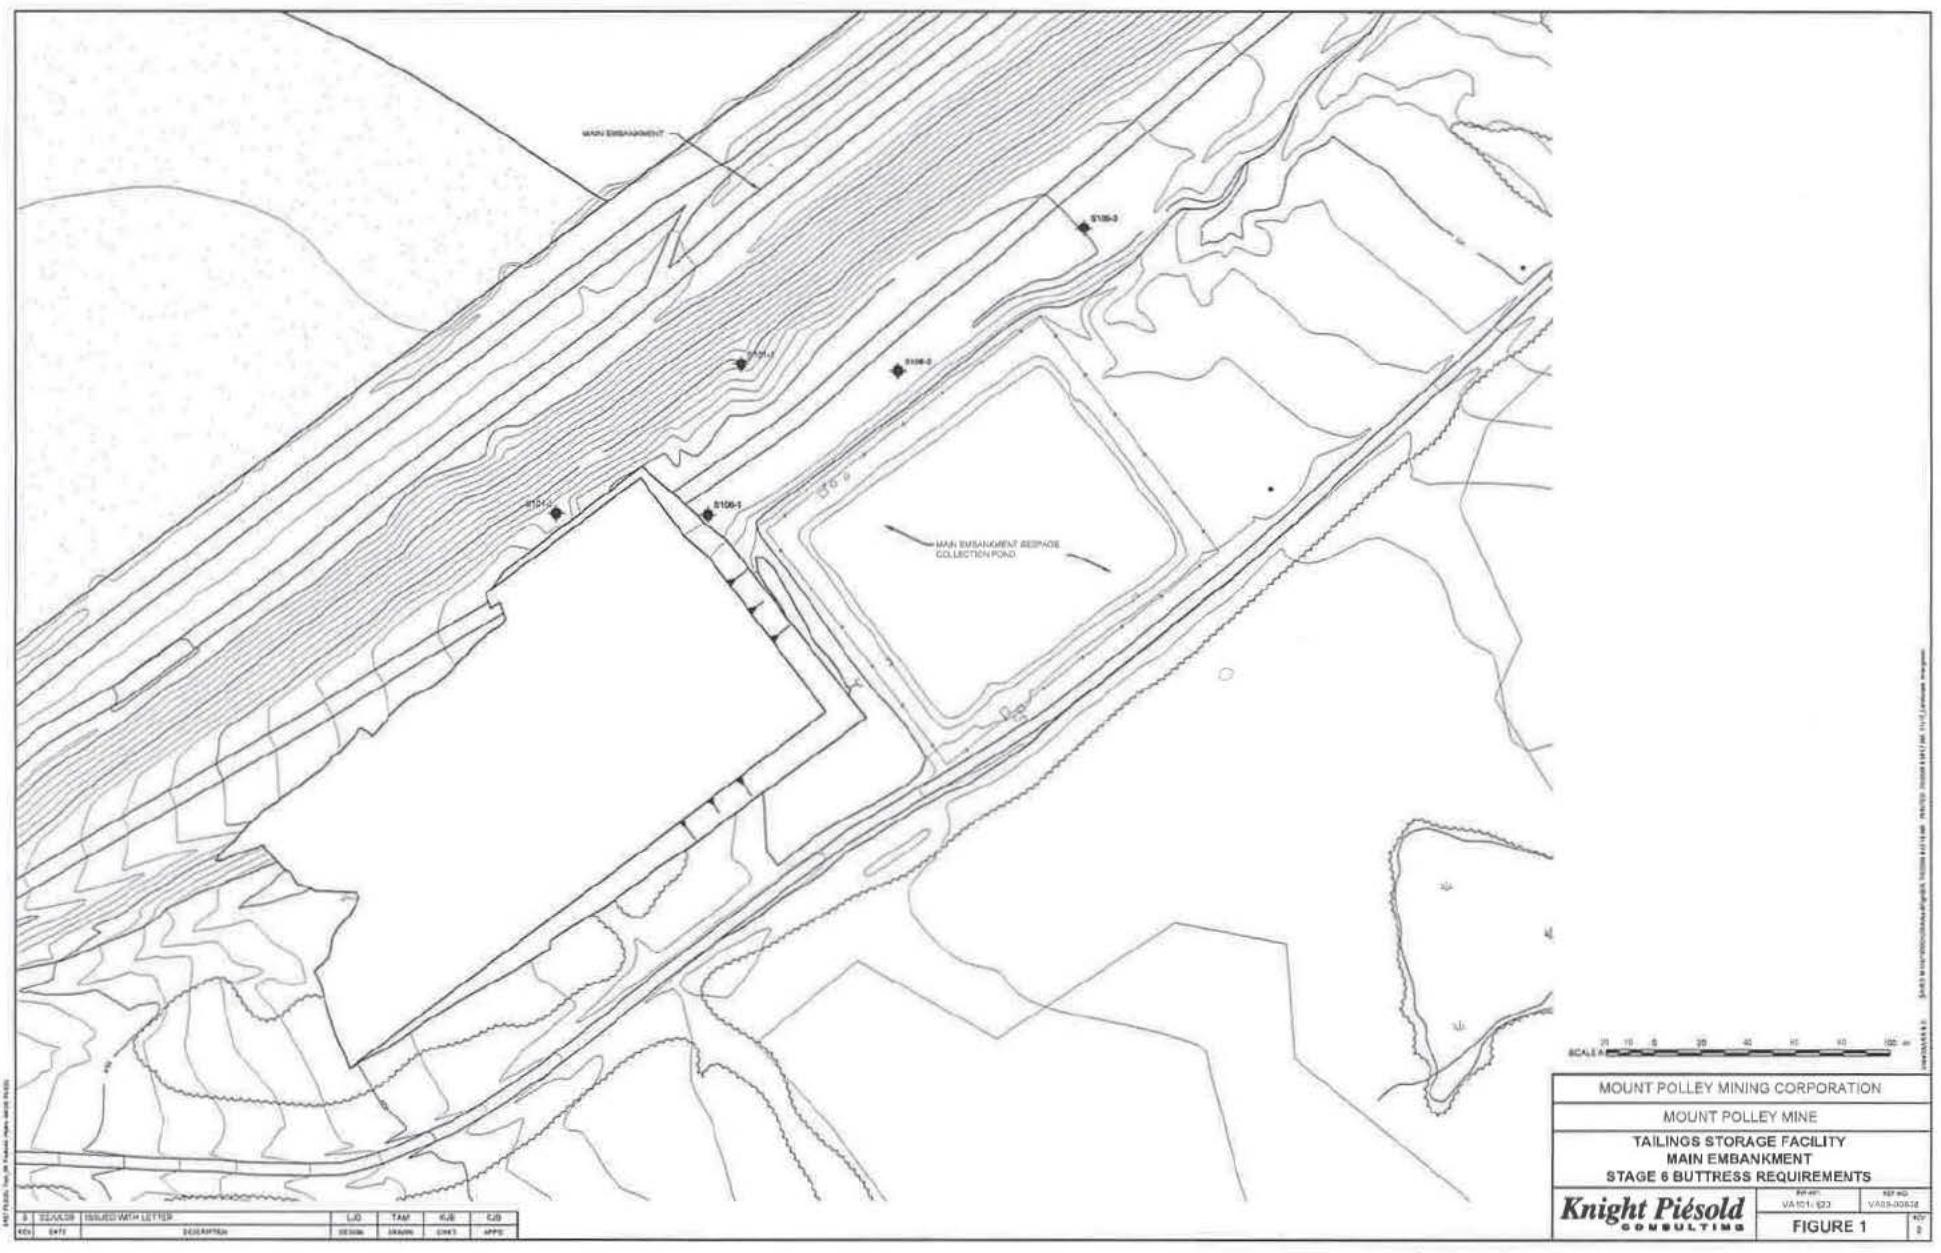
Attachments: Figure 1 Rev 0

The approximate extent of the buttress for the west side of the Main Embankment is shown on Figure 1.
