Province of British Columbia  
MINISTRY OF ENERGY, MINES AND  
PETROLEUM RESOURCES  
Mining & Mineral Division  
Report of Inspector of Mines  
(Issued pursuant to Section 15 of the *Mines Act*)

Inspection Report

NAME OF MINE	Westside Pit	LOCALITY	51.022, -118.221 Revelstoke
OWNER/OPERATOR	Interoute Construction Ltd.	ADDRESS	PO Box 9297 Revelstoke BC V0E 3K0
MANAGER	Roy Rokosh	AREAS INSPECTED	Pit and proposed expansion.

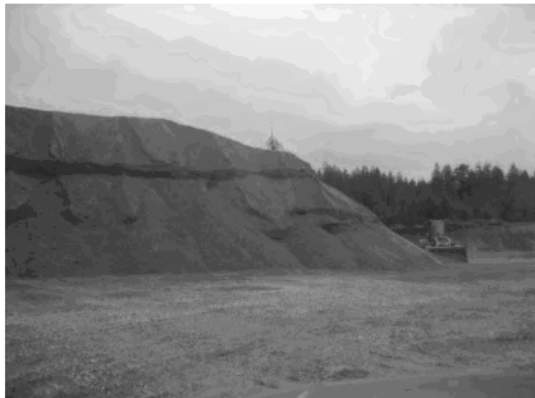
no vertical faces exceed two meters above the reach of the loading equipment pursuant to section 6.23.4 of the Health, Safety and Reclamation Code, to be completed immediately.

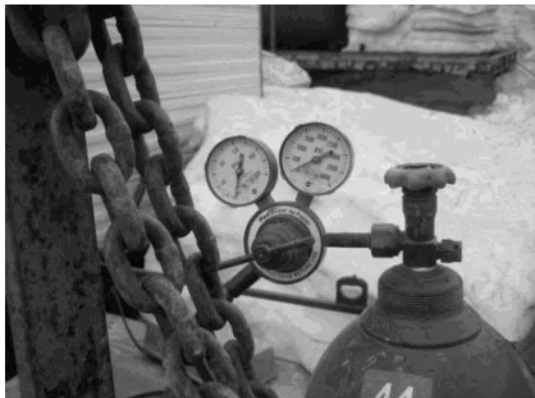
## SECTION : 1.9.1 General Workplace Conditions

Snow accumulations in and around the working areas have created a substantial hazard to slips and falls. The first aid / spill kit shed was not accessible. The manager shall have access to all areas re-established pursuant to section 1.9.1 of the Health Safety and Reclamation Code, to be completed immediately.

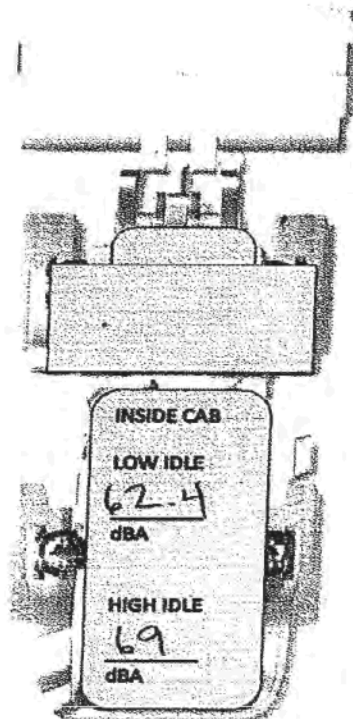
LOW IDLE  
77 dBA  
HIGH IDLE  
90.2 dBA

LOW IDLE  
59.5 dBA  
HIGH IDLE  
72 dBA

LOW IDLE  
78 dBA  
HIGH IDLE  
89 dBA

EQUIPMENT TYPE 980H Cat.EQUIPMENT CONDITIONS ~3 yrs old  
3391 hrs.
