Re: Mine Inspection February 9, 2010
Property: Kelly Pit

Mining & Mineral Division
Report of Inspector of Mines
(Issued pursuant to Section 15 of the *Mines Act*)

Inspection No.: 17393
File: 18080-02-02
Mine No.: 1620302
Permit No.:
Emp/Cont: 0 / 0
Orders H&S: 8 RECL: 0
Stop Work: 0

| NAME OF MINE | Kelly Pit | LOCALITY | Revelstoke Hwy 23N |

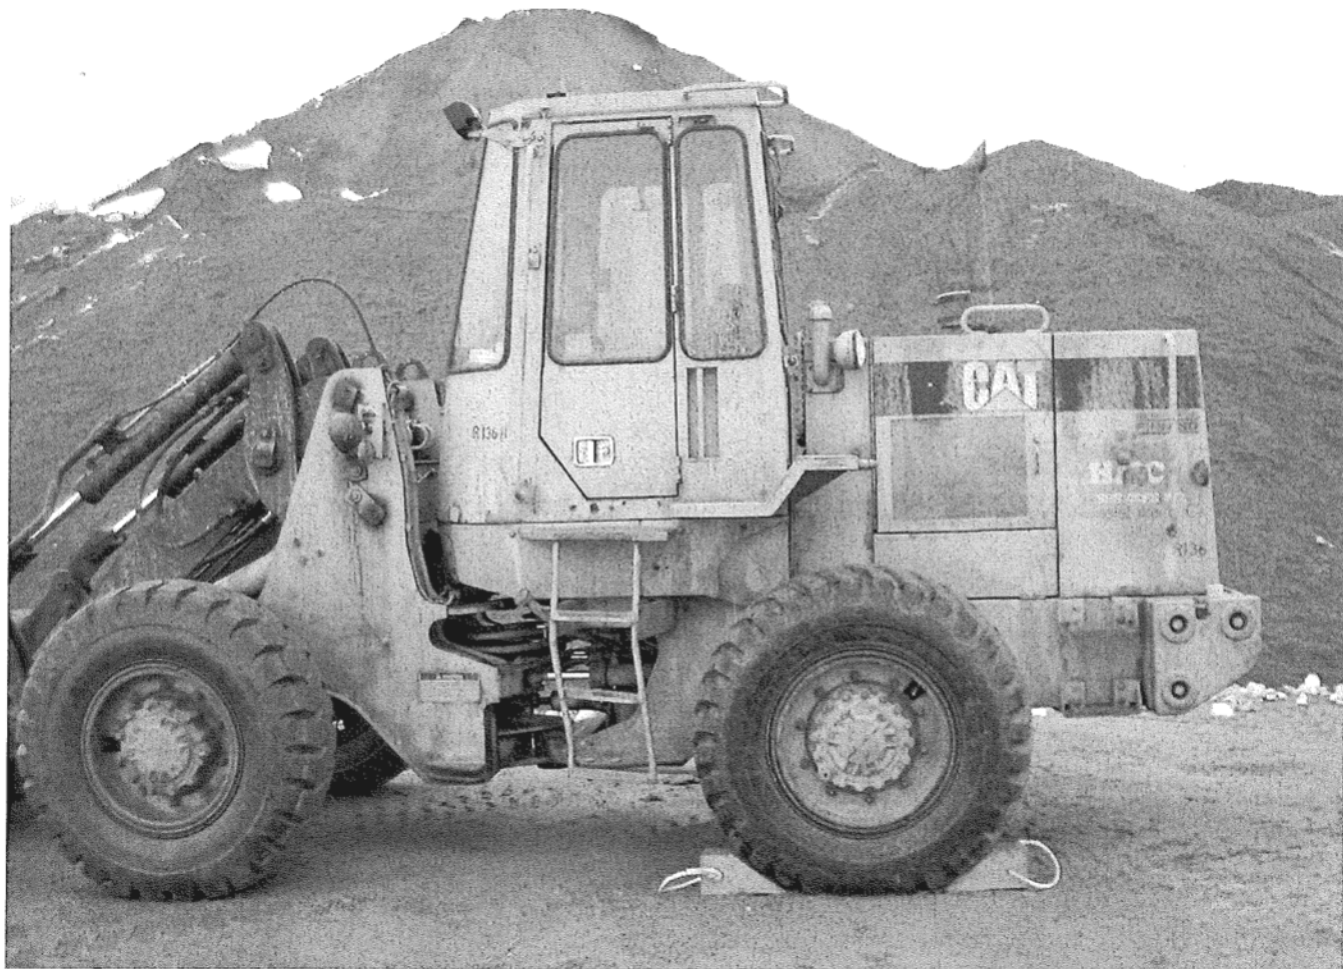
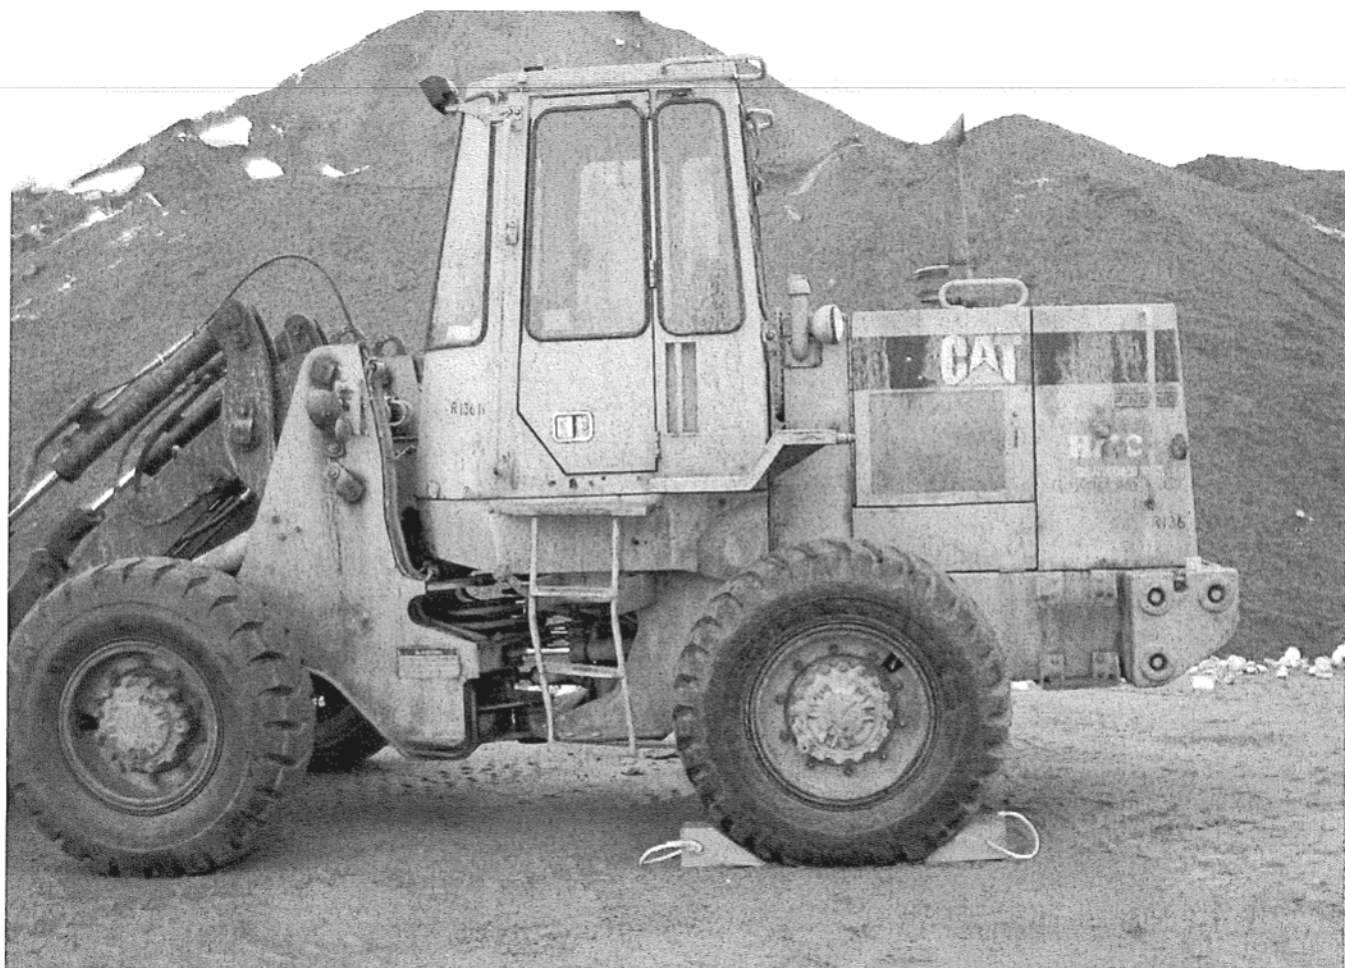
KELLY PIT.

| INSPECTION ORDERS | MANAGERS RESPONSE OF ACTION TAKEN |
|---|--|
| <p>working back up alarm should be noted in the logbook at the time of the pre trip inspection. To be remedied immediately.</p> <p>SECTION :4.9.3 Fire Extinguisher</p> <p>The Cat loader shall have a fire extinguisher of adequate size and the proper type, to be mounted in the loader. To be remedied immediately.</p> <p>SECTION :6.19.2 Logbook to be Maintained</p> <p>The Manager shall provide and maintain an effective logbook system for each unit of mobile equipment over 7000kg GVW where</p> <p>(a)the vehicle operator notes the operating condition prior to operating the vehicle,</p> <p>(b)note any unsafe conditions, and</p> <p>(c)a qualified person making repairs, notes any repairs made and if vehicle is safe to operate. To be remedied immediately.</p> <p>SECTION :6.23.3 Surface Mine Faces and Bench Heights</p> <p>No part of a face or wall of a surface mine shall overhang. To be remedied immediately.</p> <p>SECTION :6.23.4 Surface Mine Faces and Bench Heights</p> <p>Where material is being worked or removed, the vertical component of the mining face shall not be greater than 2 meters beyond the reach of the loading equipment. To be remedied before any material is removed from the face.</p> | <p>LOADER SENT TO SHOP</p> <p>NEW LOG BOOK IN CAT LOADER AND OPERATORS INSTRUCTED TO FILL OUT + MAINTAIN. FEB 10/10</p> <p>EXCAVATOR ON SITE FEB 10/10 @ 12:00</p> <p>OVERHANG + OVER HEIGHT RECTIFIED AS PER PHOTOS</p> <p>EXCAVATOR SENT TO AUCA Pit FEB 11/10</p> |
