Government takes action on Chief Inspector of Mines' recommendations

Investigation Report
of the Chief Inspector of Mines

MOUNT POLLEY MINE
MOUNT POLLEY MINING CORPORATION
SUBSIDIARY OF
IMPERIAL METALS CORPORATION

MOUNT POLLEY TAILINGS STORAGE FACILITY BREACH, AUGUST 4, 2014

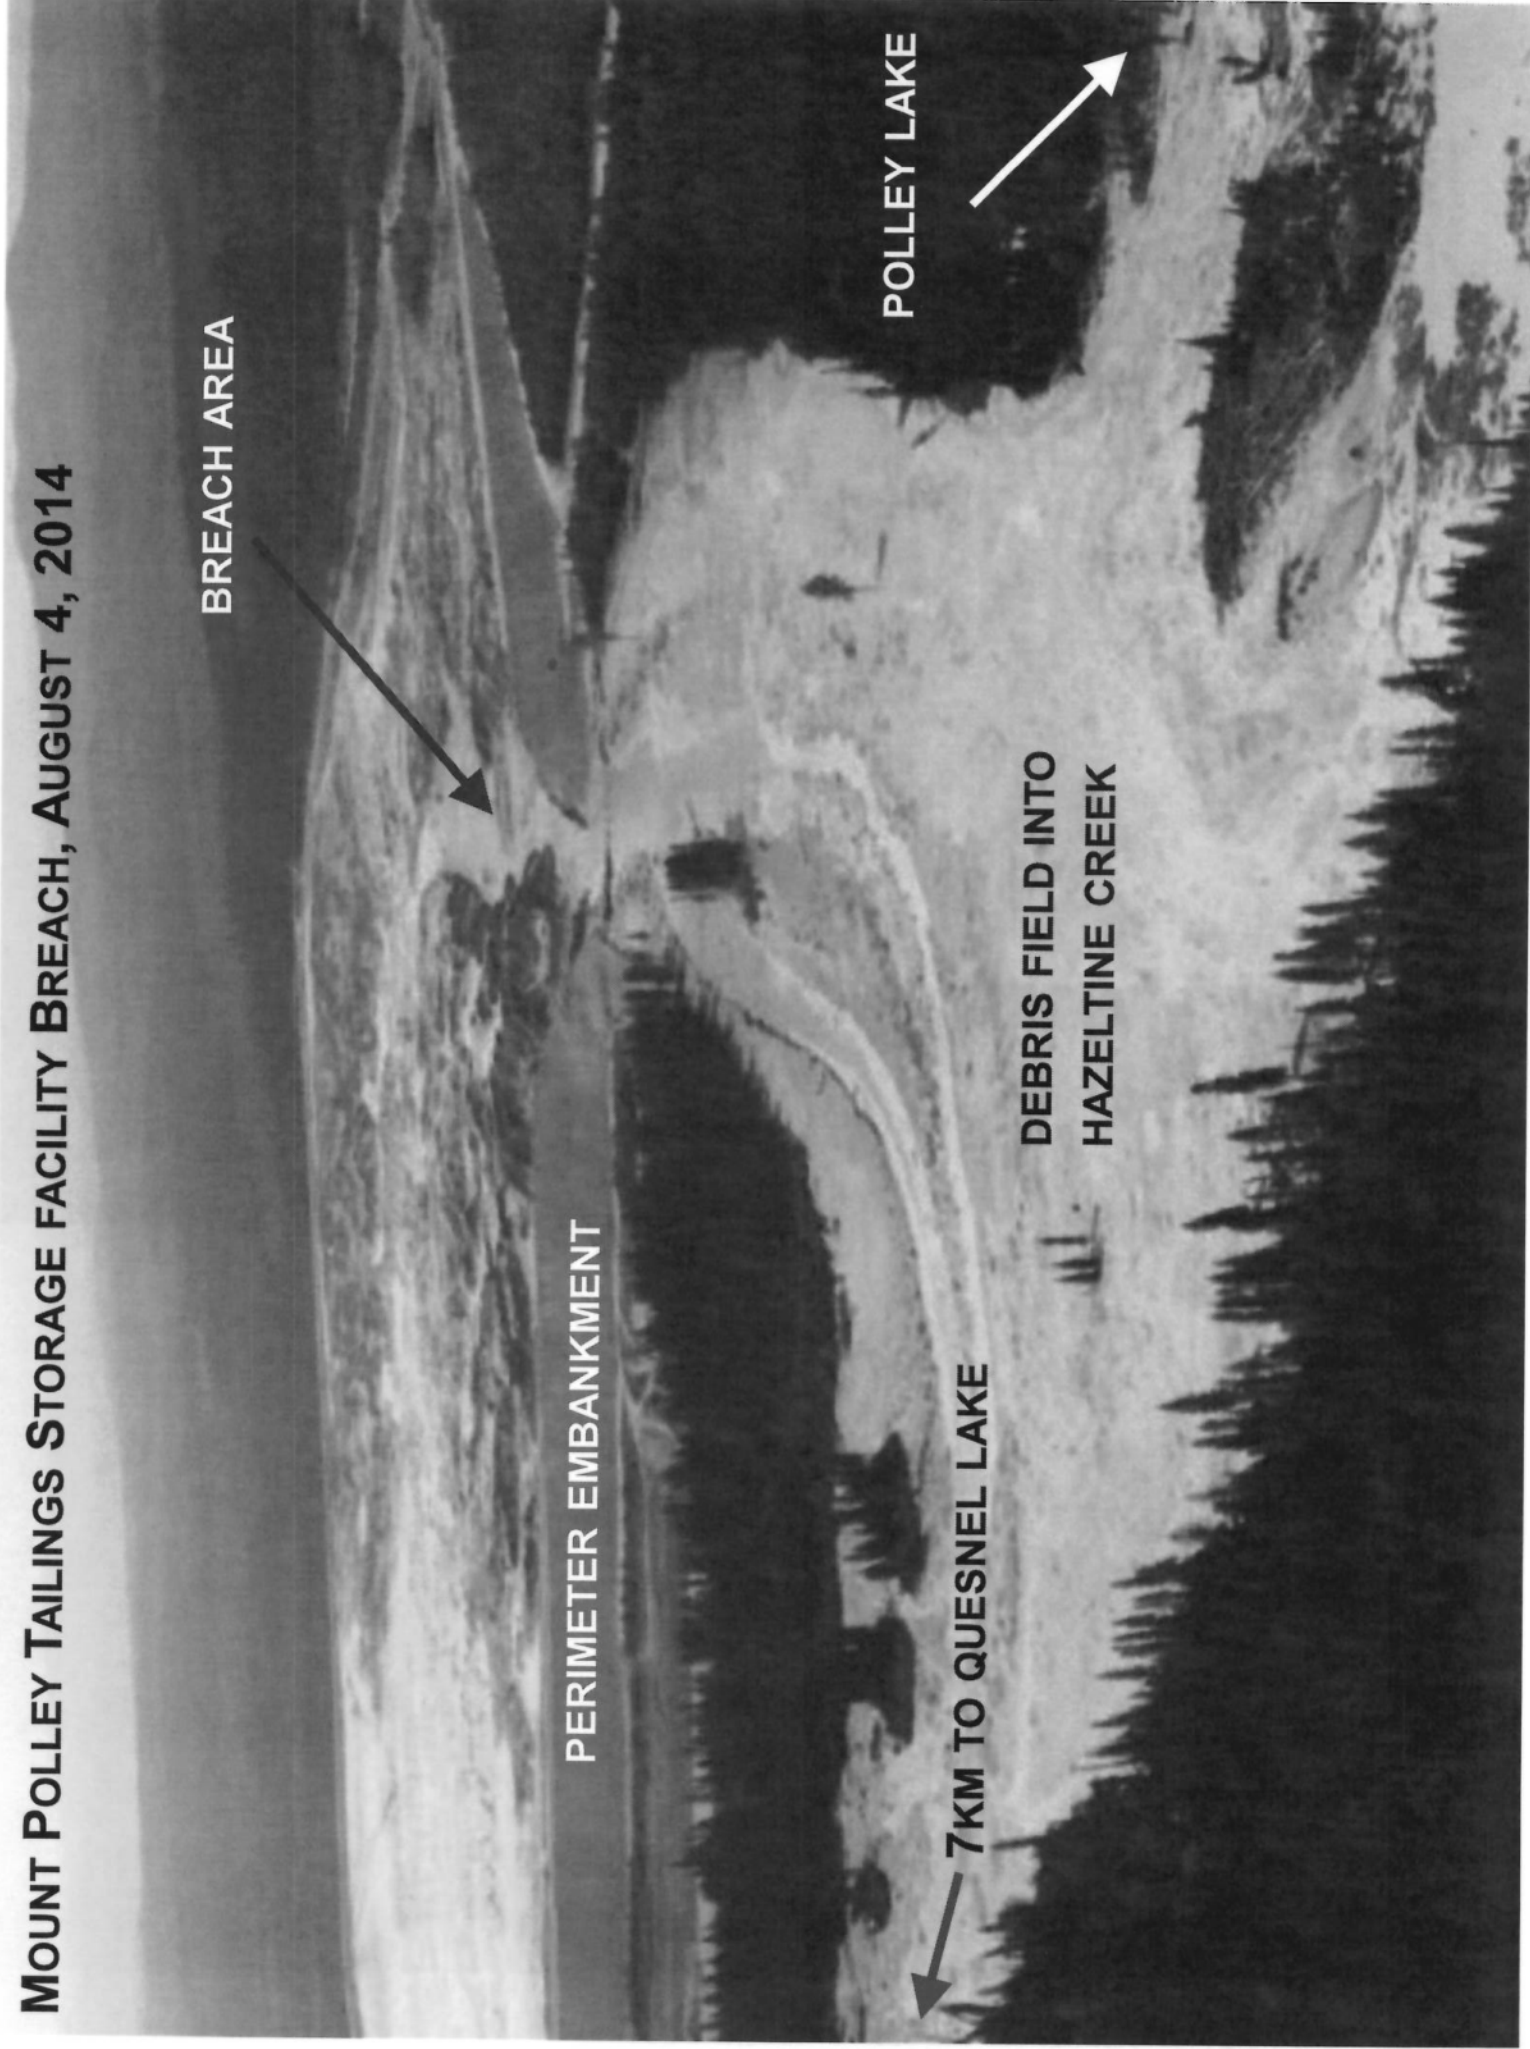
PERIMETER EMBANKMENT

7KM TO QUESNEL LAKE

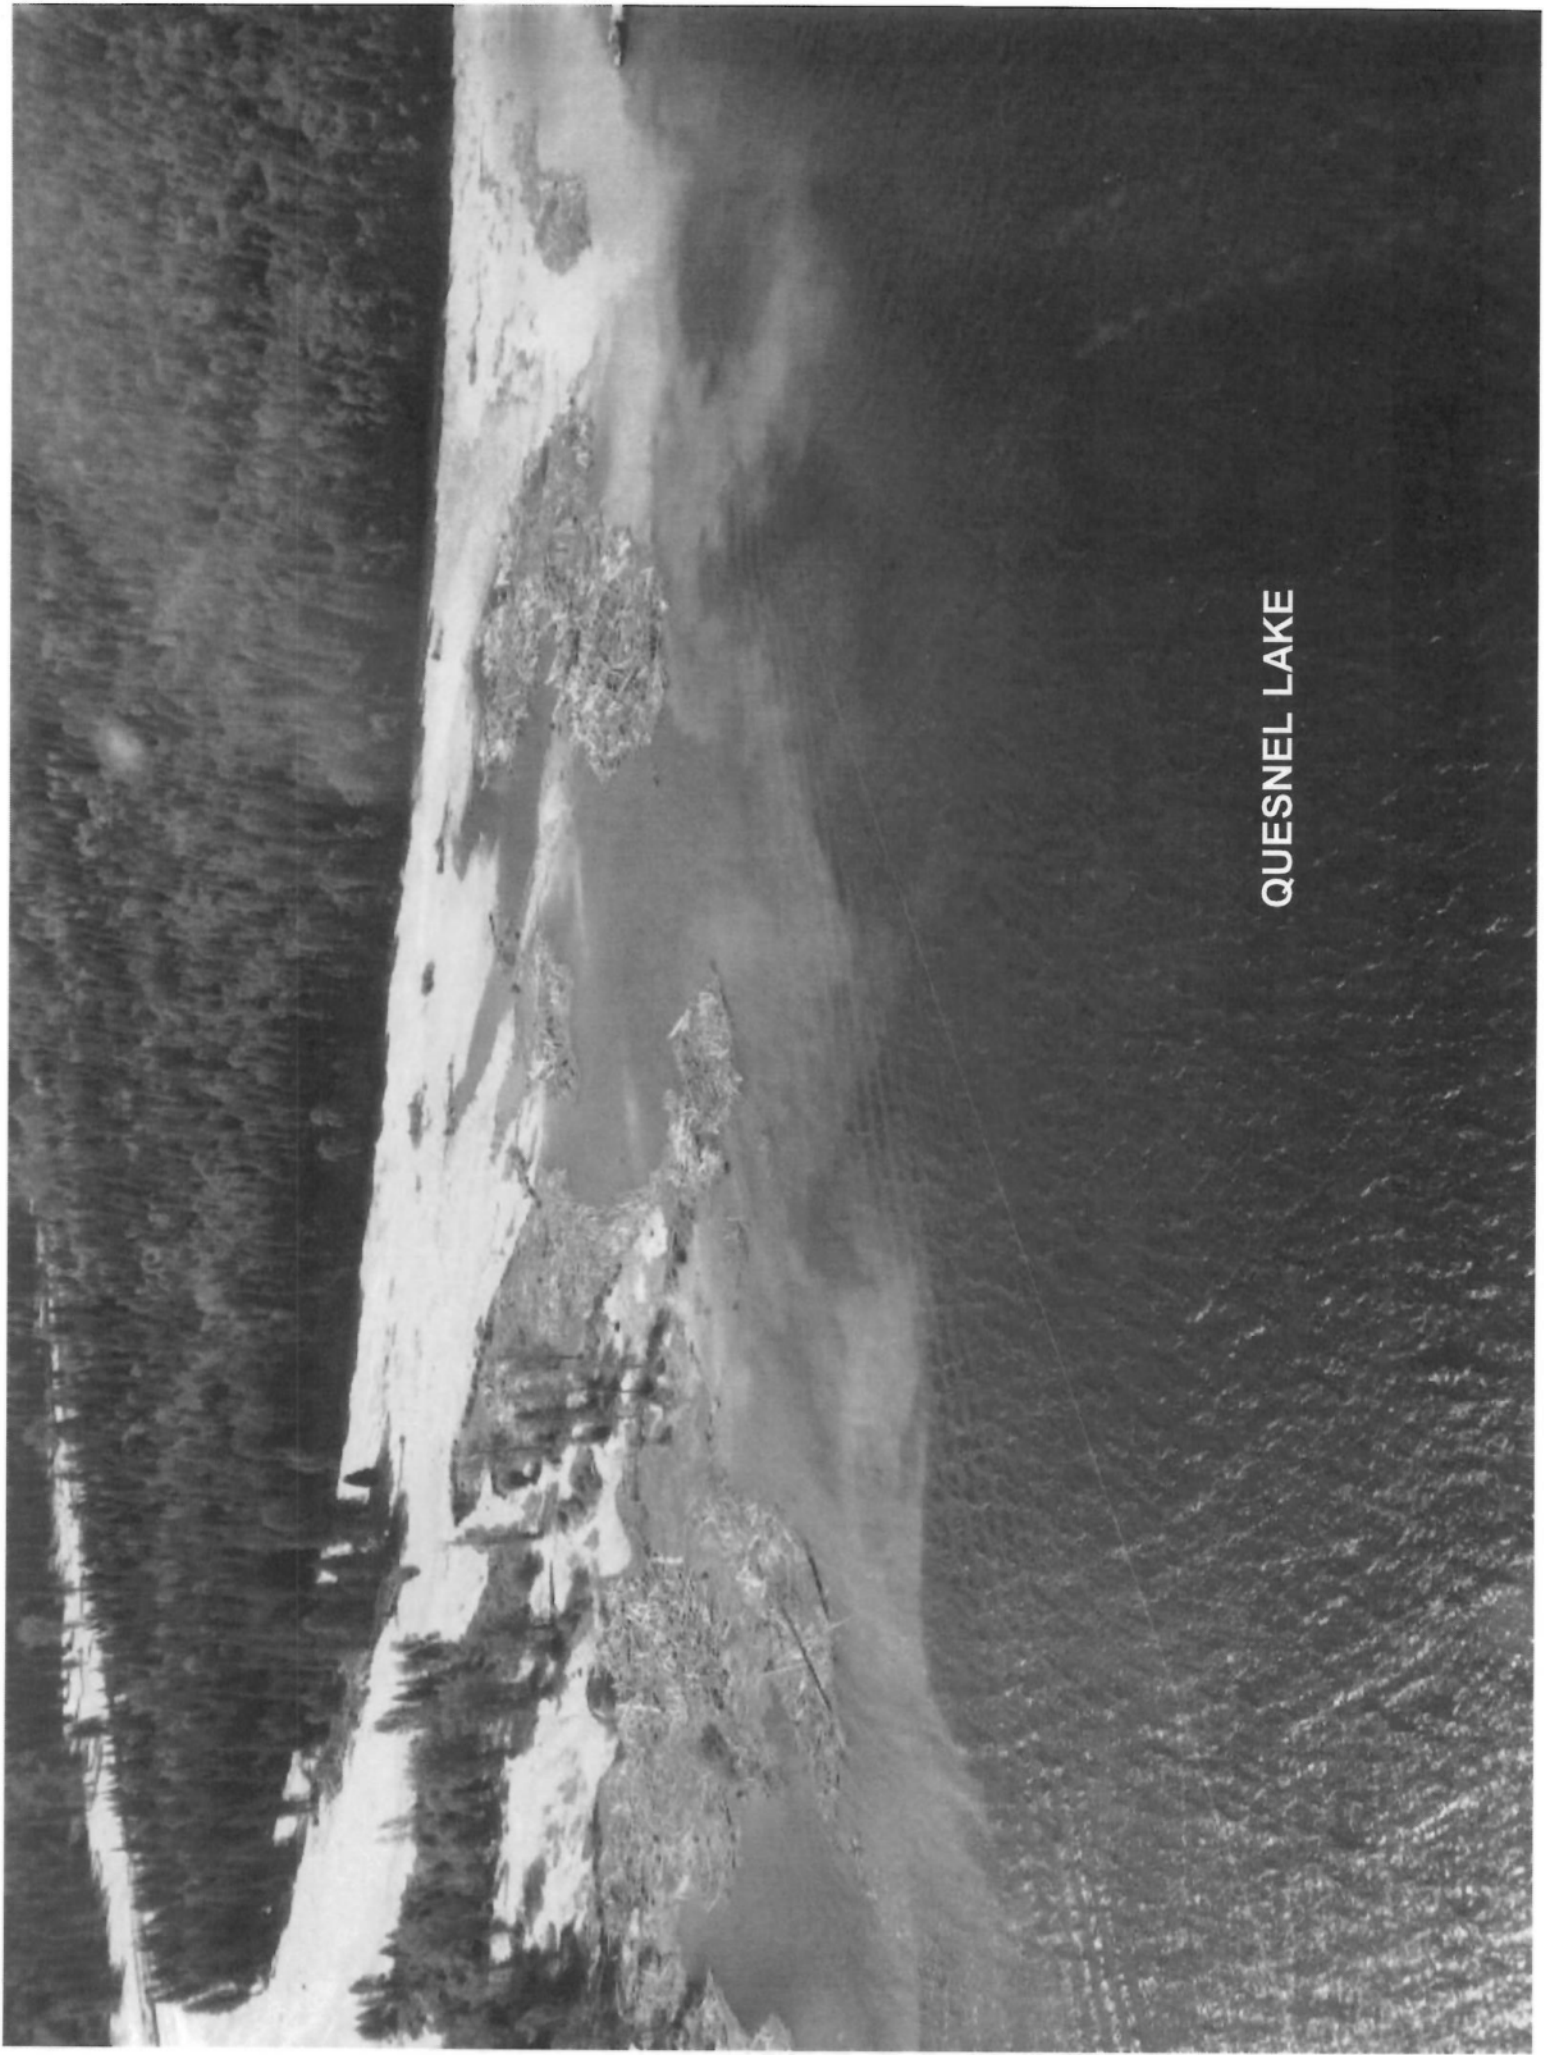
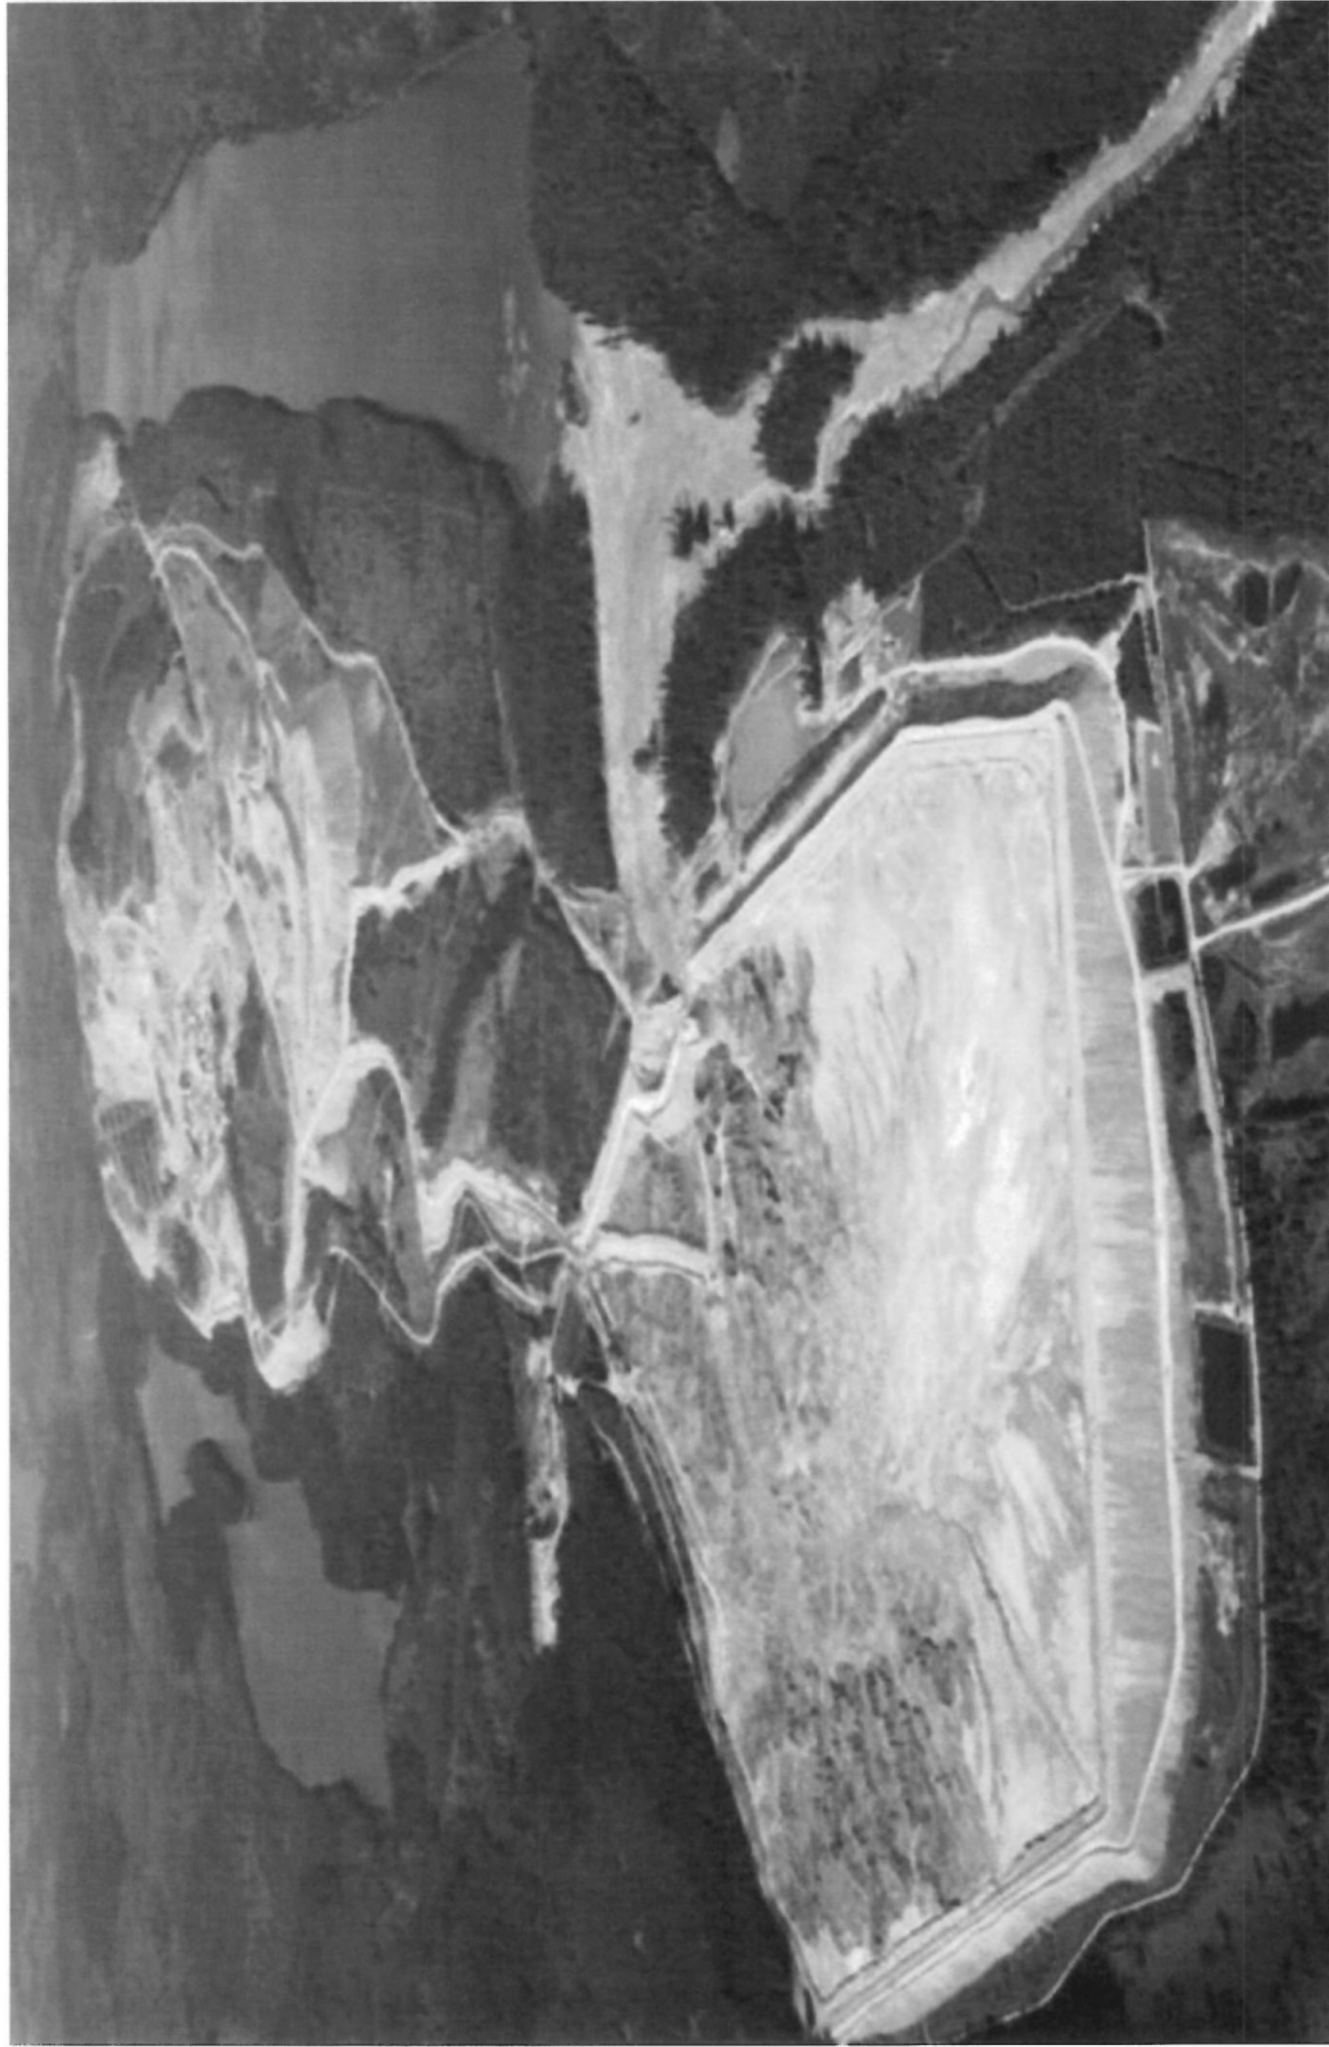
QUESNEL LAKE

**DEBRIS FIELD THOUGH
HAZELTINE CREEK**

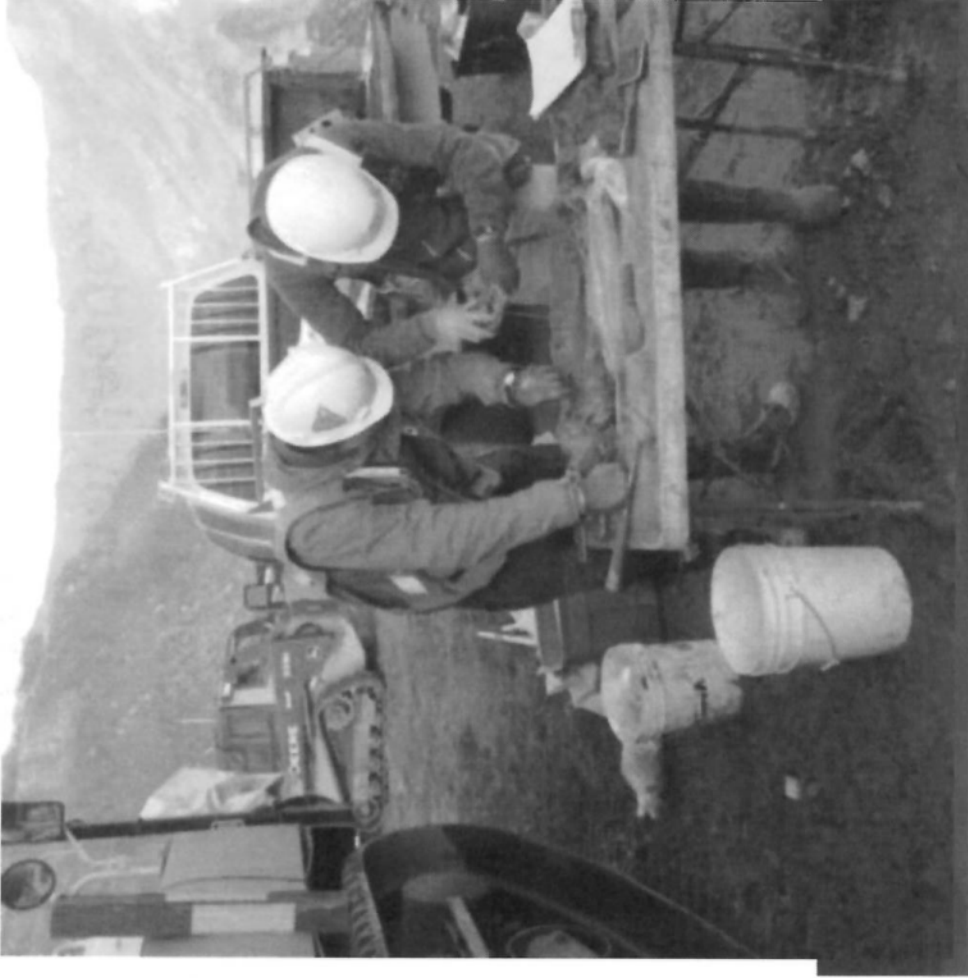
Comprehensive geotechnical investigation to support Expert Panel and Chief Inspector:

- Contracted Klohn Crippen Berger
- Comprehensive site investigation and drilling program to characterize the foundation
- Field mapping, geophysics, test pits and trenches
- In situ and laboratory strength testing
- Instrumentation

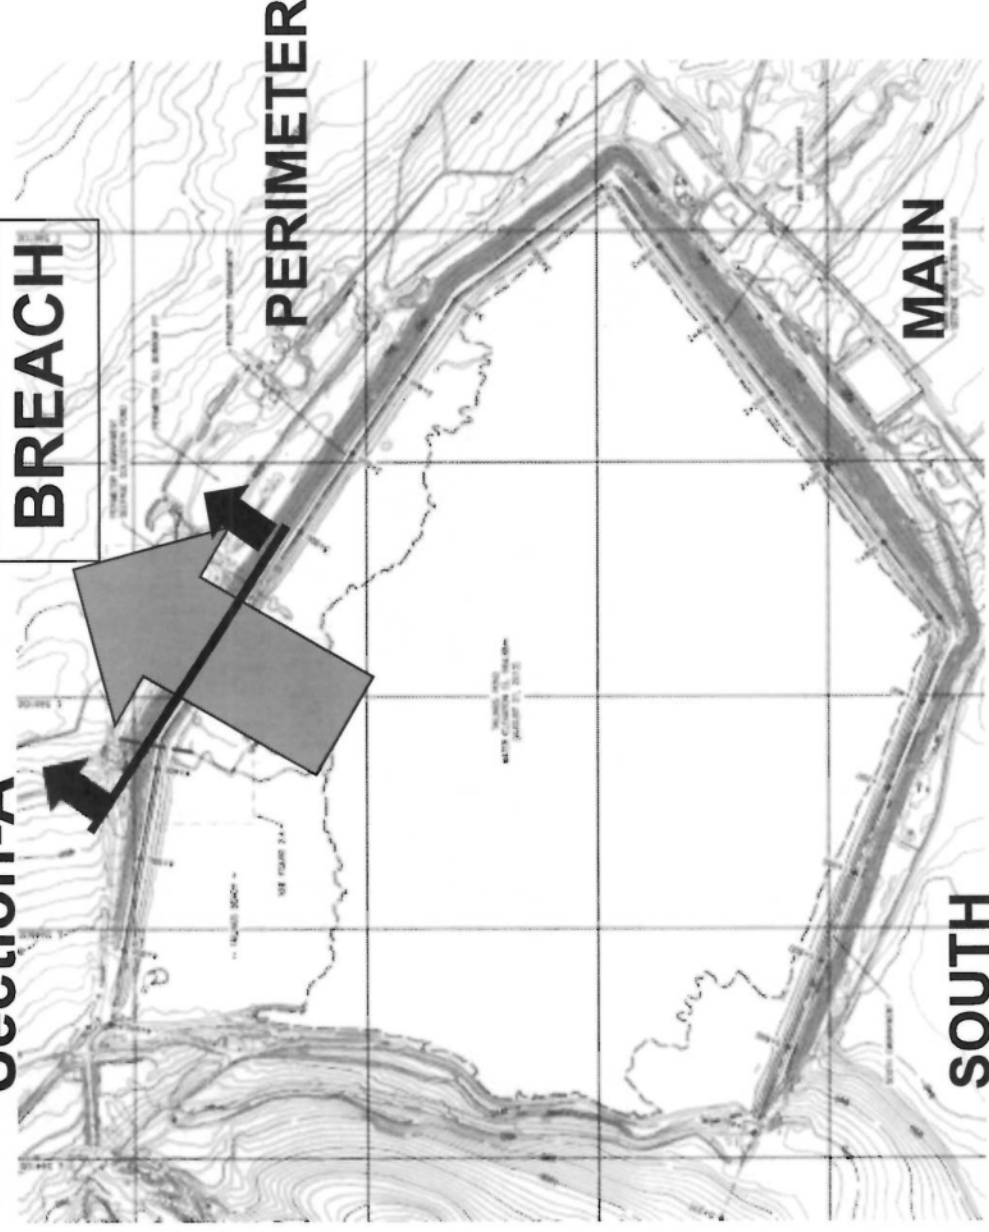
Section-A

1. Assessed pre-breach knowledge;
2. Geoforensic investigation & analysis

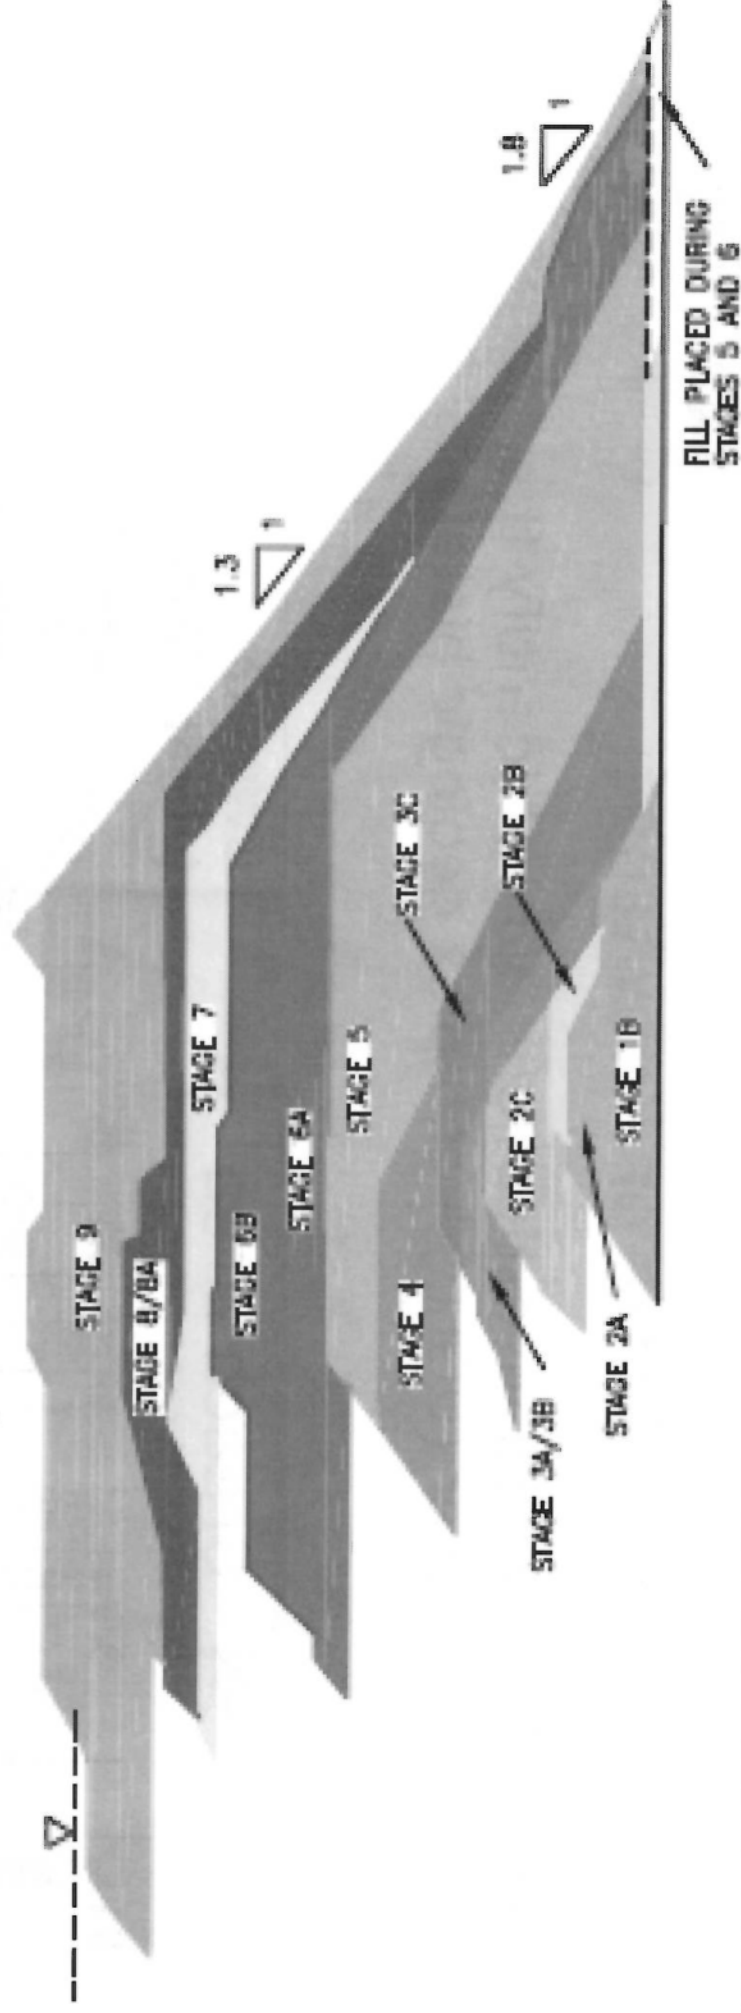
- Perimeter Embankment as-constructed condition
- Constructed in 9 stages (raises)
 - Modified centerline dam with low permeability core zone, downstream rockfill with filters

The soil foundation conditions did not include the UGLU.

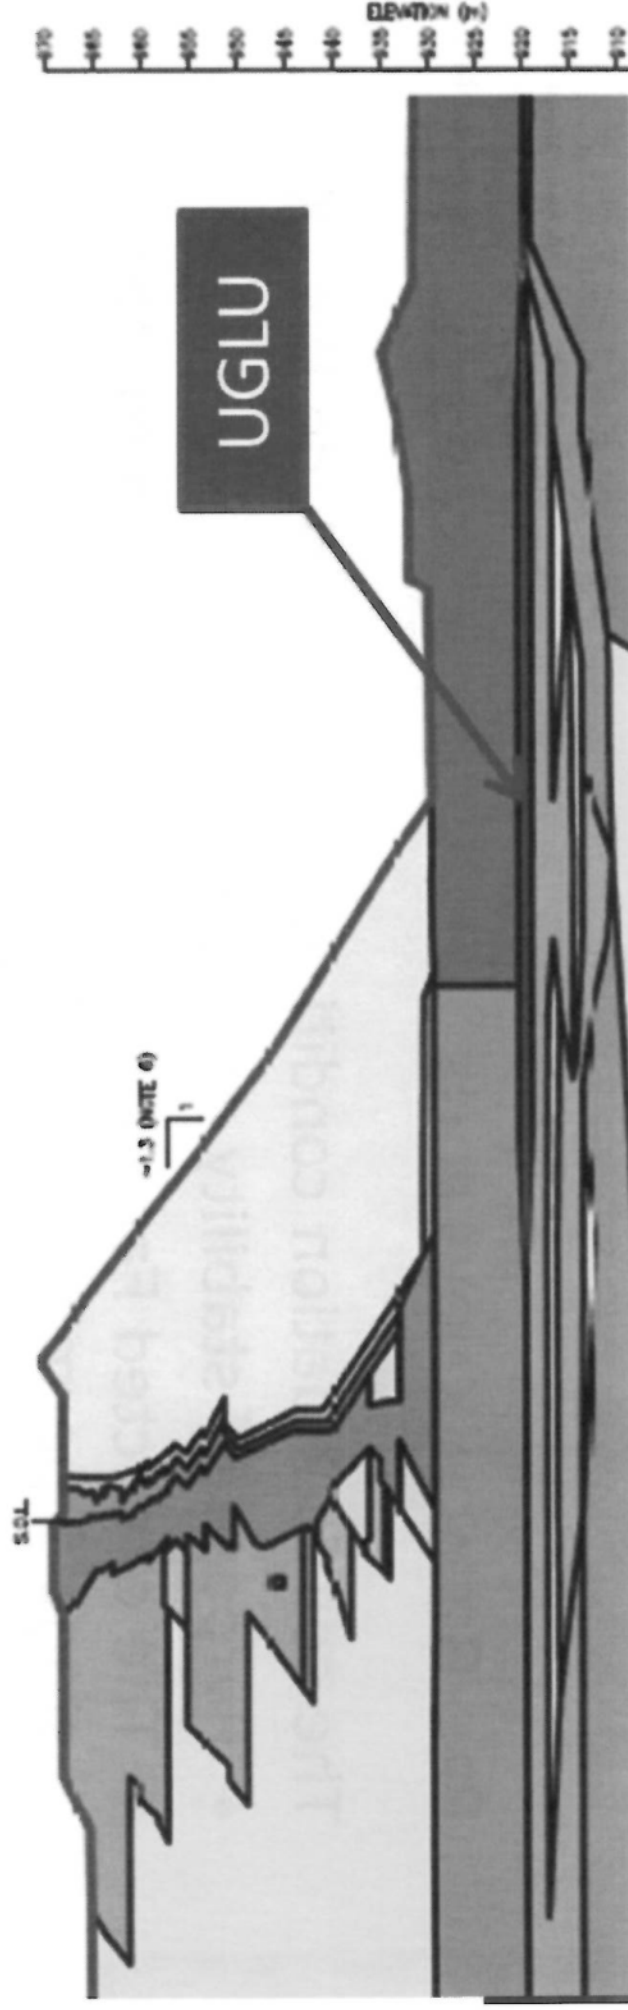
Dam failed by sliding on foundation clay layer, glaciolacustrine in origin at 10 m depth (UGLU)

- Location was confirmed in area of breach
- 40 m high steep embankment subjected UGLU to stresses initiating progressive failure of dam
- Comprehensive analysis builds upon Expert Panel

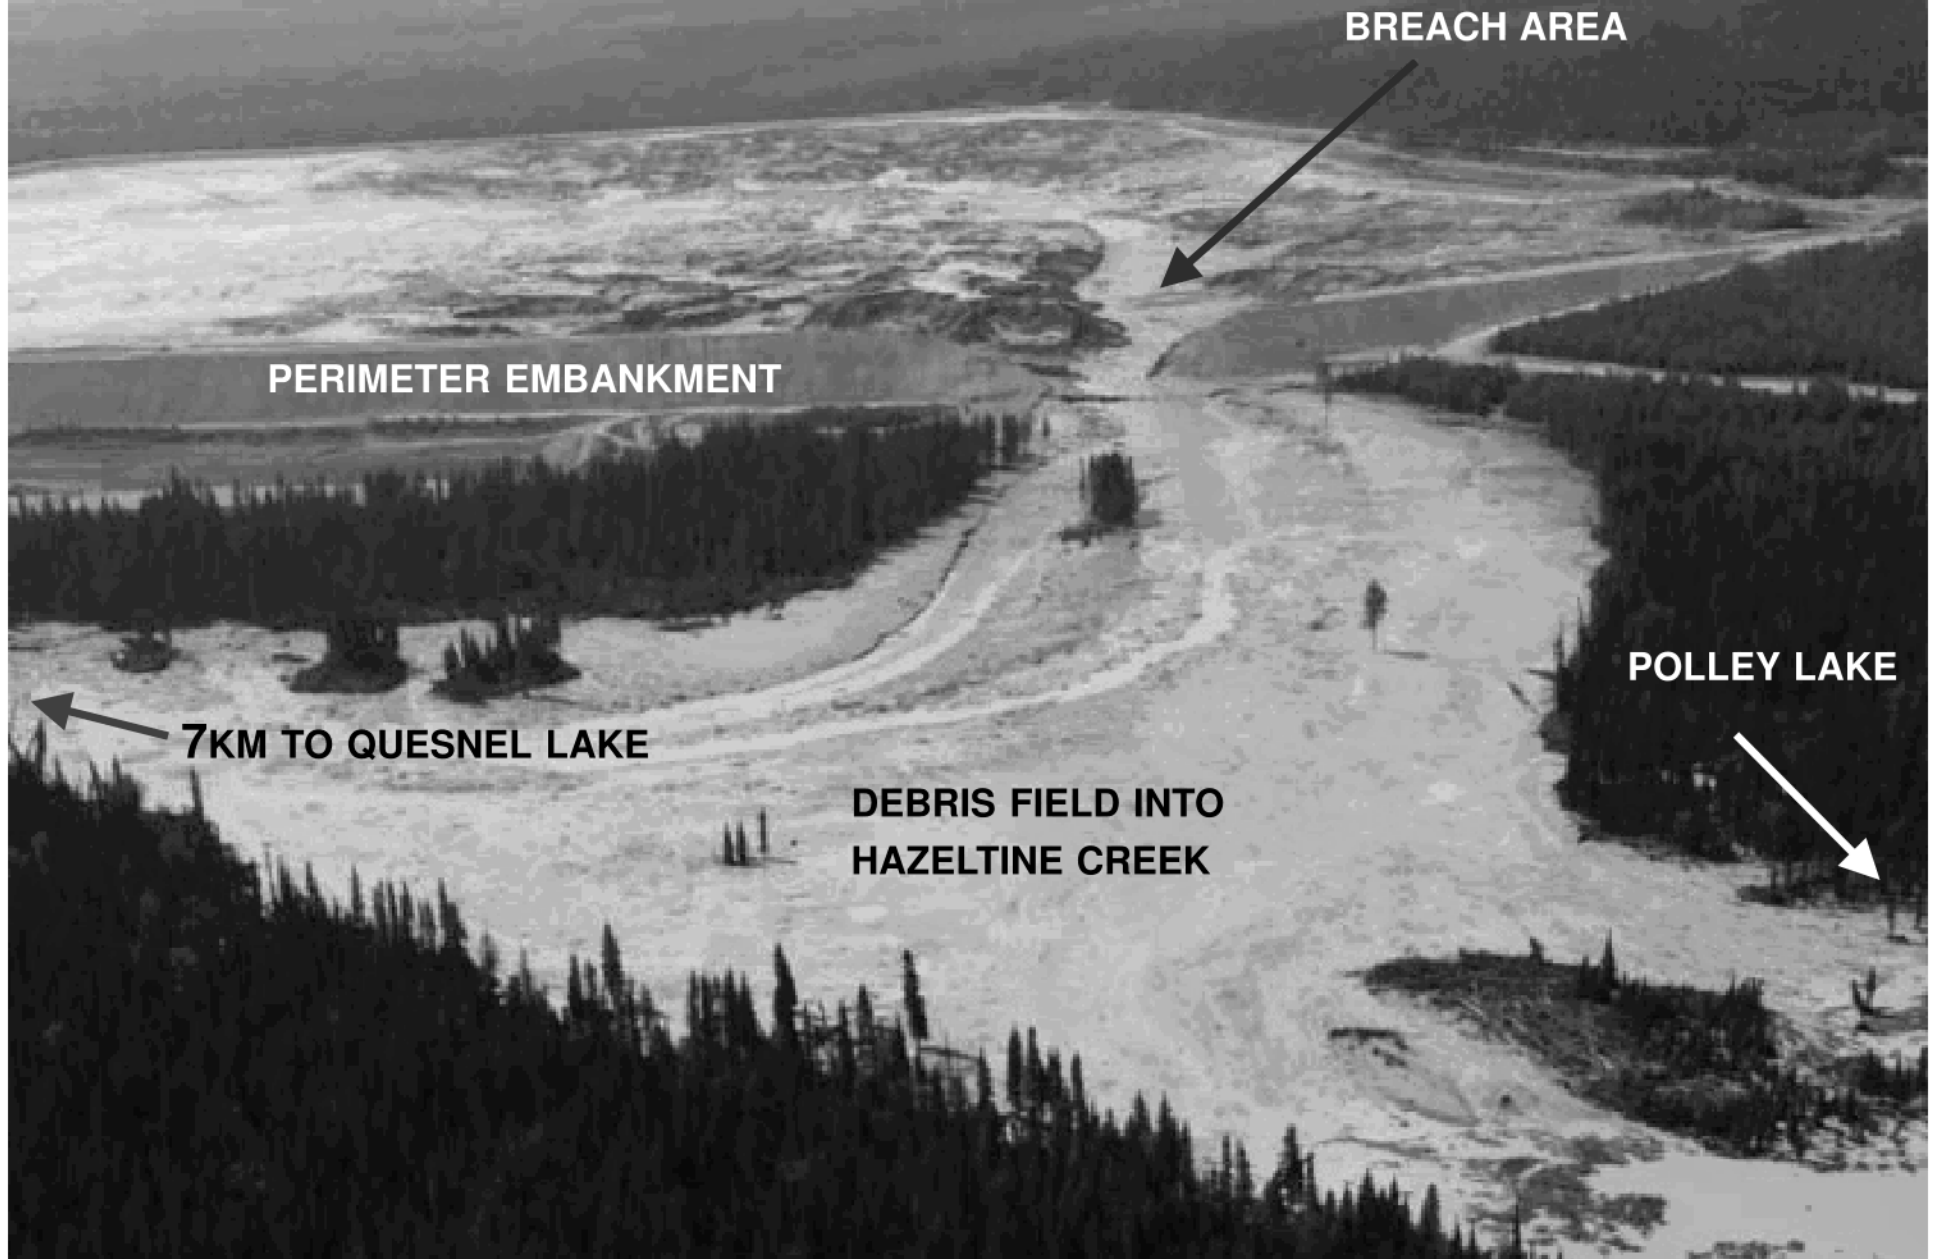
**DEBRIS FIELD THROUGH
HAZELTINE CREEK**

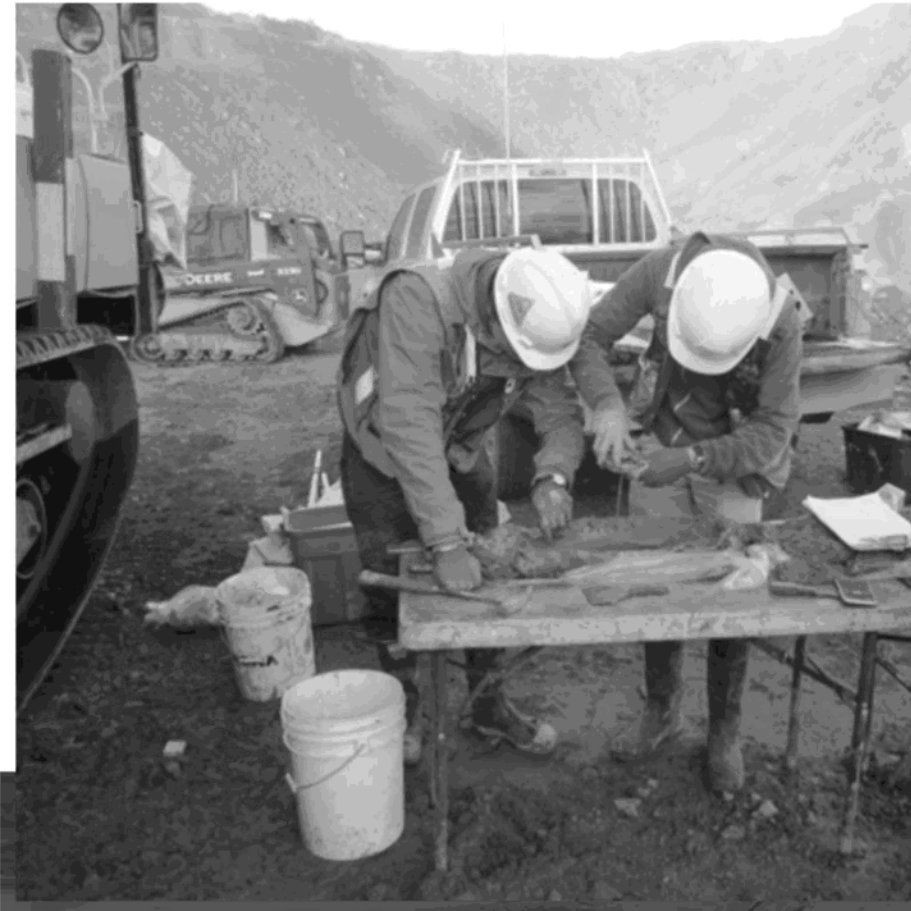
Comprehensive geotechnical investigation to support
Expert Panel and Chief Inspector:

- Contracted Klohn Crippen Berger
- Comprehensive site investigation and drilling program to characterize the foundation
- Field mapping, geophysics, test pits and trenches
- In situ and laboratory strength testing
- Instrumentation

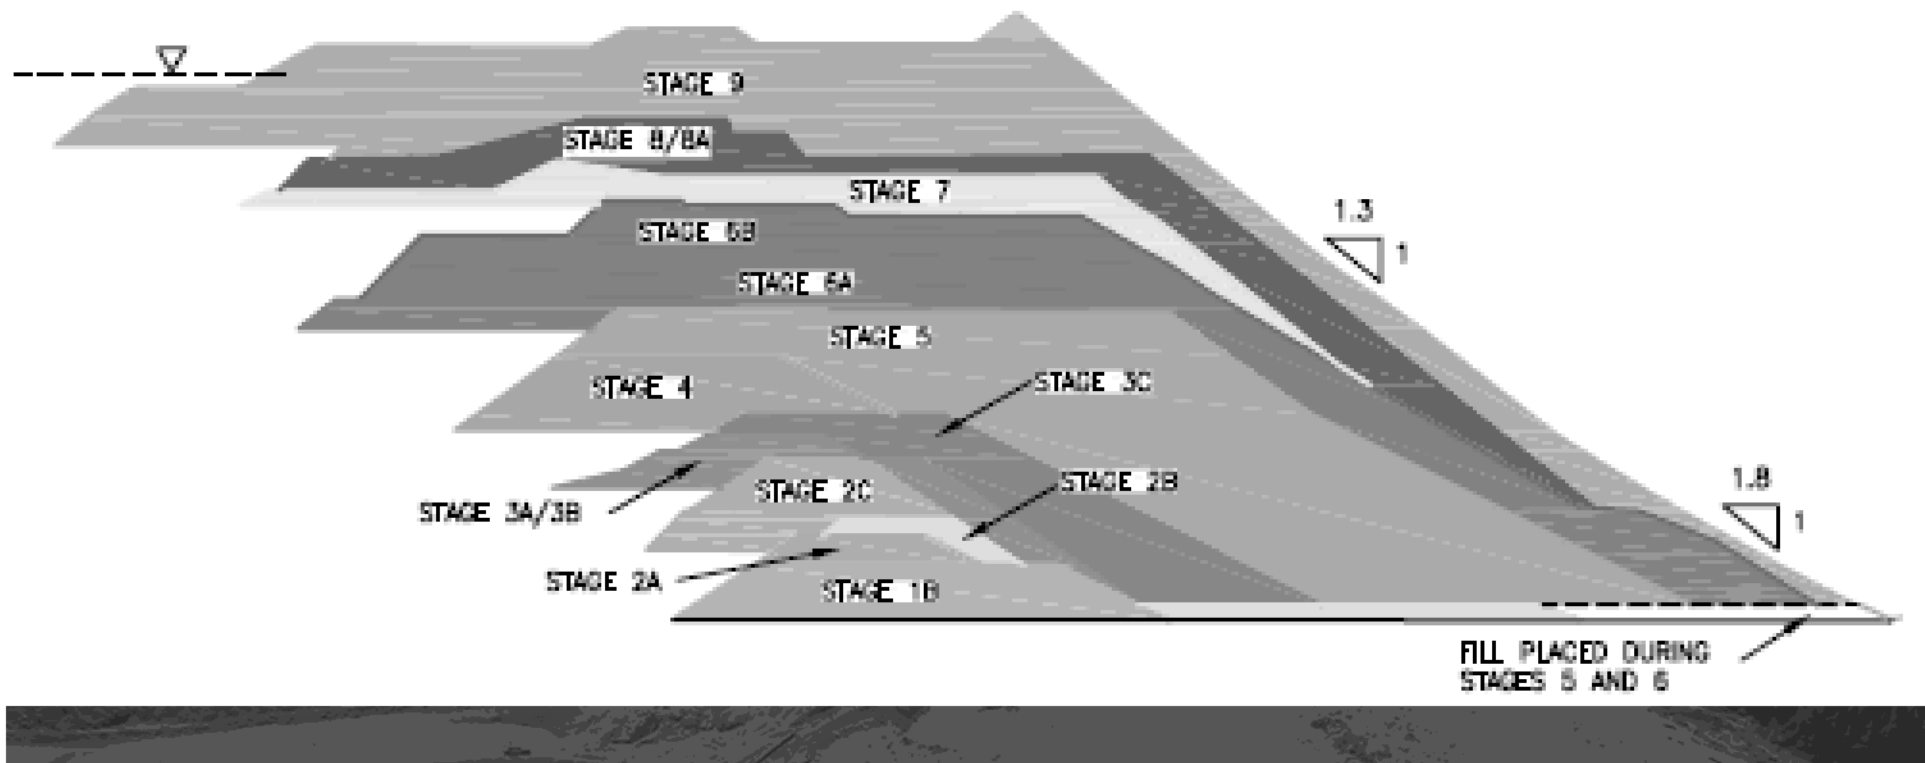
Perimeter Embankment as-constructed condition

- Constructed in 9 stages (raises)
- Modified centerline dam with low permeability core zone, downstream rockfill with filters

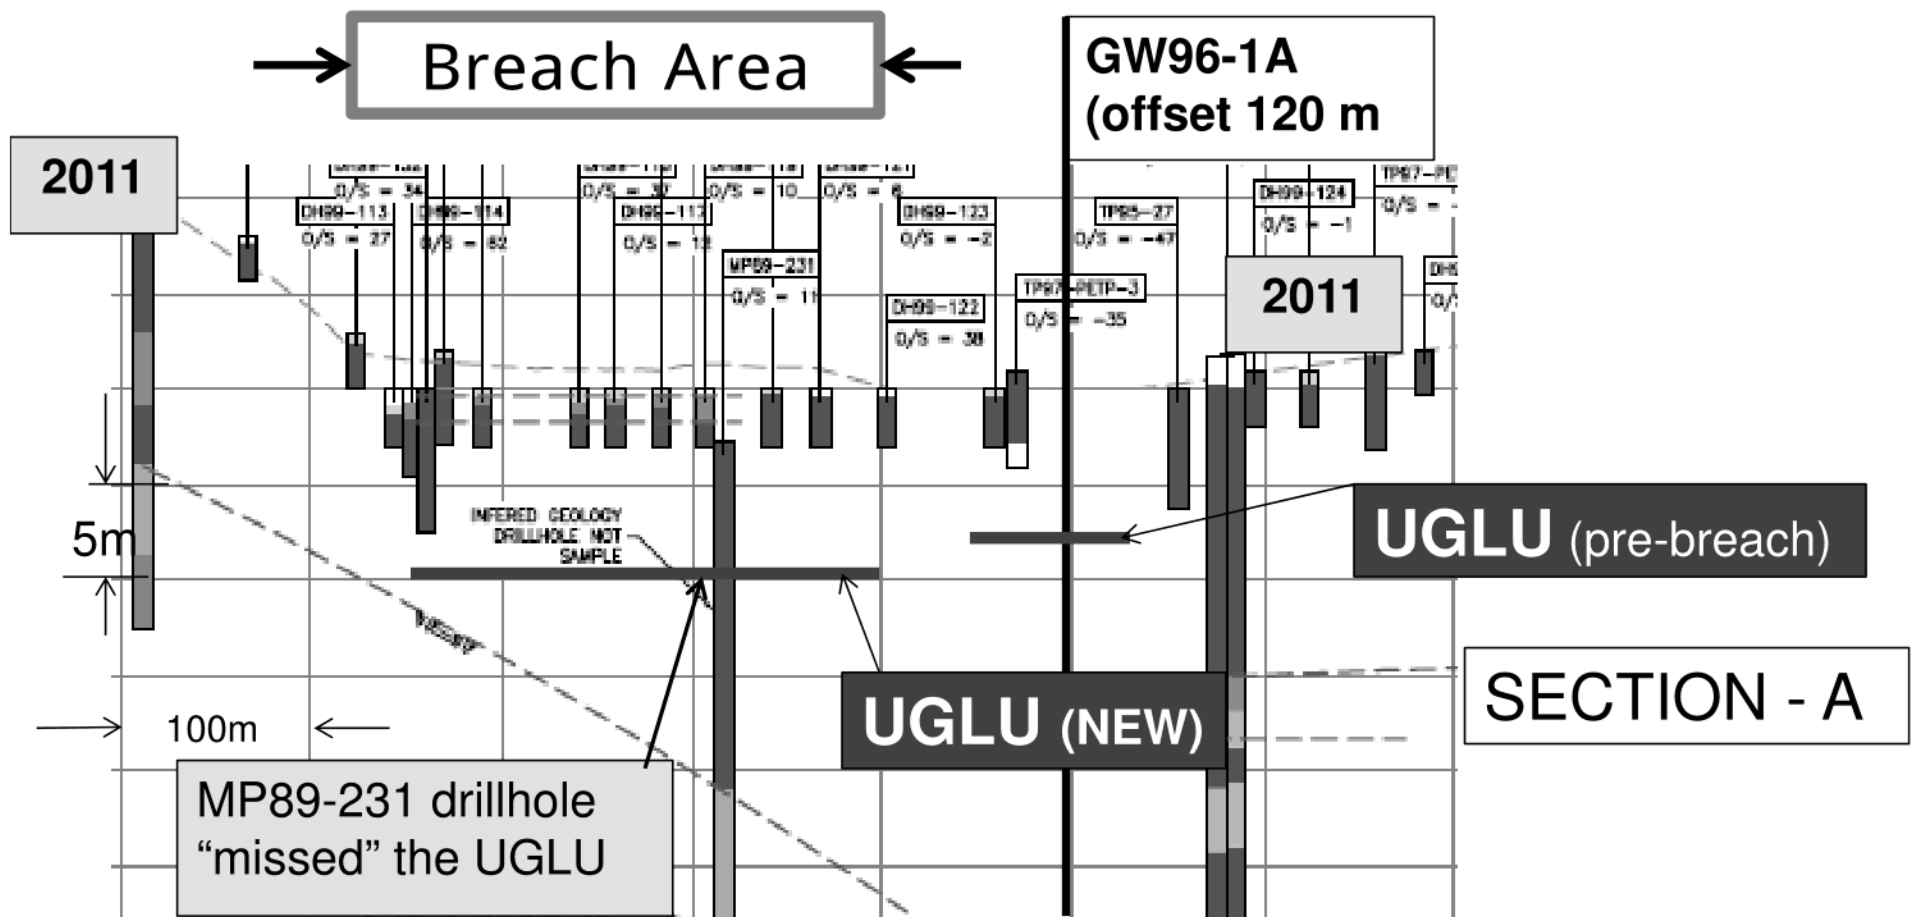
Limited deep soil investigations did not identify the weak clay layer (UGLU) - complex geologic history

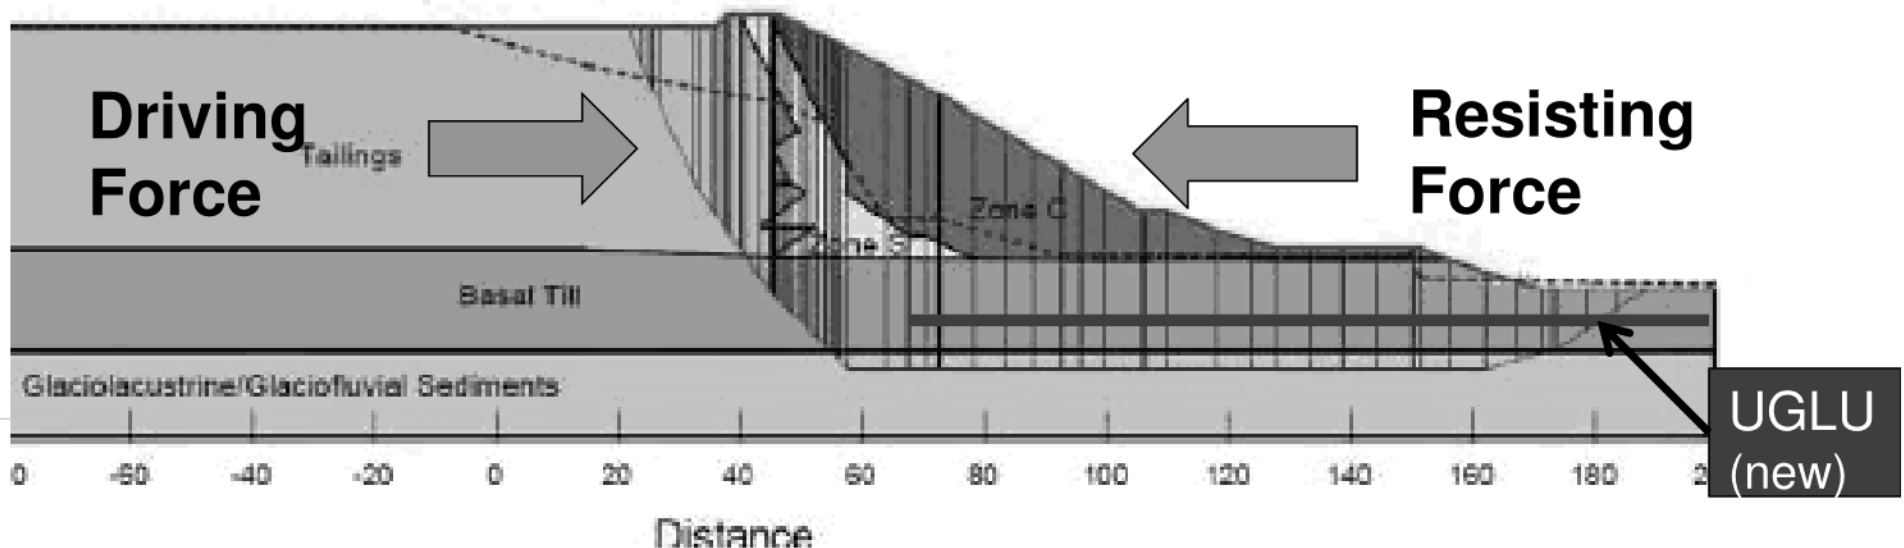
The soil foundation conditions did not include the UGLU.

- Purpose of stability analyses
- The expected Factor of Safety calculated for the stage 9 permit was 1.63
