Re: Tulsequah Chief M-232 Mines Act Permit Amendment for care and maintenance monitoring and reporting activities.

EP System: <u>AMS</u>	Inspection Status: <u>FINAL</u>	
System Number: <u>105719</u>	Inspection No: <u>23226</u>	
EP System Status: <u>Active</u>	Inspection Date: <u>2015-10-15</u>	
Region: <u>Skeena</u>	Office: <u>Smithers</u>	
Trigger: <u>Planned</u>	Incidents of Non-Compliance Observed: <u>Yes</u>	
Non-Compliance Decision Matrix Level: <u>Level 1</u>	Non-Compliance Decision Matrix Category: <u>Category B</u>	
Inspector Name(s): <u>Neil Bailey</u>	Risk Ranking: <u>0 to 1 = Low</u>	
Audit: <u></u>	Total Non-Compliance(s): <u>2</u>	
Regulated Party: <u>CHIEFTAIN METALS INC.</u>		
Regulated Party Contact(s): <u>Rob Marsland</u> <u>Senior Environmental Engineer</u>		
Mailing Address: <u>Chieftain Metals Inc. c/o Terry Chandler, Executive Vice President, Unit 118, 1515 Broadway St, Port Coquitlam BC V3C 6M2</u>		
Phone No: <u>(604) 836 7559</u>	Fax No: <u></u>	
Contact Email: <u>rob.marsland@chieftainmetals.com</u>

Project Name: <u>Tulsequah Chief Mine Project</u>	Inspection Status: <input type="text"/>
Certificate #: <u>M02-01</u>	Inspection No: <input type="text"/>
Cer

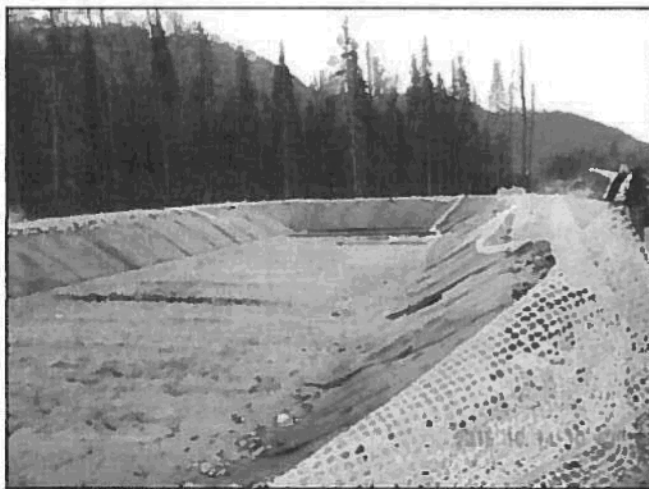
The temporary lime sludge storage pit, located just off the airstrip, contains approximate 35m³ of sludge generated from the WTP and is lined with a filter fabric to prevent migration of the sludge to the subsurface gravel. No deposition has occurred since the WTP shut down in June 2012. CMI maintains monitoring from 3 groundwater wells. CMI has committed, should mine operations not resume, to relocating the sludge to a secure location to the Rogers Creek area, which will be capped and re-vegetated.

Photo 1: Lime Sludge Pit Shaza AirStrip.

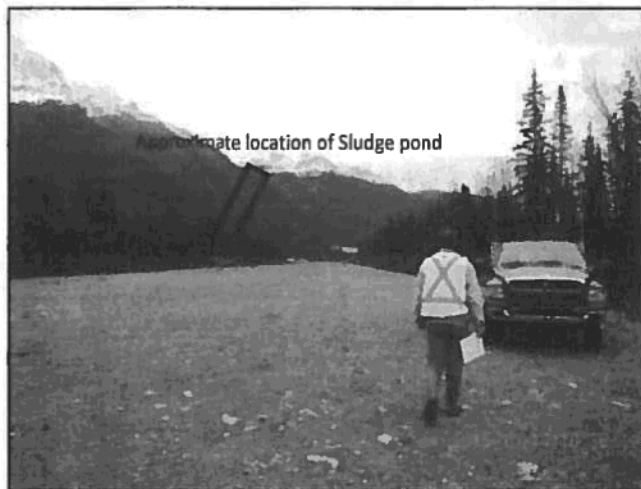
Photo 2: Shaza Airstrip location of Sludge Pit

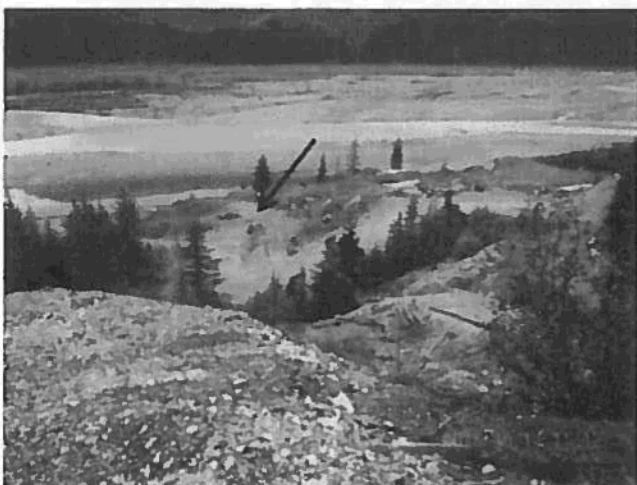
The acidic drainage seen exiting the mine as an orange flow (approx. 1L/s)(Photo 3) is captured in a pipe near the portal and is directly conveyed by a buried pipeline to the exfiltration pond located near the Tulsequah River. All drainage from the 5400 portal has been directed away from the historical waste thus limiting contaminated flows. (Photos 5 and 6)

Photo 5: The black pipe (arrow) is the acidic discharge from the 5400 portal. Portal Creek and the combined non-acidic drainage discharge to the left of the picture in an underground HDPE pipe.

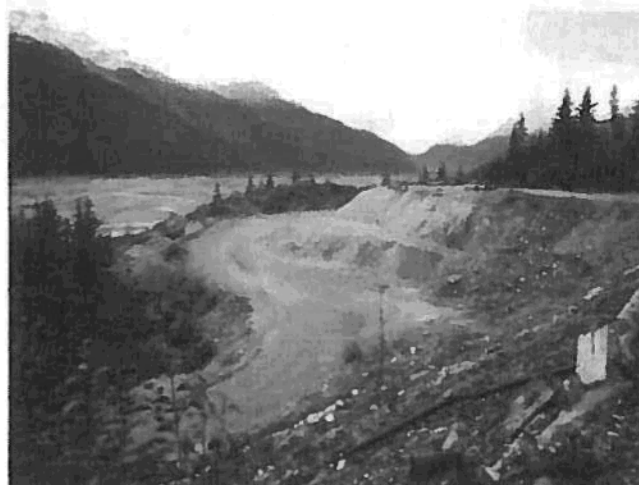
Photo 6: showing the historical PAG rock left from early mining. The ~80,000 tonnes of material to be relocated once mining restarts to the PAG dump on Rogers Creek.

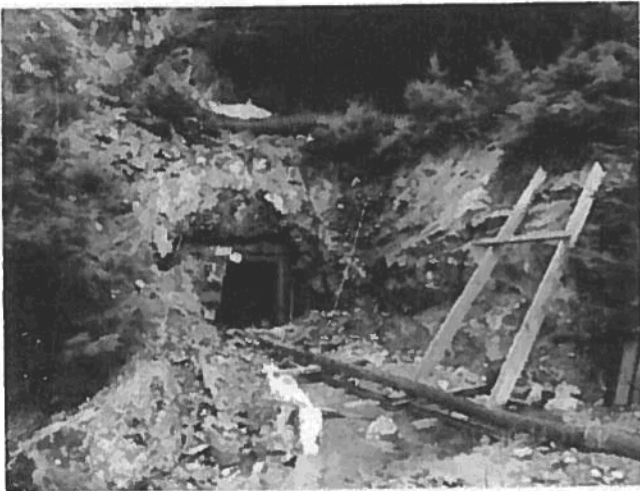
The 5200 portal, the lower most accessible portal is appropriately signed with "Danger No Entry" signs but the wood door is open to allow the passage of the discharge pipe seen in photo (Photo 7). Within 300 meters inside the entrance however, is a 1.8 m high dam used as part of an inactive passive water treatment system and the tunnel beyond is partially flooded. Acidic flow from this portal; which also includes partial flow from the 5400 and 5900 levels, averages ~ 7L/s.

Photo 7: 5200 Portal. Acidic discharge is in smaller pipe exiting mine. 5400 non acidic and Portal creek water is contained in the larger pipe located above the portal.

Notable in Photo 7 is the 600mm HDPE pipe over top of the 5200 Portal entrance which is conveying the Portal Creek and 5400 non-acidic drainage to the Tulsequah River. The pipe requires ongoing monitoring and maintenance because of rock falling onto the pipe and at times crushing the pipe causing leakage. From the photo it can be seen the pipe is currently leaking with water spilling down to pond in front of the Portal. This pond drains into the ex-filtration pond via ditching and a culvert under the road.

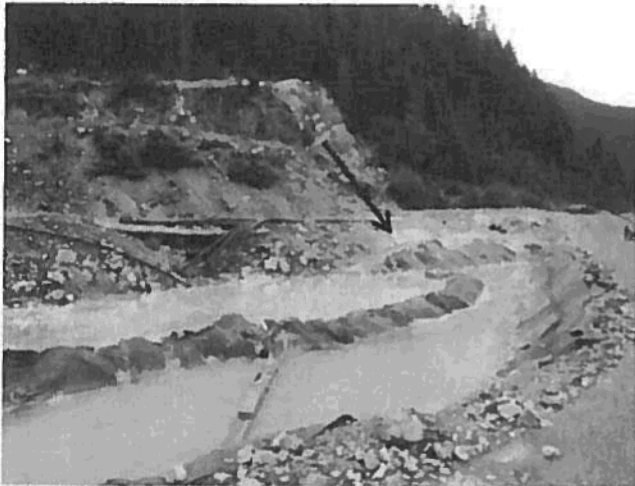
The observed ex-filtration pond was constructed in 2011 and was reportedly built to capture site drainage from the PAG waste dumps (Photos 9-11). Currently it is being used to capture all drainage, including the portal drainage, where the contaminated discharge is allowed to ex-filtrate through the road berm to the Tulsequah River (Photo 12). A filter fabric is used to prevent the migration of the Fe sludge into the dam rock void spaces would effectively block the diffuse flow. As noted in the 2014 ARR the sludge built up in 2013/14 nearly causing the pond to overflow requiring remediation to be taken by the company. (Note this incident was not reported to MEM)

A significant concern is the proper operation of the pond given there is no spillway observed and there is no continuous onsite presence.

Photo 9: Exfiltration pond receiving ditch water from the 5200 portal

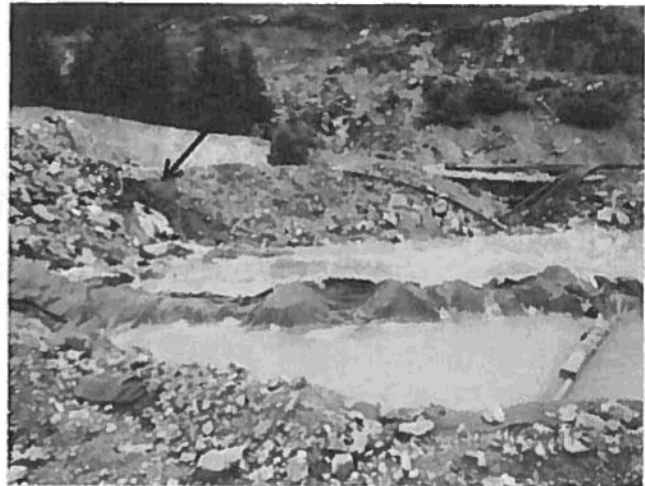
Photo 10: Exfiltration pond receiving acidic discharge from the 5400 portal

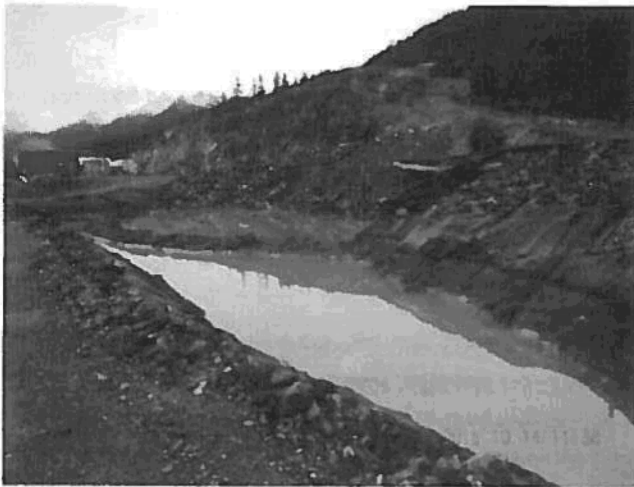
Photo 11 Exfiltration pond. Note high water level of sludge.

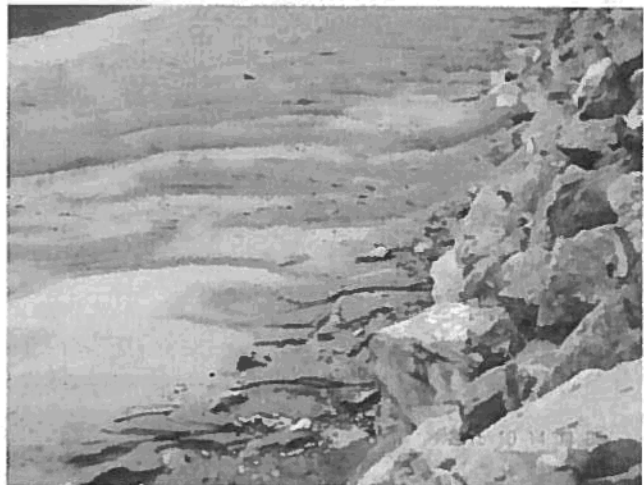
Photo 12: Diffuse discharge location through berm onto the Tulsequah river floodplain.

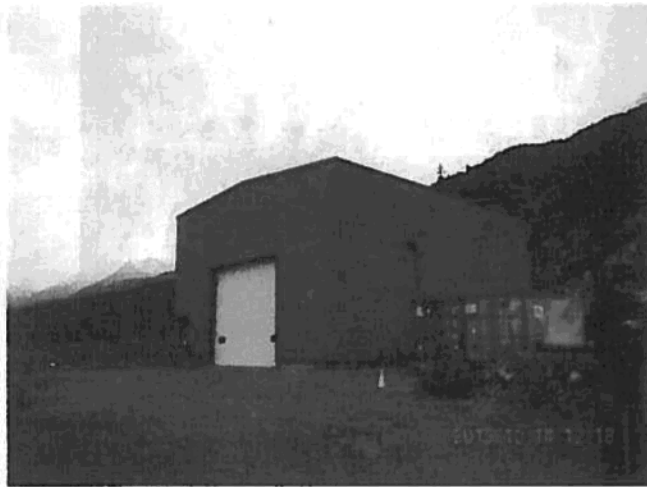
The WTP was constructed in its current location in 2011 after receiving approvals from the province to relocate and upgrade the previously proposed WTP (Photos 13, 14). The WTP is designed to treat acidic discharge on a temporary basis until the upper mine workings could be backfilled as per the mine design proposed in 2009. The plant ran from October 2011 till June 22, 2012 at which time operations were suspended due to operational issues. Since that time the company has sought guidance on process modification strategies to address the high operating costs. CMI has stated they are committed to re-commissioning the WTP at the earliest time upon completion of full project financing.

Photo 13: Acid Water Treatment Plant

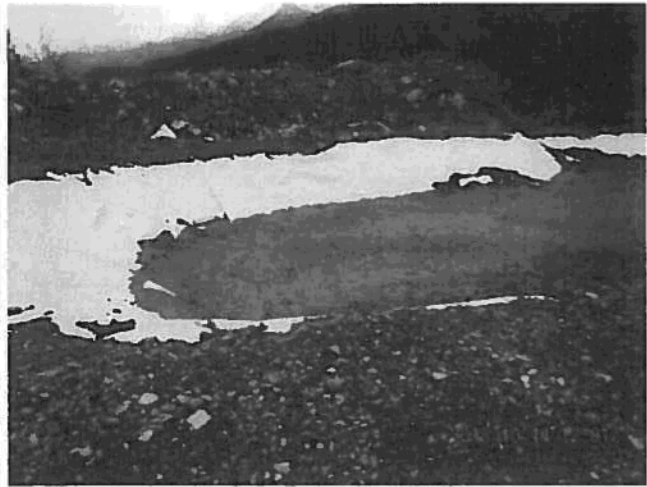
Noted during the inspection, beside the WTP, was another sludge pond which has not been approved by MEM (Photo 15)

Photo 15: Temporal Sludge pond beside AWTP

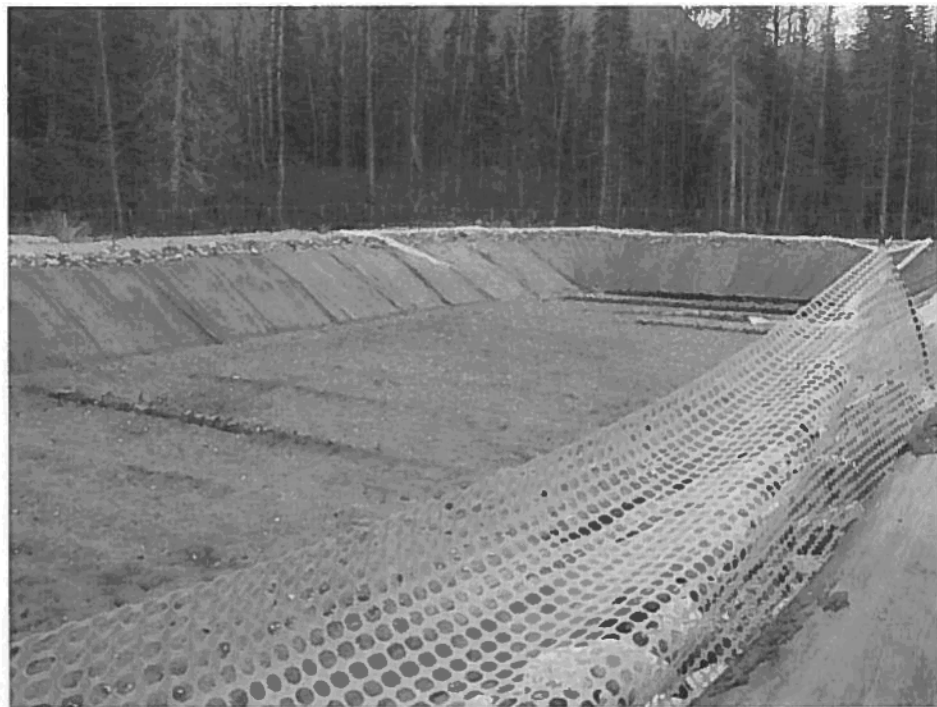
Photo 2

Sludge pond
adjacent runway.

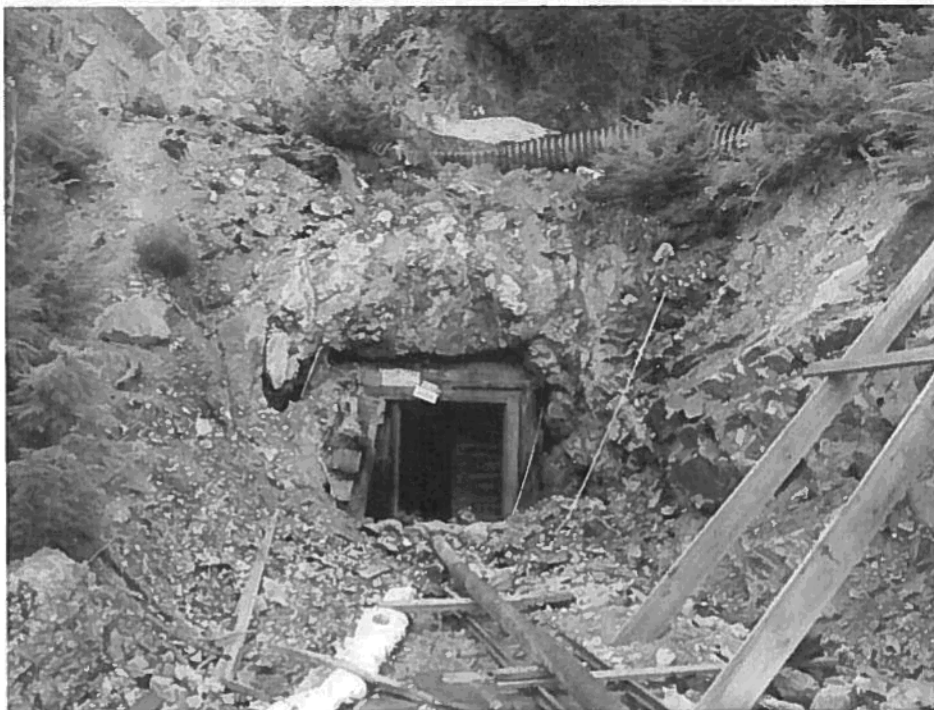
Photo 8

5200 portal.
Large rock on
neutral mine
water bypass
pipe.

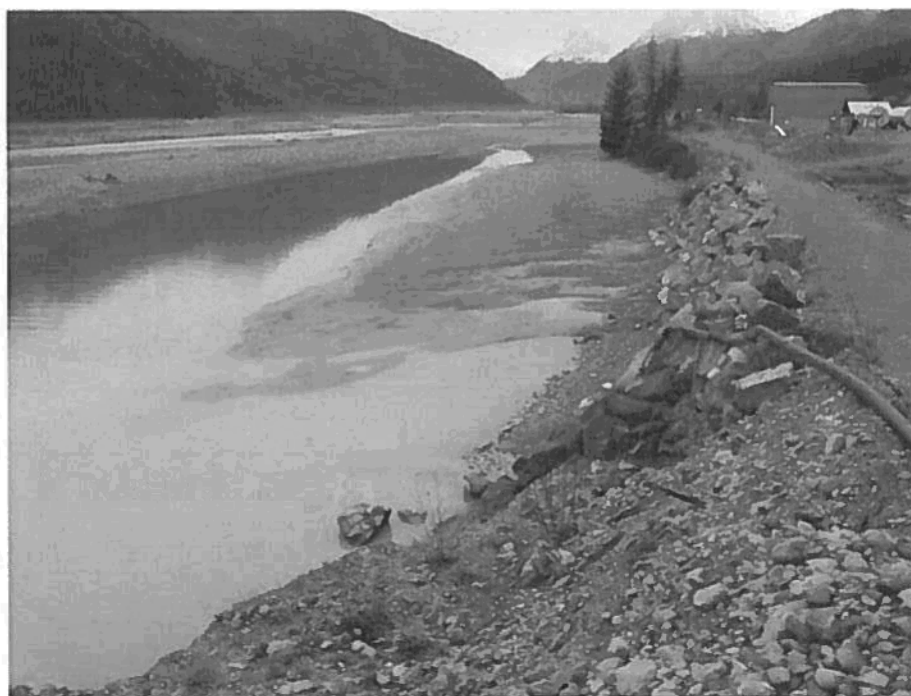
Photo 9

Written Approval for the bypass of the water treatment plant was not obtained and the discharge does not meet the conditions specified in Section 3.6. As a result, Chieftain Metals Inc. is in violation of Section 2.1 Bypasses of Permit 105719.

5200 discharge location. Samples for TSS, total metal and dissolved metals taken at this location.

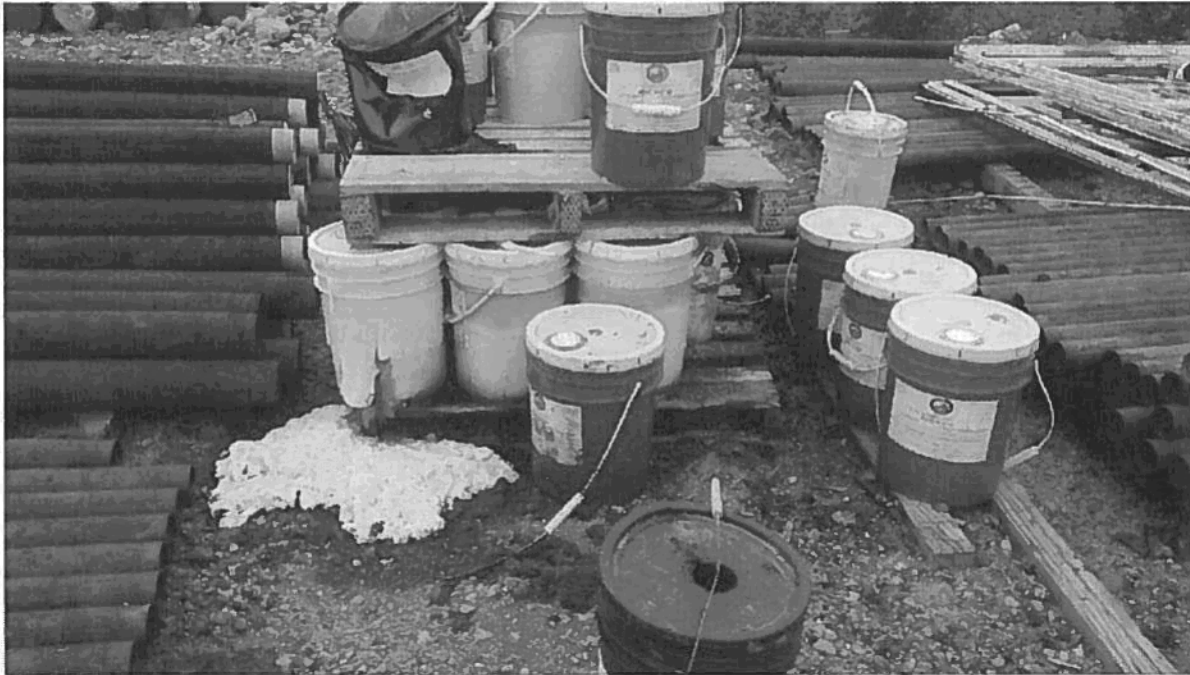
There were 22 pails of unused drilling products, including 2 partial (20 litre) pails of rod grease. The leaking white bucket contained AMC Pure Vis, a non-hydrocarbon drilling polymer. Bucket likely burst due to freezing conditions. Wildlife may have disturbed grease buckets but unlikely to have consumed any. Green buckets contain AMC K-Ion. Initial clean-up completed July 14. Pallets moved in to storage Oct 16, 2015 (photo below).

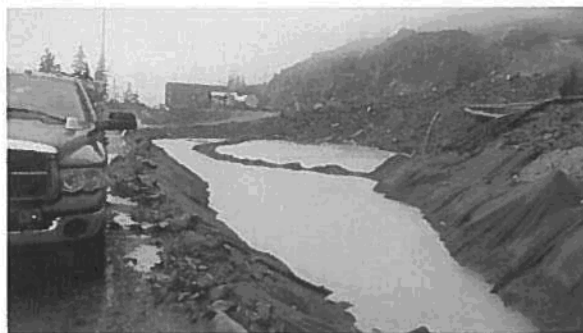
Station SE-2 continues to be characterized by high dissolved metal concentrations, and low pH (pH 3.0-3.5), primarily driven by the loading from the 5200 portal discharge. Sample results for sulphate, total and dissolved zinc and cadmium concentrations for the monitoring period are shown in Figure 2, Figure 3 and Figure 4, respectively. Trends at station SE-2 are generally scattered, reflecting the variety of inputs; however, metal concentrations in Q4 2015 are generally comparable to previous concentrations. It should be noted that the highest values for sulphate, Cd and Zn (Aug 2014 and June 2015) both coincided with the times when the 5200 portal flow has been directed to the river rather than through the Exfiltration Pond and thus the reported results are more representative of the small amount of 5400 Portal flow rather than the larger 5200 Portal flow. The complete set of analytical results for station SE-2 is provided in the water quality database in Appendix A. Appendix B provides a number of plots comparing the 5200 and 5400 portal discharge analyses with the more recent SE-2 values, further demonstrating that biogeochemical conditions remain consistent with the past.

Picture 3 – Exfiltration pond (Oct 17, 2015)

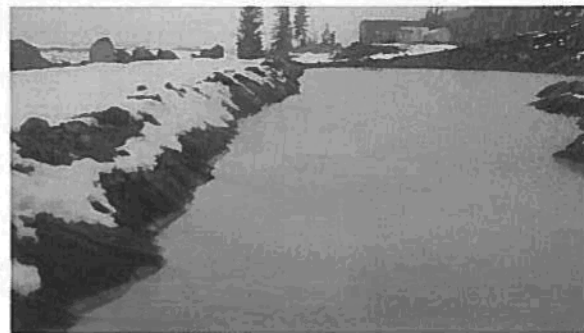
Picture 4 – Exfiltration pond (Nov 22, 2015)

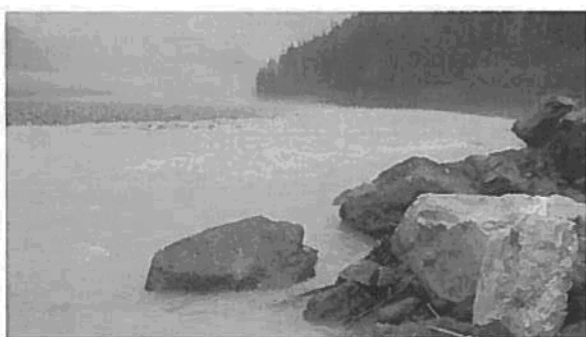
The conditions at the station W10 in Q3 are shown in Picture 7 and Picture 8. The jokulhaup has brought the main flow of the river right in to the riprap protecting the northern end of the airstrip and has caused some undercutting there. Concentrations for key parameters are presented in Figure 5 compared to the water quality objectives, for the 2012 - 2015 monitoring period. Generally the water quality at station

Picture 7 – Station W10 (Oct 17, 2015)

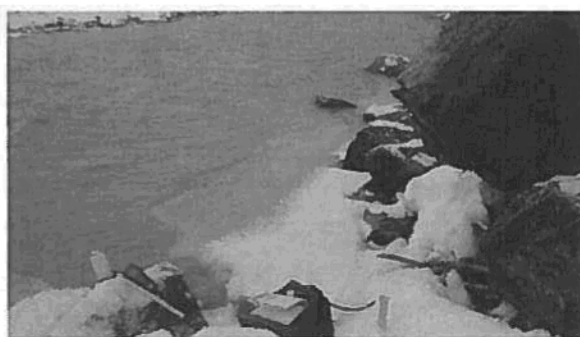
Picture 8 – Station W10 (Nov 22, 2015)

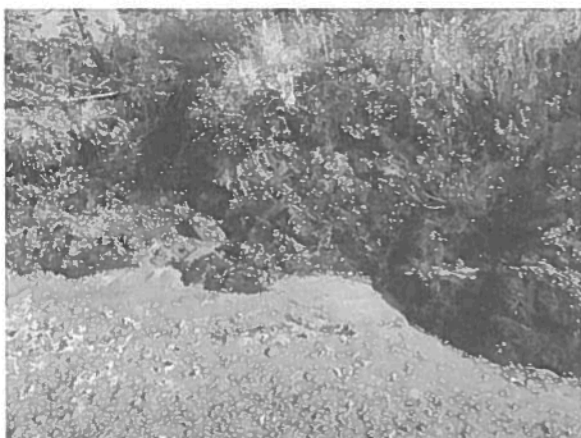
Picture 9 – ATP Discharge location – upstream of W46 (October 14, 2015)

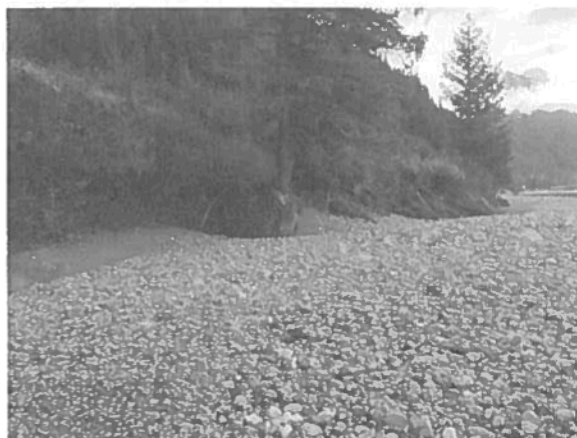
Picture 10 – Looking downstream towards Station W46 (October 14, 2015)

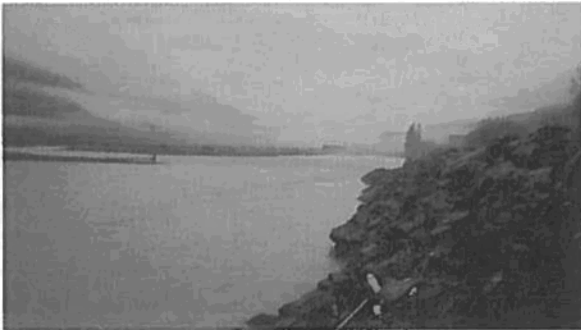
Picture 11 – Station W51 (Oct 17, 2015)

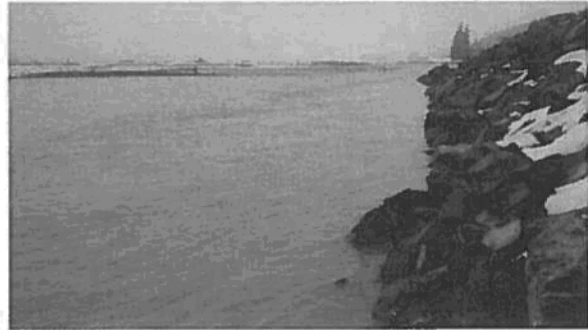
Picture 12 – Station W51 (Nov 22, 2015)

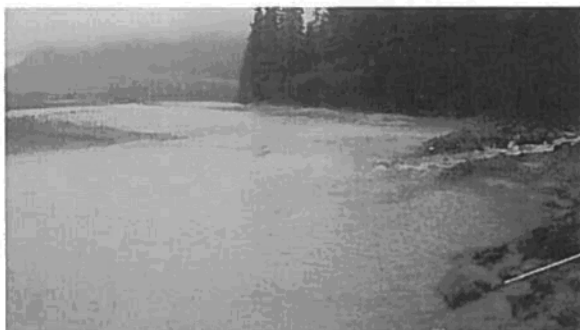
Water quality results for station W32 are presented in Figure 8 and are compared to the water quality objectives for the 2012 - 2015 monitoring periods. Station W32 in October and November is shown in Picture 13, and Picture 14, respectively. It is worth noting that the discharge of Limestone Creek entering the river can be seen – which was not typical in the past. Furthermore, the colour of the water at W32 is different than at W10 and W51. This is primarily because of lower turbidity (caused by lower TSS) in the water. Based on visual observations in October 2015, it appeared that most of the water at the W32 sample location is derived from Roger's Slough and Limestone Creek, with some contribution from Roger's Creek and a small braid of the Tulsequah river mainstem. Dissolved metal fractions at station W32 were generally low in Q3 and Q4 2015, and many were less than the reportable detection limit. Similarly, total metal fractions at station W32 were lower than at the other two (W10 or W51) river stations. Total metal concentrations of copper and zinc were also lower in Q3 and Q4 than in Q1 or Q2 2015. Based on the analytical results and observations of the river braiding in October, it appears that the sampling location used for W32 since late 2008 is no longer viable for assessing far-field impacts of the discharge from the mine site. For the November sampling campaign, the sample location was moved across the floodplain and slightly downstream to a river braid that is better exposed to the contaminant loading. Appendix C contains a series of photos to show the river braiding between the minesite and W32. It appears that most of the contaminant load from the mine is being directed away from the outlet of Limestone Creek, where W32 has been located since 2008. It does appear that most of the load should re-combine at about the location where the W32 sample was collected in November (and again in January 2016). However, closer inspection of the water quality data from November suggests that the new location may still have been just a little bit too far upstream to catch the full load from the mine. The February 2016 sample location will again be moved slightly further downstream such that the full mixing of the two braids can be sampled. It should also be noted that the Exfiltration Pond drainage is currently

Picture 16 – Looking upstream from Station W32 (Oct 17, 2015) – Limestone Creek can be seen entering from right

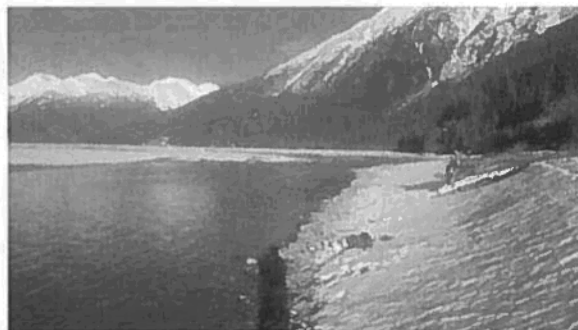
Picture 17 – New Station W32 looking towards Chief minesite (Nov 23, 2015)

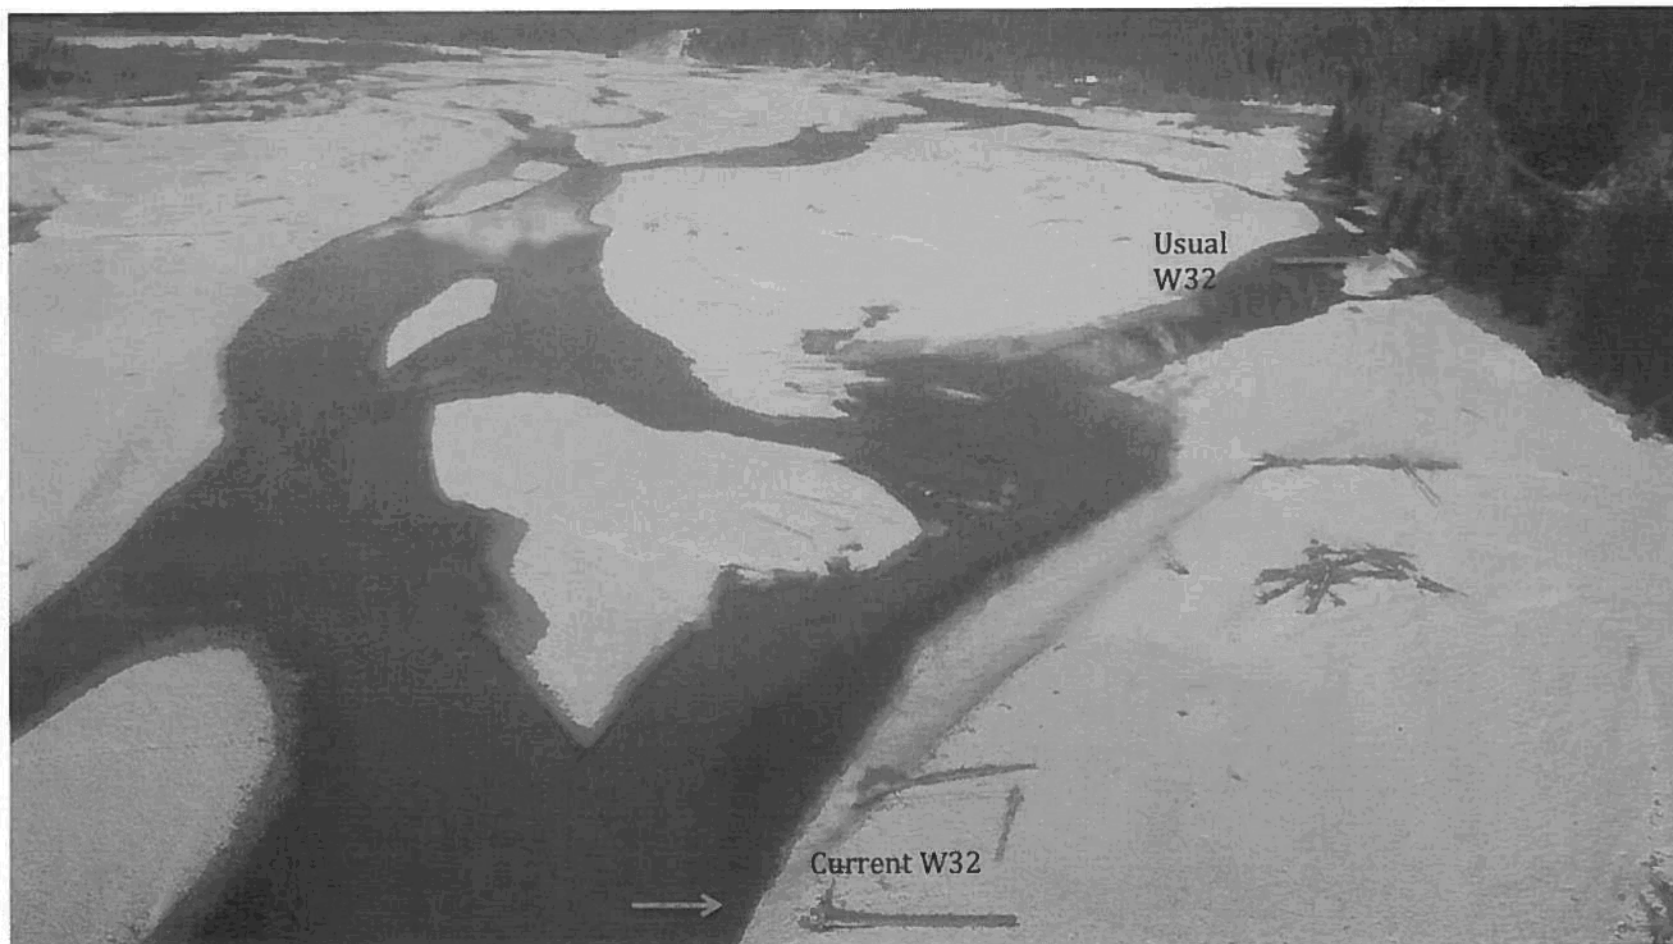
Figure 1 - Revised W32 sample location, downstream from Limestone Creek

The location used to collect the W32 sample in November and January is just upstream of the confluence of two braids. The February sample will be collected downstream of the confluence instead. The recent measured concentrations have been lower than historical values for this station. This may be a result of the braids having differing concentrations. However, it may also be a result of the Exfiltration Pond now discharging to the dry flood plain rather than in to the river water.

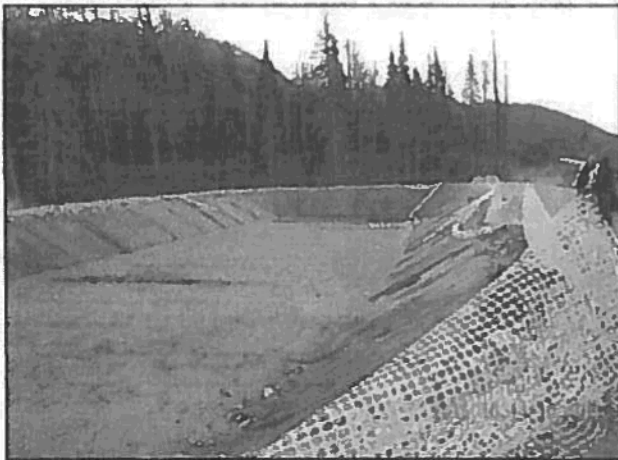
The temporary lime sludge storage pit, located just off the airstrip, contains approximate 35m³ of sludge generated from the WTP and is lined with a filter fabric to prevent migration of the sludge to the subsurface gravel. No deposition has occurred since the WTP shut down in June 2012. CMI maintains monitoring from 3 groundwater wells. CMI has committed, should mine operations not resume, to relocating the sludge to a secure location to the Rogers Creek area, which will be capped and re-vegetated.

Photo 1: Lime Sludge Pit Shaza AirStrip.

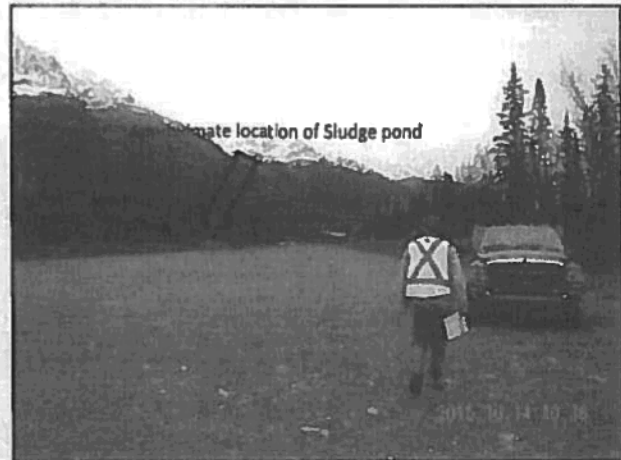
Photo 2: Shaza Airstrip location of Sludge Pit

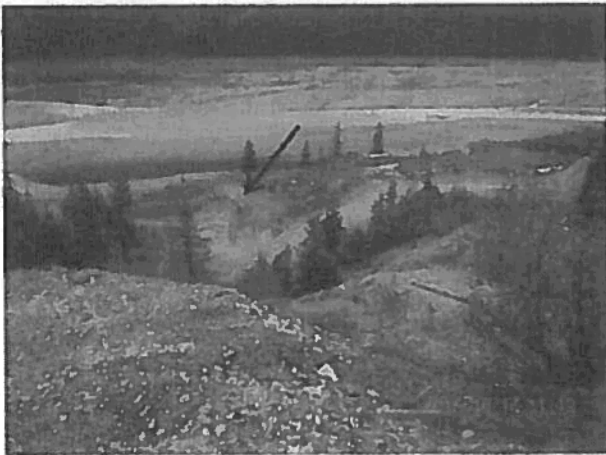
Photo 5: The black pipe (arrow) is the acidic discharge from the 5400 portal. Portal Creek and the combined non-acidic drainage discharge to the left of the picture in an underground HDPE pipe.

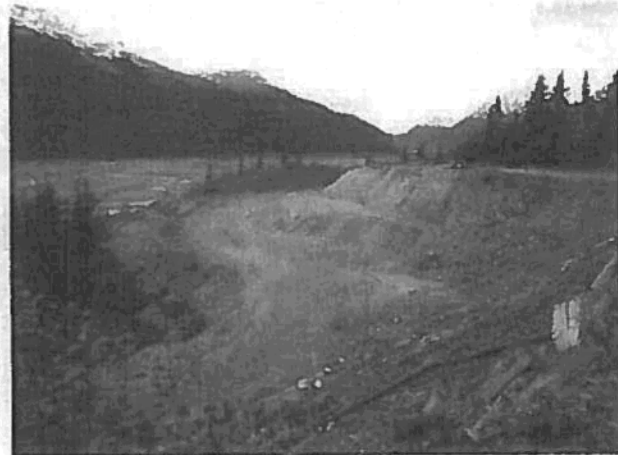
Photo 6: showing the historical PAG rock left from early mining. The ~80,000 tonnes of material to be relocated once mining restarts to the PAG dump on Rogers Creek.

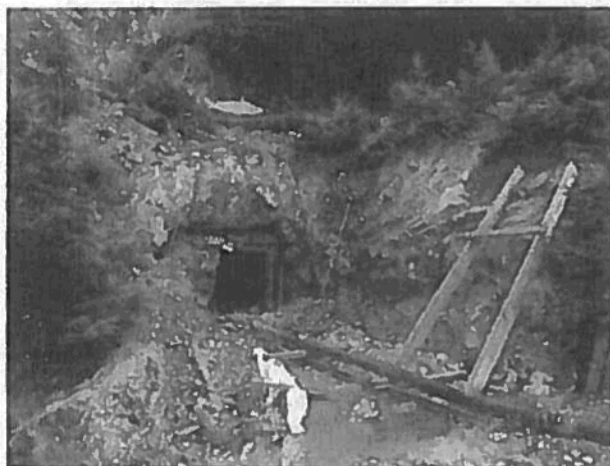
Photo 7: 5200 Portal. Acidic discharge is in smaller pipe exiting mine. 5400 non acidic and Portal creek water is contained in the larger pipe located above the portal.

Notable in Photo 7 is the 600mm HDPE pipe over top of the 5200 Portal entrance which is conveying the Portal Creek and 5400 non-acidic drainage to the Tulsequah River. The pipe requires ongoing monitoring and maintenance because of rock falling onto the pipe and at times crushing the pipe causing leakage. From the photo it can be seen the pipe is currently leaking with water spilling down to pond in front of the Portal. This pond drains into the ex-filtration pond via ditching and a culvert under the road.

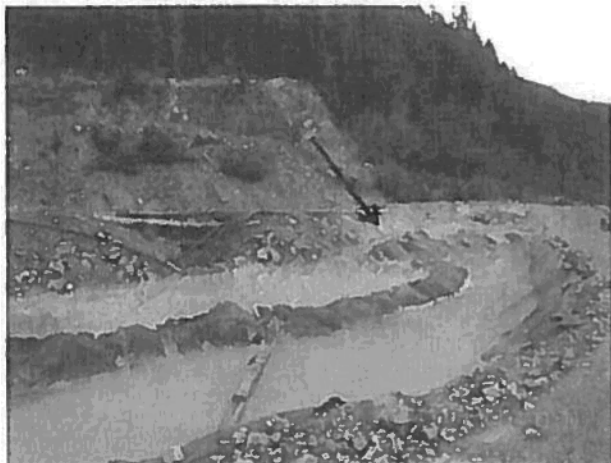
Photo 9: Exfiltration pond receiving ditch water from the 5200 portal

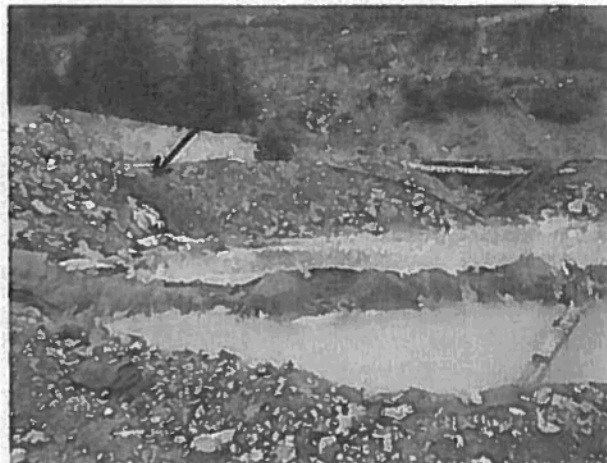
Photo 10: Exfiltration pond receiving acidic discharge from the 5400 portal

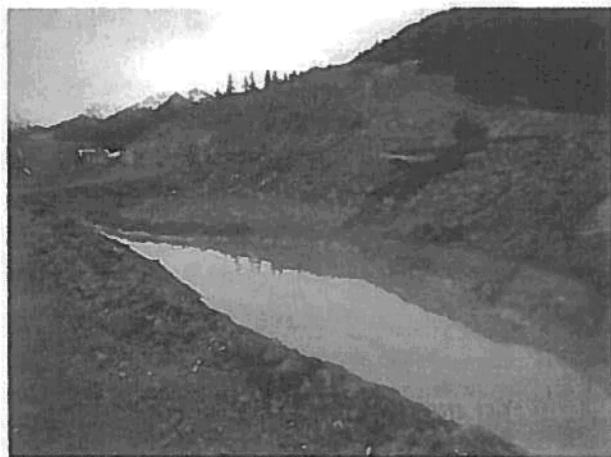
A significant concern is the proper operation of the pond given there is no spillway observed and there is no continuous onsite presence.

Photo 11 Exfiltration pond. Note high water level of sludge.

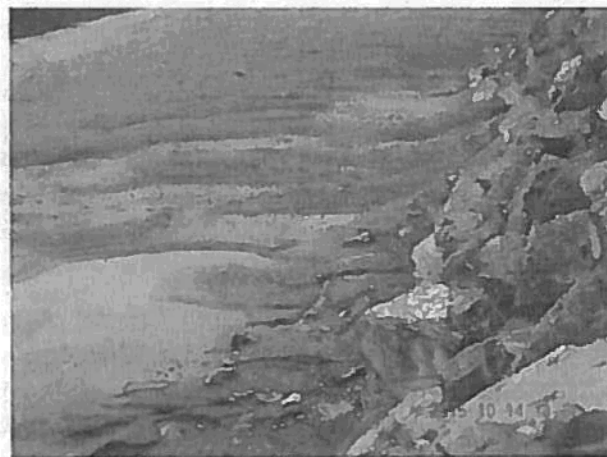
Photo 12: Diffuse discharge location through berm onto the Tulsequah river floodplain.

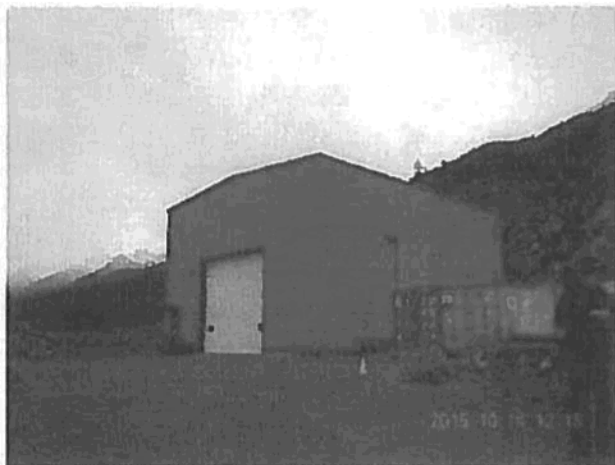
The WTP was constructed in its current location in 2011 after receiving approvals from the province to relocate and upgrade the previously proposed WTP (Photos 13, 14). The WTP is designed to treat acidic discharge on a temporary basis until the upper mine workings could be backfilled as per the mine design proposed in 2009. The plant ran from October 2011 till June 22, 2012 at which time operations were suspended due to operational issues. Since that time the company has sought guidance on process modification strategies to address the high operating costs. CMI has stated they are committed to re-commissioning the WTP at the earliest time upon completion of full project financing.

Photo 13: Acid Water Treatment Plant

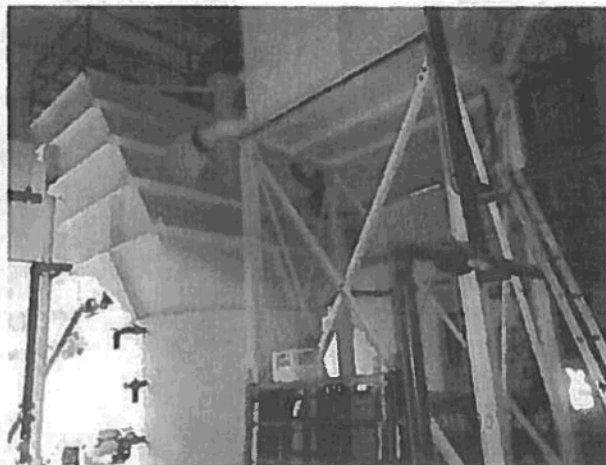
Photo 14: Inside the AWTP

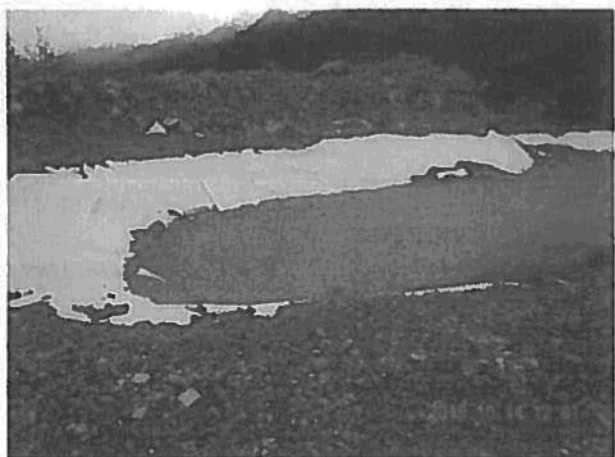
Noted during the inspection, beside the WTP, was another sludge pond which has not been approved by MEM (Photo 15)

Photo 15: Temporary Sludge pond beside AWTP

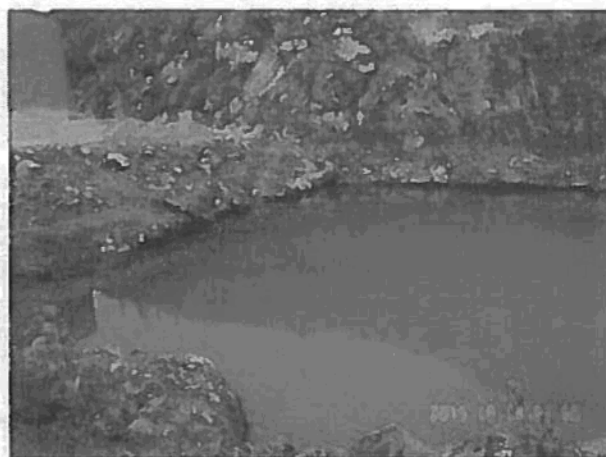
Photo 16: Site Collection Pond

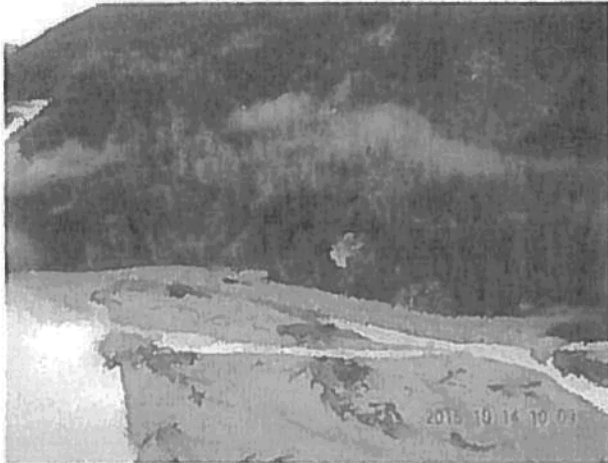
Other than clearing, and some minor construction of berms the areas reserved for PAG and NAG waste rock storage has been minimal (Photo 18). Access to these areas from the main mine site is good; the causeway remains in good condition (Photo 17).

Photo 17: Causeway between mine and Rogers Creek area.

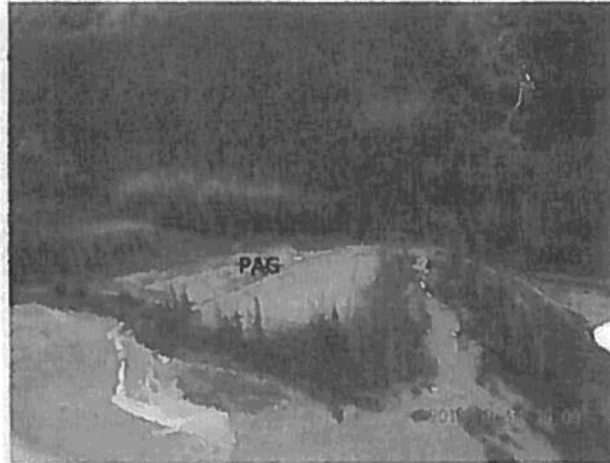
Photo 18: Clearing for the PAG and NAG waste rock areas.

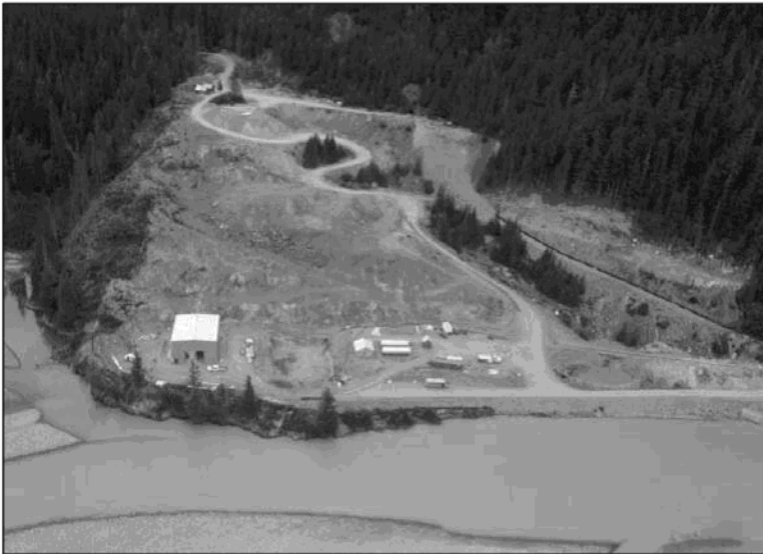
14 - August 8, 2011

Earthwork Activities along the 5200 Portal level. Note that the river is now adjacent to the berm and toe of 5200 waste rock (compare with Oct 2008 photos). Berm construction completed and riprap placed.

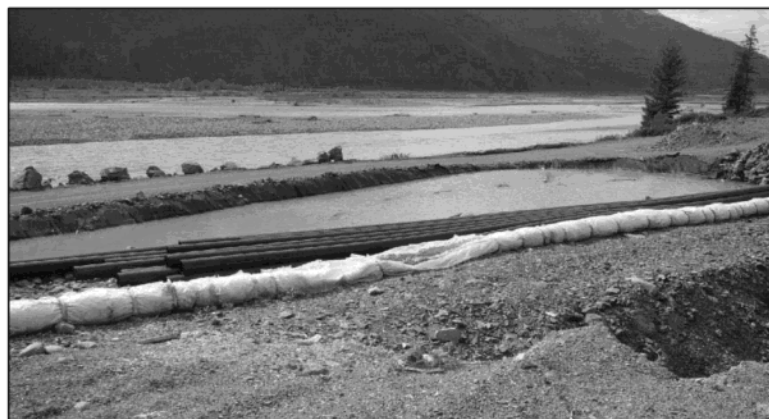
22 - June 2, 2015

Pond full.

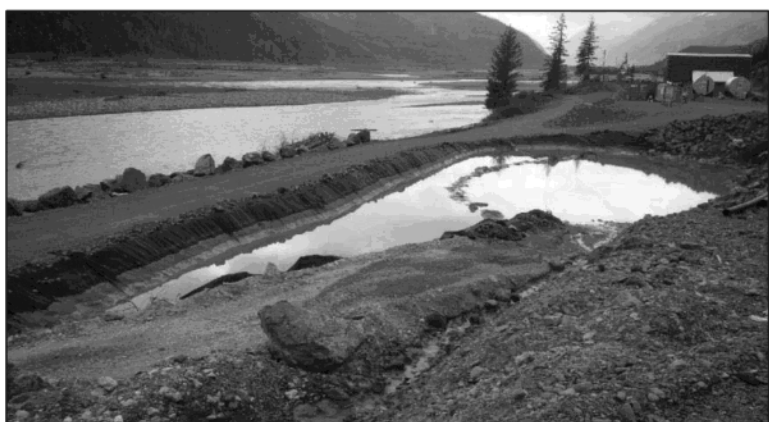
23 - June 2, 2015:

Pond after 16 hours
without 5200 Portal flow.
