Report of Inspector of Mines - Health and Safety

Mine Name/Number	Westside Pit 1620313	Visit Date	2021-05-12
Type of Mining	BCL	Location	
Latitude/Longitude	51.02194, -118.2227	Northing/Easting/Zone	414245, 5652976, 11U
		Permittee	Terus Construction Ltd.
Inspector	Jerrold Jewsbury, INSPECTOR	Accompanying Inspector	Haley Kuppers, Inspector;
Address	202-100 Cranbrook Street North Cranbrook, B.C. V1C 3P9		
In Attendance	Corey Rokosh, Site manager, TERUS; Jordan Leroy, New Site Manager, TERUS		
Copies to

Inspection Number: 178143
File Number:
Permit Number: G-4-188
Total Orders: 0
Mine Number: 1620313

Inspection Number: 188318
File Number:
Permit Number: G-4-188
Total Orders: 0
Mine Number: 1620313

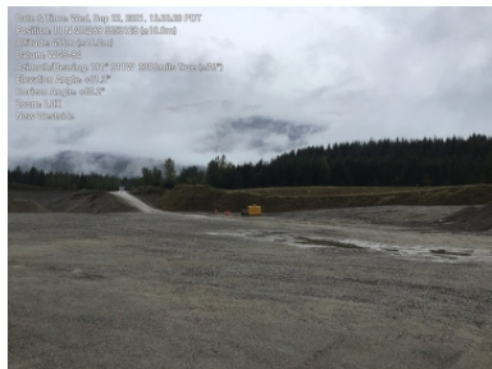
Westside Pit

The site was in active and in good condition. Pit walls and stockpiles were sloped appropriately. Signage was in place and there were appropriate access controls in place. The weather was rainy and dust was not a concern on site.
