# 2017 Dam Safety Inspection, Placid Tailings Storage Facility

Bull River Mine, Bull River, BC

December 22, 2017

Project No.:643035

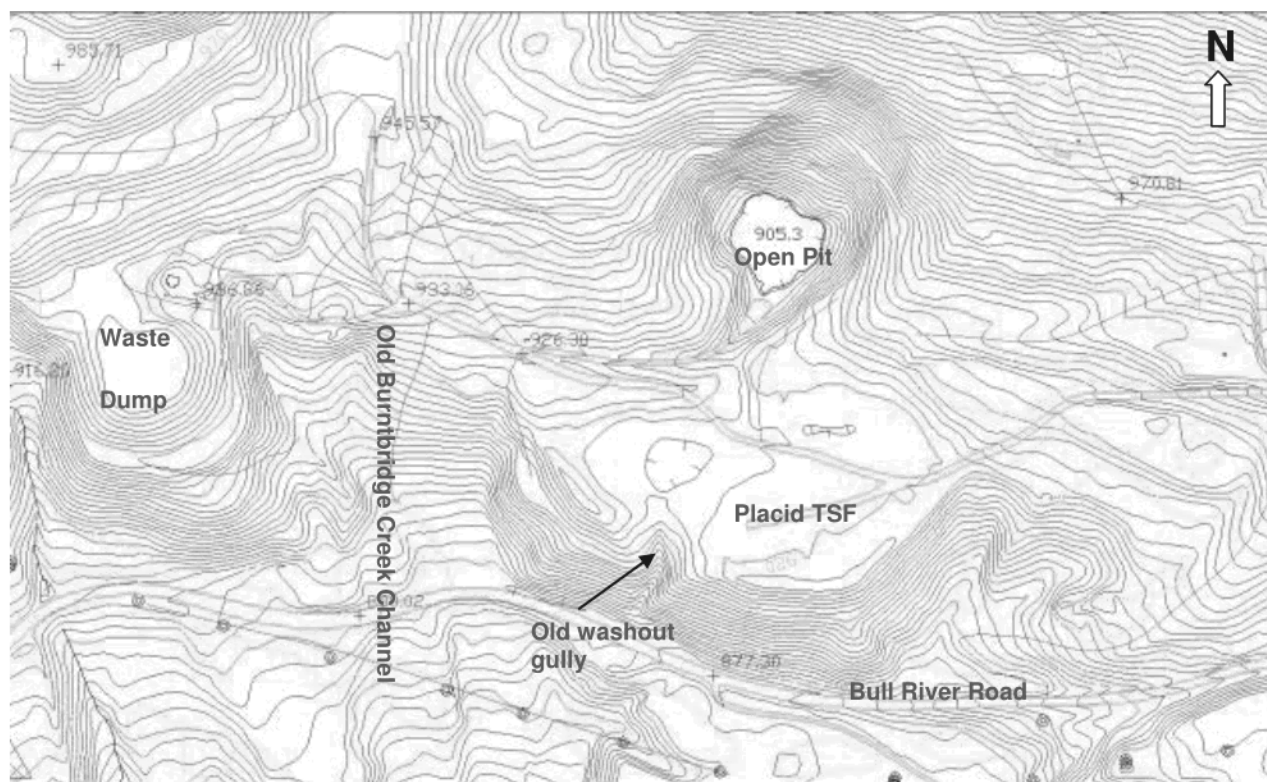
Figure 3: Contour data (2 m interval, magenta lines are 10 m apart).

Contour data from 1996 is shown in Figure 3 below, taken from a CAD file of topographic data having 2 m contour intervals. Key site features are labeled on the figure.

The TSF consists of a relatively flat surfaced fill that has been reclaimed and slopes gently to the north, into the mountain slope. As observed in the field, and corroborated by examination of the as-built contour data in Figure 3, the TSF surface slopes north to the open pit. It also slopes in westward and eastward to a point located just north of the old washout gully. Surfaces mostly slope to the open pit. The washout gully captures water only that falls within its confines, and the ground surface north of its headwall is graded down to the north toward the pit.
