REPORT NO. 212003/1

**MYRA FALLS OLD TAILINGS DISPOSAL FACILITY
2013 DAM SAFETY REVIEW**

MYRA FALLS OLD TAILINGS DISPOSAL FACILITY 2013 DAM SAFETY REVIEW

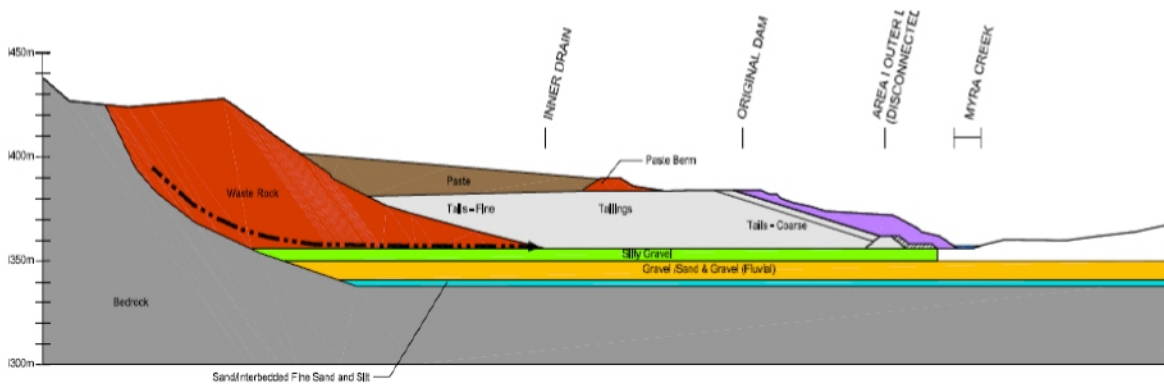
Waste rock dumps 1 and 6 to the north of the TDF rise at their natural angle of repose above the adjacent tailings surface. Note these rock dumps also underlie the tailings as shown in the Figure 3 below.

While we are of the opinion that these dumps do not currently constitute a dam safety issue, we concur that as part of closure their stability and covering should be addressed.

Figure 3. North to south cross section through the TDF. Note the waste rock dumps on the left side of the section. These dumps were initially placed against the hillside. Subsequently the tailings were placed up against these dumps. Note that the (purple) seismic stability berm to the right of the section has now been constructed to full height.

The writers of this report were informed that in accordance with Hoffman (2013) the stability and cover for these dumps are being reevaluated and action will be taken in accordance with plans for the closure of the TDF.

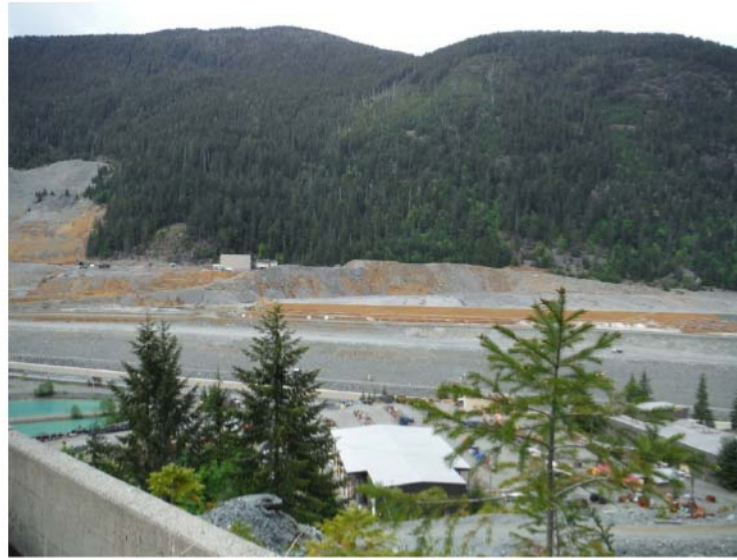
Figure 4. The TDF. Looking north from the hillside on the south side of the valley. Note the waste rock dumps are the orange-gray surface just below the trees at the base of the hillside. (See also Figure 5 for more detail.)

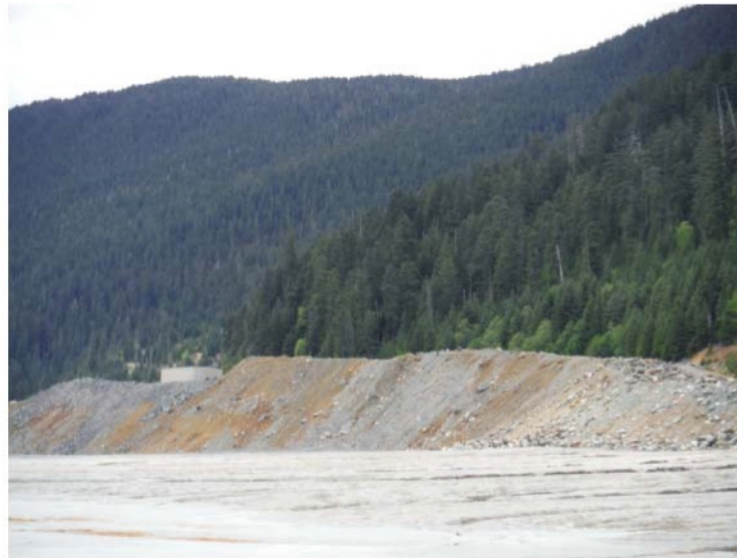
Figure 5. The south face of the waste rock dumps rising from the surface of the paste tailings area.

At the toe of the waste rocks dumps and extending to the south is the surface of the paste tailings (Figures 3 and 5). This area is sometimes referred to as the Amalgamated Paste Area (APA). The

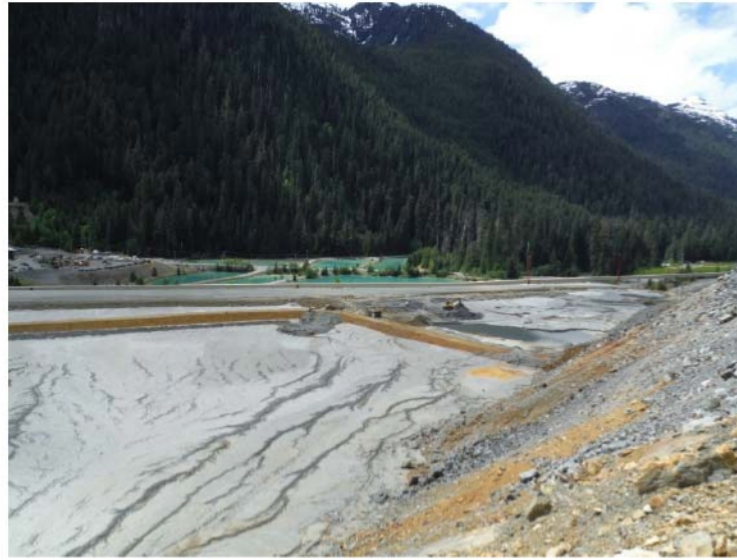
Runoff from the surface of the paste tailings generally flows downslope from north to south, and hence towards the west along the upgradient side of the paste berm (Section 4.6). Runoff is removed from the surface via the decant structure at the south-west corner of the upper surface of the paste tailings area (Figures 7-A to 7-C). The decant conveys water to the Super Pond.

Figure 7-A. The decant location at the south-west corner of the paste tailings area. The sand management area (Section 4.8) is to the west. At the bottom right of the photo are the steeper slopes of the waste rock dump.

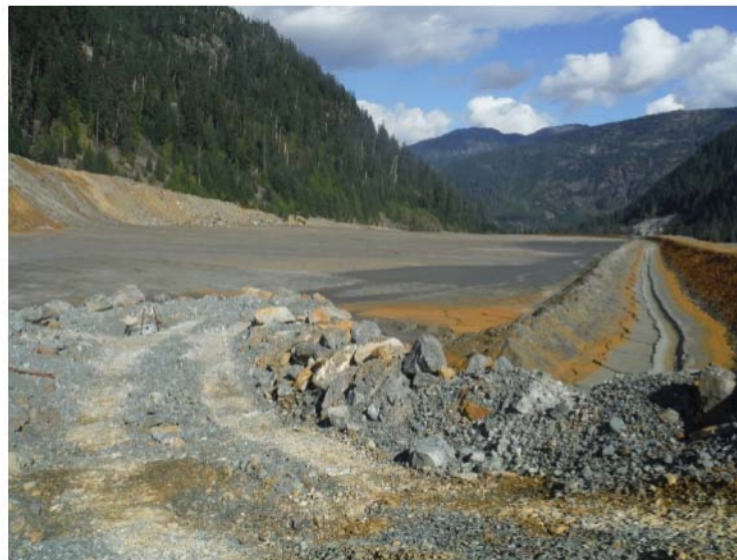
Figure 7-B. The Amalgamated Paste Area decant facility as seen from the south-west corner of the area. Note surface water runs east to west in the channel to the right of the photo, then ponds to flow into the area of rock in the middle of which is the decant pipe leading to the Superpond.

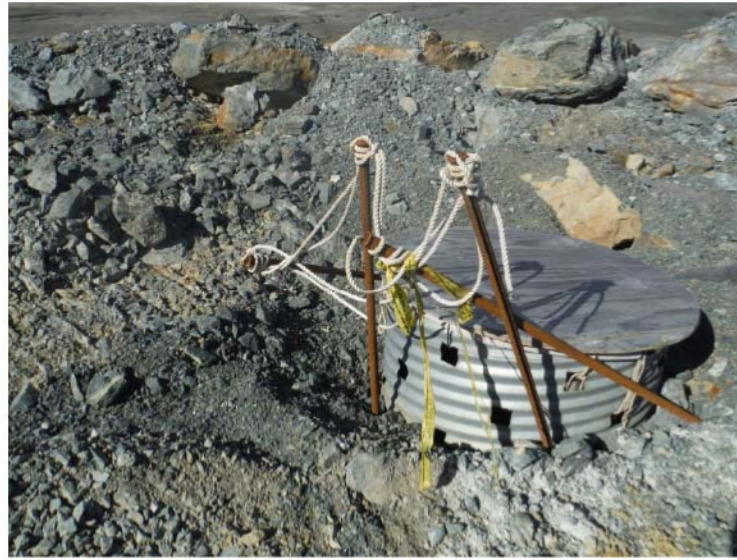
Figure 7-C. The inlet to the decant pipe from the Amalgamated Paste Area. Note the wooden top. Water is intended to pass through the square openings in the pipe.

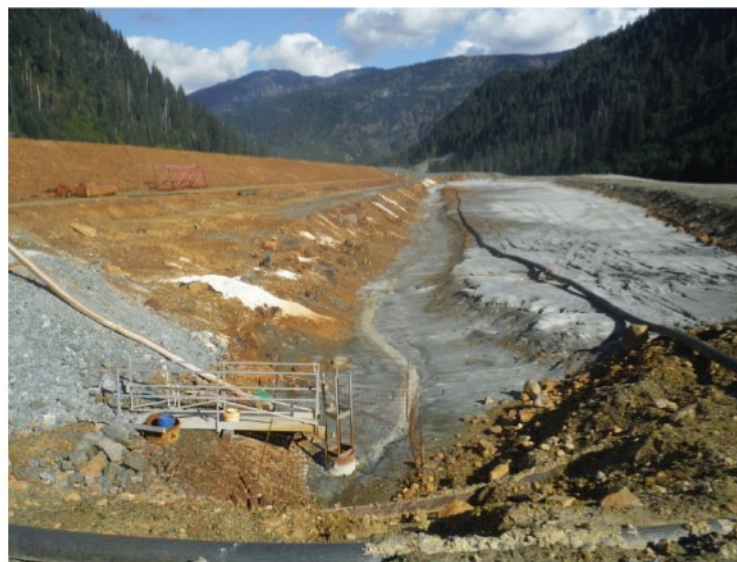
Surface water runoff from this area generally flows from east to west into the decant facility. (Figure 9).

Figure 9. The Strip Area looking east. Surface water runs in the “channel” to the decant facility, which is seen in the foreground of the photo.

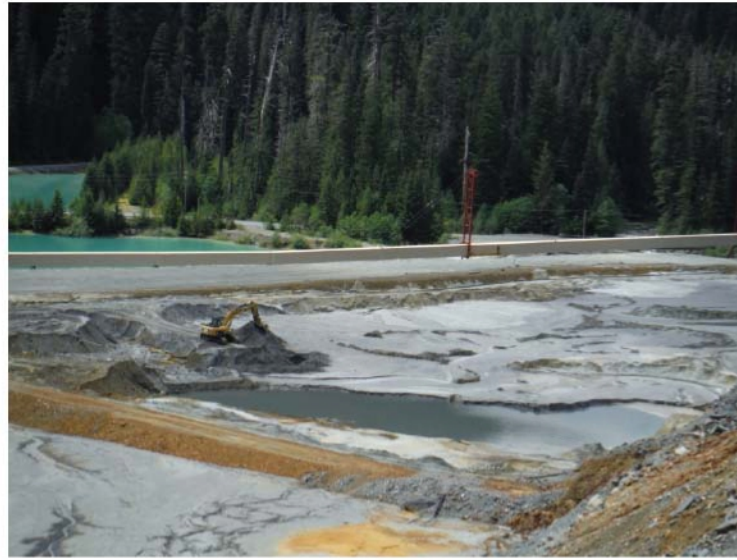
Cyclone underflow sand is placed, as part of temporary storage, into the sand management area to the south west of the TDF. The quantity of sand in the area varies as demand for sand for underground backfilling varies and as the use of the sand for construction varies. The ability of the sand area to retain water from upgradient runoff and incident precipitation accordingly varies. The perimeter berms are kept at least one meter above the sand, and in accordance with AMEC (2008) this is considered sufficient to retain the 1 in 200 year, 24-hour storm event. Water passes from the sand area via a dedicated decant to the Super Pond.

Figure 12. General view of the sand area looking from east to west.

The sand area is part of TDF closure area. It will be reclaimed as and when other facilities to stockpile the sand can be established.

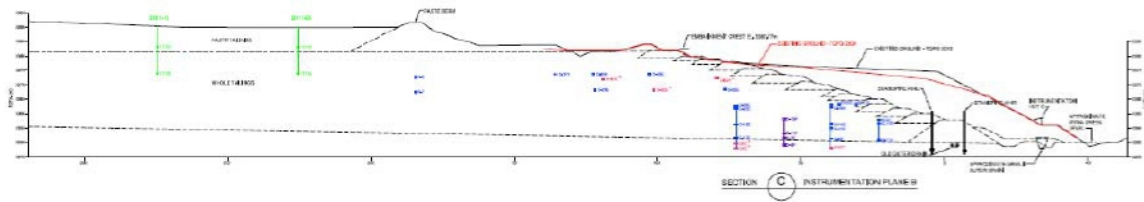
The seismic berm was constructed on the south side of the TDF in order to provide for stability of the TDF in the event of large earthquakes. The analysis of the stability of the berm and its design are documented in Klohn Crippen Consultants Ltd. (1999a) and (2004a), and AMEC (2011). The latter presentation notes factors of safety for the TDF for various earthquakes that are consistent with industry standards. The presentation also notes “Even with adequate factor of safety, some liquefaction-related deformation is anticipated in the APA and TDF following the MCE.” The calculated deformation under the most extreme seismic loading by the Maximum Credible Earthquake, is that “the berm will horizontally translate about 3 m to 4 m into Myra Creek and the tailings surface at the berm will vertically drop 1.5 m to 2.0 m.” This deformation has been calculated using standard procedures and is consistent with similar calculated deformation for other facilities in high seismic areas.

Figure 13. Cross section of the seismic berm (from AMEC, 2011.) Note the seismic berm is to the right of the section and is constructed over the previous outer face of the TDF.

In terms of Hoffman (2013) “Updated slope stability analyses shall be undertaken to complete the detailed closure design for the TDF.” In the opinion of the writers of this report, such a course is necessary and appropriate.

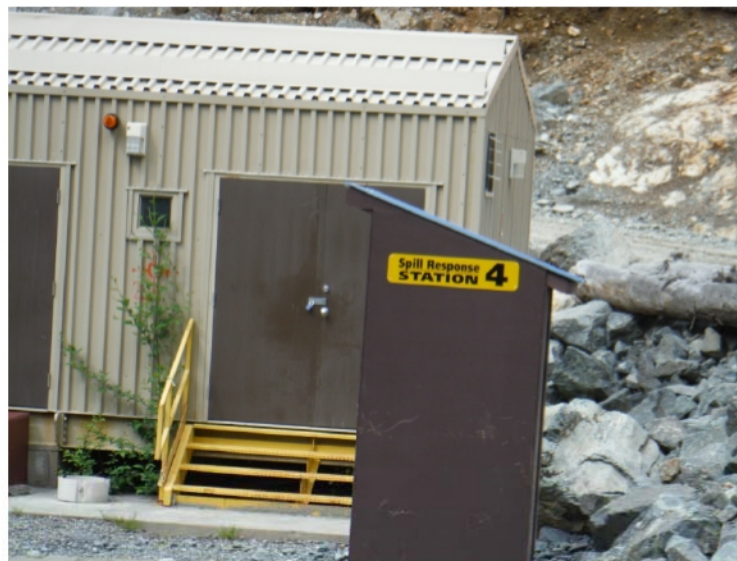
The underdrains of the TDF drain to a sump in the Pumphouse #4 building. Seepage from the underdrains is collected in this sump and returned to the Superpond.

Figure 16. The Pumphouse 4 Building.

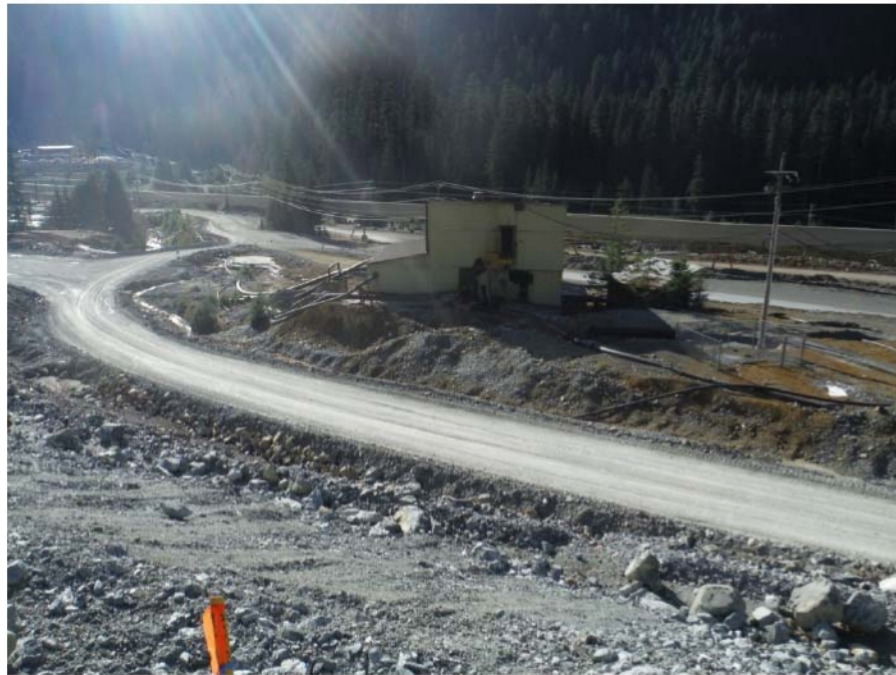
When observed in September 2013, raising of the embankment dam had just been completed. The authors of this report were informed that the zone of cracking was removed and replaced as part of the embankment raising. No cracking of the embankment was observed (Figures 4 and 5).

Figure 5. The access road along the toe of the embankment. To the bottom left of the picture is the inclined downstream face of the embankment. Above, and to the right of the access road are various material stockpiles and other facilities that will be removed to make way for the embankment as, in the future, additional embankment raising is undertaken.

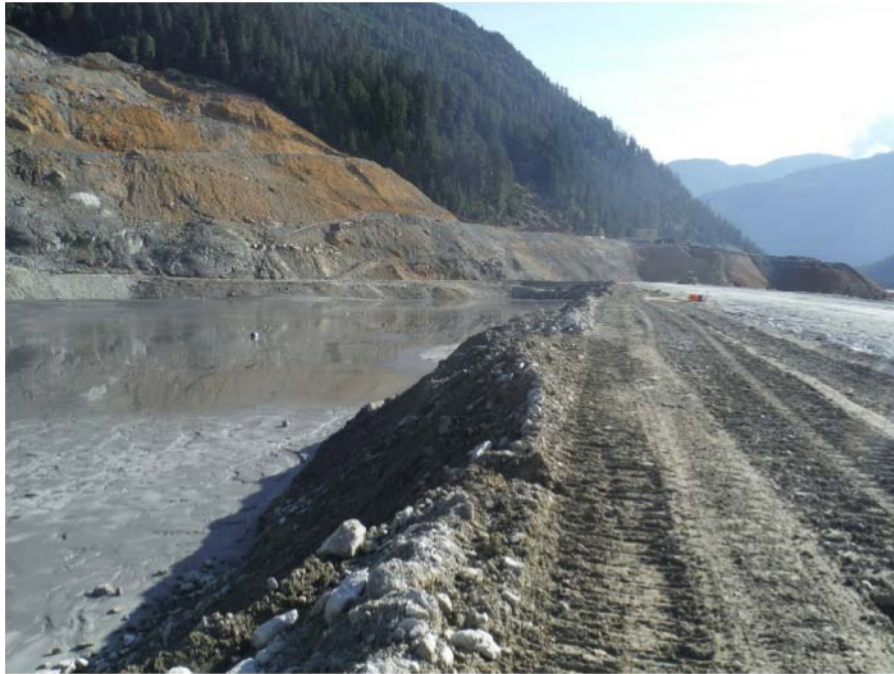
The top surface of the upstream filter zone was observed (Figure 6). The material is finer than the rockfill and in appearance suitable for its design purpose—controlling migration of tailings into the voids of the embankment rockfill. On the upstream side of the filter zone is either paste tailings or sand (Figures 7 and 8).

Figure 7. Looking west to east along the upstream crest of the embankment. To the left is the surface of the tailings

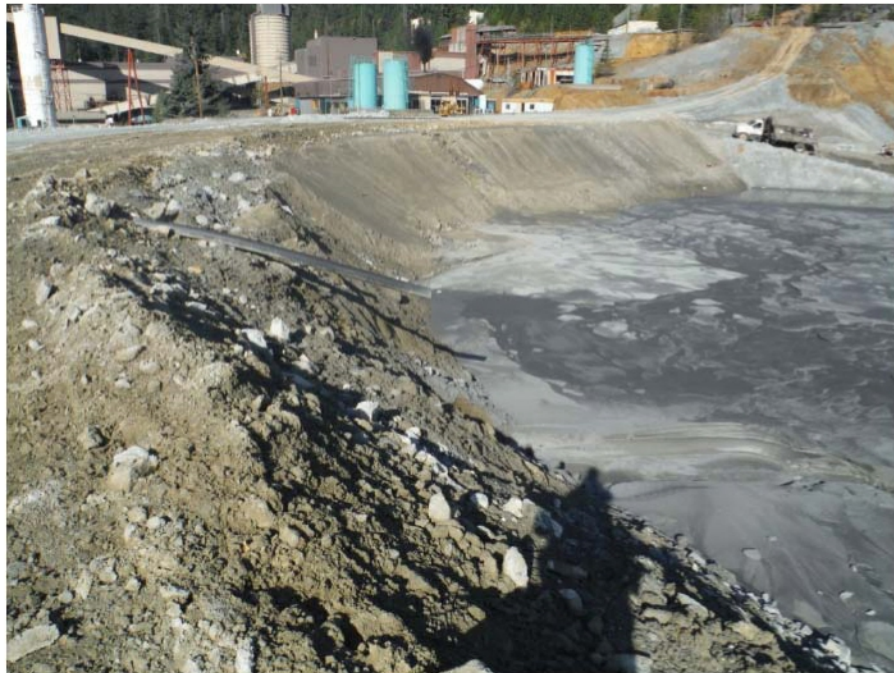
Figure 8. Looking east to west along the upstream crest of the embankment. Sand is deposited from the pipe in order to control the beach and hence to push standing water back and away from the embankment.

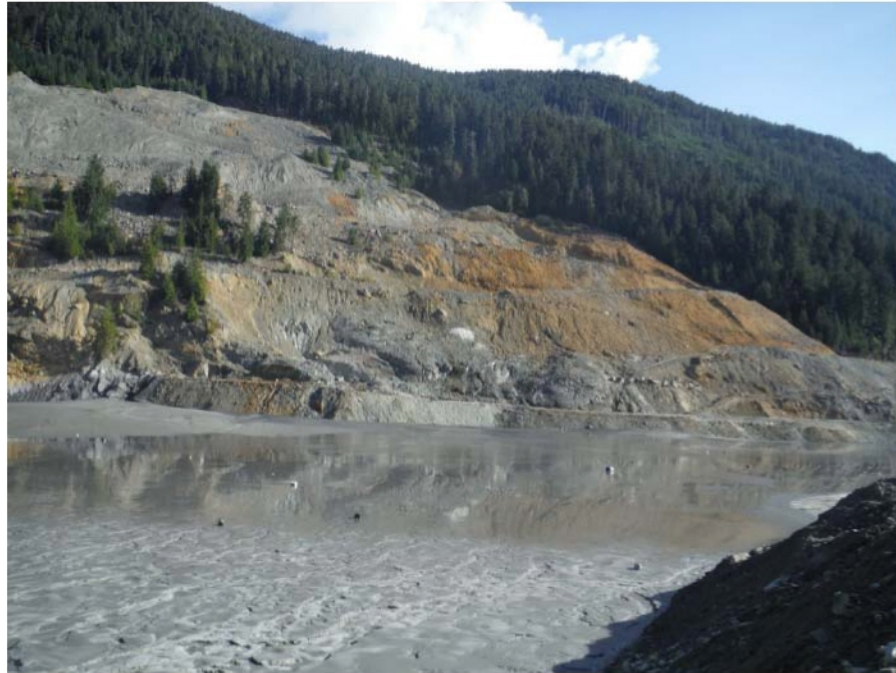
The topography of the tailings surface is controlled by the discharges into the area, including the paste tailings line, the sand line, and overflow from the Super Pond dredging (Figures 9 and 10).

Figure 9. Looking from the crest of the embankment to the north-east across the surface of the tailings. In the foreground is sand, and behind this is the wet upper surface of tailings. Rising from the surface of the tailings are the natural bedrock slopes and waste rock dumps above the Lynx TDF.

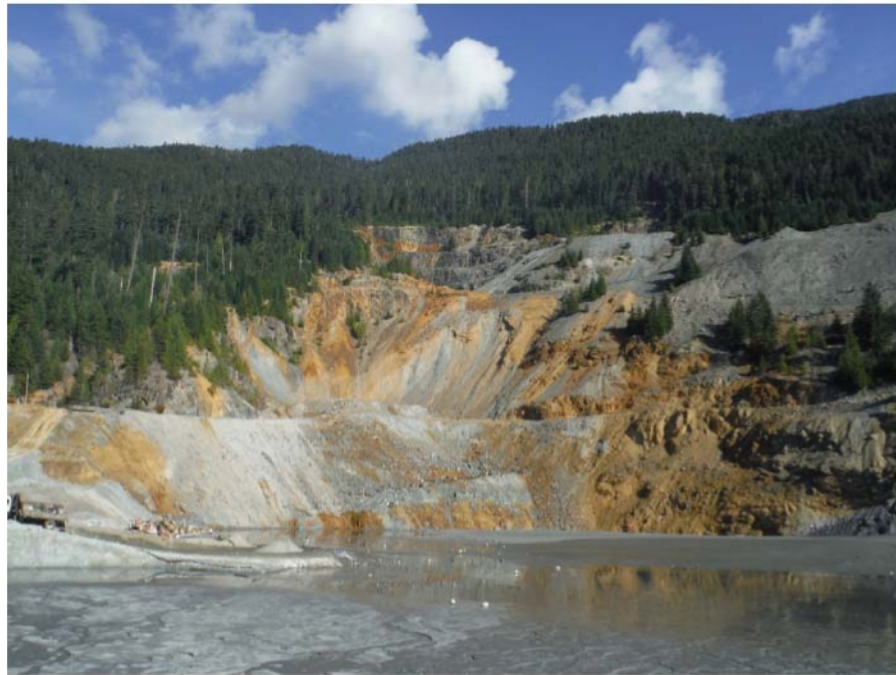
Figure 10. Looking from the crest of the embankment to the northwest across the surface of the tailings. Rising from the surface of the tailings are the natural bedrock slopes and waste rock dumps above the Lynx TDF

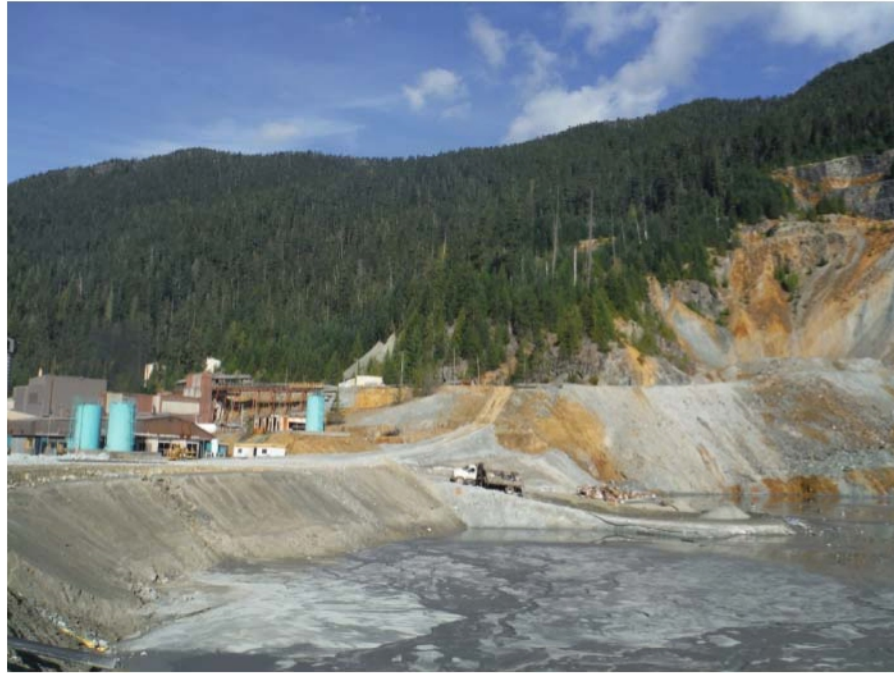
Mine refuse is deposited into the tailings (Figure 11). In essence as the tailings surface rises, the tailings surround and encapsulate the individual refuse items.

Figure 11. The truck has just dumped refuse at the right-hand end of the road that slopes down to the tailings surface. Note also the significant difference in elevation shown here between the top of the tailings and the crest of the embankment.

Because of the recent raising of the embankment there is significant freeboard (Figure 11). As of August 29, 2013 the reported elevation of the tailings surface against the embankment was 3393.2 m and the elevation of the embankment crest was 3398.8 m. This freeboard (5.6 m) will reduce as tailings are deposited and the surface of the tailings rises. The design operating freeboard is such that there is sufficient volume to retain 78,000 m³ of precipitation and runoff plus an additional 0.5 m provision for wind and wave action (AMEC 2008b).

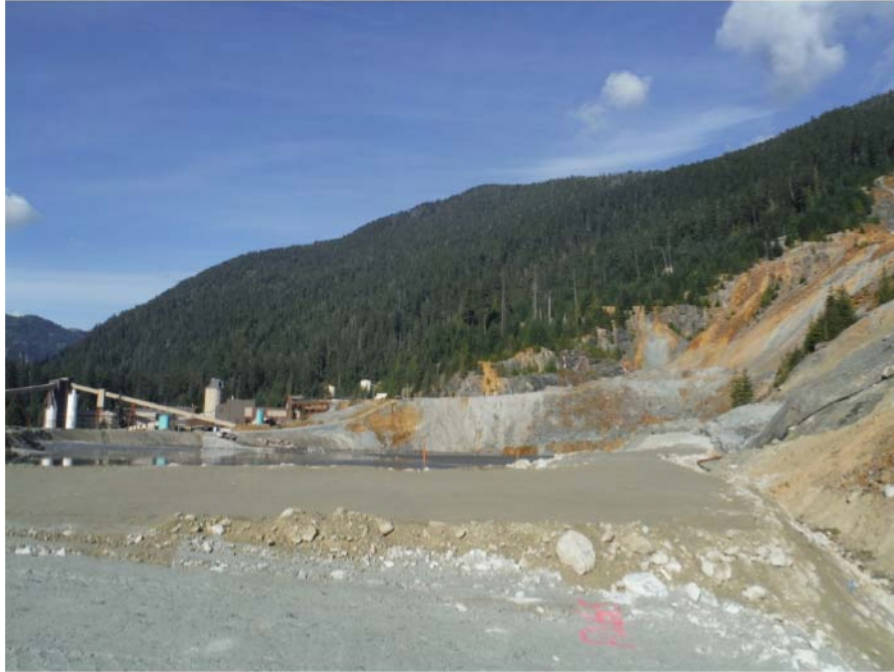
Towards the east end of the north side of the Lynx TDF, there is seepage from the bedrock (Figure 12). The seepage is directed to a channel formed on the north side by the bedrock and on the south side by piled-up waste rock (Figures 13 and 14).

Figure 14. *Looking west along the access road on the south side of the channel.*

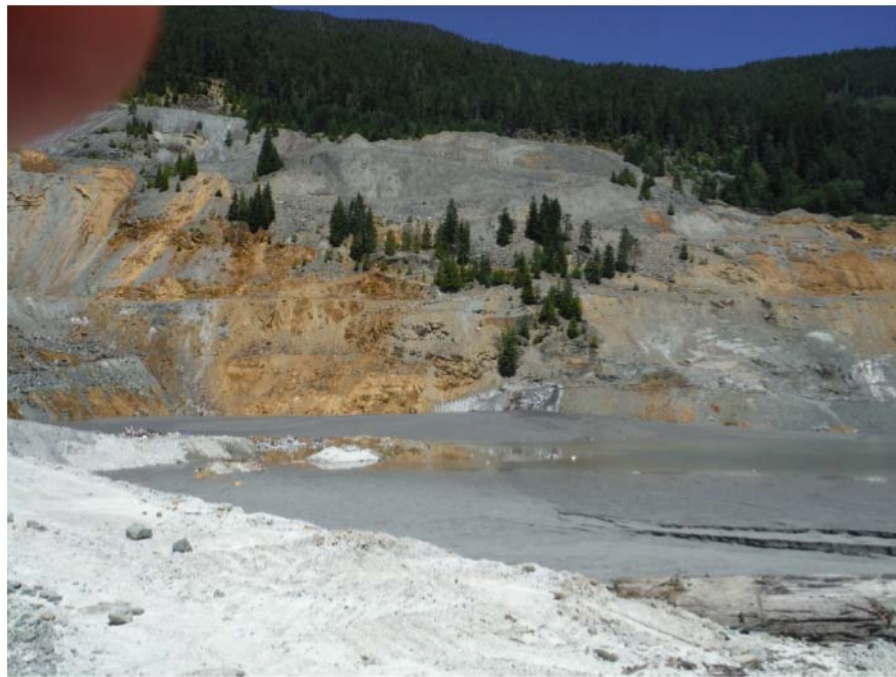
Upgradient diversion of surface waters is partially achieved by the roads and channels upgradient of the Lynx TDF in the area to the north of the facility (Figure 15).

Figure 15. *The slopes upgradient and to the north of the Lynx TDF. Some interception and diversion of runoff is achieved via the roads and channels of this area.*

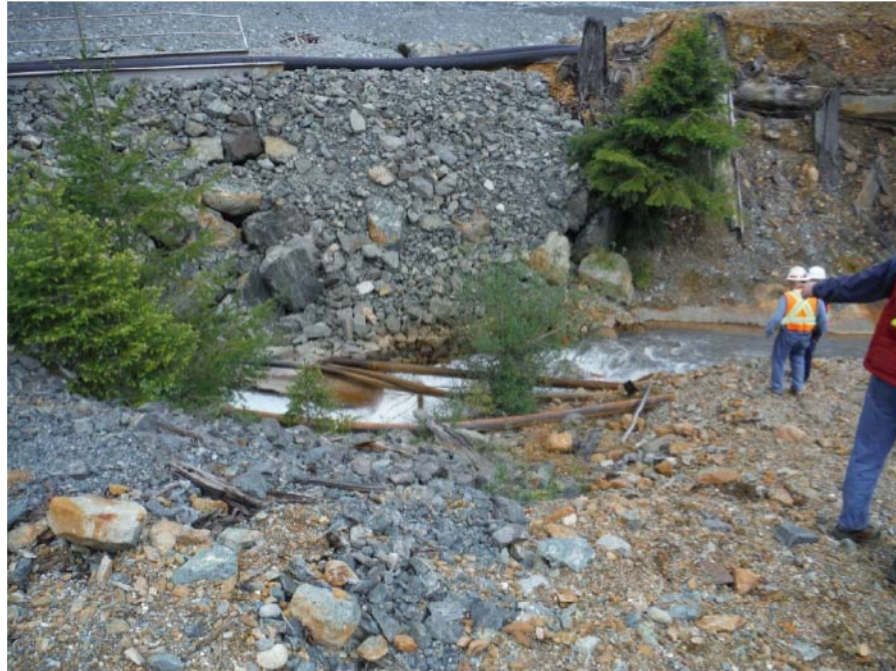
There are drains beneath the starter dam (Figure 2). Water from the drains is reported to seep to the shotcrete lined ditch at the upstream end of the water treatment system (Figure 16). We could not observe this as the elevation of the discharge is approximately 0.6 m beneath the rockfill cover.

Figure 16. The area downstream of the embankment where tailings bleed water may report via an underdrain at the base of the starter dam.

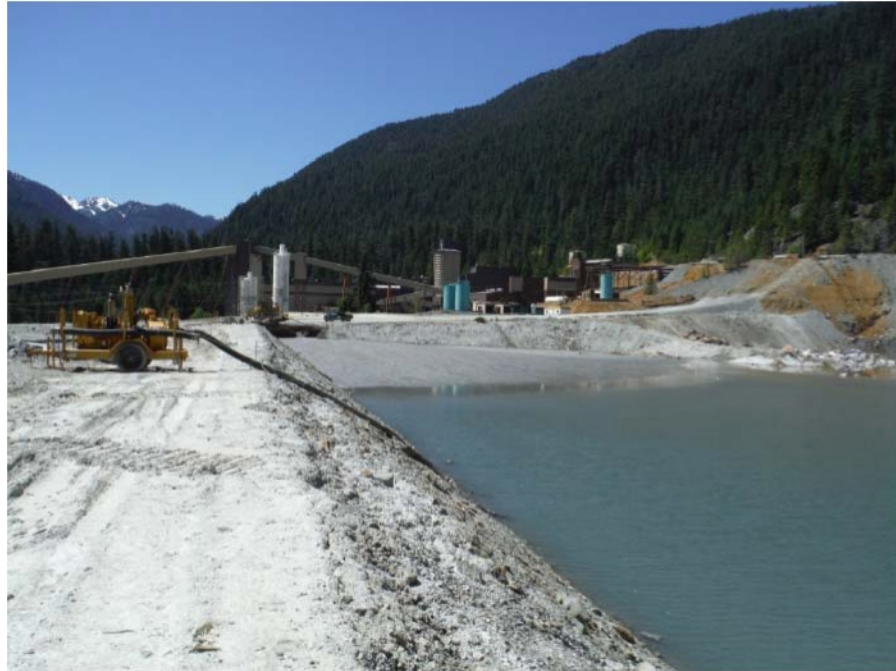
Supernatant water on the surface of the tailings is removed, as required, by pumps (Figure 17).

Figure 17. A pump used to remove supernatant water from the surface of the tailings.

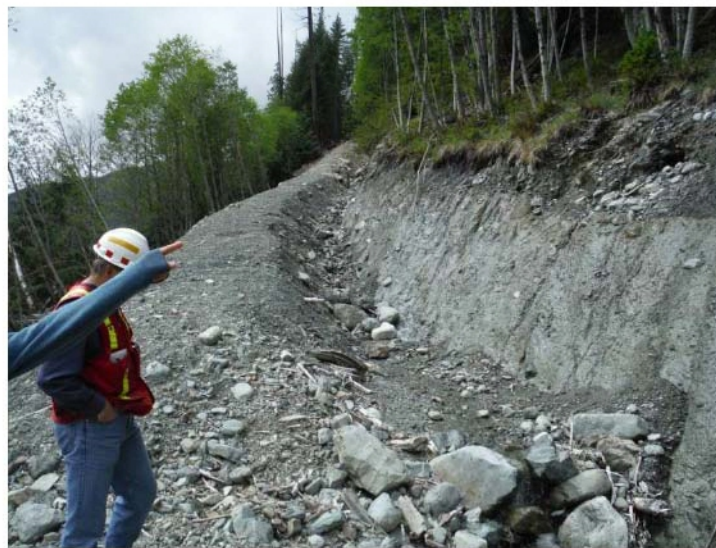
Figure 2. The Secondary Upgradient Channel. Note the steep cut into consolidated clay on the upgradient side. Note also the accumulation of gravels and boulders in the channel.

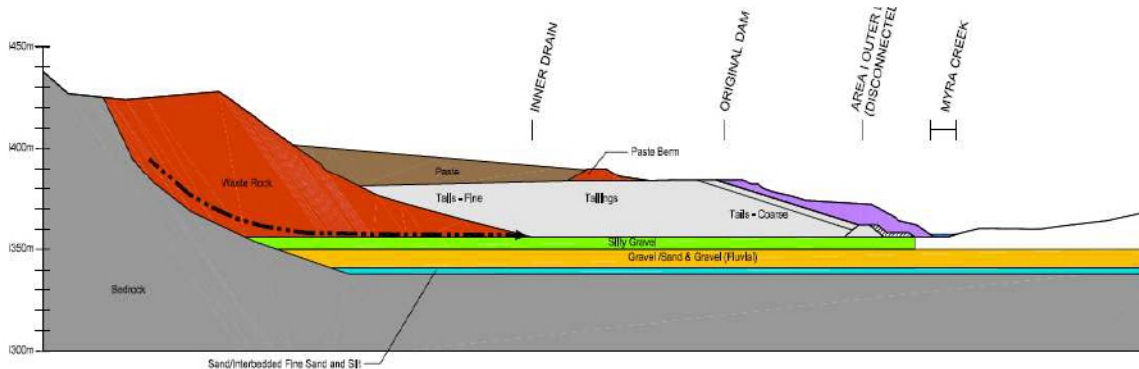
Waste rock dumps 1 and 6 to the north of the TDF rise at their natural angle of repose above the adjacent tailings surface. Note these rock dumps also underlie the tailings as shown in the Figure 3 below.

Figure 3. North to south cross section through the TDF. Note the waste rock dumps on the left side of the section. These dumps were initially placed against the hillside. Subsequently the tailings were placed up against these dumps. Note that the (purple) seismic stability berm to the right of the section has now been constructed to full height.

While we are of the opinion that these dumps do not currently constitute a dam safety issue, we concur that as part of closure their stability and covering should be addressed.

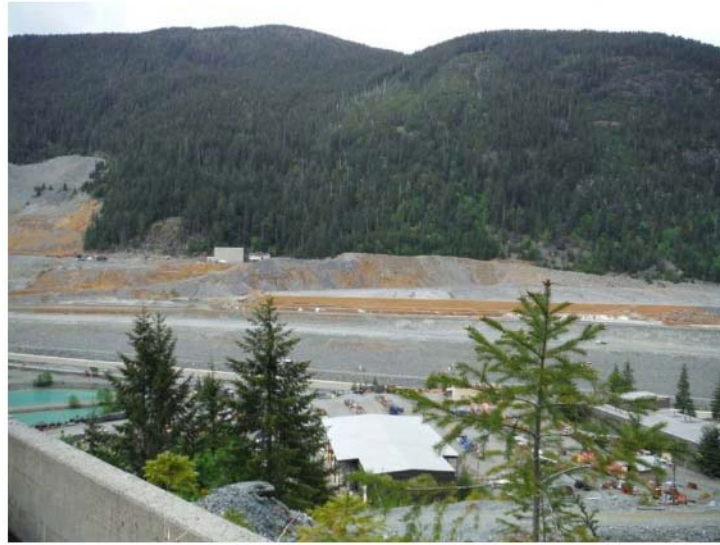
Figure 4. The TDF. Looking north from the hillside on the south side of the valley. Note the waste rock dumps are the orange-gray surface just below the trees at the base of the hillside. (See also Figure 5 for more detail.)

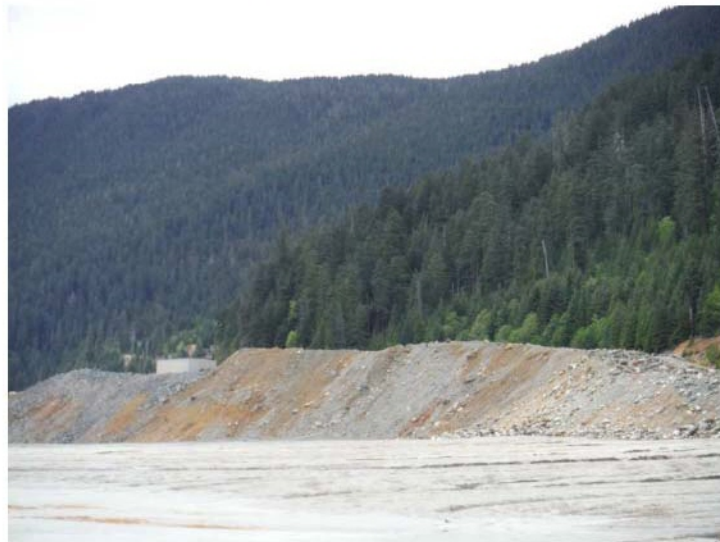
Figure 5. The south face of the waste rock dumps rising from the surface of the paste tailings area.

At the toe of the waste rocks dumps and extending to the south is the surface of the paste tailings (Figures 3 and 5). This area is sometimes referred to as the Amalgamated Paste Area (APA). The

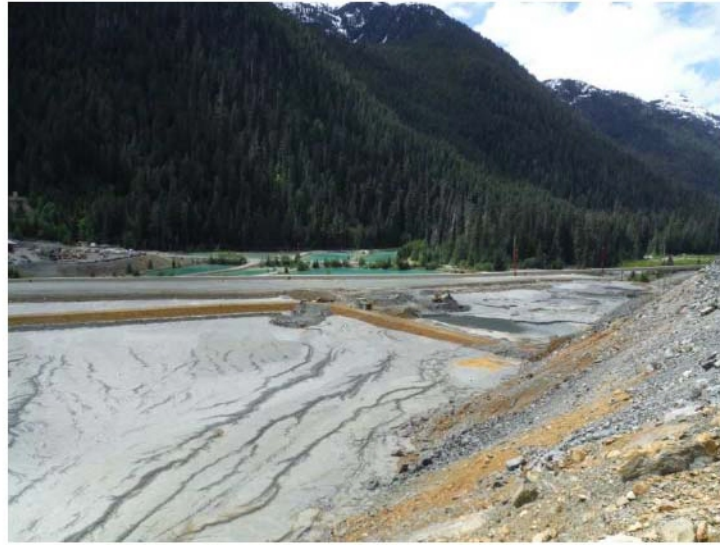
Figure 7-A. Looking southwest from the top of waste dump #6. The decant location at the south-west corner of the paste tailings area. The sand management area (Section 4.8) is to the west. At the bottom right of the photo are the steeper slopes of the waste rock dump.

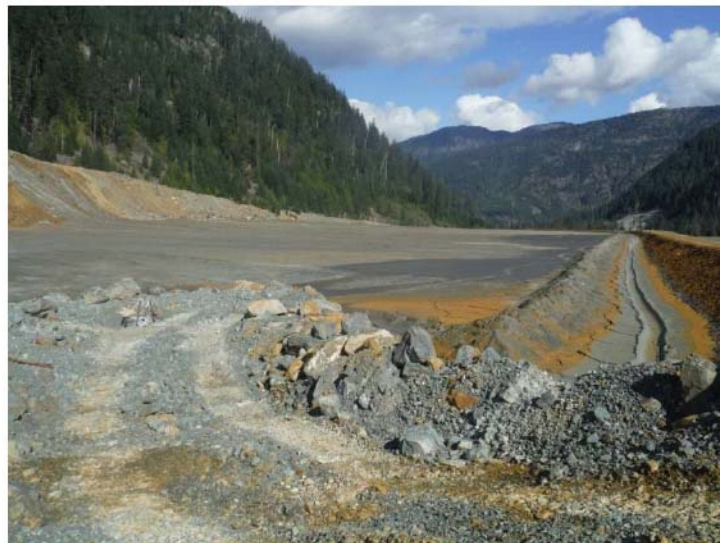
Figure 7-B. Looking east along the paste berm. The Amalgamated Paste Area decant facility as seen from the south-west corner of the area. Note surface water runs east to west in the channel to the right of the photo, then ponds to flow into the area of rock in the middle of which is the decant pipe leading to the Super Pond which is located at the upstream end of the site's water treatment system.

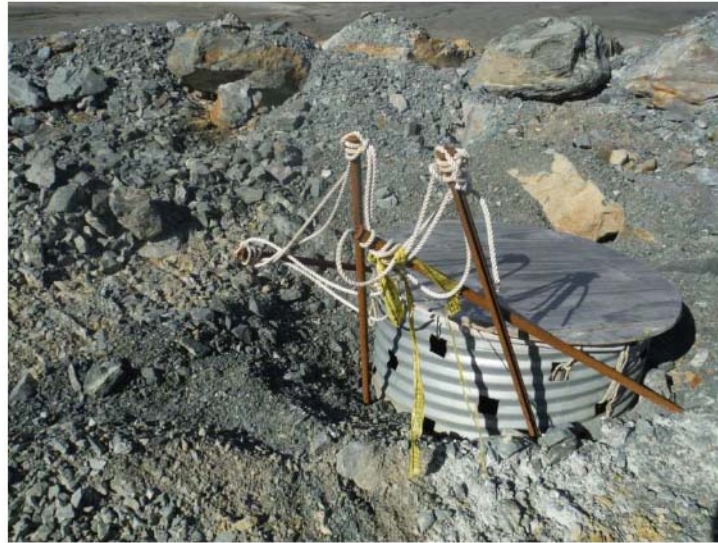
Figure 7-C. The inlet to the decant pipe from the Amalgamated Paste Area. Note the wooden top. Water is intended to pass through the square openings in the pipe.

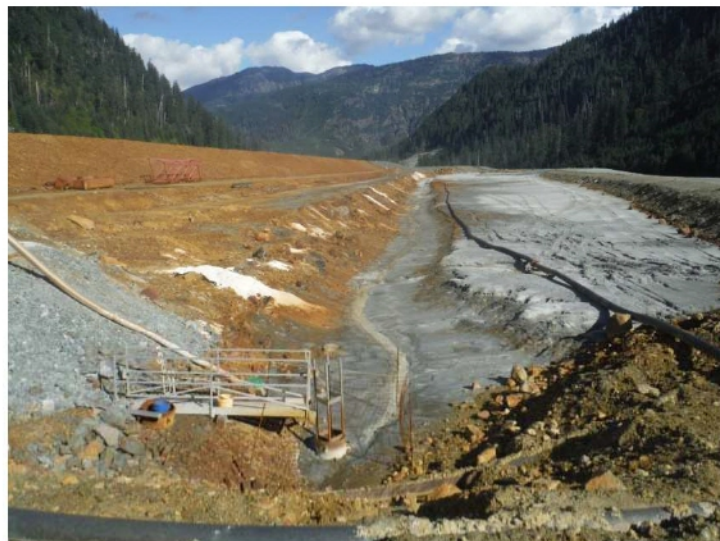
Surface water runoff from this area generally flows from east to west into the decant facility. (Figure 9).

Figure 9. The Strip Area looking east. Surface water runs in the “channel” to the decant facility, which is seen in the foreground of the photo.

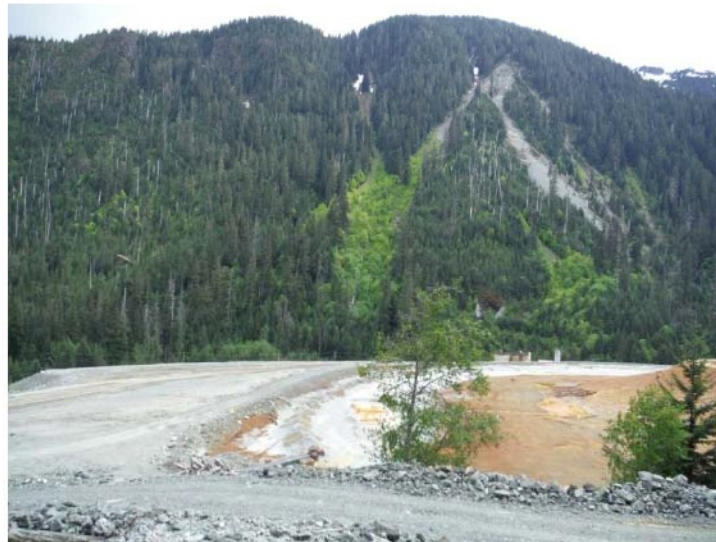
When observed, construction work was in progress to regrade the surface of this area and the top of the recently completed seismic buttress. The area was variously undulating and rough. Incident precipitation would pool in low points or flow to the edge of the seismic berm and hence down the outer face of the berm.

Because of the active regrading of the area, no erosion or cracking (if any) was observed.

Figure 11. The top surface of the old tailings and seismic buttress. The surface was being regraded to comply with closure requirements.

The writers of this report were informed that the surface is being regraded prior to covering in accordance with closure plans, and hence provisions for surface water management.

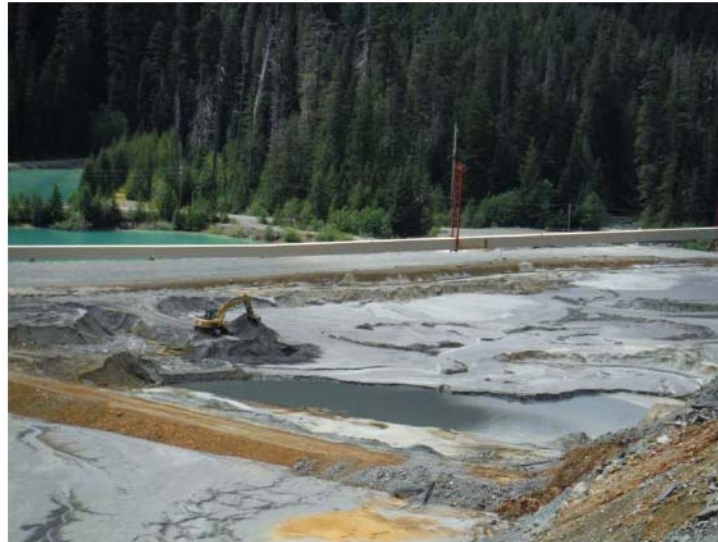
Figure 12. General view of the sand area looking from east to west.

The sand area is part of TDF closure area. It will be reclaimed as and when other facilities to stockpile the sand can be established.

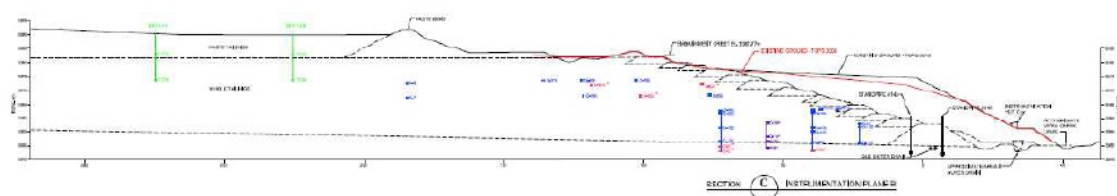
AMEC concludes that the TDF Seismic Upgrade project is complete and satisfies its design intent with respect to the slope stability factor of safety given a MDE with a PGA of 0.30 g. The TDF has a minimum calculated post-seismic global factor of safety of 1.1 and a post-seismic factor of safety of 1.25 for failures passing through the Outer Drain. Correlation of limit equilibrium stability modeling to dynamic finite element modeling predicts an associated toe displacement of the Seismic Upgrade Berm of 3 m or less. This conclusion was reached based on:

In our opinion, these conclusions as based on the documents reviewed, are reasonable and acceptable.

Figure 13. Cross section of the seismic berm (from AMEC, 2011.) Note the seismic berm is to the right of the section and is constructed over the previous outer face of the TDF.

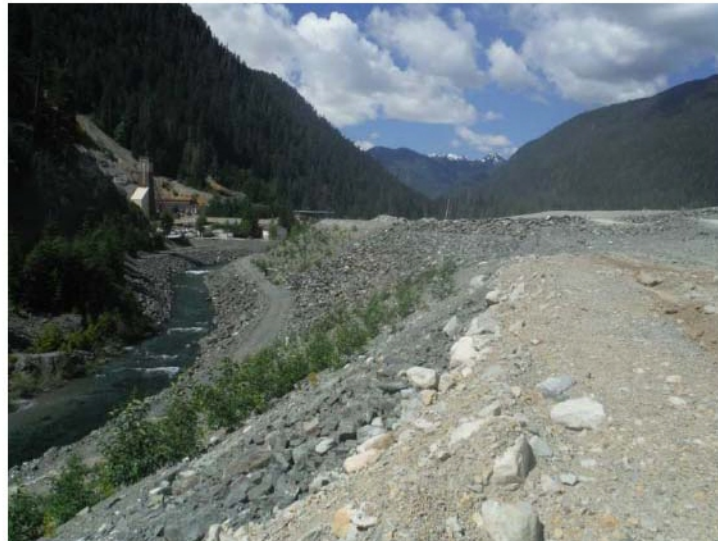
The downstream face of the recently constructed seismic berm is subtended by an access road/path and Myra Creek. New vegetation has been established on the face of the berm. Minor erosion was observed near the upper crest of the berm.

Figure 14. The outer face of the seismic berm, looking north. Note from left to right: Myra Creek; the toe access road; and the sloping face of the berm with new vegetation.

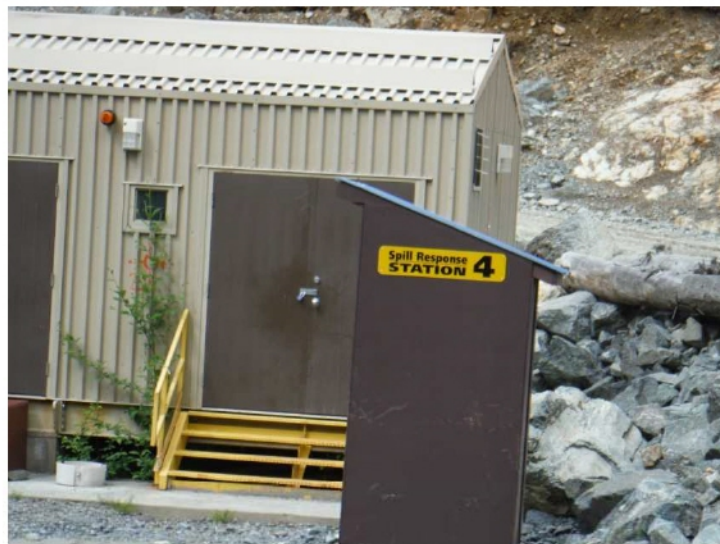
The underdrains of the TDF drain to a sump in the Pumphouse #4 building. Seepage from the underdrains is collected in this sump and returned to the Super Pond.

Figure 16. The Pumphouse #4 Building.

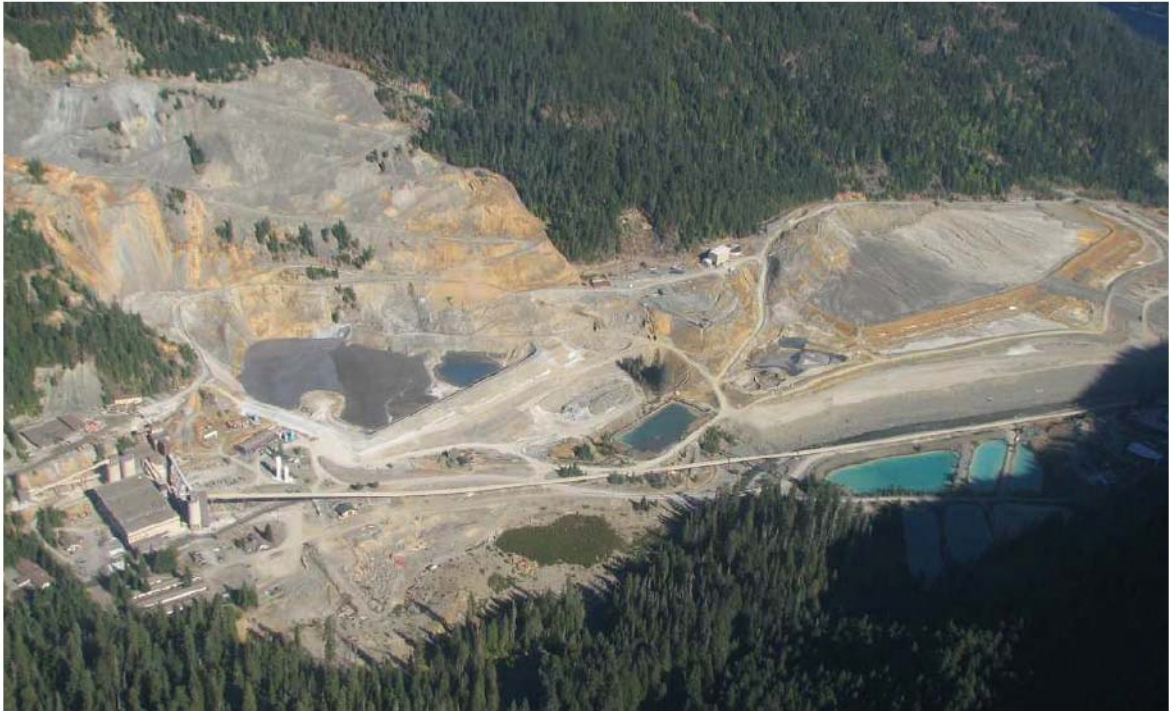
Figure ES-1. Aerial view of the Myra Falls mine showing the Lynx TDF on the left. The darker gray surface is the top of the tailings; the light gray to the right of the tailings is the embankment dam of rockfill; the brown and gray mottled areas to the upper left of the tailings are the steep slopes of bedrock and the waste rock piles above the Lynx TDF. (From AMEC 2013a)

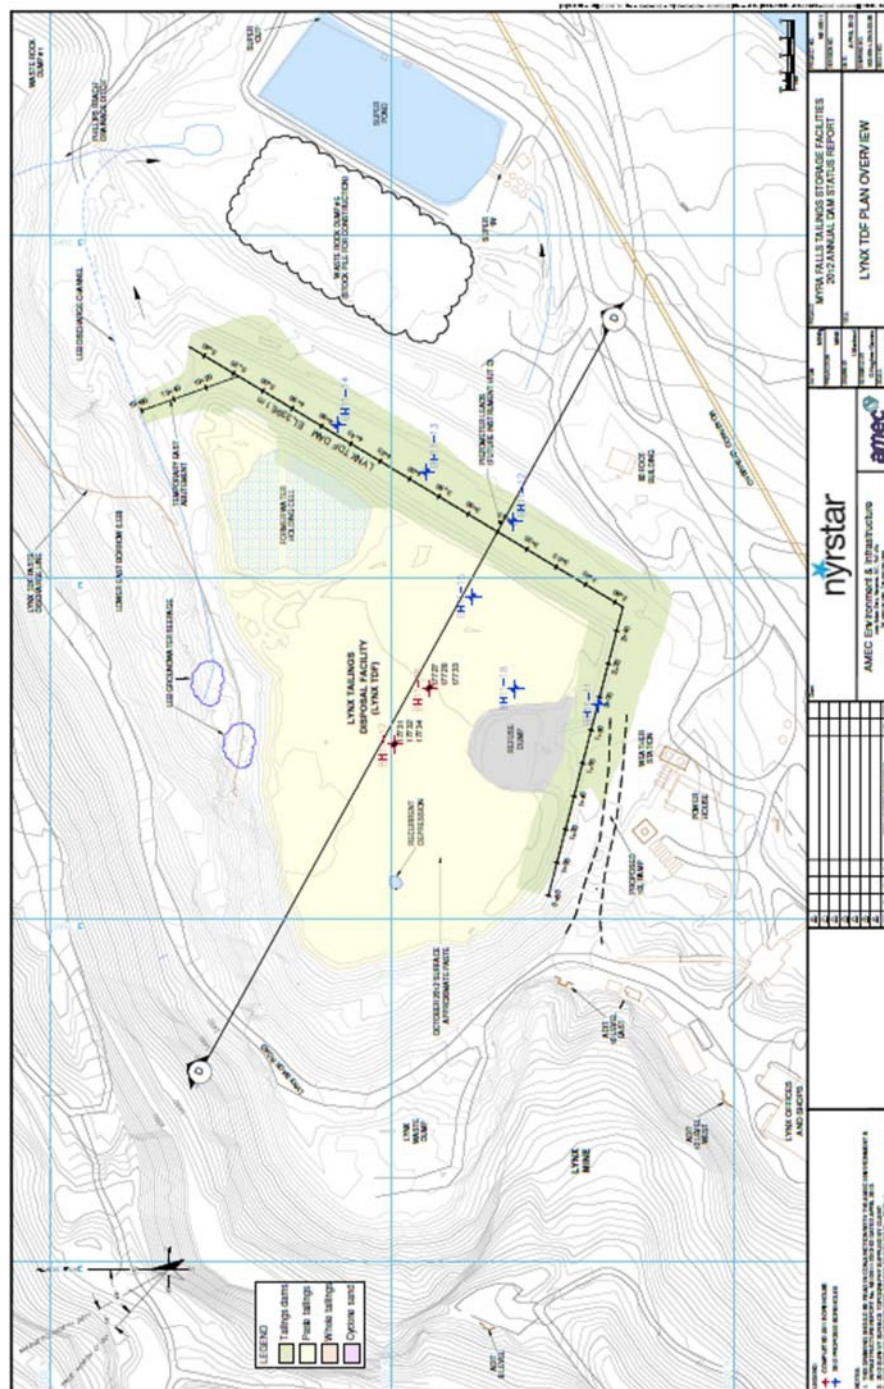
Figure 1. The Layout of the Lynx TDF. The green shading is the rockfill embankment dam on the downgradient perimeter of the old Lynx open pit. The yellow shading is the top surface of the deposited tailings.

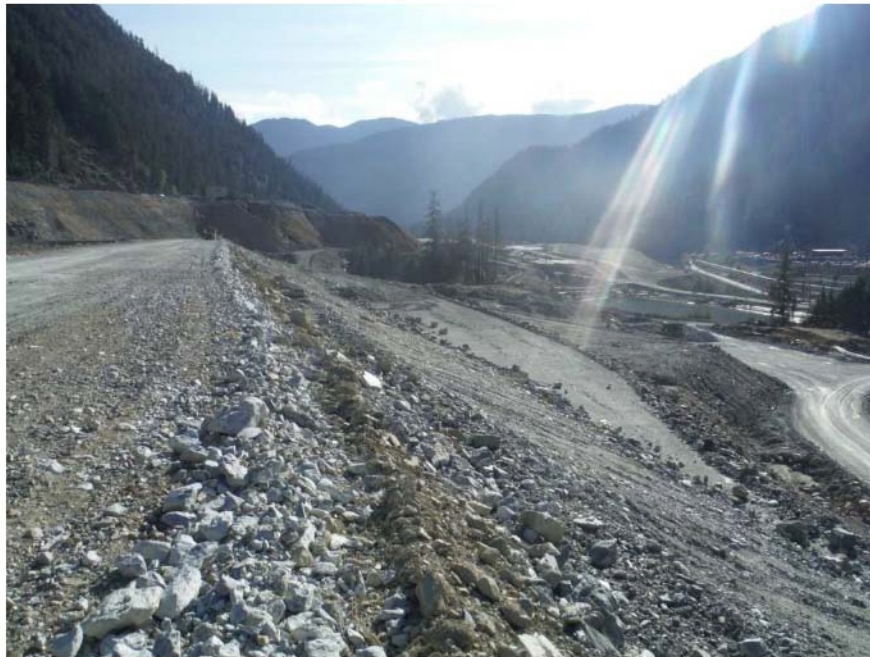
When observed in September 2013, raising of the embankment dam had just been completed. The authors of this report were informed that the zone of cracking was removed and replaced as part of the embankment raising. No cracking of the embankment was observed (Figures 4 and 5). Construction was done under the management of Myra Falls staff by the contractor, Upland Excavating Ltd. Engineering oversight was provided by AMEC who are also the engineers of record for the design of the raise. We are informed that the as-built report on this work will be available only after submittal of this report.

Figure 4. Looking west to east along the downstream crest of the embankment dam in September 2013. To the left of the crest line is the top of the embankment, which is a compacted surface of waste rock. To the right of the crest line is the downstream face of the embankment which is also compacted waste rock.

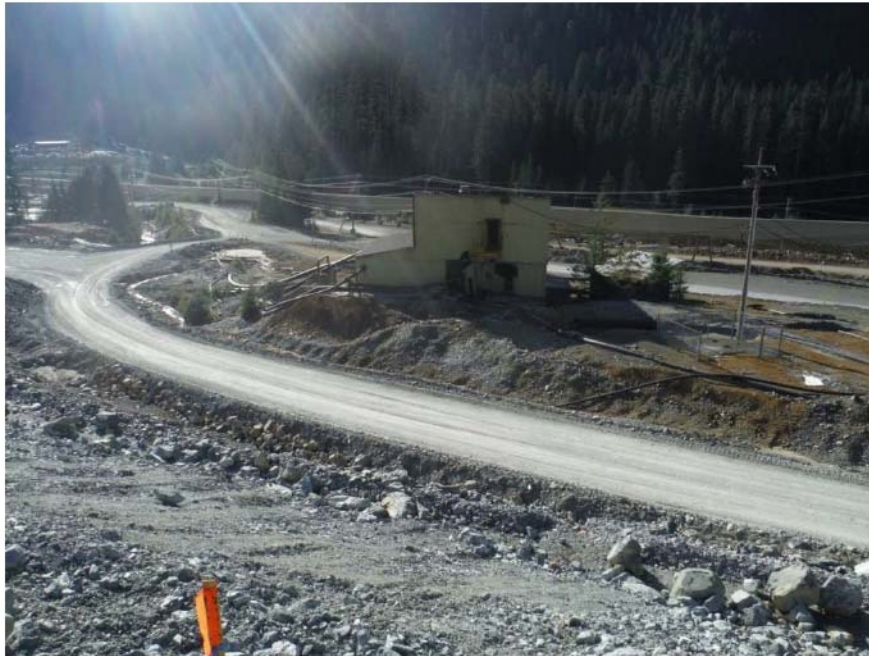
Figure 5. *The access road along the toe of the embankment. To the bottom left of the picture is the inclined downstream face of the embankment. Above, and to the right of the access road are various material stockpiles and other facilities that will be removed to make way for the embankment as, in the future, additional embankment raising is undertaken.*
