REPORT NO. 212003/1

**MYRA FALLS OLD TAILINGS DISPOSAL FACILITY
2013 DAM SAFETY REVIEW**

MYRA FALLS OLD TAILINGS DISPOSAL FACILITY 2013 DAM SAFETY REVIEW

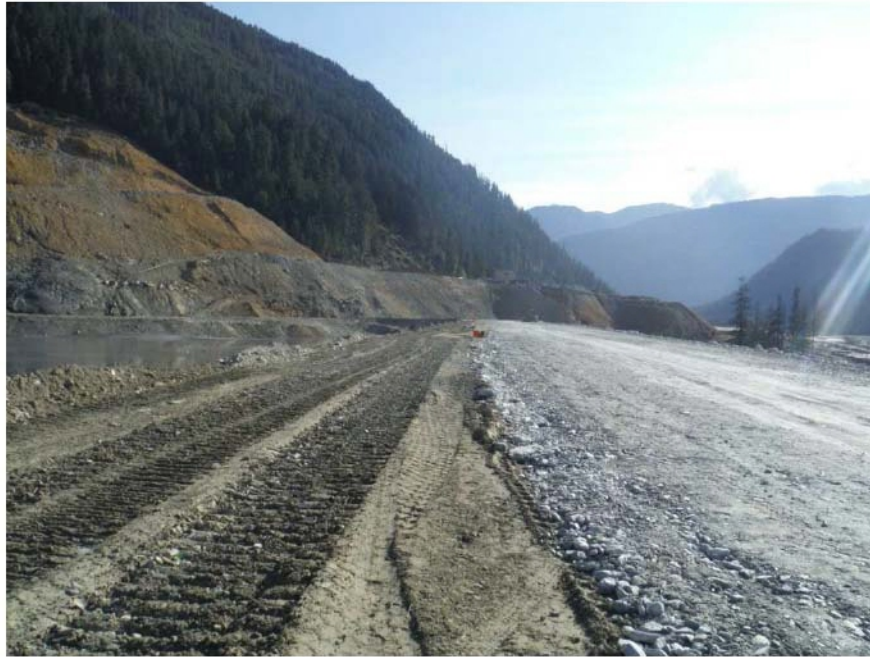
The top surface of the upstream filter zone was observed (Figure 6). The material is finer than the rockfill and in appearance suitable for its design purpose—controlling migration of tailings into the voids of the embankment rockfill. On the upstream side of the filter zone is either paste tailings or sand (Figures 7 and 8).

Figure 6. Looking west to east along the upstream crest of the embankment. To the left is the compacted finer-grained material of the filter zone; to the right is the top surface of the compacted waste rock.

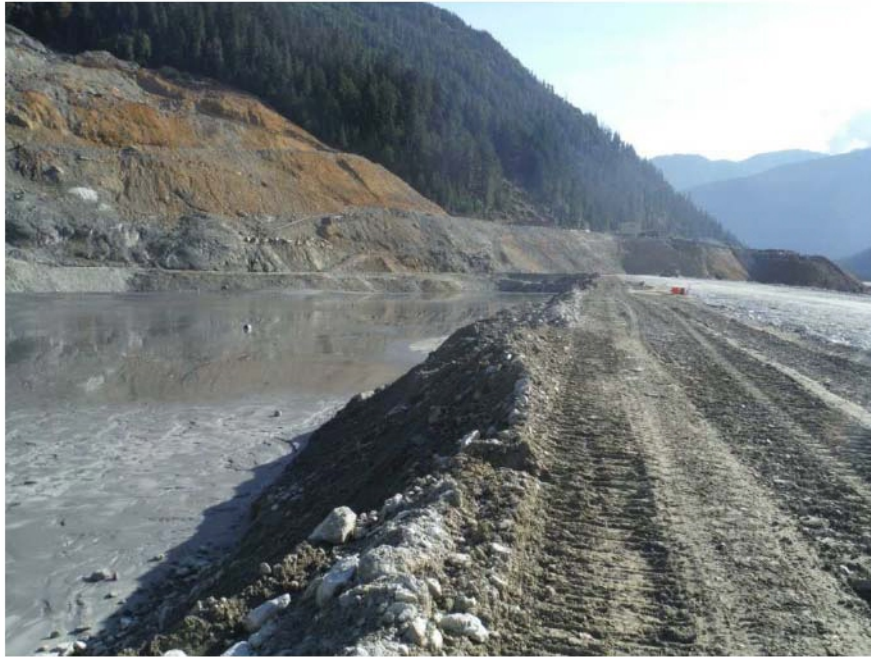
Figure 7. Looking west to east along the upstream crest of the embankment. To the left is the surface of the tailings

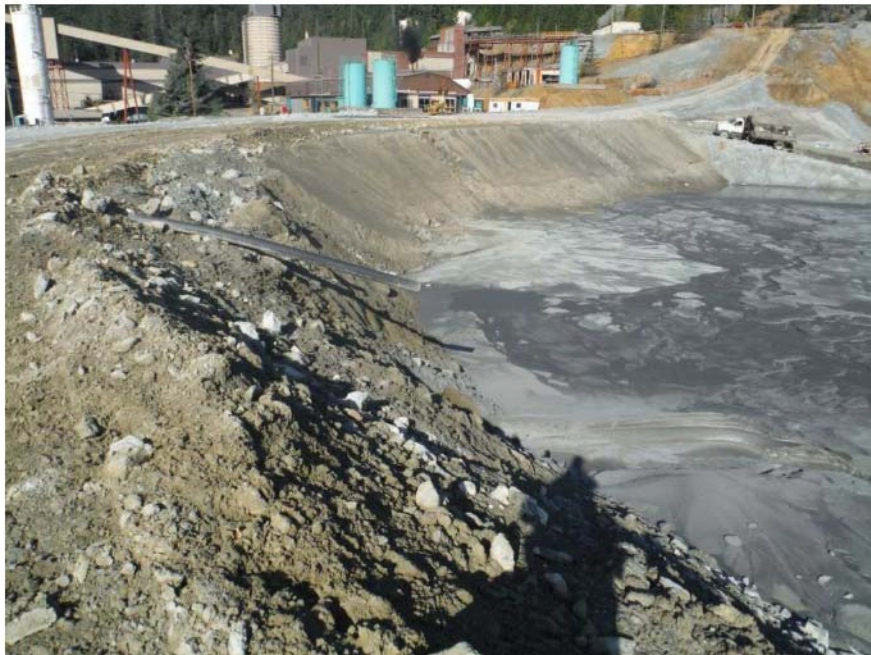
Figure 8. Looking east to west along the upstream crest of the embankment. Sand is deposited from the pipe in order to control the beach and hence to push standing water back and away from the embankment—a operating procedure that is considered to be good practice.

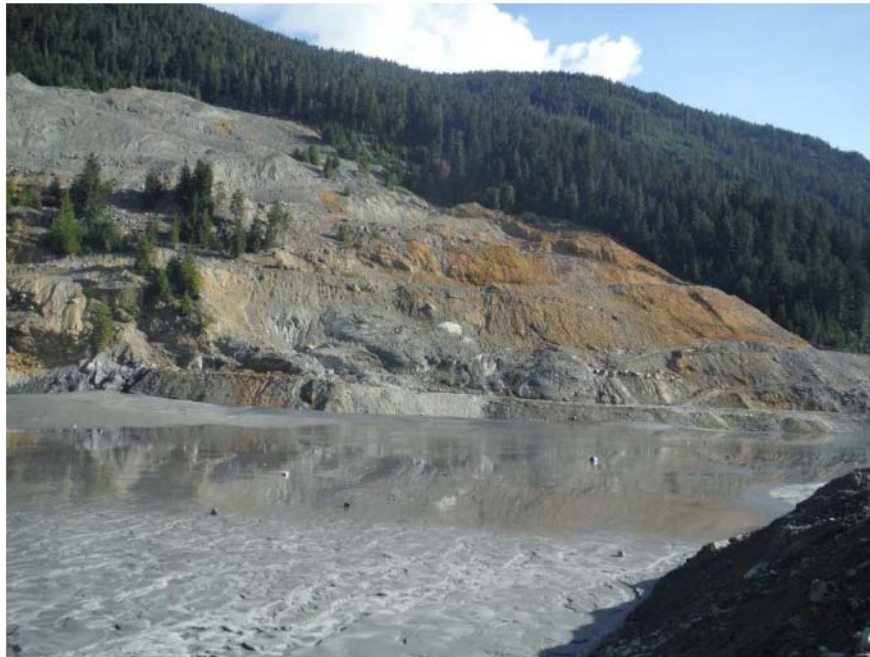
The topography of the tailings surface is controlled by the discharges into the area, including the paste tailings line, the sand line, and overflow from the Super Pond dredging (Figures 9 and 10). The Super Pond is located at the upstream end of the site's water treatment system.

Figure 9. Looking from the crest of the embankment to the north-east across the surface of the tailings. In the foreground is sand, and behind this is the wet upper surface of tailings. Rising from the surface of the tailings are the natural bedrock slopes and waste rock dumps above the Lynx TDF.

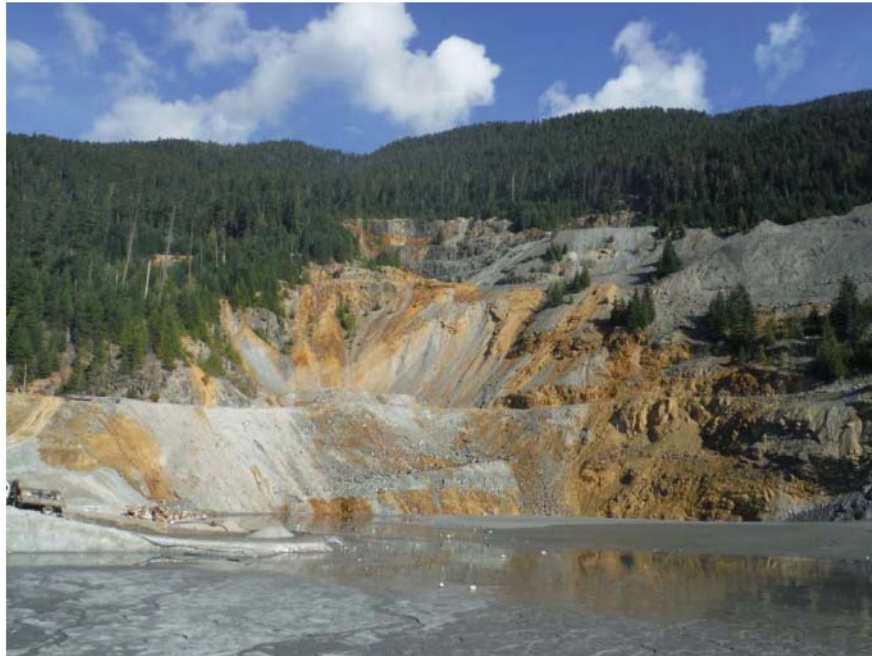
Figure 10. Looking from the crest of the embankment to the northwest across the surface of the tailings. Rising from the surface of the tailings are the natural bedrock slopes and waste rock dumps above the Lynx TDF

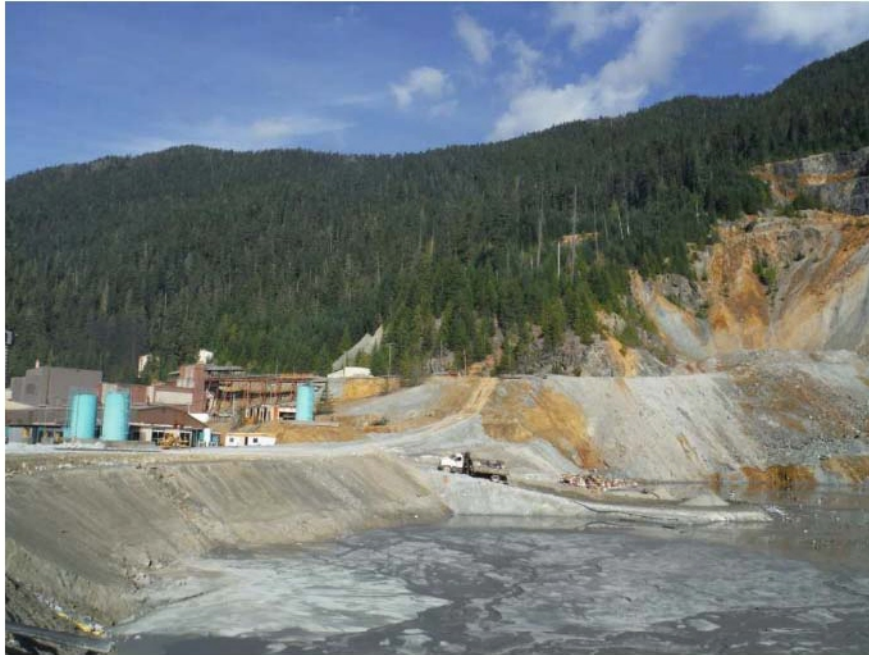
Mine refuse is deposited into the tailings (Figure 11). In essence as the tailings surface rises, the tailings surround and encapsulate the individual refuse items.

Figure 11. *The truck has just dumped refuse at the right-hand end of the road that slopes down to the tailings surface. Note also the significant difference in elevation shown here between the top of the tailings and the crest of the embankment.*

Because of the recent raising of the embankment there is significant freeboard (Figure 11). As of August 29, 2013 the reported elevation of the tailings surface against the embankment was 3393.2 m and the elevation of the embankment crest was 3398.8 m. This freeboard (5.6 m) will reduce as tailings are deposited and the surface of the tailings rises. The design operating freeboard is such that there is sufficient volume to retain 78,000 m³ of precipitation and runoff plus an additional 0.5 m provision for wind and wave action (AMEC 2008b).

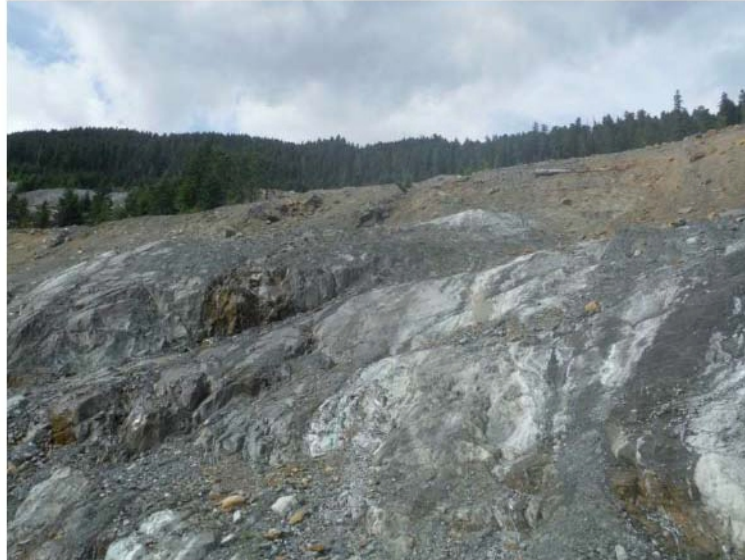
Towards the east end of the north side of the Lynx TDF, there is seepage from the bedrock (Figure 12). The seepage is directed to a channel formed on the north side by the bedrock and on the south side by piled-up waste rock (Figures 13 and 14).

Figure 12. Seepage from joints in the bedrock on the north side of the Lynx TDF. Flow quantities vary in response to precipitation. The zone of bedrock seepage is relatively large and extends some meters up the slope.

We were informed that a rock-filled drain will be constructed to collect the bedrock seepage and direct it east where it will exit the Lynx TDF embankment and be conveyed to the Super Pond.

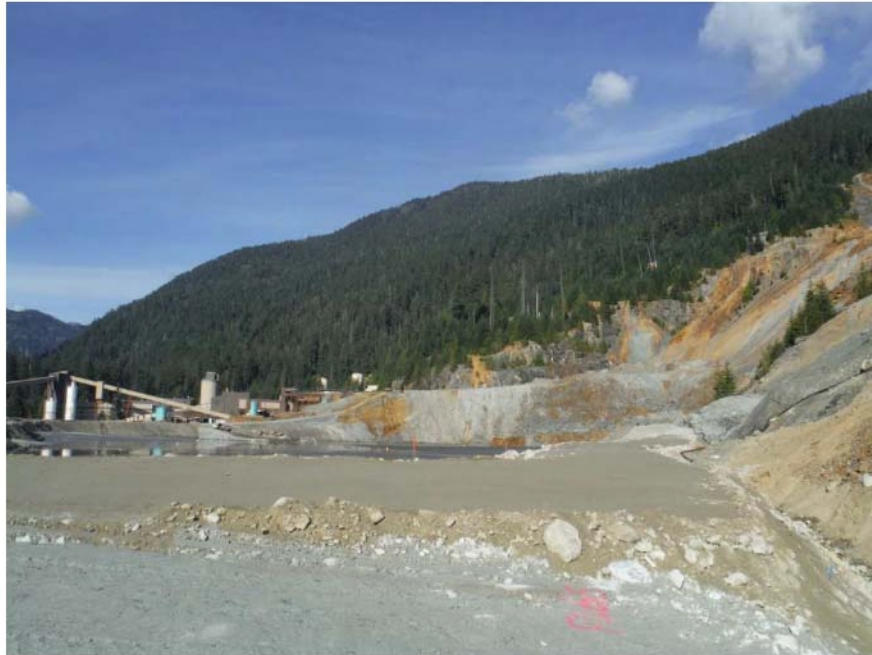
Figure 14. Looking west along the access road on the south side of the channel.

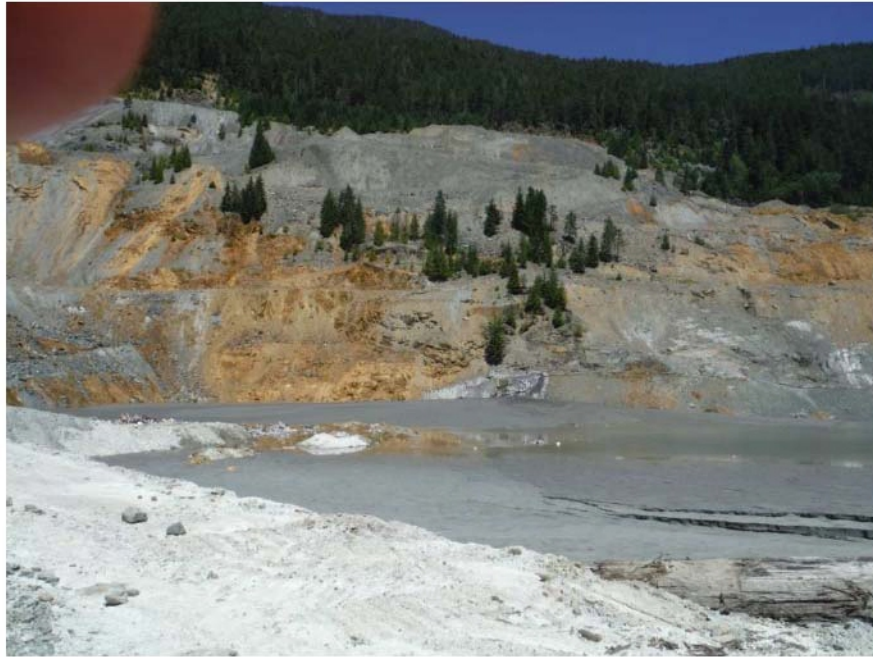
Upgradient diversion of surface waters is partially achieved by the roads and channels upgradient of the Lynx TDF in the area to the north of the facility (Figure 15).

Figure 15. *The slopes upgradient and to the north of the Lynx TDF. Some interception and diversion of runoff is achieved via the roads and channels of this area.*

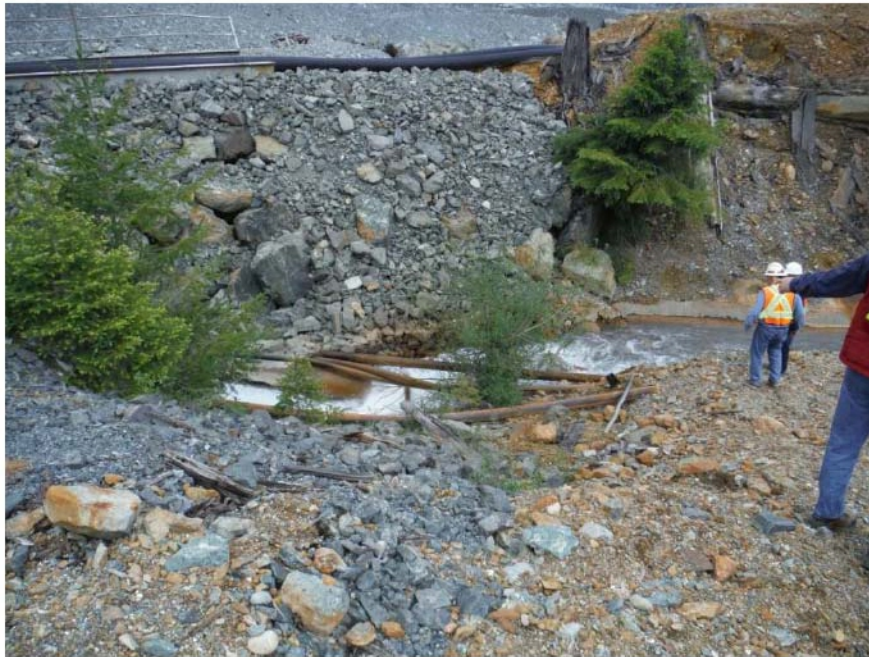
There are drains beneath the starter dam (Figure 2). Water from the drains is reported to seep to the shotcrete lined ditch at the upstream end of the water treatment system (Figure 16). We could not observe this as the elevation of the discharge is approximately 0.6 m beneath the rockfill cover.

Figure 16. *The area downstream of the embankment where tailings bleed water may report via an underdrain at the base of the starter dam.*

As noted in Section 3.3, groundwater information indicates downward seepage from the Lynx TDF to the sediments beneath the facility and hence to groundwater beneath and downgradient of the facility. This would indicate that some or all of the seepage through the embankment is downward and not necessarily primarily to the reported drains.

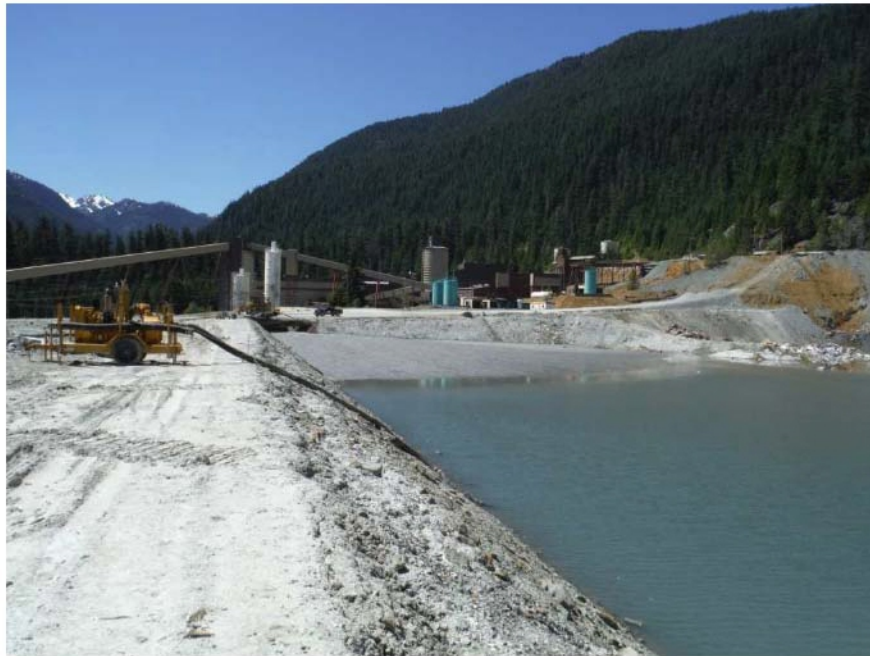
Supernatant water on the surface of the tailings is removed, as required, by pumps (Figure 17).

Figure 17. A pump used to remove supernatant water from the surface of the tailings.

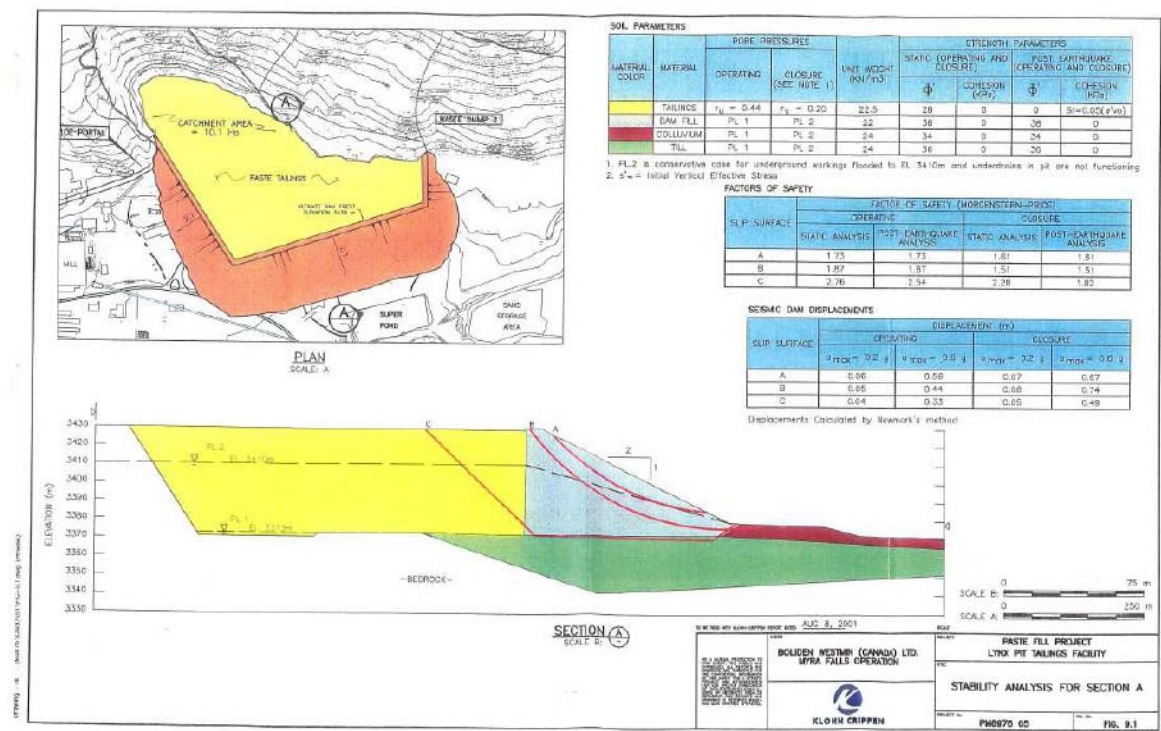
AMEC (2008b) describes slope stability analyses of the Lynx TDF. As noted in Figure 18, failure surfaces through the tailings and beneath the embankment assume that the foundation materials are a high-strength, cohesionless till.

Figure 18. Static stability analyses for the Lynx TDF. Note the failure surface through the tailings and beneath the rockfill embankment passes through a till of high strength. This figure is the basis of a conclusion that the embankment has an adequate static factor of safety.

Drilling in 2013 undertaken as part of preparation of the site closure plan and characterization of site groundwater conditions indicates that the foundation materials may differ from those assumed in previous stability analyses. Specifically one borehole (well number MW13-05) indicates that from about 15 to 45 m, the material is as follows:
