Province of
British Columbia
MINISTRY OF ENVIRONMENT
LANDS AND PARKS

Re: Landslide on Brooklyn Creek

CPR Landslide Brooklyn Creek

BROOKLYN CREEK - CPR FAILURE

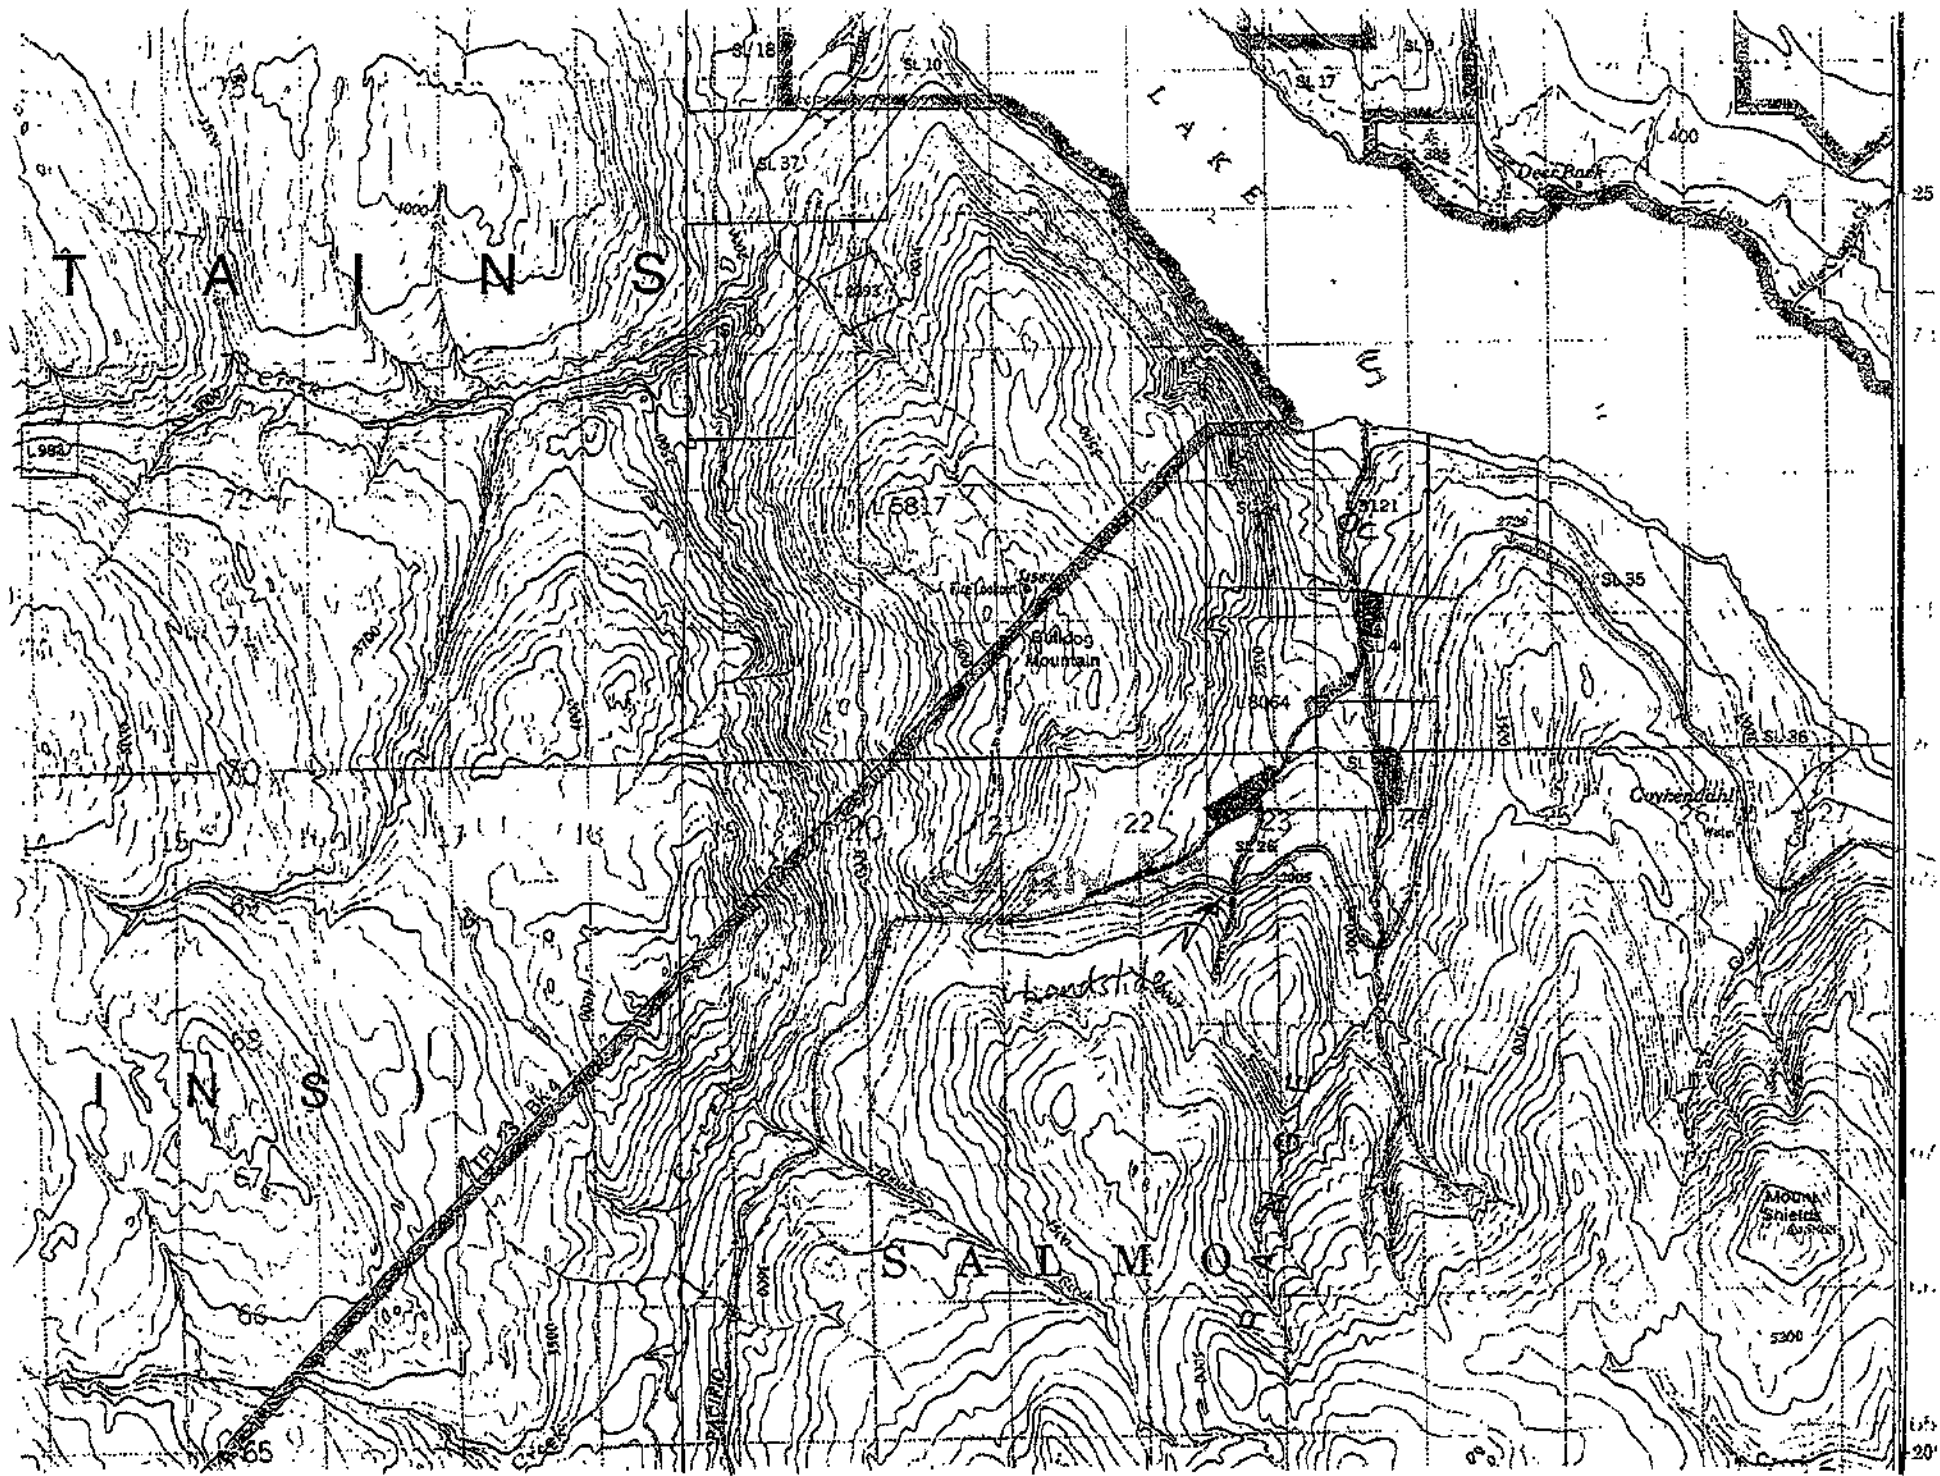
Rough dimensions of the fill failed material and pondage are shown on the attached sketches. The slump was on the upstream side of the crossing. (photos 1 - 61) There was no evidence of any culvert through the base of the structure at the time. The upstream side of the railway grade was covered in debris (photos 3, 5 & 6). There was no evidence of a culvert at the downstream side of the railway grade (photos 11 & 12). Approximately 100 m upstream from the crossing, in a 1.3 m wide and 0.6 m deep half culvert (see photos 7, 8 & 9) was used to convey the water by the structure and discharge it on the slope as shown in the sketch and photos 9 & 10. The flow in the creek above the structure was estimated at $7 \text{ ft}^3/\text{s}$

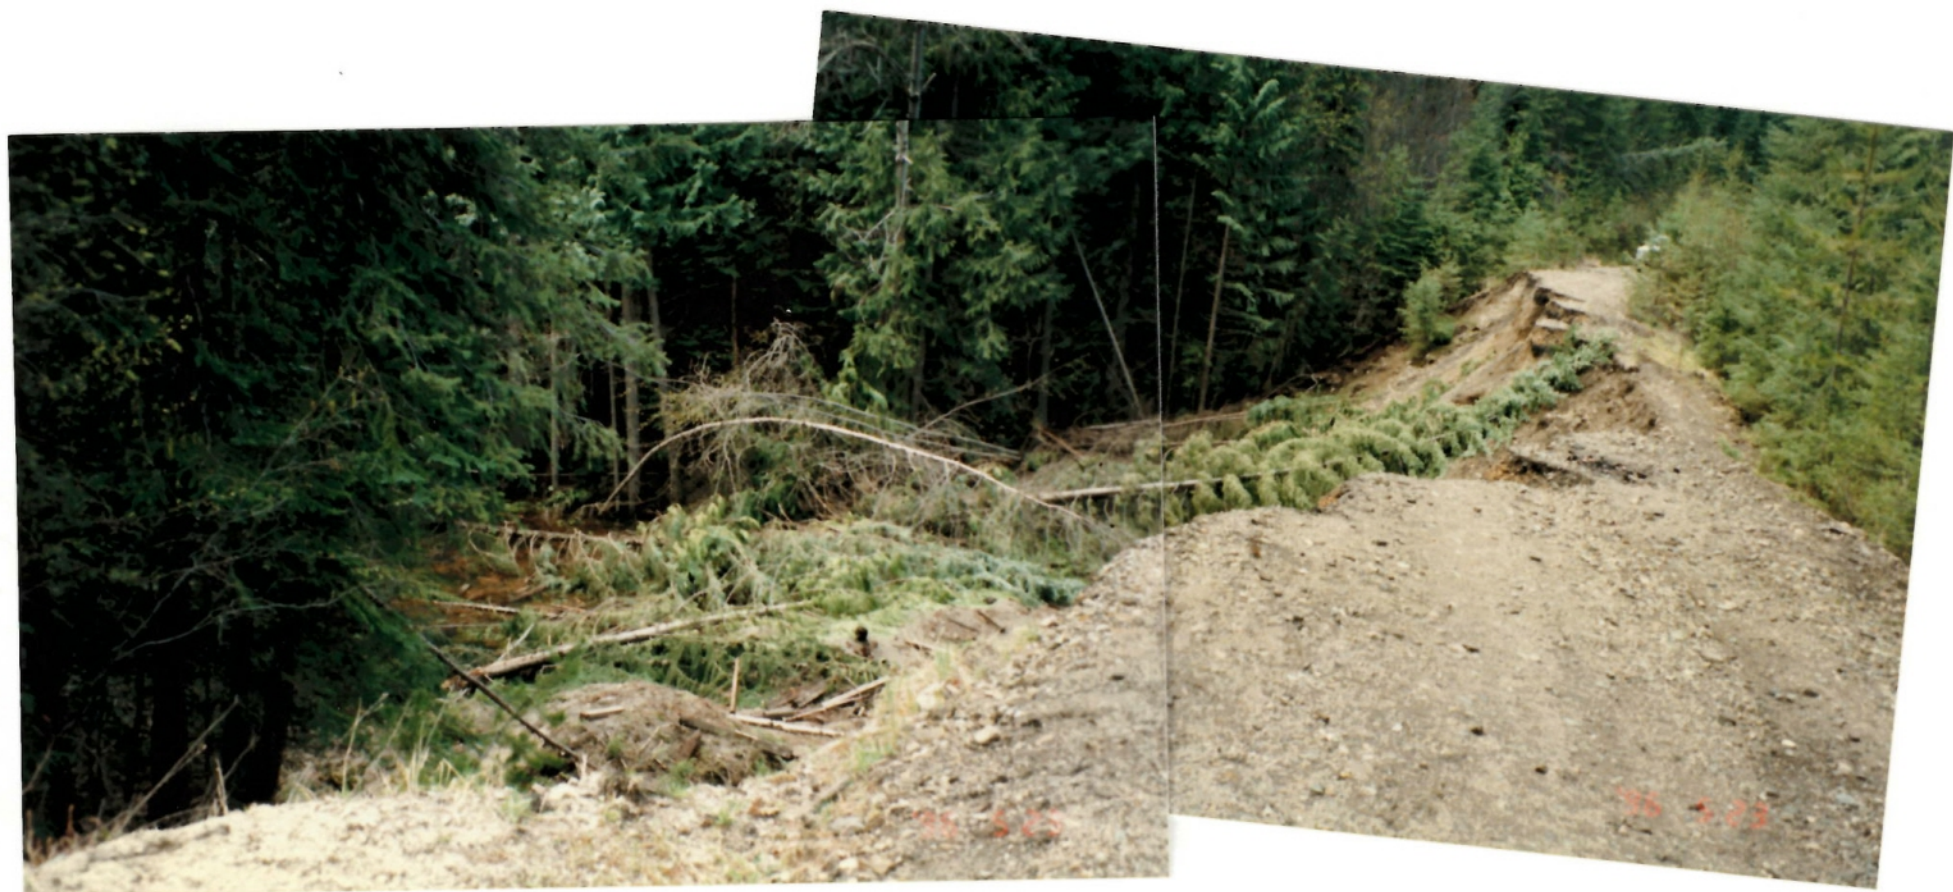
7

Unfortunately, a section of the conveyance channel failed (see photos and sketch) resulting in all the water flowing to the railway crossing embankment. The failure was caused when foundation pedestals were displaced by a minor hill slope failure. The water flowing into and ponding against the fill may have caused the failure of the railway fill.

1. View of fill failure looking east
2. Closer view of fill failure looking east
3. Closer view of fill failure looking east - diversion channel
4. View of remaining fill
5. View of gully upstream from vantage point on top of railway fill
6. View of failure looking west
7. View of half culvert side hill diversion channel. Arrow points to diversion structure
8. View of failed section of channel
9. End of diversion channel
10. Dry channel down slope where water was previously diverted
11. Flow emerging from downstream toe of fill. Arrows show two spots where flow emerges
12. Closer view of main flow from toe of fill.
