Investigation of the 2012 Woodlot 1572 Landslide

Investigation of the 2014 Woodlot 1572 Landslide

RE: Woodlot 1572 landslide field review (April 2012)

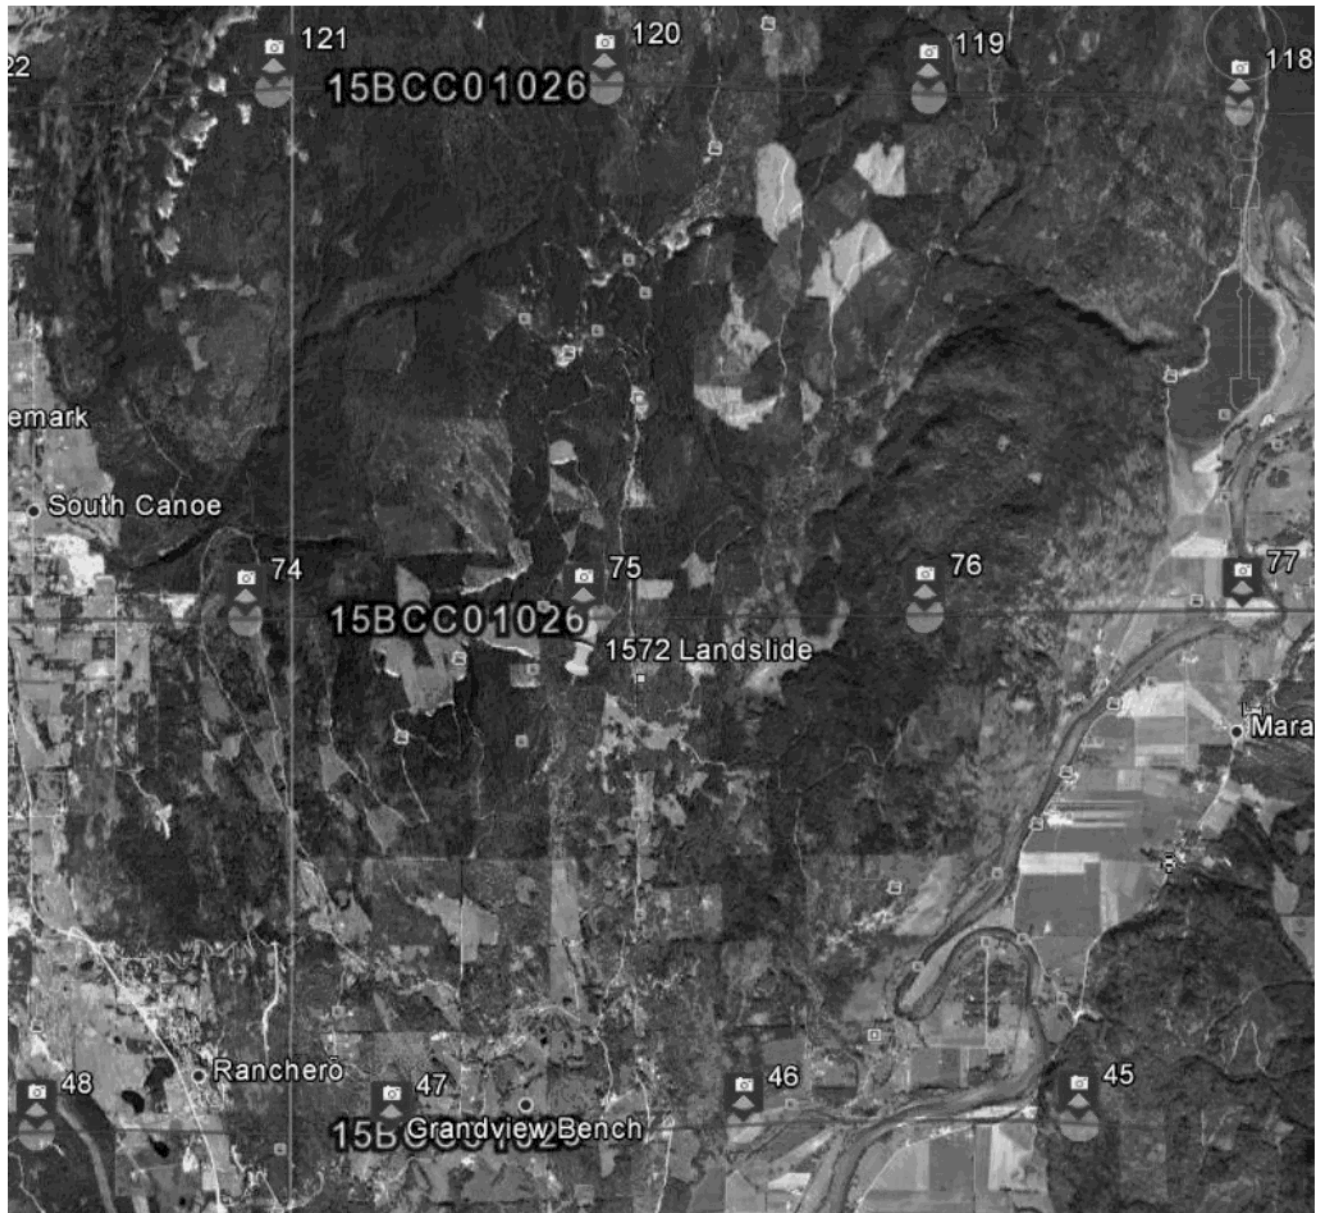
Figure 1 – Overview location of Woodlot 1572 landslide

The landslide occurred below the SE corner of Block B-3, immediately west of Edgar road. For reference, the landslide occurred at UTM E. 348510.18, N. 5617230.0 (elevation 933m above sea level) and Google Earth images with location pins have been provided below:
