# BC Ministry of Forests, Lands and Natural Resource Operations Thompson Okanagan Region

## Investigation of the 2014 Cooke Creek Debris Flood

## INVESTIGATION REPORT INTO THE COOKE CREEK/DALE LAKE LANDSLIDE OF MAY 2, 2014

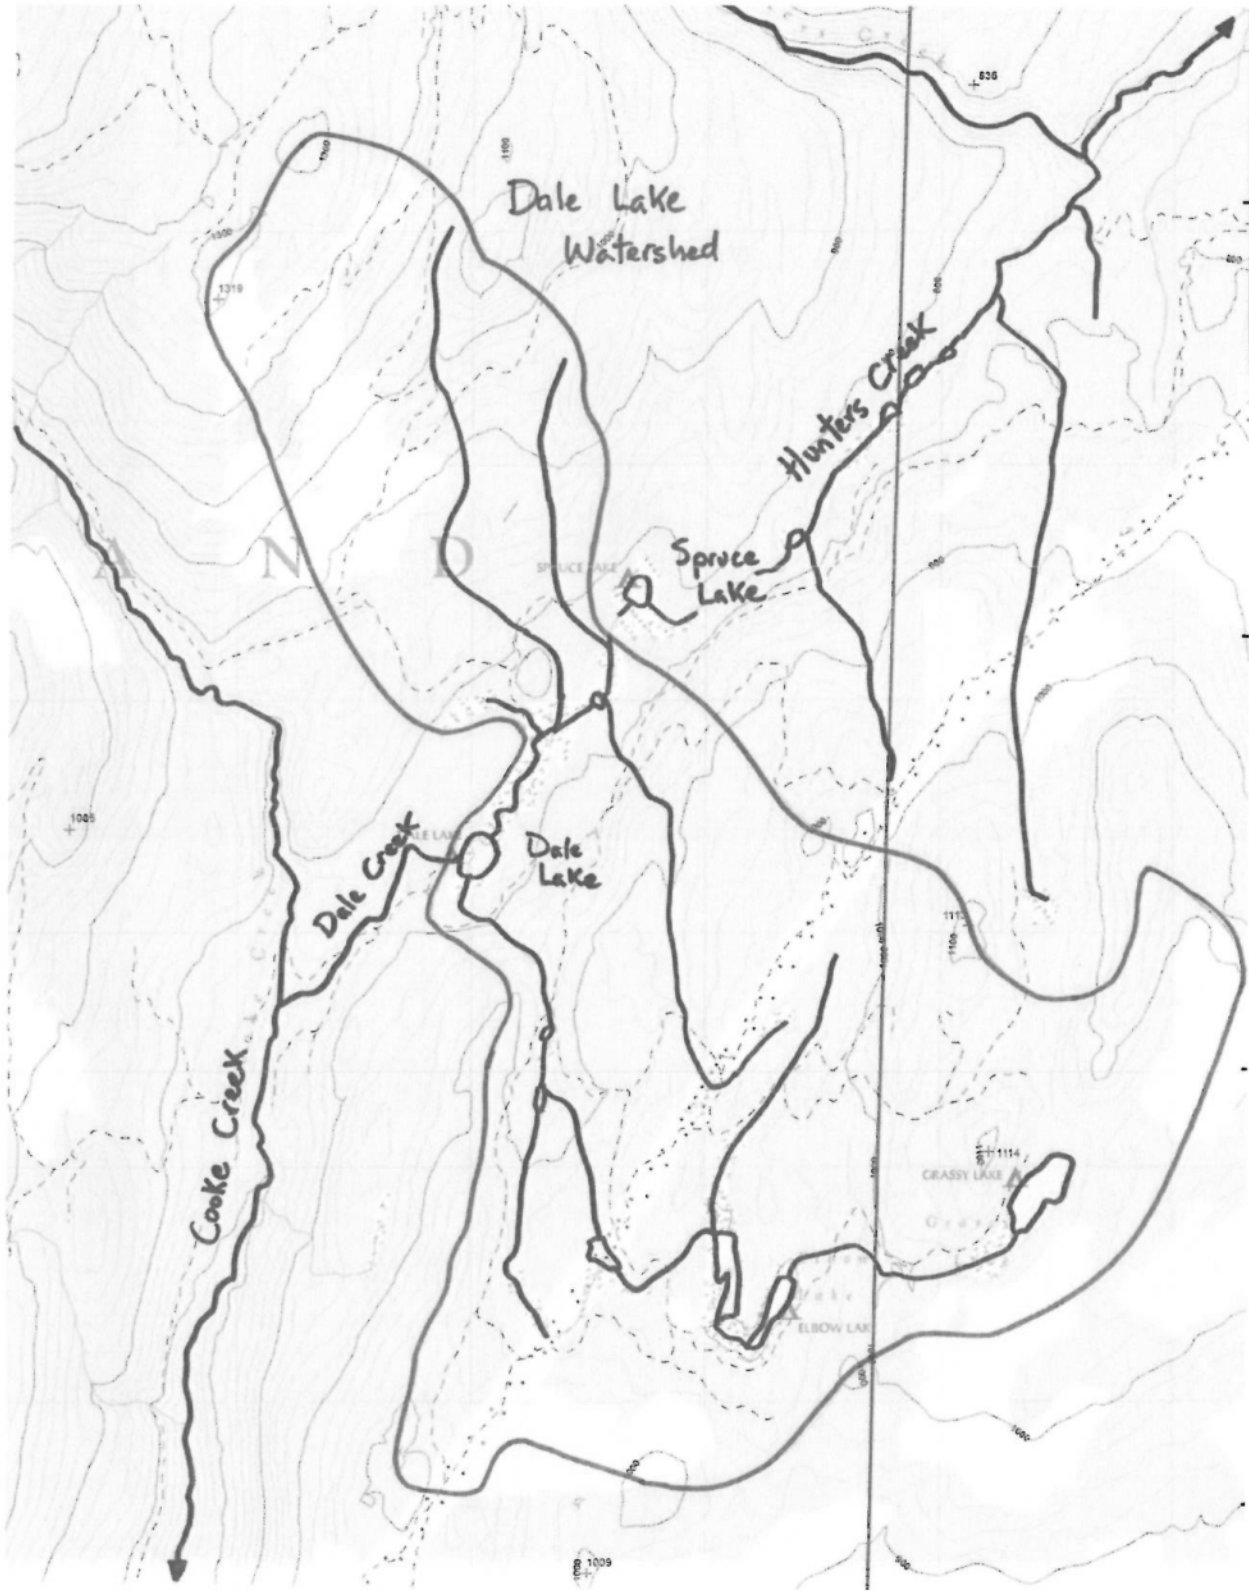
Figure 1: 1:20,000 topographic map showing the Dale Lake watershed. Creeks and watershed boundary were derived from interpretation of contours and fieldwork. The location of the breach is at the outlet of Dale Lake as it enters Dale Creek.

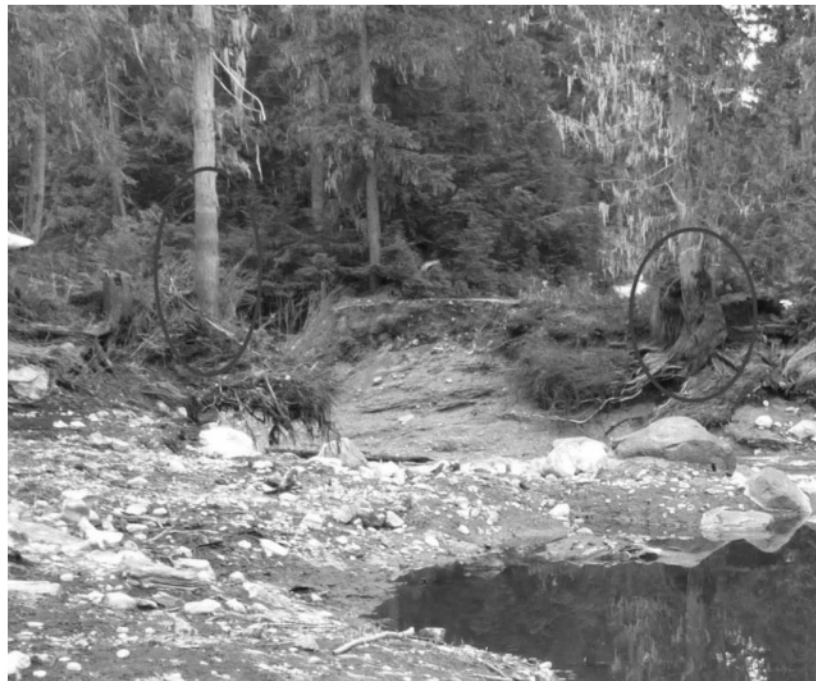
The scarring on the trees at the margins of the breach is a result of passage of one of the large marsh grass mats that used to exist in the lake. A piece of grass mat can be seen surrounding the trunk of the tree on the north side of the breach (Plate 8). Large accumulations of marsh grasses were observed in the first 300 m of the Dale Creek channel (Plate 9). These mats were readily entangled by standing trees along the margins of the flow, by large woody debris in and across the creek, and in overbank areas.

The Investigators observed aquatic vegetation in the trees above the road surface at the breach location, which indicated that the lake water had overtopped the road. View from the lake bed of two scarred trees located on the upstream side of the breach. The tree on the right has a section of marsh grass (grassy mats) wrapped around it.

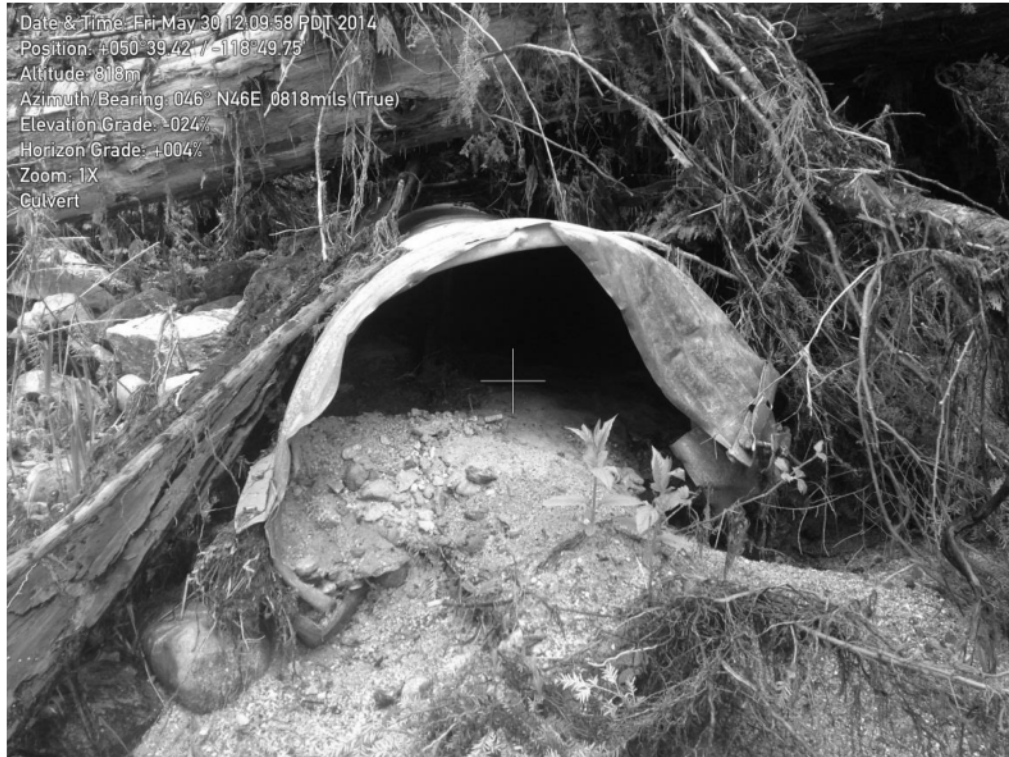
## Overflow Culvert found downstream

In the spring of 2014, the only outlet from Dale Lake was through the two 800 mm culverts leading into the draw of Dale Creek. Both culverts were removed by the escaping lake waters and were located bent and crumpled but intact, 200 m and 300 m downstream of the breach. The plastic beaver-stop end piece, complete with one of the two metal grates was found 300 m downstream from the breach.

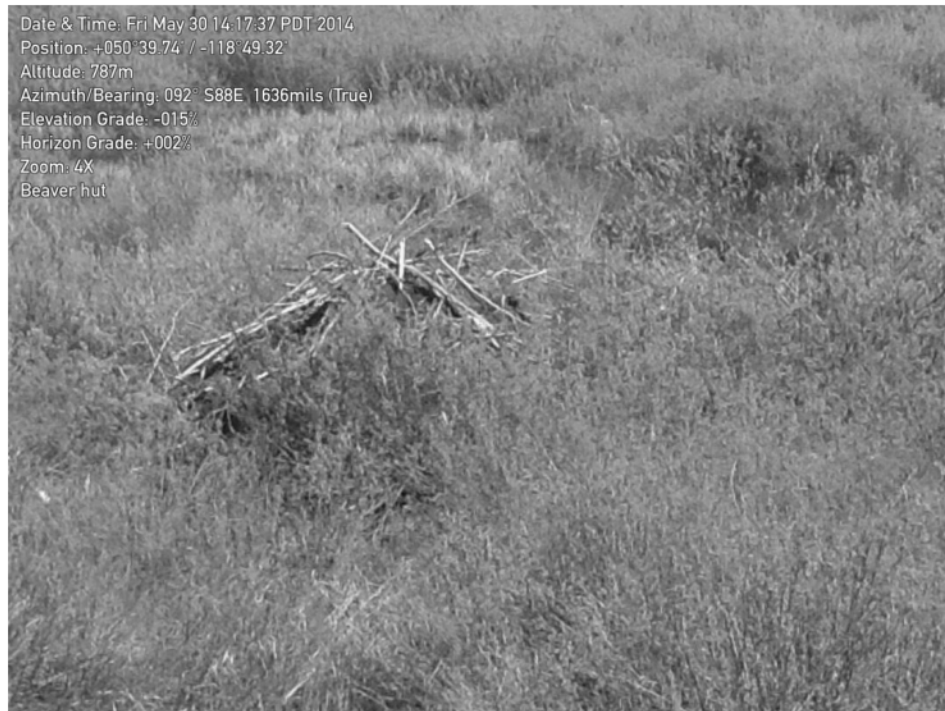
## Close-up of Beaver Lodge

Review of aerial photographs shows a beaver lodge on the margin of the south basin, immediately north of the breach site, prior to 1984. This lodge was viewed in the field as it had been exposed by the lowered lake level, it was flattened, broken and inactive (Plate 3). The exit runs from the lodge were still visible but have become infilled with shrubbery. Remnants of an old beaver dam were observed on the upstream side of the breach (Plate 4) and this suggests that at some time beavers may have controlled the elevation of outflow of the lake. No sign of this dam can be seen on the 1959 aerial photographs.

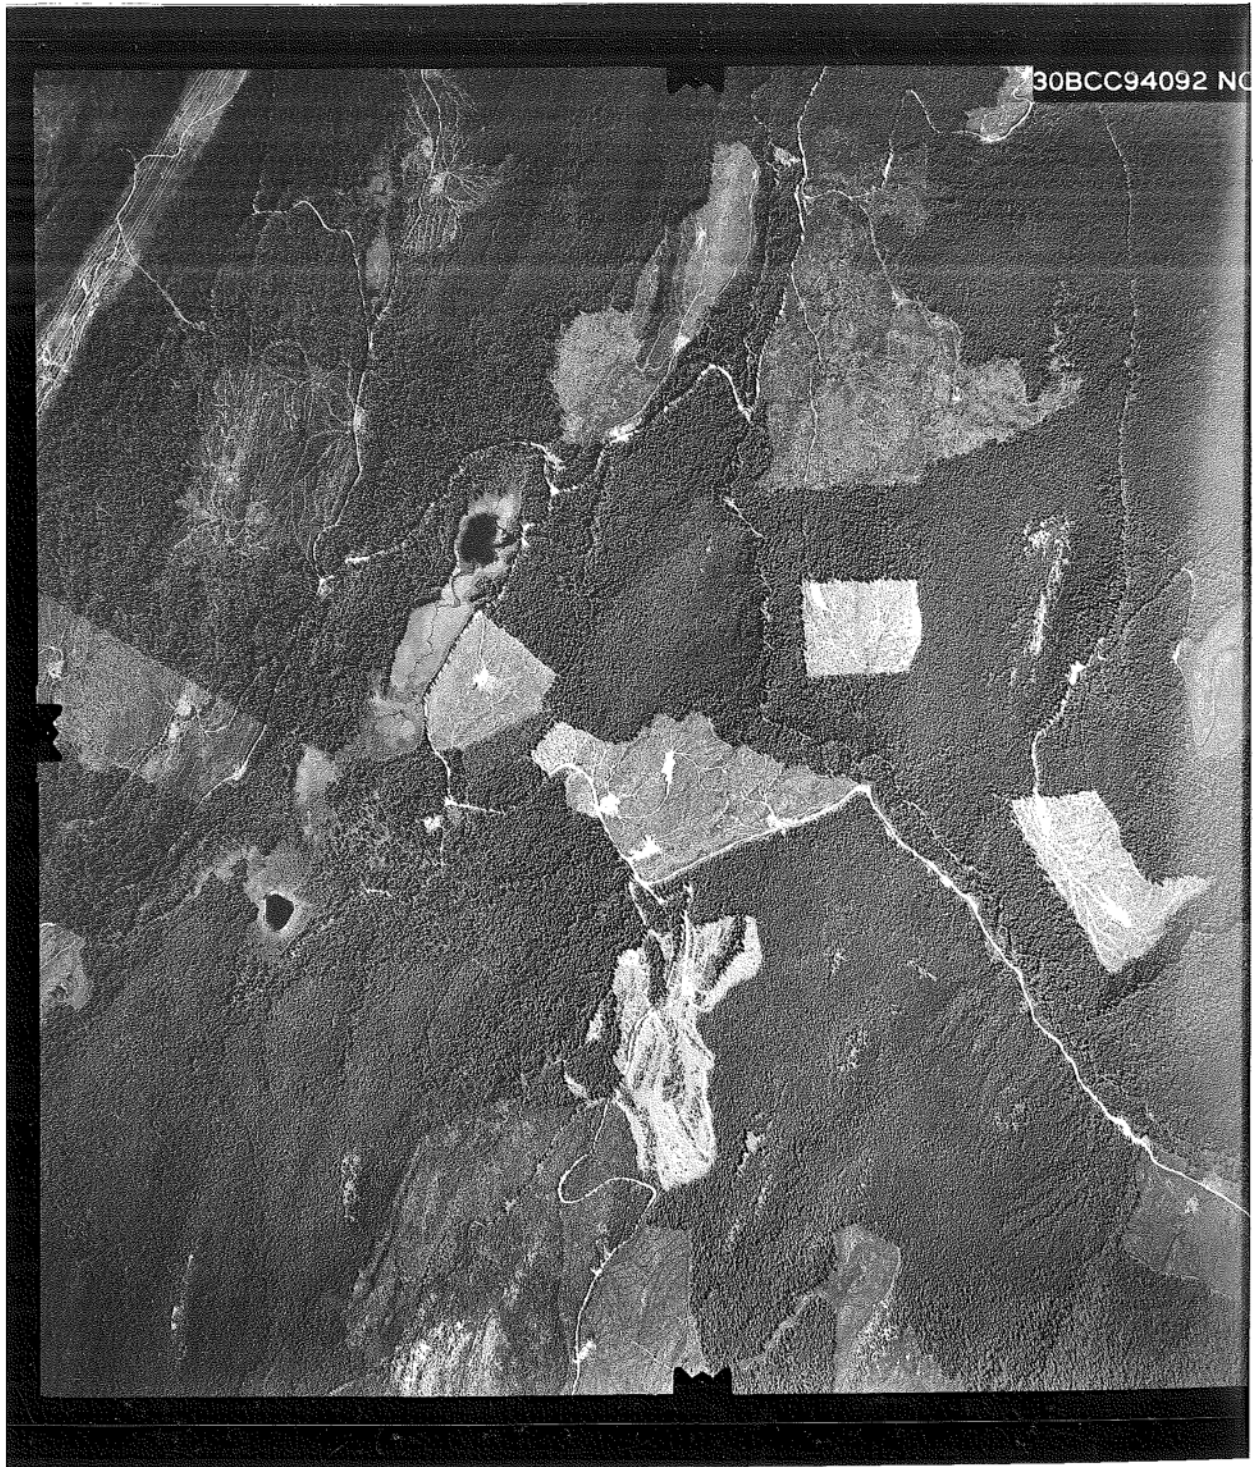
**Dale Lake size from 1959 – 2004**

Lake levels change through the years of photography, but the basic form of the lake remains similar between 1959 and 2004 (Plate 1). The lake has three basins: south, central and north. The south basin has always had an open pond of water, approximately a hectare in size, through all years of imagery prior to 2007. The central basin is elongate, up to 600 m long over 100 m wide with marsh grasses and a defined stream channel running through the centre of it. In a few images the north end of the central basin has open ponds, likely associated with beaver dams. The north basin is small, 100 m by 80 m wide and originally had a small open pond which over the years has ingrown with marsh grasses. The stability of the lake levels implies that the drainage systems into and out of Dale Lake were sufficient to manage the streamflow.

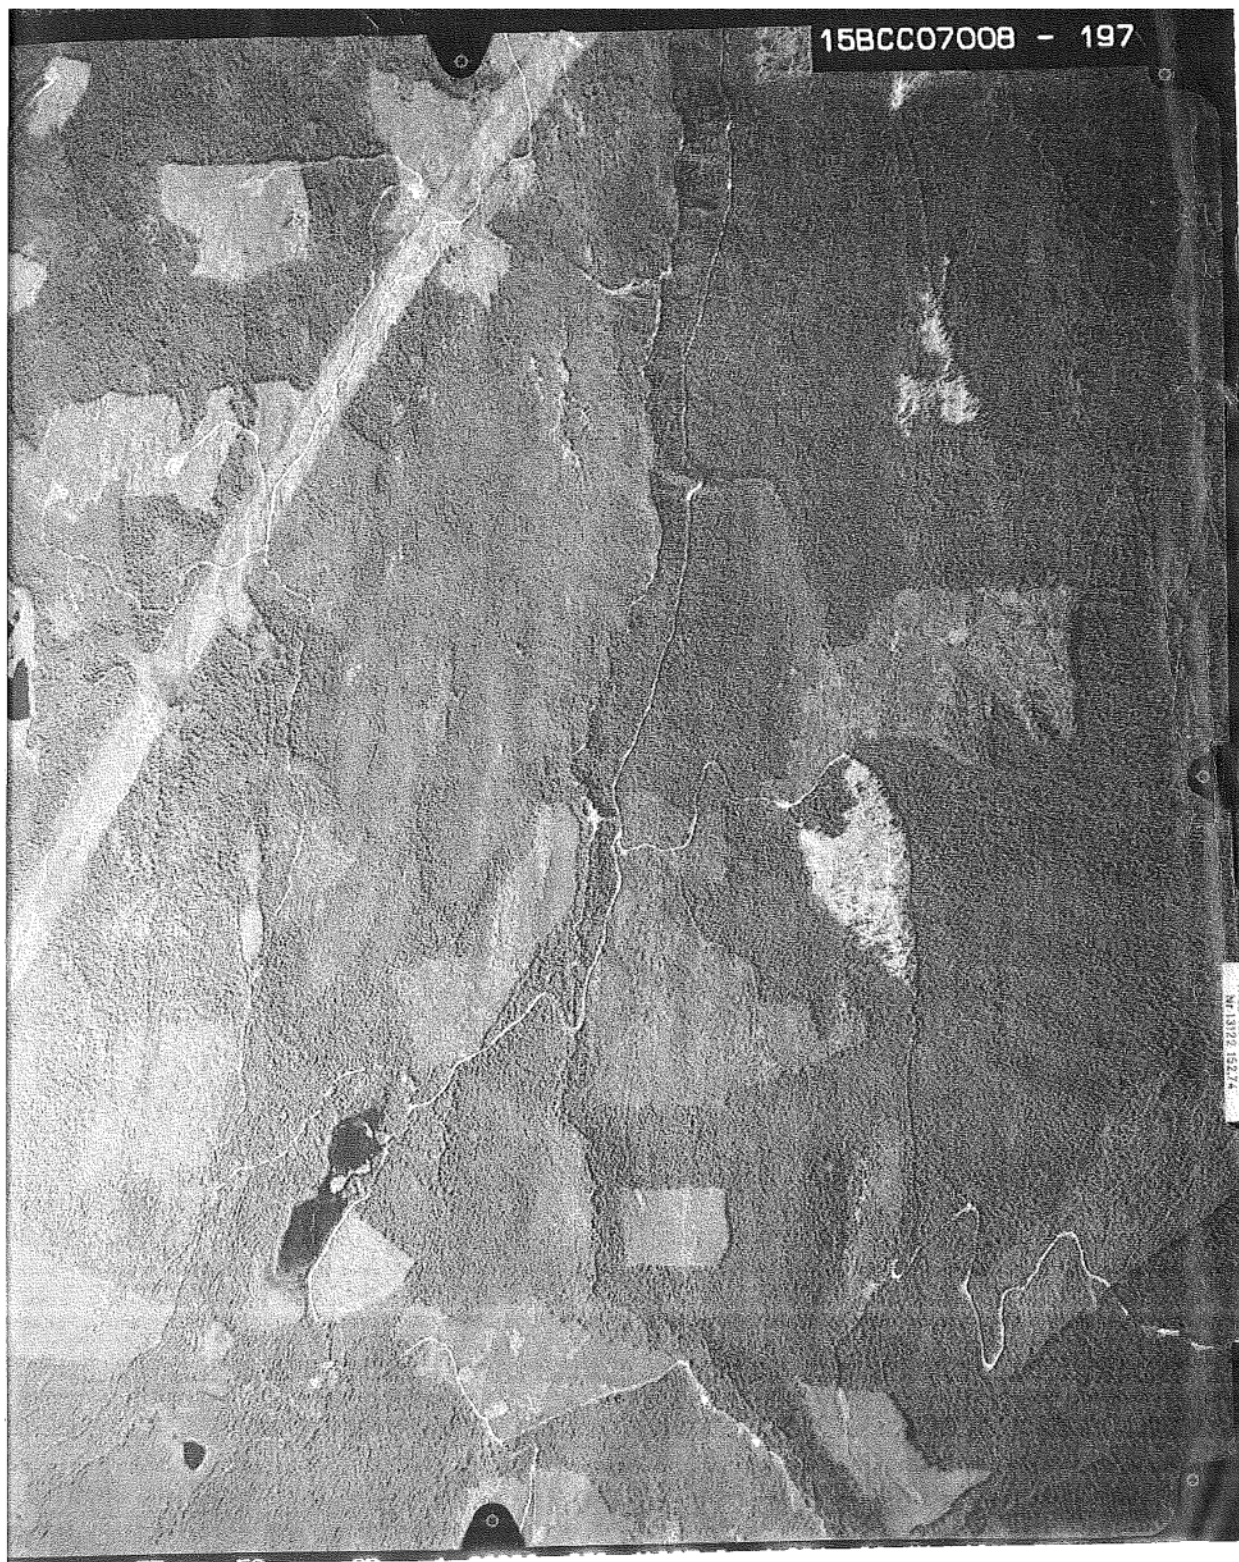
Dale Lake in 2007

In the 2007 imagery a major change in the water level of the lake can be observed and indicates that something has changed at the outlet. The lake expands from a small pond in the south to a large lake which covers the south and central basin. The south basin can still be seen, outlined by a ring of marsh grass, and the central section of the lake is inundated with water, covering as far north as the first beaver dam. Change at the outlet may signify an increase in the flow coming into the lake, but with no change in the outlet level only excess inflow to outflow beyond the capacity of the lower culvert would cause the lake level to rise. This, however, is unlikely as this image is from July 5, 2007 and the peak inflows from freshet have passed allowing the culvert time to pass the water and lower the lake level. For the lake to cover this aerial extent the water level must rise significantly, and impoundment must be maintained. I believe this indicates that the old culvert was non-functional in 2007 and that the new upper culvert now controlled the lake level. The elevation difference between the base of the old and new culverts is approximately 1 m which due to the shallow sloping nature of the shorelines probably means a large increase in the surface area of the lake.
