## **Mount Ida - Haines Creek South FSR (0825.05) Drainage Review**

Ministry of Forests, Lands and Natural Resource Operations  
Okanagan Shuswap Natural Resource District  
2501 – 14<sup>th</sup> Avenue,  
Vernon, BC V1T 8Z1  
Attention: Paul Blomberg RFT

**Westrek Geotechnical Services Ltd.**  
101 – 1285 Dalhousie Drive  
Kamloops, BC V2C 5Z5  
[www.westrekgeotech.com](http://www.westrekgeotech.com)

September 11, 2017  
File No. 017-049

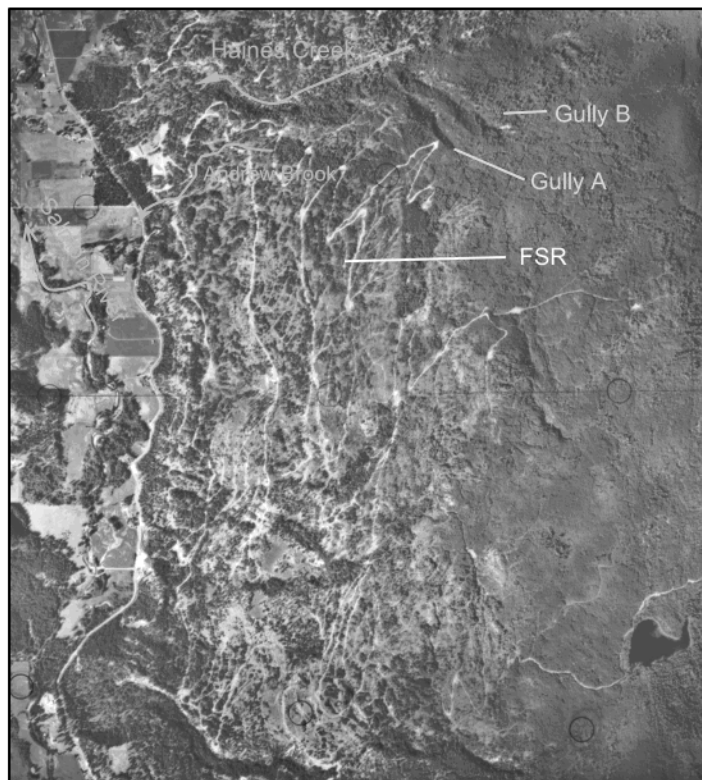
*Figure 3: 1974 provincial air photograph showing the extensive historical logging in study area.*

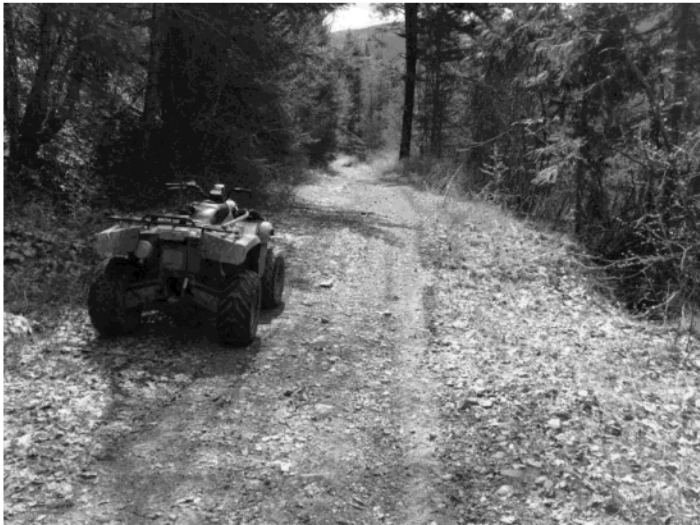
From the valley bottom to the top of terrace, the surficial deposits generally consist of uniform silt and sand. The terrace slope is 60% to 65% and irregular in shape. Grades on the FSR and its spur roads are generally steep, commonly ranging from 10% to 15% (Photo 1, attached). Road cuts along the terrace slope are up to 8 m high and actively ravelling in many places, or actively being eroded by local recreational vehicle traffic. These deposits are highly erodible, and several deep ruts had formed in some places from uncontrolled runoff off the terrace.

*Photo 1 – Typical section of road.*
