**Watershed Assessment of Proposed Forest Development  
within the  
Peachland Creek Community Watershed**

**Prepared for  
Tolko Industries Ltd.  
BC Timber Sales (Okanagan-Columbia Business Area)  
Ntityix Resources LP**

**Revised Final Report**

**November 5, 2018**

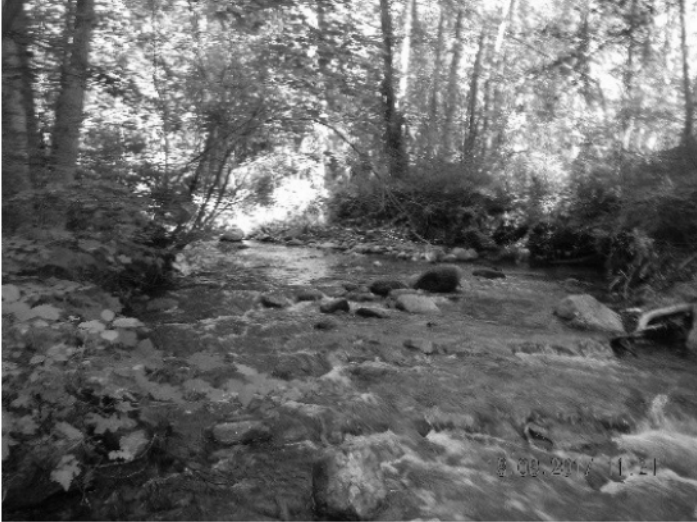
| <p><b>Photo #8 (Field Stop #4):</b></p> <p><b>Location:</b><br/>Peachland Creek directly above relocated channel</p> <p><b>Notes:</b><br/>Stable, Cascade-Pool (Boulder) channel</p> | |

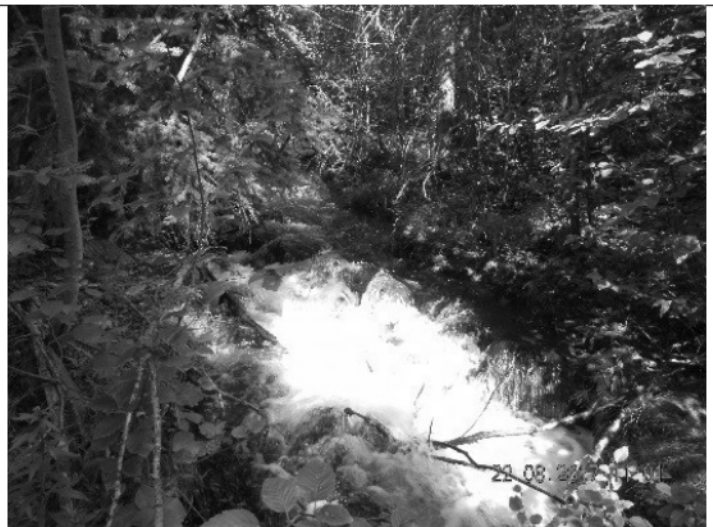
**Photo #38 (Field Stop #38):**

- **Peachland Lake Spillway** (Field Stop #38, Photo 38) – The east end of the Peachland Lake spillway channel that drains onto a steep valley slope was highly eroded (i.e. gully erosion). It is assumed this sediment source is directly connected to Peachland Creek.

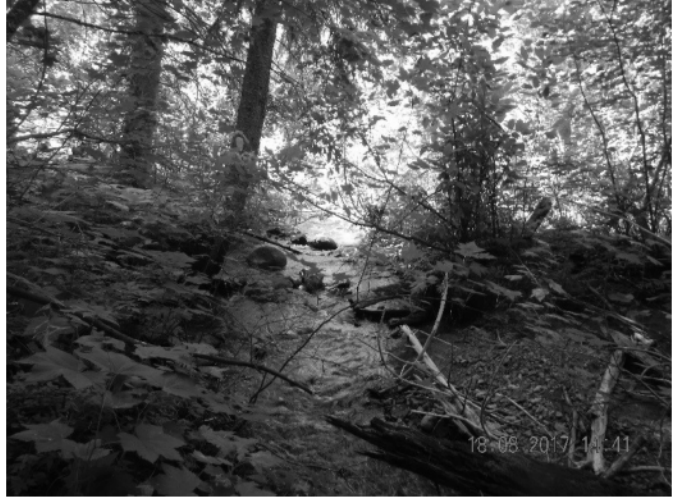
| <p><b>Photo #45 (Field Stop #51):</b></p> <p><b>Location:</b></p> <p>Mid-reach of Greata Creek</p> <p><b>Notes:</b></p> <p>Stable, Riffle-Pool (Cobble) channel.</p> | |

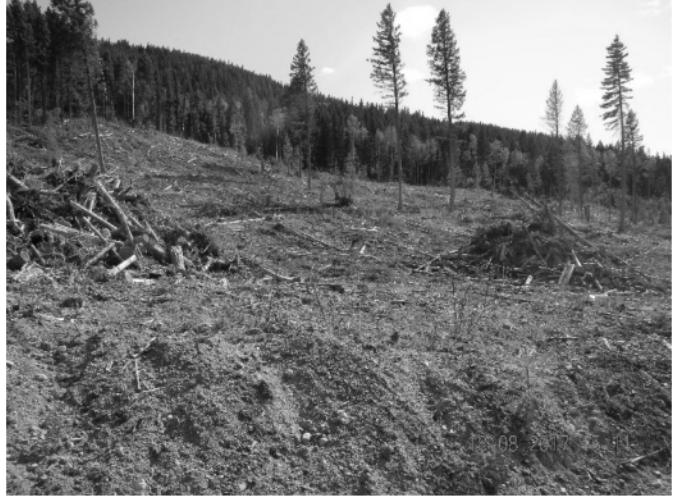
| <p><b>Photo #46 (Field Stop #52):</b></p> <p><b>Location:</b></p> <p>Recent harvesting in BC Timber Sales operating area</p> <p><b>Notes:</b></p> <p>Surface erosion and ground disturbance within the cutblock was minimal.</p> | |

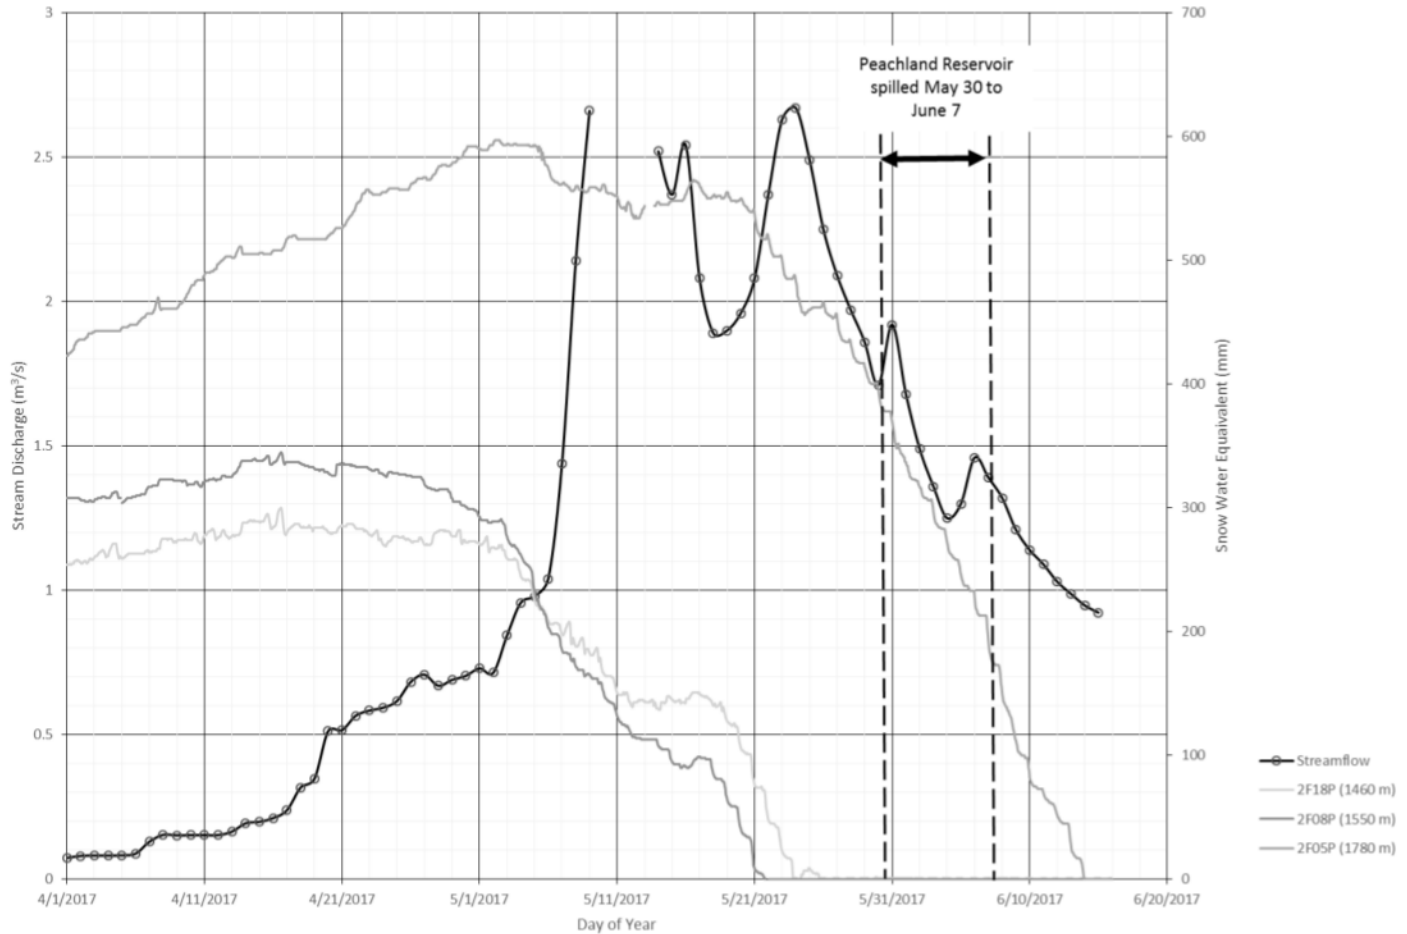
**Figure D.1.** Greata Creek streamflow data (Stn #08NM173) from April 1, 2017 to June 20, 2017. Peak flow on May 12, 2017 and on May 24, 2017 exceeded a one in 50 year event. Also shown is automated snow survey data from various elevations within the Okanagan Basin (Brenda Mines (2F18P), Greyback Reservoir (2F08P), Mission Creek (2F05P)). The dates at which the Peachland Lake reservoir spilled are also shown. Note: In 2017 stream discharge data is missing for May 10 to May 13, 2017 therefore the annual maximum peak flow in 2017 likely exceeded the actual recorded maximum peak of  $2.67 \text{ m}^3/\text{s}$ .

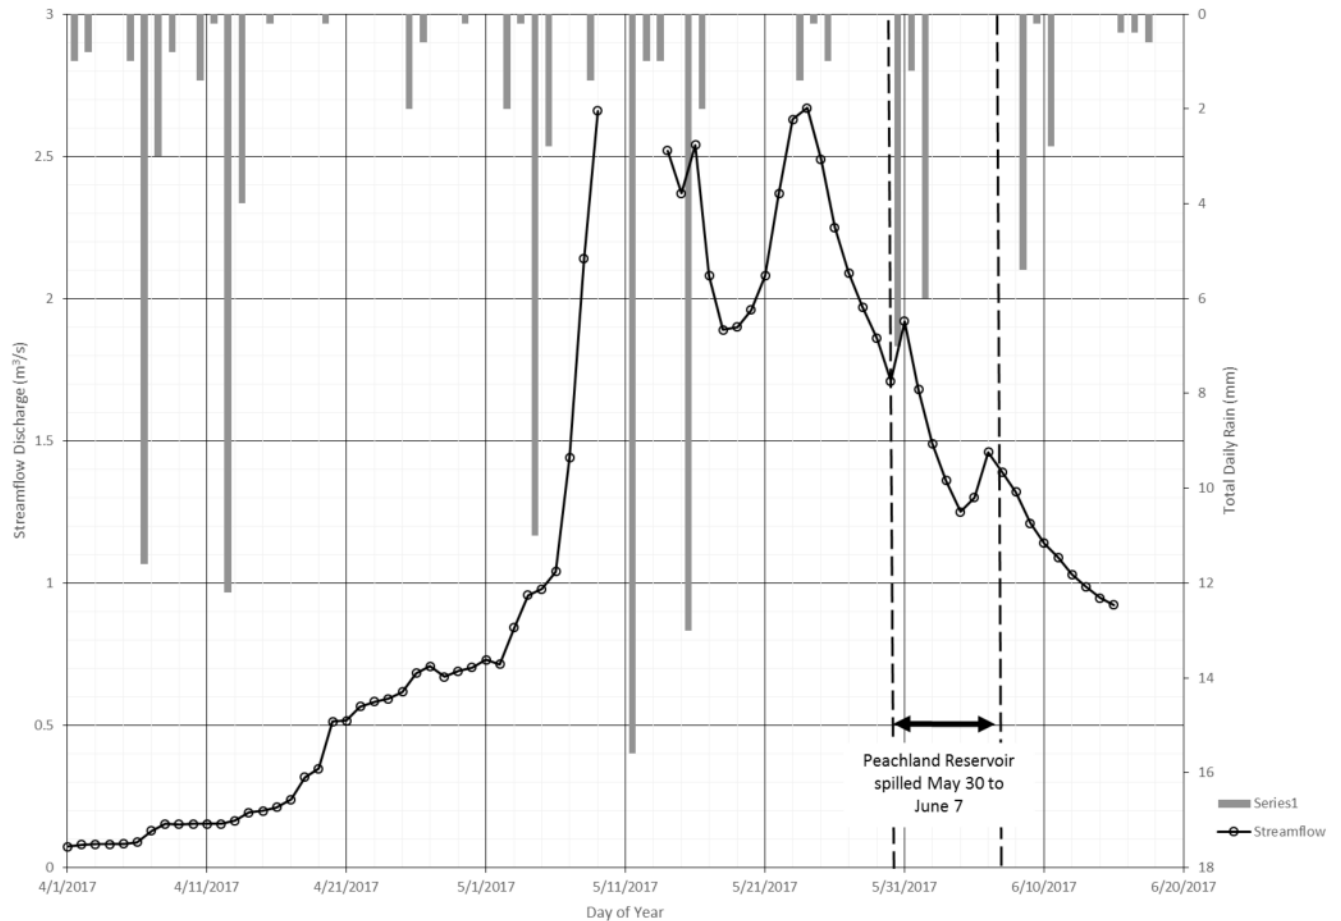
**Figure D.2.** Greata Creek streamflow data (Stn #08NM173) from April 1, 2017 to June 20, 2017. Peak flow on May 12, 2017 and on May 24, 2017 exceeded a one in 50 year event. Also shown is rainfall data from the Peachland Environment Canada weather station (Climate ID #1126070). The dates at which the Peachland Lake reservoir spilled are also shown. Peak flows in Greata Creek were primarily related to mid-elevation (1300 m to 1500 m) snowmelt and rainfall.

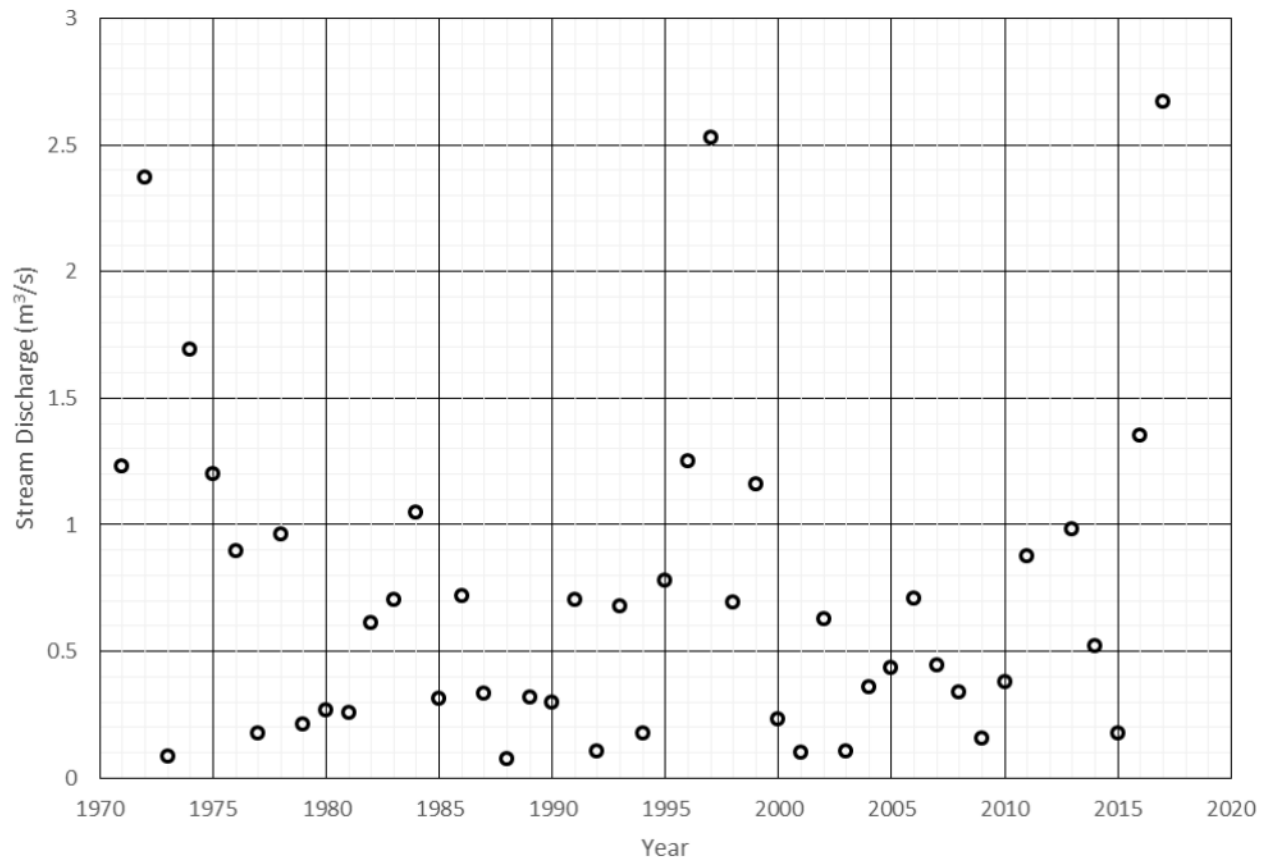
**Figure D.4.** Annual peak stream discharge for Greata Creek (Stn #08NM173) from 1971 to 2017. Note the three largest annual peak flows on record occurred in 2017, 1997 and 1972. Note: In 2017 stream discharge data is missing for May 10 to May 13, 2017 therefore the annual maximum peak flow in 2017 likely exceeded the actual recorded maximum peak of 2.67 m<sup>3</sup>/s.
