Inspection Date	2021-11-17 12:35:12 PM	Latitude	Longitude
User Name	Samuel Lyster	49.336651	-117.798922
Structure ID #	CW-003	49°20'11.94"	-117°47'56.12"
ORCS File #	CW-003		Accuracy (m) 5
Road Resp.	DSE	Design Info Available	No
FSR Project		Construction Info Available	No
File ID / Branch		Estimated Year Installed	
Road Name	Columbia Western Railway	ORG Responsible for Design	
User km	10		
Design Function	Wall to retain road fill or bridge approach fill		
Wall Type	Gravity		
Facing Type	Cast in place concrete		
Inspection Comments

Inspection Date	2021-11-17 12:56:17 PM	Latitude	Longitude
User Name	Samuel Lyster	49.336364	-117.796188
Structure ID #	CW-002	49°20'10.91"	-117°47'46.28"
ORCS File #	CW-002		Accuracy (m) 7
Road Resp.	DSE	Design Info Available	
FSR Project		Construction Info Available	
File ID / Branch		Estimated Year Installed	
Road Name	Columbia Western Railway	ORG Responsible for Design	
User km	9.8		
Design Function	Wall to retain road fill or bridge approach fill		
Wall Type	Gravity		
Facing Type	Cast in-place Mass Concrete		
Inspection Comments

Inspection Date	2021-11-17 1:15:56 PM	Latitude	Longitude
User Name	Samuel Lyster	49.335554	-117.792881
Structure ID #	CW-0

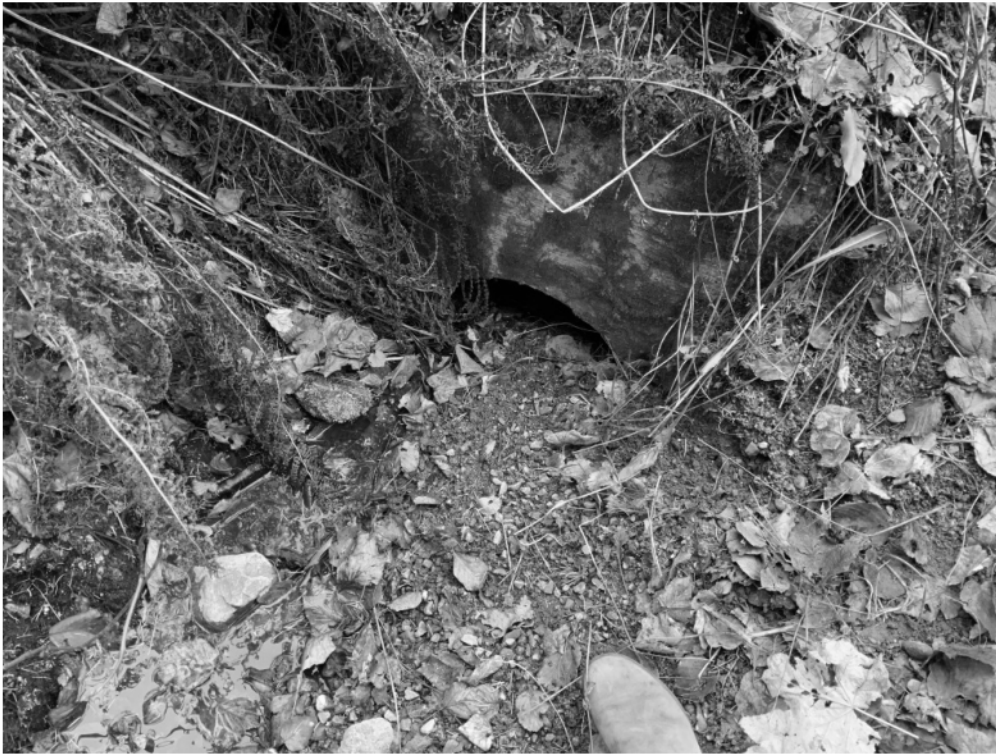
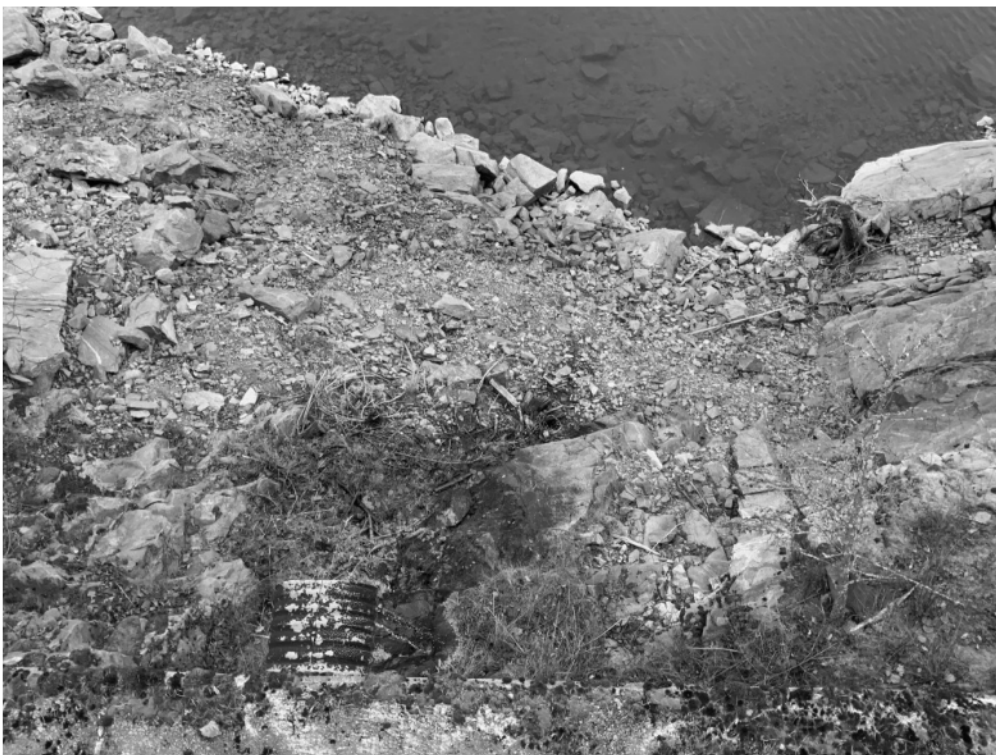
Foundation erosion located 1.5m left and 2m right of culvert plunge location. See

Drainage System	Poor	5 drain pipes observed with evidence of drainage. Evidence of subsurface flow and erosion of wall foundation 1.5m left of where culvert flow hits rock. Erosion 50cm into wall, 1.2m wide. Additional erosion unlikely as it's on bedrock.
Traffic Barrier/ Fence	Good	
Road	Good	4.4m wide
Upslope	Good	
Downslope	Good	Bedrock
Lateral Slope	Good	Potential for erosion from surface flow at left end
Detrimental Vegetation		
Culvert	Poor	Inlet blocked 75%
Curb/Berm/ Ditch	Good	1.5 to 3m wide ditch
Other Secondary Element

Potential surface flow erosion location
