# **Rails to Trails** **Routine Condition Bridge Inspection Form**

Crossing <b>OTTER CREEK</b>	Structure # <b>KV-060</b>	Site # <b>KV-060</b>	Length <b>103</b>	UTM Zone and E <b>10 662211</b>	UTM N <b>5491037</b>
Trail Name <b>KVRT</b>	Km <b>139.3</b>		Deck Type <b>TIMB</b>	Girder Type <b>TIMBER</b>	Abutment Type <b>TIMBER</b>
Inspection Co. Name <b>SNT Engineering Ltd.</b>	Inspector's Name /Signature <b>J Cox, E Miller</b>			Inspection Date: <b>3-Oct-12</b>	Next Inspection: <b>1-Jul-13</b>

## BRIDGE INFORMATION:

<b>Bridge No./Name</b>	KV-060: Kettle Valley Railway		
<b>Inspection Date</b>	October 9, 2020		
<b>Inspected By</b>	Mike Hanson, P.Eng. Josh Stadnyk, EIT.		
<b>Temperature (°C)</b>	15		
<b>Access Method</b>	Ground level assessment		
<b>Year Built</b>	Unknown		
<b>Camp/Town</b>	River Right		
<b>Number of Spans</b>	23	<b>Span Lengths (m)</b>	4.3 to 4.8 m
<b>Superstructure</b>	Six creosote treated sawn stringers, spaced 150 mm in pairs and 650 mm clear distance between pairs. Stringers are 245 x 500 mm and generally continuous over two spans, aside from the stringers in the first and last spans, which are simply supported.		
<b>Deck</b>	Untreated ties, 185 x 185 mm spaced

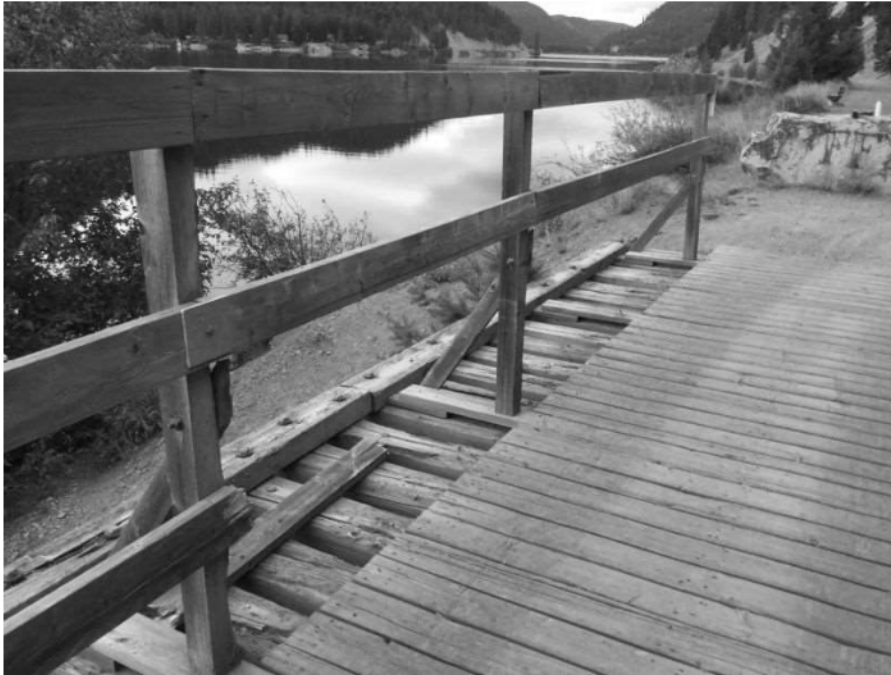
**Photo 7**  
Railing at left abutment

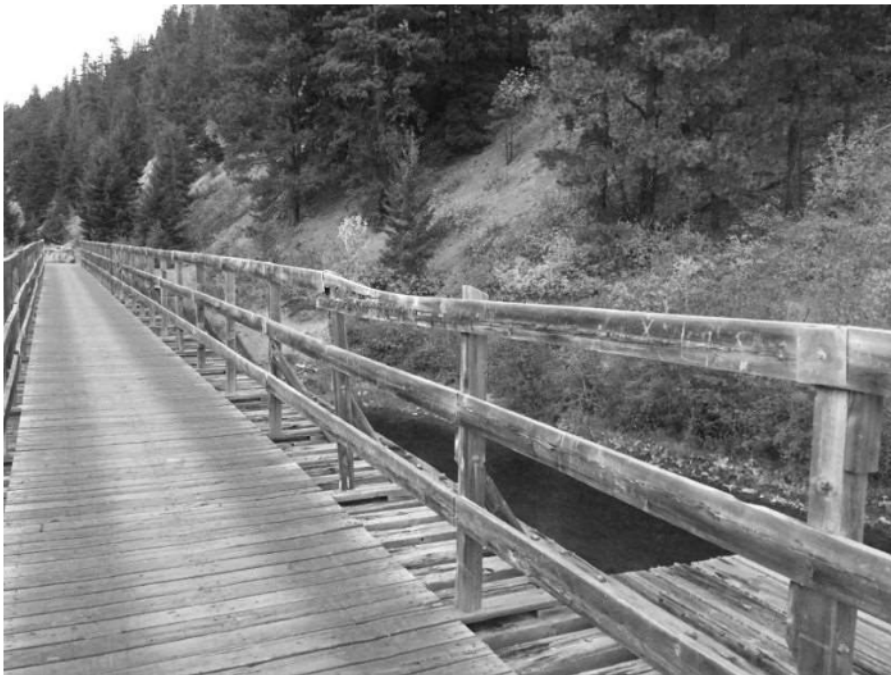
**Photo 8**  
Railing near middle of bridge

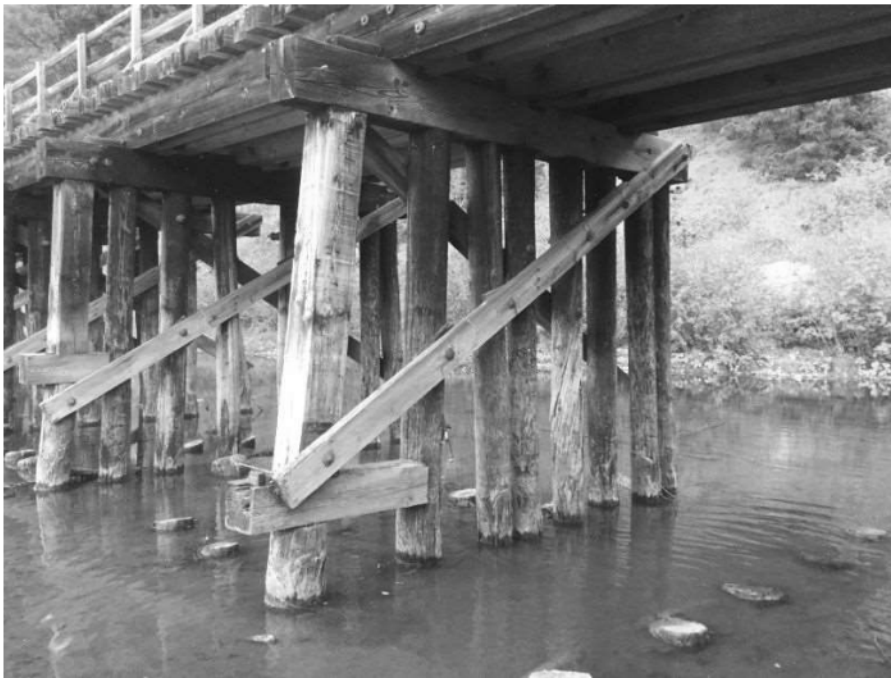
**Photo 30**  
Pier 11

Pier	Pile									Bracing		Comments
	1	2	3	4	5	6	7	8	9	Left	Right	
1												Pile 4 cored, sound
2												
3												Pile 3 sound at ground level
4					P							Pile 1 cored, soft but no rot
5												
6												Pile 8 cored, sound
7												Pile 7 rot at 1.0m above PWL
8												
9	P											Pile 7 cored, sound
10	P											
11	P											Pile 6 cored, sound
12	P											
13	P					P						
14												Pile 3 cored, sound
15												
16						P

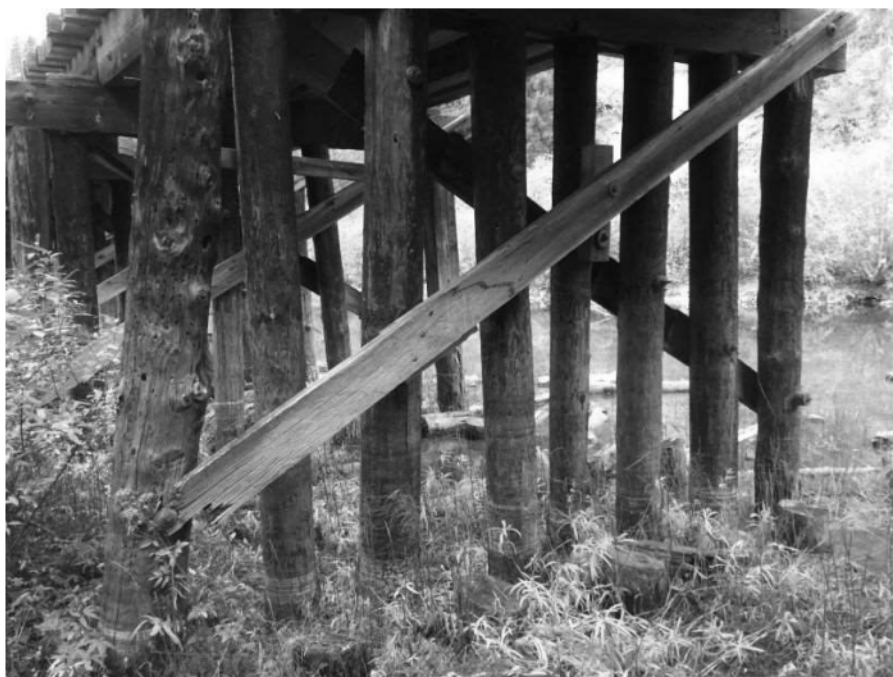
**Photo 36**  
Pier 17

Pier	Pile									Bracing		Comments
	1	2	3	4	5	6	7	8	9	Left	Right	
17								P				
18												
19						P						Pile 3 cored, sound
20												Pair of piles at 7, right is rotten
21	P		P									Pile 6 has wide split, no rot
22				P								Rot in pile 4 is in the sill/ blocking, no crushing noted
