DGIR 214026 Fire Duncan

Email from North Cowichan re DGIR 214026 Fire at OK Tire in North Cowichan

Re: *SURFACE WATER INSPECTION LETTER* – 6482 Norcross Road, Duncan, BC

Site Photographs – January 24, 2022

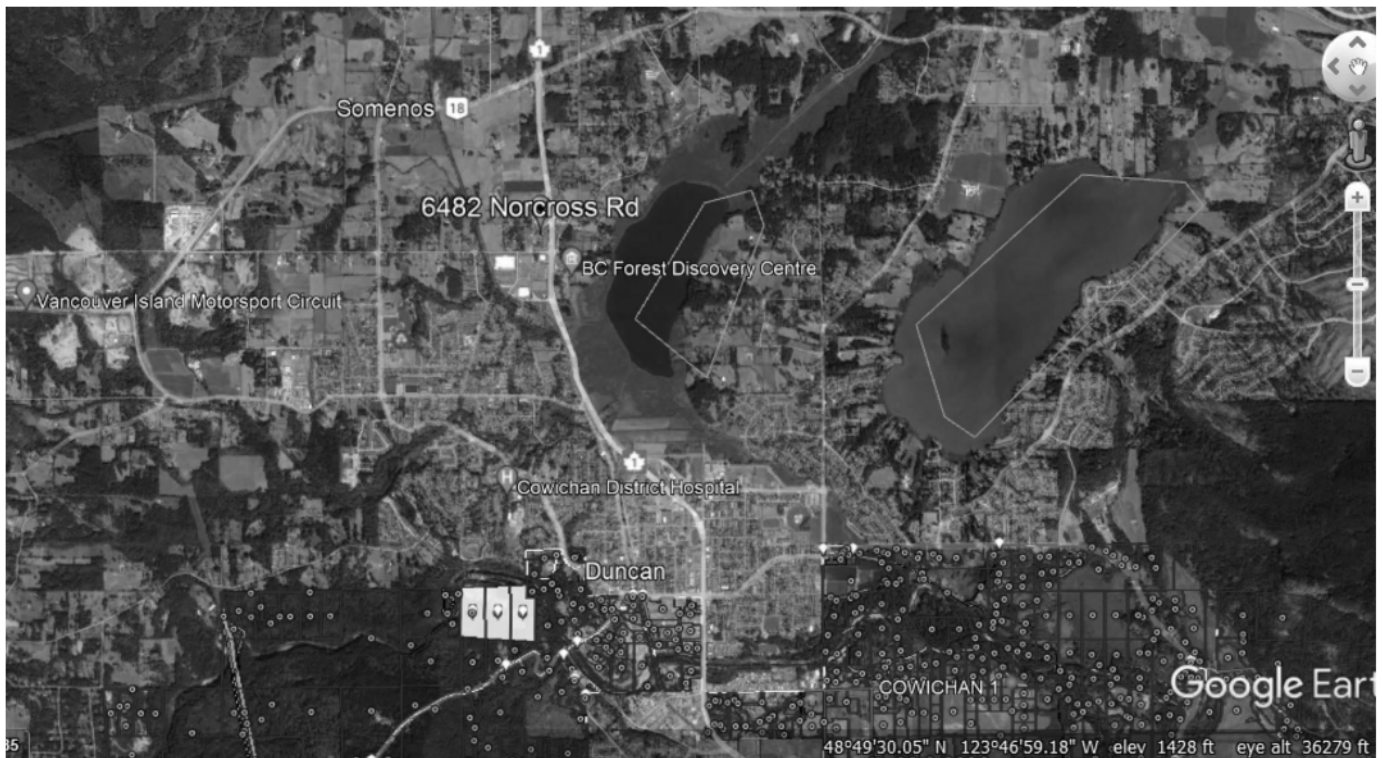
Hi Greg, Akhil and Alec, I'm passing this email along to you for your information and action as you deem necessary. I conclude from this Google Earth snapshot that Cowichan is likely the closest First Nation Community so I have copied Alec, the Public Works Manager. I'm hoping that the marsh is not a source of drinking water. I have also copied Island Health as a precautionary measure.

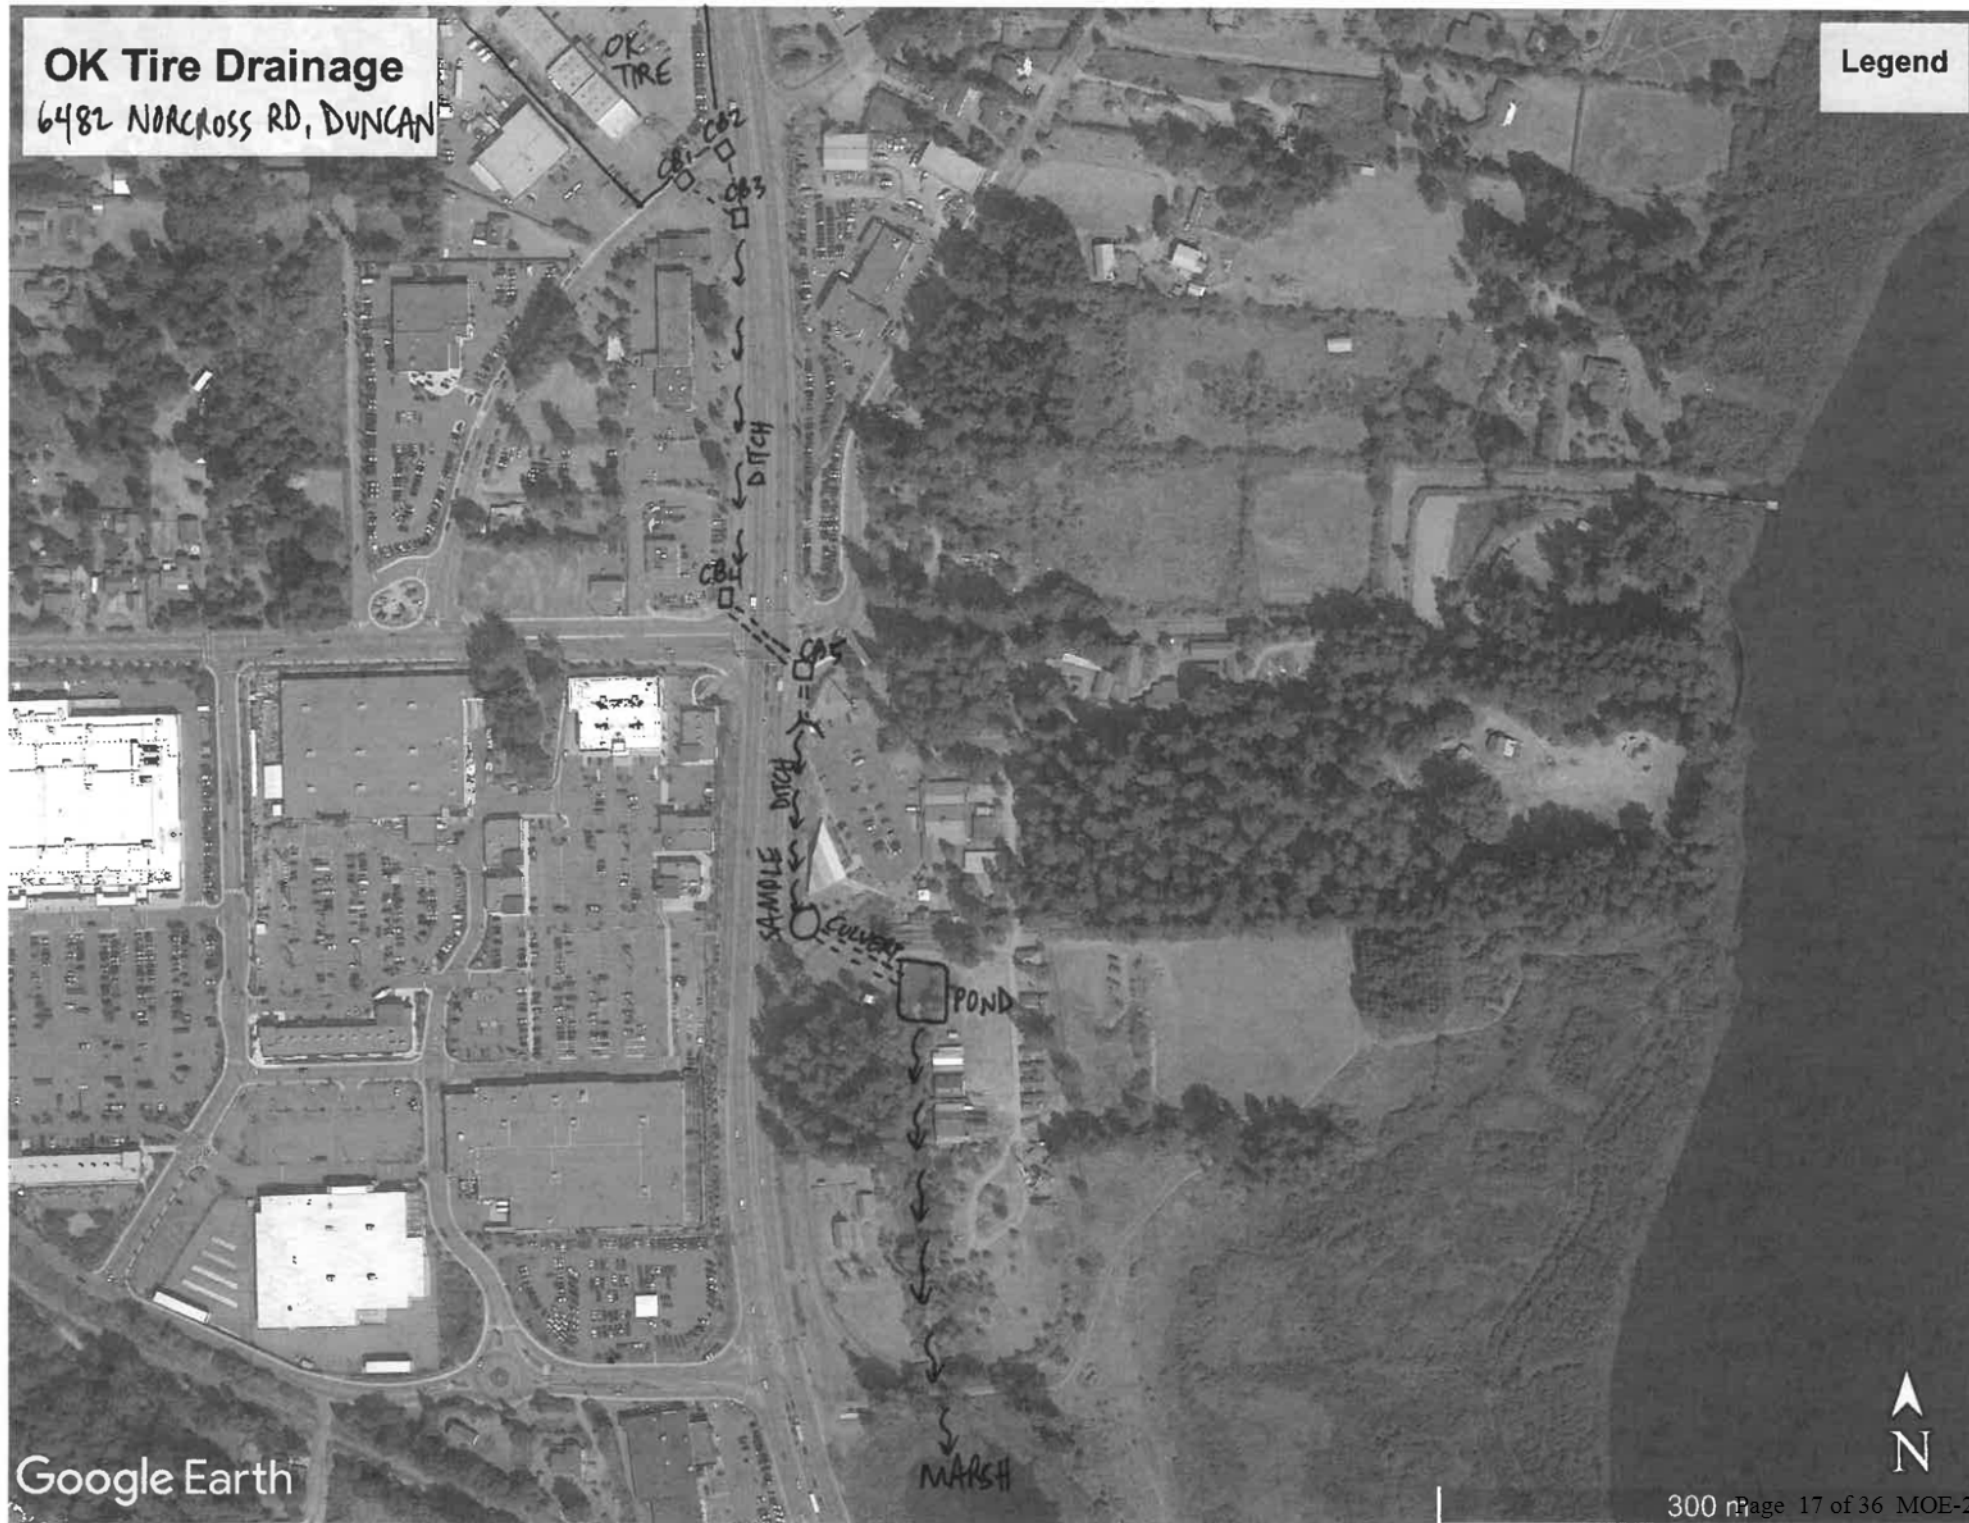
OK Tire Drainage
6482 NORCROSS RD, DUNCAN

A visual foot search was completed following the flow of water to the catch basins and eventually to the Forest Discovery Centre. It was observed that at the time of the search, run off from heavy rains and significant snow melt had mixed with firefighting waters leaving the Site. Limited tire residue was observed in the ditch bordering the Forest Discovery Centre and no tire residue or evidence of contaminated water was observed in downgradient aquatic receiving bodies (i.e. the pond at the Forest Discovery Centre or its surrounding drainage systems).

From TerraWest's visual inspection, no downstream detrimental impacts were noted to the drainage systems or Aquatic Receiving Bodies. However, laboratory results of the collected surface water sample indicate that select petroleum hydrocarbons exceed the applicable aquatic criteria (i.e. toluene and benzo(a)pyrene).

- Complete a follow up visit to visually inspect the drainage systems following the snow melt when all drainage is accessible;
- Collect a second confirmation sample at the culvert south of the Forest Discovery Center. Based on water quality results from analysis of the collected sample, additional recommendations may be warranted.
