BGC ENGINEERING INC.

Project No. 0378-002-01

January 3, 2008

Re: Cohoe Creek Landslide and Landslide Induced Wave (Seiche) at Chehalis Lake

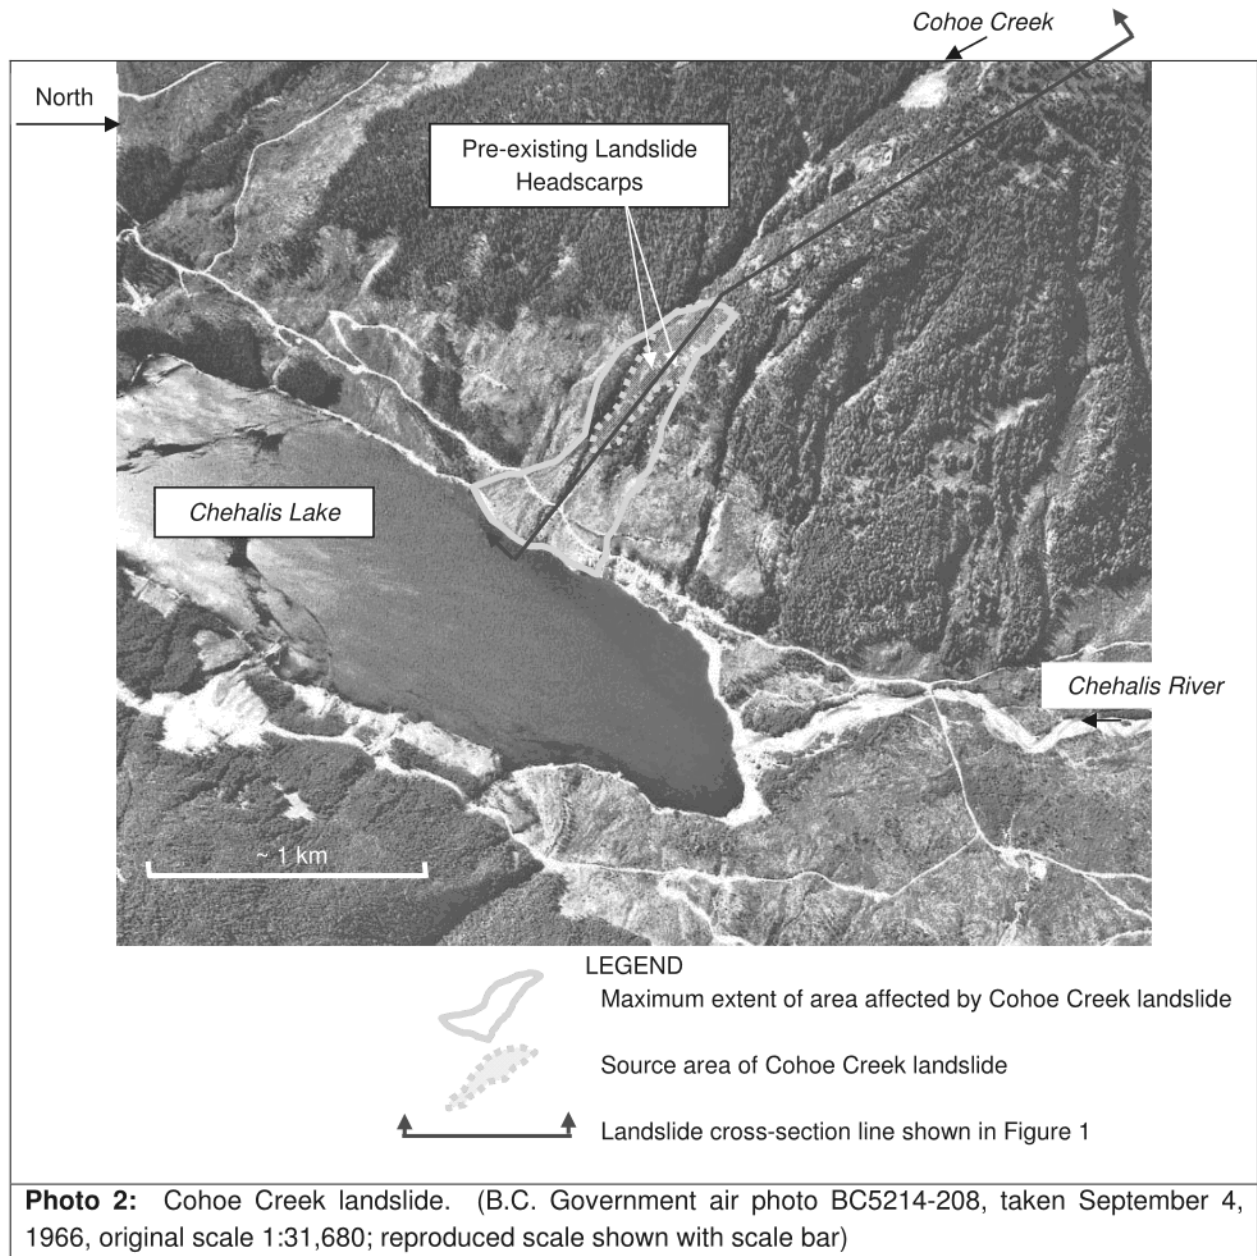
The landslide developed on the left side of Cohoe Creek as shown in Photo 1. The highest headscarp elevation is approximately 843 m, which is 648 m vertically above Chehalis Lake (elev. ~235 m) as shown in Figure 1. The source area extends from the headscarp down to approximately elevation 444 m (Photos 2 and 3), an on-slope distance of ~675 m. The total on-slope distance affected between the headscarp and the lake is ~1,130 m and the line-of-sight angle over this distance is between 31° and 32°. The total extent of debris runout into Chehalis Lake is unknown.

Photo 1: View north-northeast along Chehalis Lake with Harrison Lake and Mt. Breakenridge in the background. The location of the Cohoe Creek landslide is indicated by the ellipse. (B.C. Government oblique air photo BC499-99, taken June 20, 1948)
