Alders Road Culvert Layout

**RE: SAFE ENTRY REQUIREMENTS
CULVERT REPLACEMENT ON SLOPE BELOW ALDERS ROAD
SALT SPRING ISLAND**

An existing corrugated steel pipe (CSP) failed on the slope below the houses at 121 and 123 Alders Road sometime in early 2013. The failure likely occurred during or shortly after a heavy rain event. The site appears to encompass a marginally stable slope under normal conditions.

ALDERS CULVERT REPLACEMENT

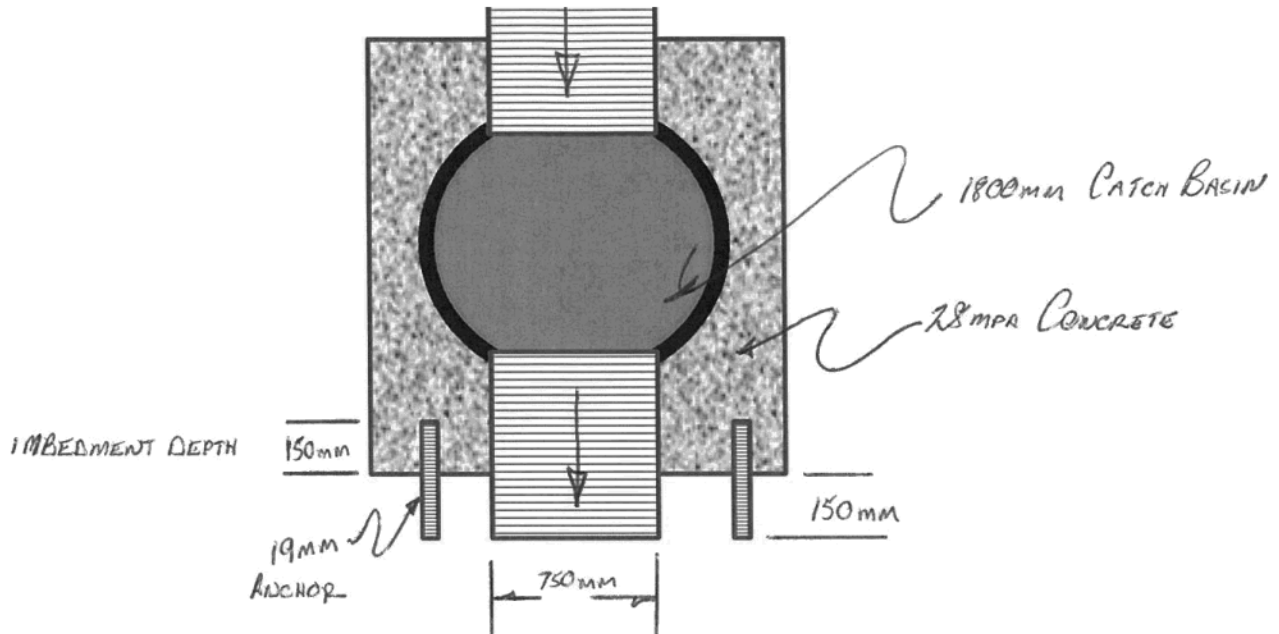
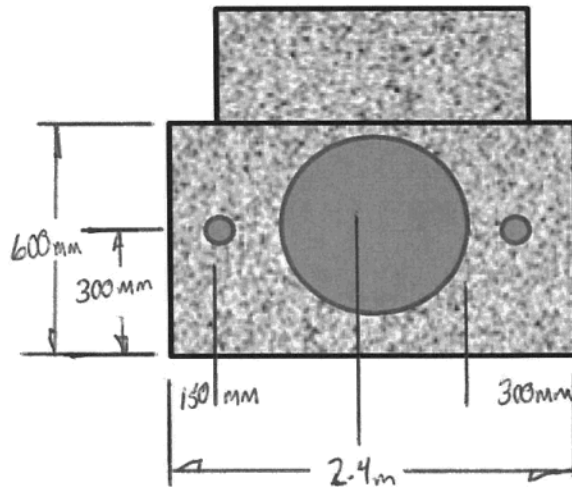
Alders Road Culvert Anchorage System

ha Pl<.oã-er1 11tJ.fal!eg - /9/>11'1 -7H1<#(il'1J 1?o Jtc11tJ

,,,Jf,,,_,fi"Y6 l!xJt.r5 (il/t.J /ICIY 4fK,/(J//.
