Ministry of Transportation and Infrastructure

Commercial Vehicle Inspection Report

**Subject:** Cariboo Hwy #97 Bus Crash update

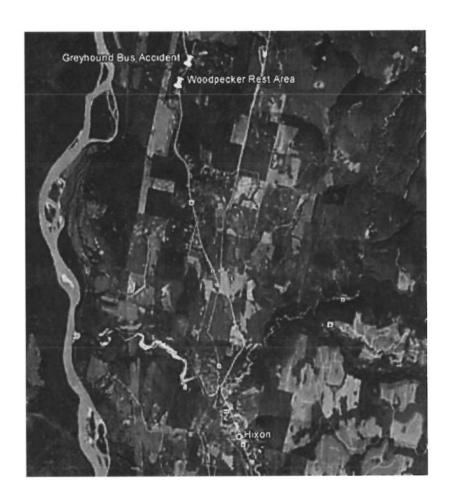
Hucal, Jackie TRAN:EX					
From: Sent: To: Subject:	Haywood, Steven TRAN:EX Thursday, January 14, 2016 10:28 AM Hunsaker, Val D TRAN:EX RE: Accident hwy #97 by ewing				
10-4 thanks s.15					
Regards, Steve					
From: Hunsaker, Val D TRAN:EX Sent: Thursday, January 14, 201 To: Haywood, Steven TRAN:EX Subject: FW: Accident hwy #97	6 9:59 AM				
Hello Steve,					
I have yet to confirm the correct	direction of travel.				
Val					
From: Hubner, Todd B TRAN:EX Sent: January-14-16 9:49 AM To: Hunsaker, Val D TRAN:EX Subject: FW: Accident hwy #97  Hi Val: here are some photos f bus was Sthbd. (yet to be conf Todd	rom Len Sauchuk, (local RAM), that is now on-scene. Our intel. is indicating the				
From: Moores, Brad A TRAN:EX Sent: Thursday, January 14, 201 To: Hubner, Todd B TRAN:EX; Ha Subject: FW: Accident hwy #97	aywood, Steven TRAN:EX				
Hi, attached are the Greyhound b	ous accident. The bus was South Bound.

Len Sauchuk is on RAM on scene.					
Thanks

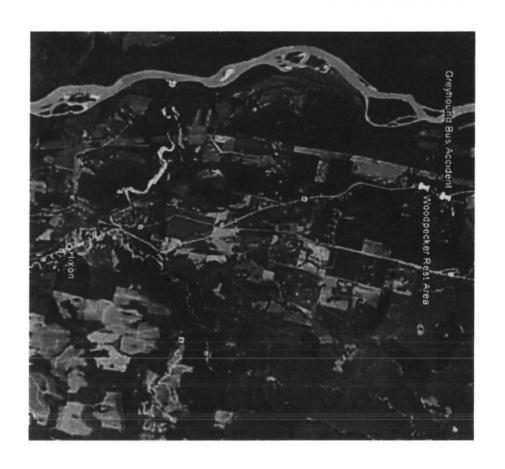
Roads were slushy. No indication of cause.
