WILSON MOUNTAIN FIRE- OLIVER BC

AUGUST 14TH 2015

INVESTIGATION REPORT

DARRELL GREEN

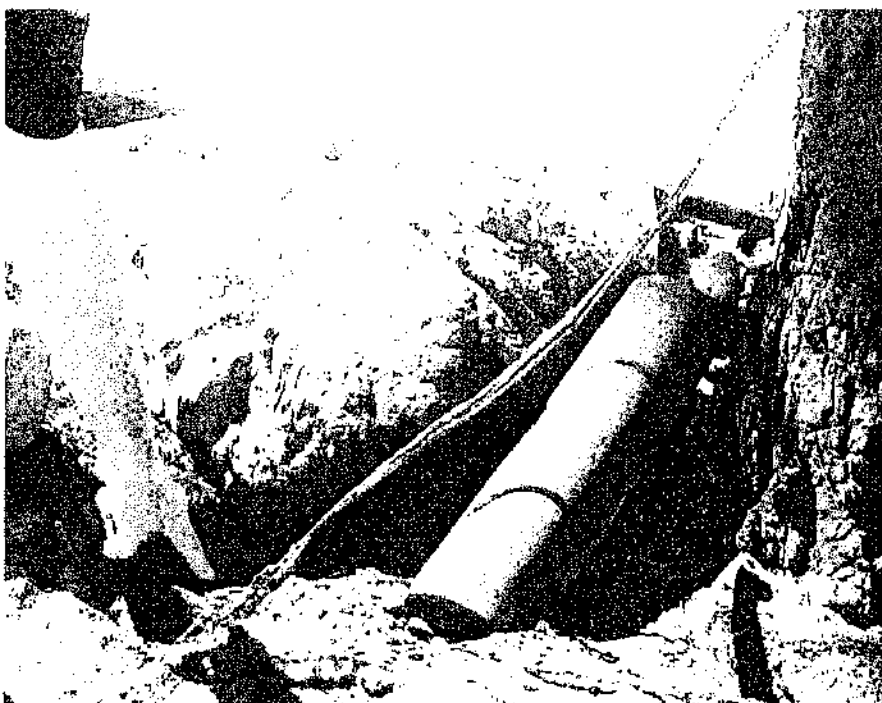
s.22 AT VARIOUS LOCATIONS THROUGHOUT THE PROPERTY WHICH RESULTED
s.22 IN PARTICULAR WAS AN AREA THAT APPEARED TO BE AN
"OPEN WORKSHOP" AREA WHICH HAD A WORKBENCH, WELDER AND VARIOUS OTHER PIECES OF EQUIPMENT. FOUND ATTACHED TO A TREE IN THAT AREA WAS IDENTIFIED BY MR FRICK AS A LARGE COMBINATION PANEL. THERE WAS EVIDENCE FOUND THAT THE PANEL WAS FEEDING VARIOUS PIECES OF EQUIPMENT. THIS TYPE OF PANELS INTENDED USE IS IN A DRY ENVIRONMENT PROTECTED FROM THE ELEMENTS. THE PANEL WAS BEING SUPPLIED TO THE MAIN COMPARTMENT AREA WITH STRANDED CONDUCTORS MEASURED AS APPROXIMATELY #10 AWG COPPER. THOSE CONDUCTORS WERE FOUND GOING UP THE TREE THAT THE PANEL WAS ATTACHED TO THEN WRAPPED AROUND THE TREE AND THEN STRUNG FROM THAT TREE TO ANOTHER TREE THEN WRAPPED AROUND THAT TREE AND THEN ATTACHED TO THE FACE OF THE TREE WITH STAPLES AND THEN INTO THE GROUND.

Conductor run down the tree into the ground

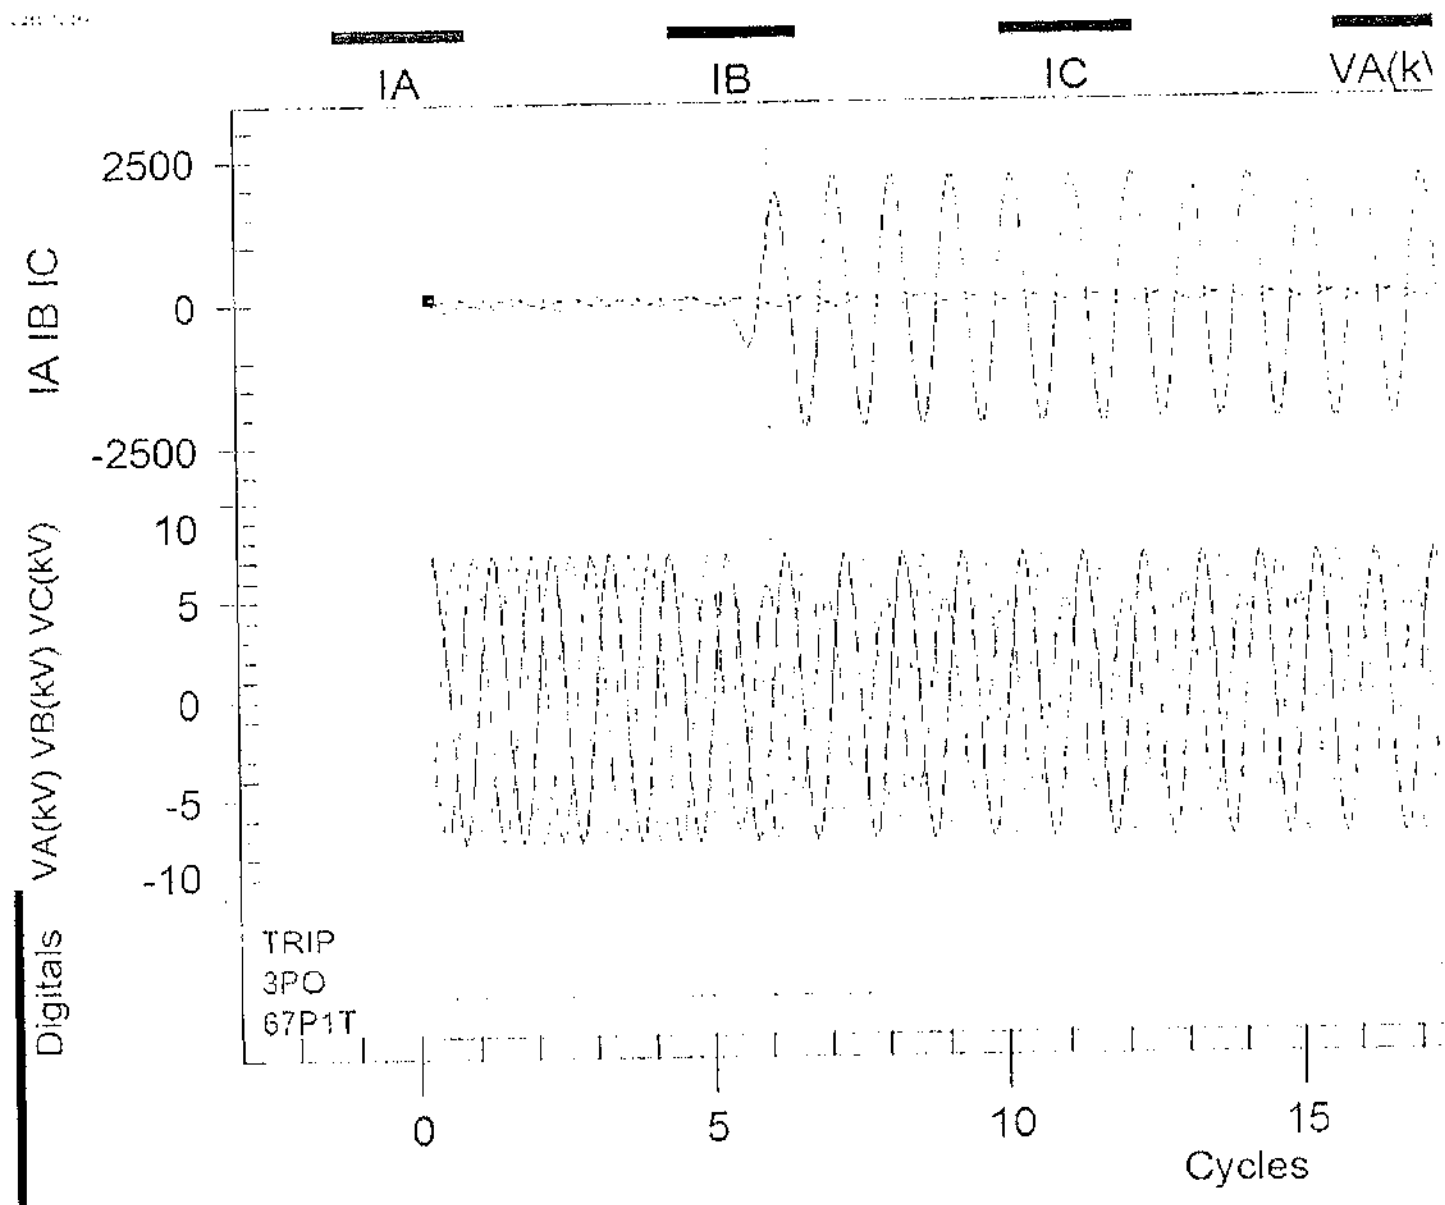
[LI DB1 14Aug2015 18:09](#)

Attached are the relay sequence of events for BEN 43L and OLI DB1 on 14Aug2015. BEN 43L did not trip and was manually opened only. OLI DB1 had two fault trips – one at 18:09 (C-phase to ground with 2900 Amps of fault current) then another event at 21:15 (B-C phase with 2800 Amps of fault current) – below are the event screen shots plus relay event record attached.

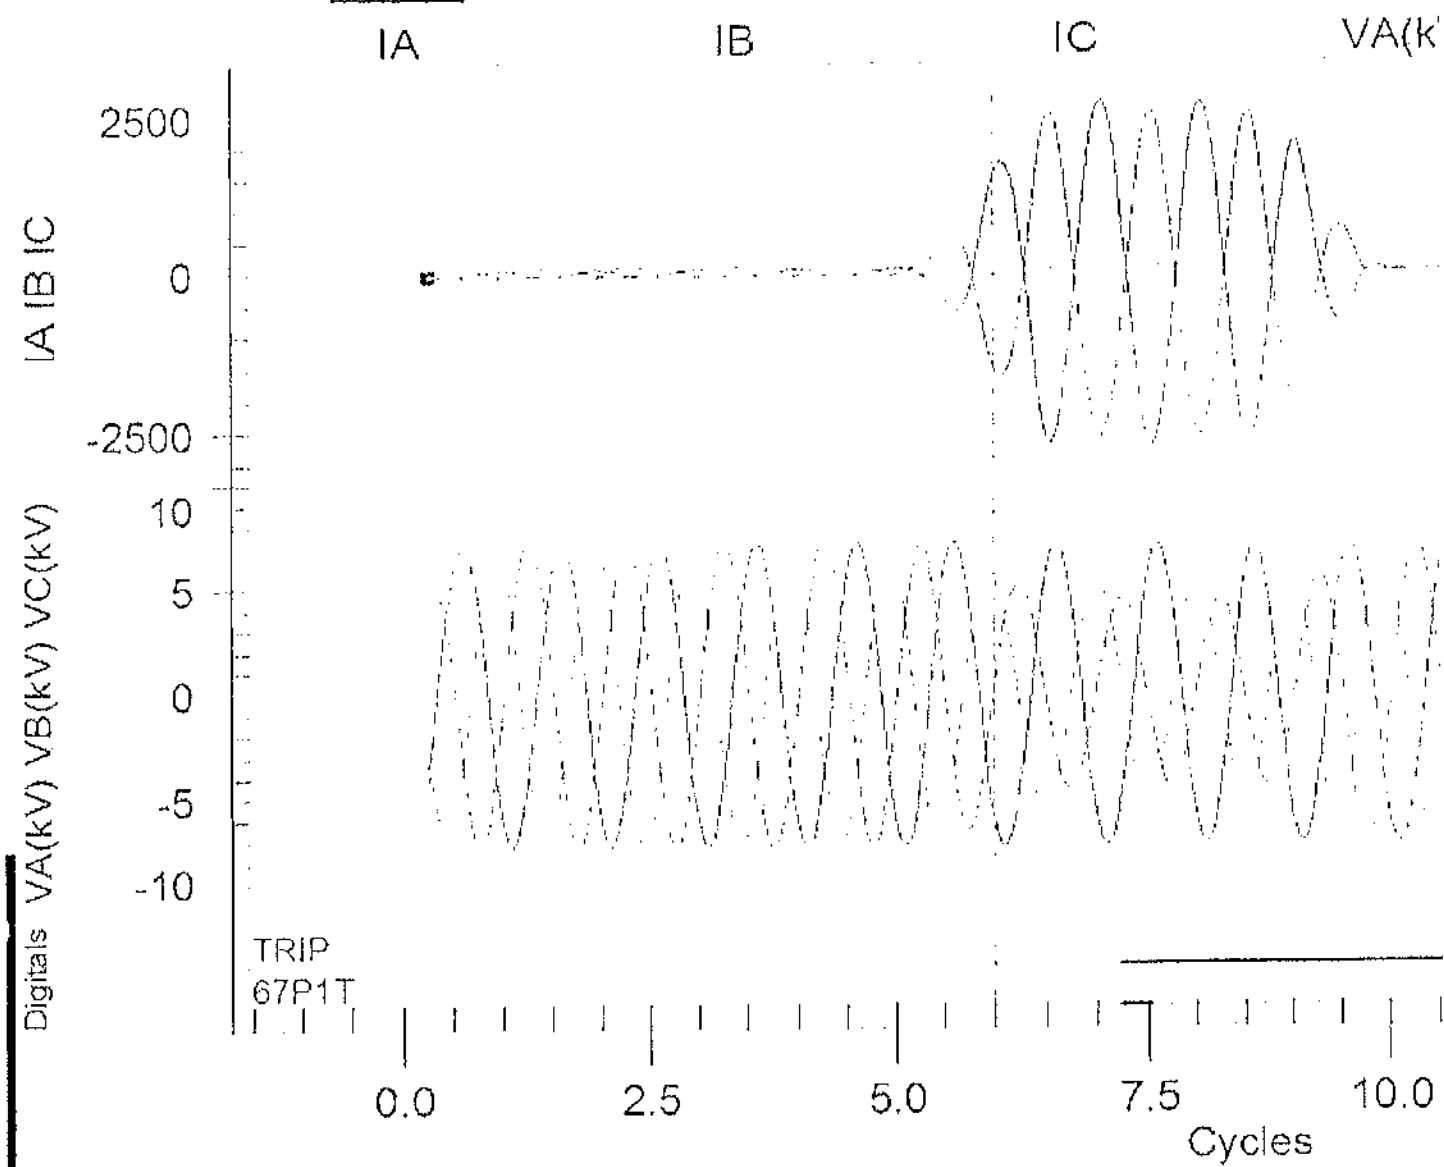
OLI DB1 14Aug2015 21:15
