KC GEOTECHNICAL CONSULTANTS LTD.

April 16, 1999

**Final Report on Geotechnical Stability Investigation
Clarke-Bromley Landslides, Princeton, BC**

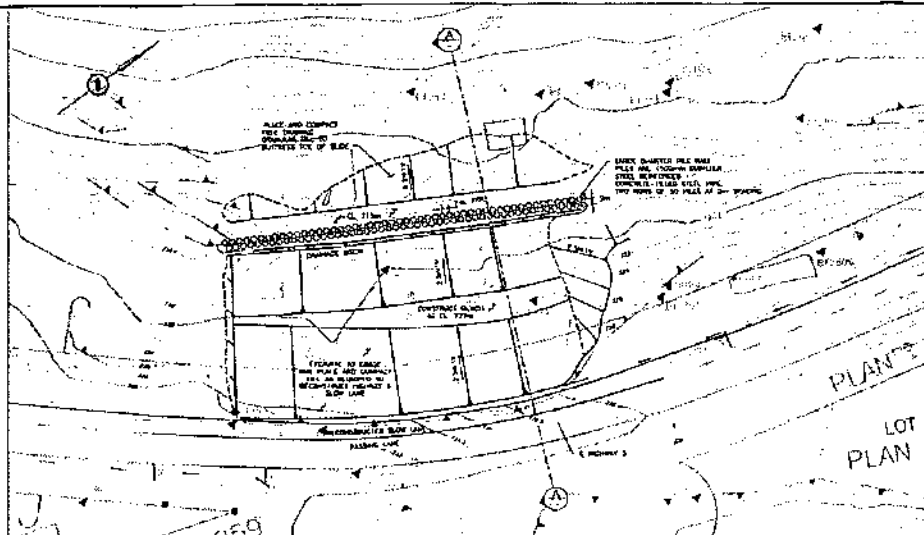
KC GEOTECHNICAL		BC MINISTRY OF TRANSPORTATION AND HIGHWAYS	
PROJECT	CLARK SLIDE REMEDIAL ALTERNATIVE 1 CONCRETE PILES	DATE	PC 0043 01
CLIENT	BC MINISTRY OF TRANSPORTATION AND HIGHWAYS	DATE	B-1006

POTENTIAL FAILURE SURFACE	STATIC FACTOR OF SAFETY (NORMINTEGRATED-PRICE METHOD)	SHEAR STRENGTH CONDITIONS
AA	1.01	RESIDUAL FRICTION ANGLES FOR ② AND ③ PEAK FRICTION ANGLE FOR ①
BB	0.89	RESIDUAL FRICTION ANGLES FOR ② AND ③
CC	0.95	RESIDUAL FRICTION ANGLES FOR ② AND ③
DD	1.00	RESIDUAL FRICTION ANGLES FOR ② AND ③
EE	1.19	RESIDUAL FRICTION ANGLES FOR ② AND ③

- NOTES:
- SEE DRAWING B-1003 FOR MATERIAL PROPERTIES AND STABILITY ANALYSIS METHOD.
 - THE TOPOGRAPHIC BASE PLAN WAS CORRECTED SURVEYED BY MATH. SLIP. 1998. TITLE = "CLARK, CORRECTED REMEDIAL ALTERNATIVE 1 CLARK SLIDE, PROJECTION".
 - THE ESTIMATED SHEAR STRENGTH OF THE CONCRETE PILES IS 708 KPa, OR 1.27 MN PER PILE. SHEAR STRENGTH PROVIDED BY THE STEEL PILES AND NEIGHBORING SILLS IS NOT INCLUDED.
